## FLYER TO THE FISHING INDUSTRY

### ***Purbeck Isle*: Foundering resulting in the loss of three lives**

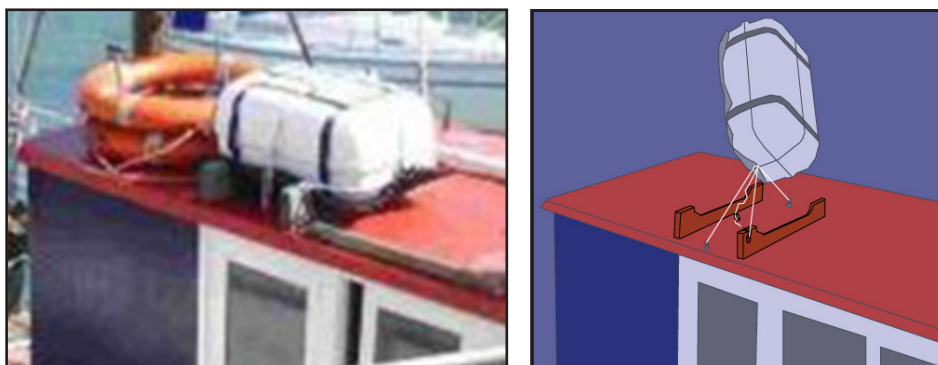
The investigation found that although the liferaft's HRU activated as designed, *Purbeck Isle's* liferaft failed to float free and automatically inflate because it had not been correctly stowed or secured in its cradle on the wheelhouse roof. Because the liferaft canister did not fit snugly into its cradle, the skipper had applied additional lashings to prevent it from falling off the wheelhouse roof in heavy seas. These additional lashings had been intertwined with the liferaft's main lashing rope and they prevented the raft from floating free.

However, had the liferaft floated free, it would not have automatically inflated because its painter had not been attached to the HRU's weak link. The liferaft had also been stowed upside down in its cradle. This would have allowed water to build up inside its canister, reducing its inherent buoyancy and increasing the likelihood of its inflation mechanism suffering from corrosion and failing.

Liferafts save many lives every year, but they are often found to be rigged incorrectly. In order to prevent similar failures in the future, fishing vessel owners are strongly advised to ensure that:

1. Liferafts are stowed and secured in accordance with the guidance provided in MGN 343 (M+F) ([www.dft.gov.uk/MCA/](http://www.dft.gov.uk/MCA/)).
2. They follow the instructions provided by liferaft and HRU manufacturers.
