FLYER TO THE FISHING INDUSTRY

***Purbeck Isle*: Foundering resulting in the loss of three lives**

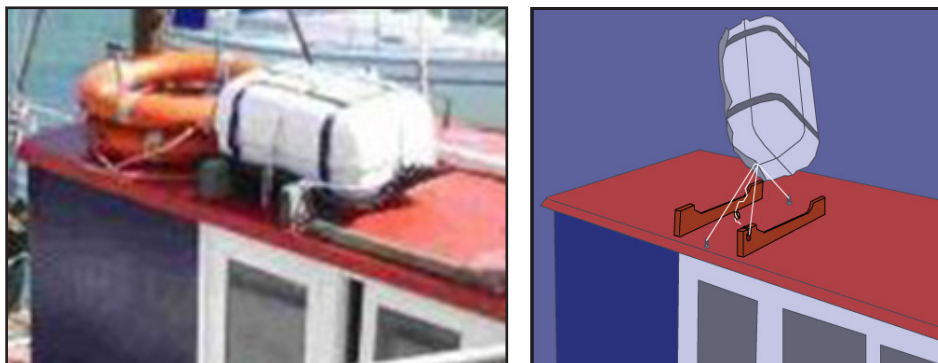
The investigation found that although the liferaft's HRU activated as designed, *Purbeck Isle's* liferaft failed to float free and automatically inflate because it had not been correctly stowed or secured in its cradle on the wheelhouse roof. Because the liferaft canister did not fit snugly into its cradle, the skipper had applied additional lashings to prevent it from falling off the wheelhouse roof in heavy seas. These additional lashings had been intertwined with the liferaft's main lashing rope and they prevented the raft from floating free.

However, had the liferaft floated free, it would not have automatically inflated because its painter had not been attached to the HRU's weak link. The liferaft had also been stowed upside down in its cradle. This would have allowed water to build up inside its canister, reducing its inherent buoyancy and increasing the likelihood of its inflation mechanism suffering from corrosion and failing.

Liferafts save many lives every year, but they are often found to be rigged incorrectly. In order to prevent similar failures in the future, fishing vessel owners are strongly advised to ensure that:

1. Liferafts are stowed and secured in accordance with the guidance provided in MGN 343 (M+F) (www.dft.gov.uk/MCA/).
2. They follow the instructions provided by liferaft and HRU manufacturers.
