MARINE ACCIDENT INVESTIGATION BRANCH

FLYER TO THE SHIPPING INDUSTRY Fatal accident to two crew members while transporting ferrous metal turnings

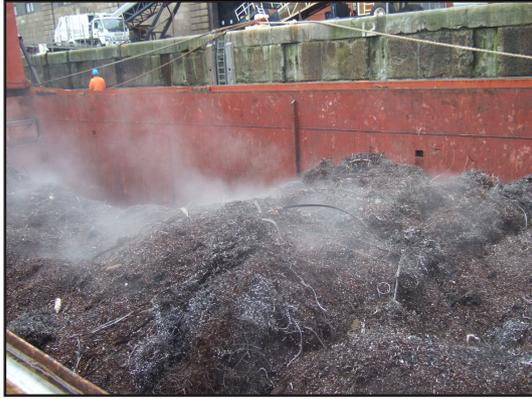
“Steel turnings”

The terminal managers in both loading ports did not consider the cargo to be hazardous, and the wet cargo was loaded in rain without trimming or measuring the cargo temperature. The correct Bulk Cargo Shipping Name (BCSN) for the IMDG Class 4.2 cargo was “ferrous metal borings, shavings, turnings, or cuttings in a form liable to self heating (UN No. 2793)”. A cargo that the ship’s Document of Compliance – Special Requirements for Ships Carrying Dangerous Goods, did not permit to be carried.

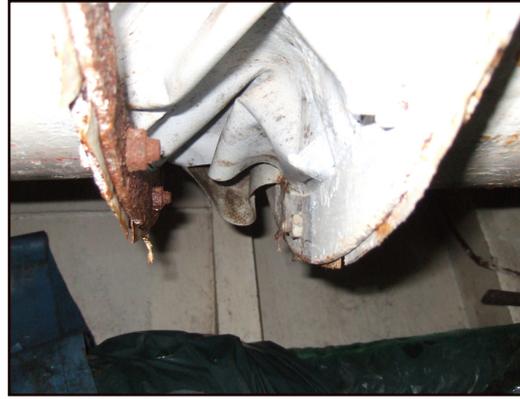
Cut ventilation duct

To allow for the drainage of sea water and the removal of cargo residue the crew had cut the cargo vent trunking bellows pieces either side of the cargo ventilation fan motor, located within the forward store. This action had provided an air path for the cargo hold atmosphere to enter the forward store, conceivably assisted by the panting of the fore part of the ship as she pitched.
