Published 14 August 2014

**CONTENTS****SPECIAL BULLETINS / INTERIM REPORTS**

S4/2014, B787-8	ET-AOP	12-Jul-13	3
-----------------	--------	-----------	---

<b>Aircraft Type and registration:</b>	B787-8, ET-AOP
<b>No &amp; Type of Engines:</b>	2 General Electric GENx-1B turbofan engines
<b>Year of Manufacture:</b>	2012 (MSN 34744)
<b>Location:</b>	London Heathrow Airport
<b>Date &amp; Time (UTC):</b>	12 July 2013 at 1534 hrs
<b>Type of Flight:</b>	Not applicable
<b>Persons on Board:</b>	None
<b>Injuries:</b>	Not applicable
<b>Nature of Damage:</b>	Extensive heat damage in upper portion of rear fuselage
<b>Information Source:</b>	AAIB Field Investigation

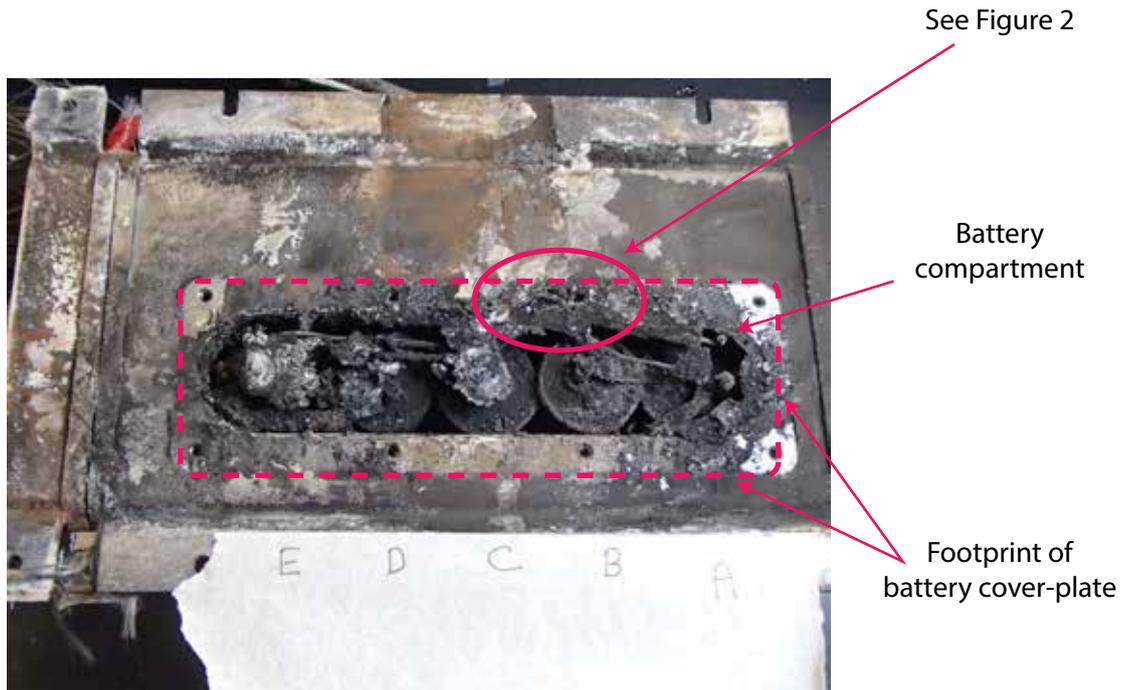
**Figure 1**

Significantly, the ELT battery wires were found to be improperly installed, in that they had been crossed and pinched together between the battery cover-plate and the ELT case, adjacent to one of the cover-plate fasteners (Figures 1 and 2). The cover-plate was notably bulged in this location, as the wires prevented it from sitting flush against the ELT case.

ELT case with battery cover-plate removed; tops of battery cells visible

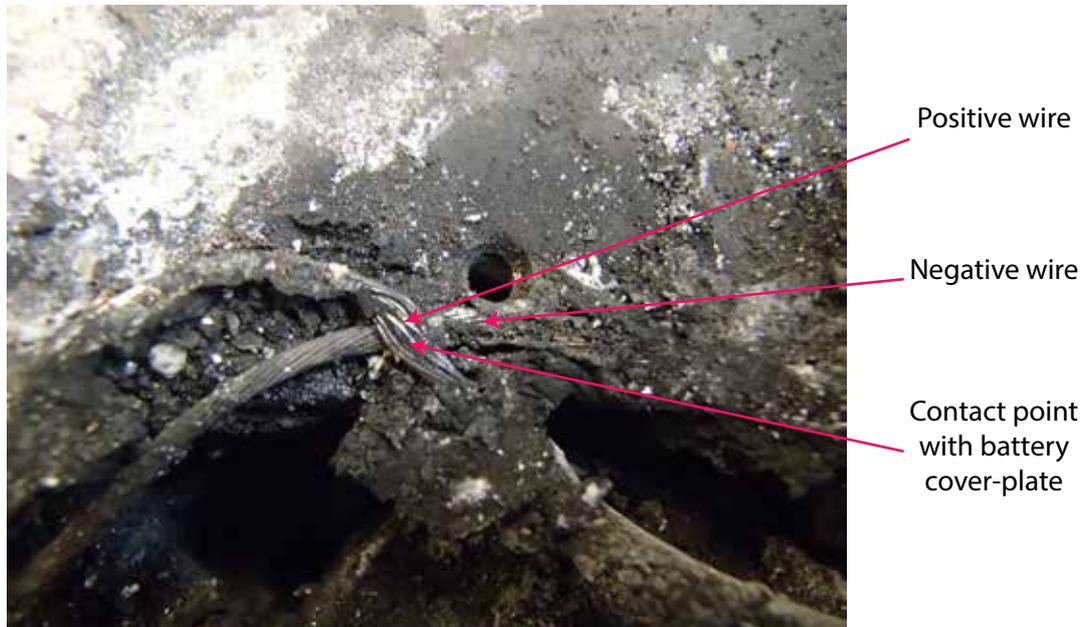
**Figure 2**

Due to the fire damage it was not possible to determine the pre-incident condition of the insulation in the area where the wires were pinched, nor the gasket which normally sits between the cover-plate and the ELT case. However, metallurgical analysis revealed strong evidence of metal-to-metal contact between the positive wire and the underside of the battery cover-plate. The surface treatment of the aluminium cover-plate had been worn away in the contact location, indicating that the integrity of the insulation may have become compromised over time, exposing the copper conductor to the cover-plate. The ELT case is electrically grounded to the aircraft Current Return Network. As such, direct

Crossed and pinched ELT battery wires

contact between the positive conductor and the cover-plate could have provided a path for current to flow through the battery circuit to electrical ground, essentially creating a 'short-circuit' condition.

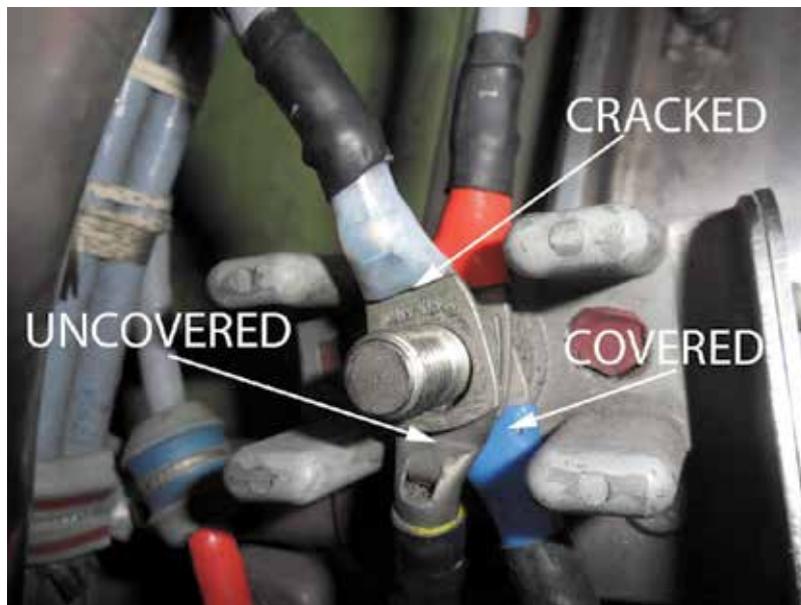
**Figure 7**

Cracked terminal lug from ground cable at T191 stud on G-GDFB's No 2 engine

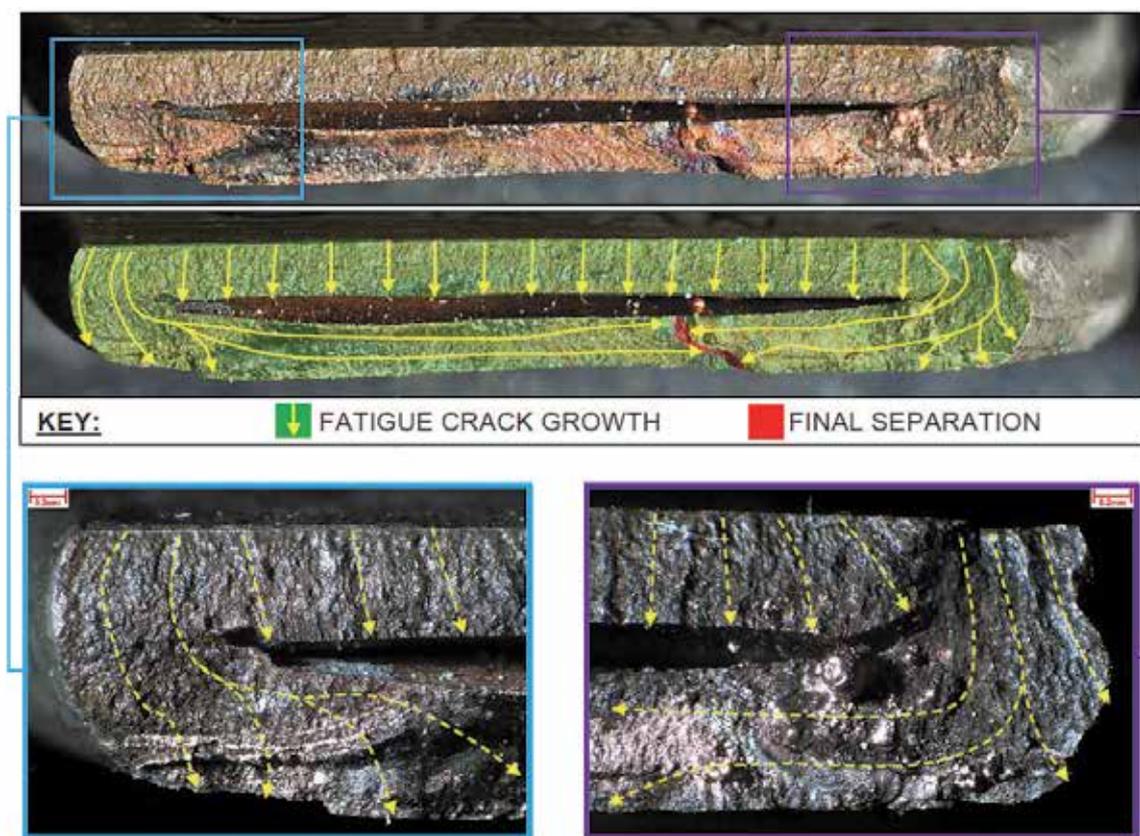
**Figure 9**

Detailed metallurgical analysis was carried out on the lugs from G-CELF, G-GDFB and G-CELL. The fracture surfaces of the failed lug on the end of the phase 'A' generator ground cable (G-CELF) are shown in Figure 9. This revealed that fatigue cracks had initiated at multiple sites on the lug's upper surface and then coalesced after a short distance to form a single crack front which propagated downwards to the centre of the lug, and then curved round the edges. The crack tips then propagated towards each other, along the lower wall, until they reached a point where the remaining section failed in overload. The large surface area of fatigue crack growth, compared with that of the final separation, indicated that the cyclic loading was of low magnitude, repeated for a large number of cycles.

Fracture surfaces of failed terminal lug on the end of the phase 'A' generator ground cable (G-CELF)
