AAIB Bulletin

3/2014

Published 13 March 2014

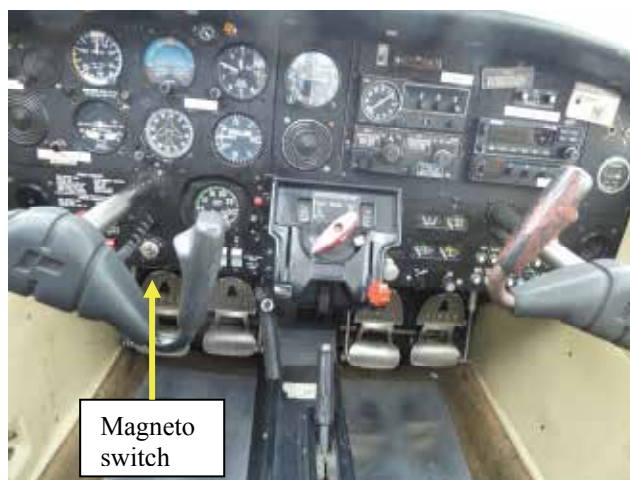
G-BGBN was equipped with four-point seat harnesses and one set of primary flying instruments positioned in front of the left seat position. The magneto switch was located beneath the left control yoke. Figure 2 shows the cockpit layout in a PA-38 similar to G-BGBN.

Location of primary flying instruments in a PA-38 similar to G-BGBN
