**FOLLOW-UP WORKS TO CRAMBER TOR  
ARCHAEOLOGICAL BASELINE  
CONDITION SURVEY, DARTMOOR  
TRAINING AREA.**

| Surveyed: | Jan-March 2008 |
| Contractor: | S Probert |
| Client: | Landmarc/Defence Estates |

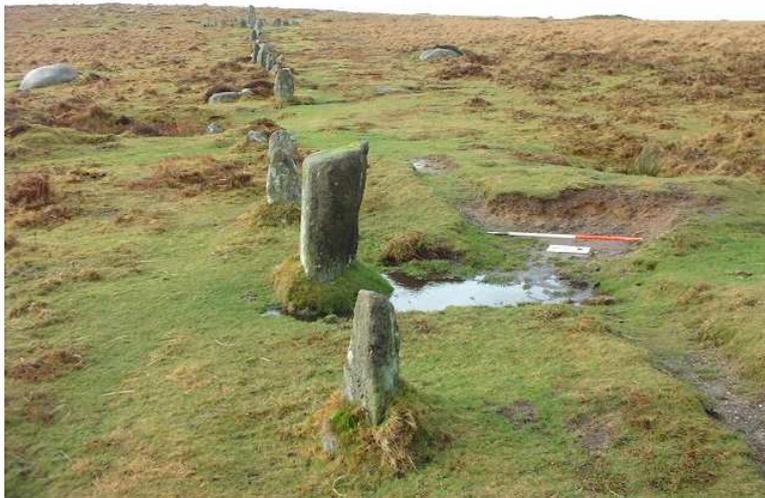
### 438583 Down Tor stone row

This monument is perhaps the major attraction for visitors to this area. Several of the stones exhibit erosion hollows at their bases, the result of being used as rubbing posts by livestock. These hollows are showing signs of regeneration as the numbers of grazing animals on this part of the moor continues to decline. The stones remain in a stable state but of more concern is the vegetation covering of the footpath immediately to the north of the row which has been denuded and, in places, removed exposing the peat and growan. This situation is exacerbated by wet weather and recedes during the drier periods of the year. This is a problem common to most of the lithic monuments on Dartmoor and in this case its effects are mitigated by the isolated nature of the site which draws relatively few visitors. At present the stones forming this monument are not in any immediate threat though monitoring of the adjacent footpaths should continue and military activity should be excluded from the immediate area.

**Fig 1** Footpath adjacent to Down Tor stone row. Probably the most extreme example of erosion

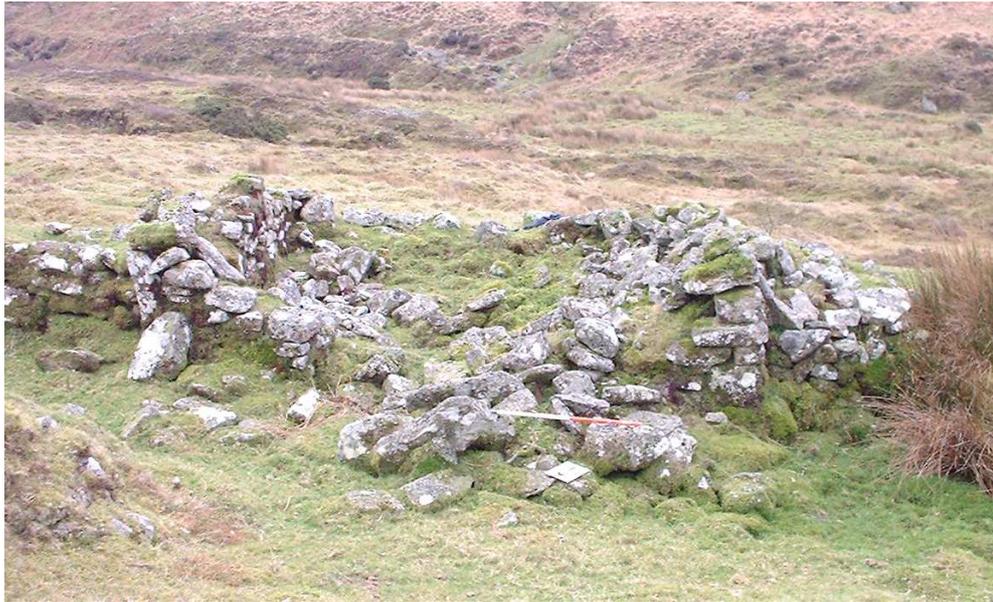
### 438852 Newleycombe Farmstead

In common with most of the abandoned structures on Dartmoor this ruined farmstead and its associated outbuildings act as magnets for visitors and livestock seeking shelter. While there is evidence of past disturbance to these remains in the form of dislodged and rearranged stonework there are no signs of fresh disturbance in the period since the recorded date of the last investigation by English Heritage in August 2006.

**Fig 2** Former outbuilding at Newleycombe farmstead

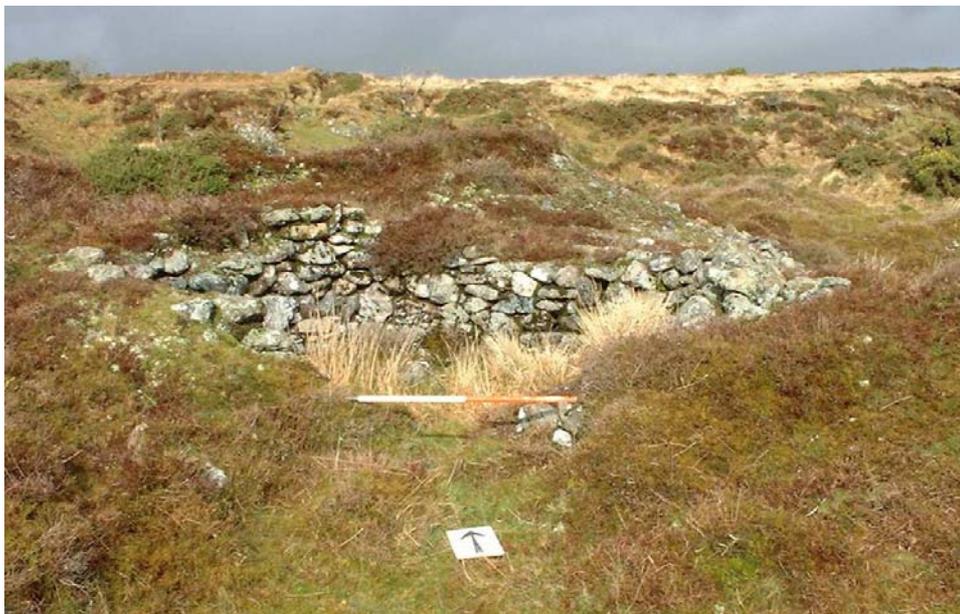
**438971** Tinnerns Hut

This former structure remains in a stable condition though it apparently attracts a number of human visitors. There is evidence to suggest the creation of small fire rings in the level interior in the recent past though the stones appear to have been derived from the surrounding area rather than the walls of the structure. A small amount of litter was removed from the interior.

**Fig 3** Tinnerns' hut amidst streamworking remains on Newleycombe Lake

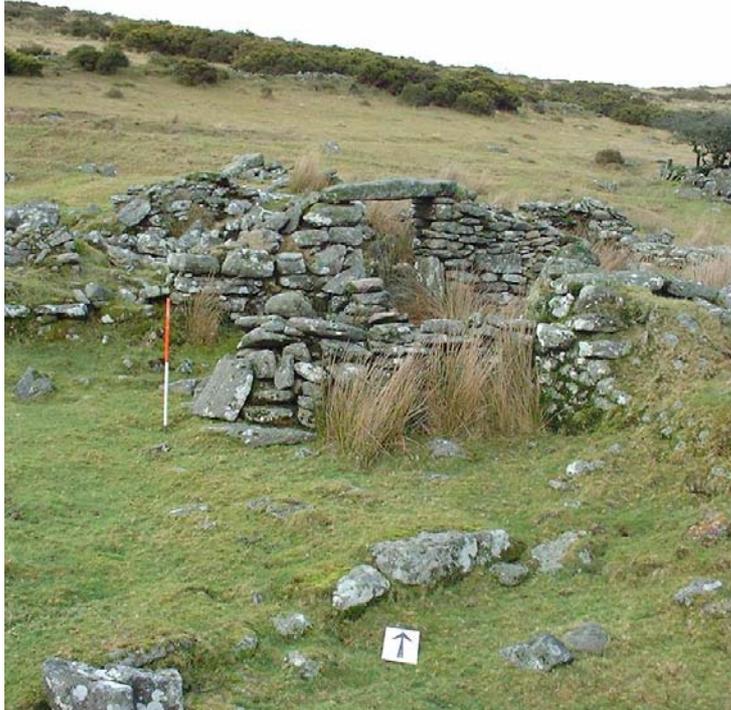
**440219** Classiwell Farmstead

This site lies in a very exposed position almost adjacent to Raddick Lane and in the past has suffered from stone removal and displacement. It now exists in a stable condition with no evidence to suggest recent disturbance.

**Fig 4** The main structure at Classiwell farmstead

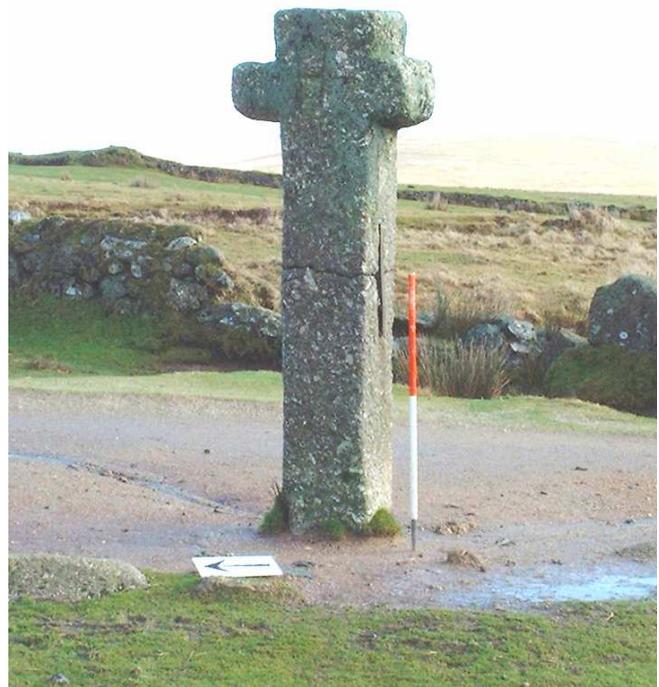
**441591** Siwards/Nun's Cross  
SX 60176991

An erosion hollow at the base of this feature has been refilled in recent years. This fact coupled with the decline in the amount of livestock grazing this part of the moor has largely removed the threat to the cross. Though the area around the base of the cross does not possess a covering of vegetation, there is no suggestion that the former erosion hollow will be re-established in the near future.

**Fig 5** Siwards/Nuns Cross. This feature lies on a popular footpath between Princetown and Eylesbarrow

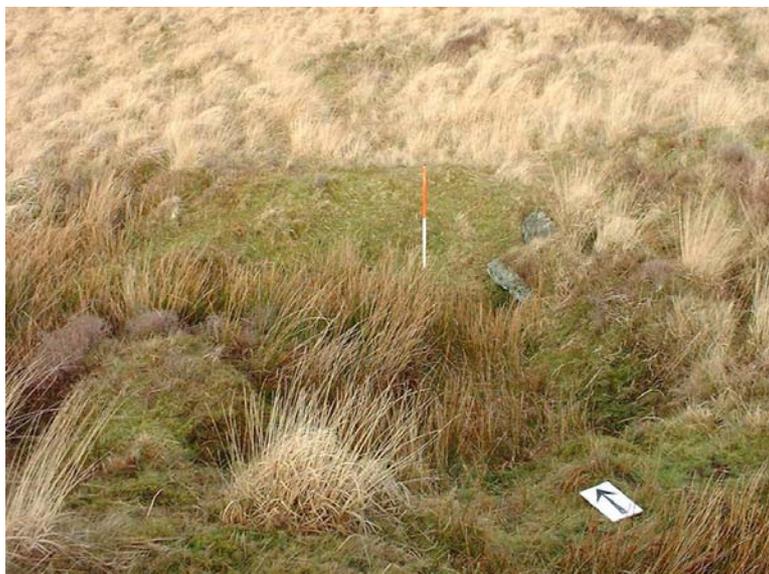
**1446125** Tinnners' Hut

Although this feature lies in an isolated position divorced from the network of footpaths in this area it has attracted a number of human visitors. Again there is no evidence of recent deliberate damage though a significant amount of civilian litter was removed from the interior.

**Fig 6** The remote tinnners' hut on Chants Hill

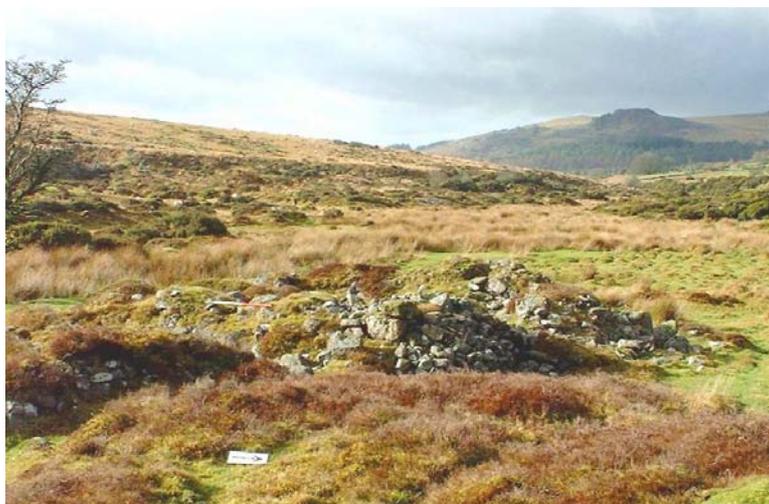
**1446210** Tinnners' Hut

This substantial former structure again displays signs of past disturbance though few signs of recent activity. Several stones in the interior show fresh, unweathered faces and appear to have been randomly moved. Their disturbance is probably a consequence of livestock seeking shelter amidst the ruins.

**Fig 7** Tinnners' hut in streamworking remains flanking Newleycombe Lake

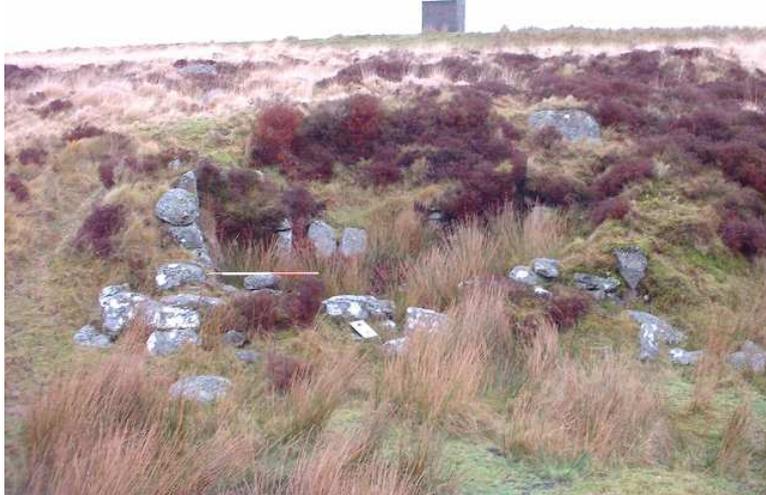
**1446519** Tinnners' Hut

Again there is no evidence to suggest recent intentional disturbance to this monument despite its proximity to the well-used footpath adjacent to the Devonport Leat.

**Fig 8** Tinnners' hut at Drivage Bottom. Devonport Leat service hut in background

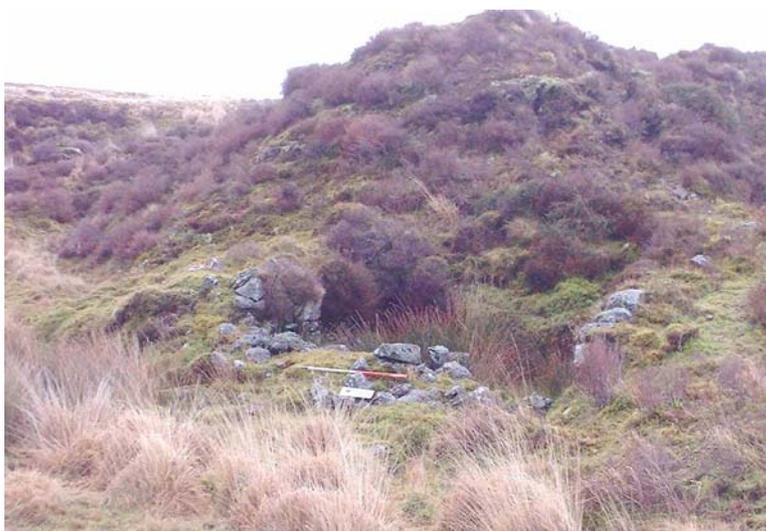
**1146523** Tinnners' Hut

Though this well-concealed feature lies in an isolated position it has not escaped disturbance in the relatively distant past. The interior has been crudely subdivided by the construction of a low boulder wall though there is no evidence to suggest any recent activity on the site which also remains litter free.

**Fig 9** Tinnners' hut on the upper reaches of Newleycombe Lake

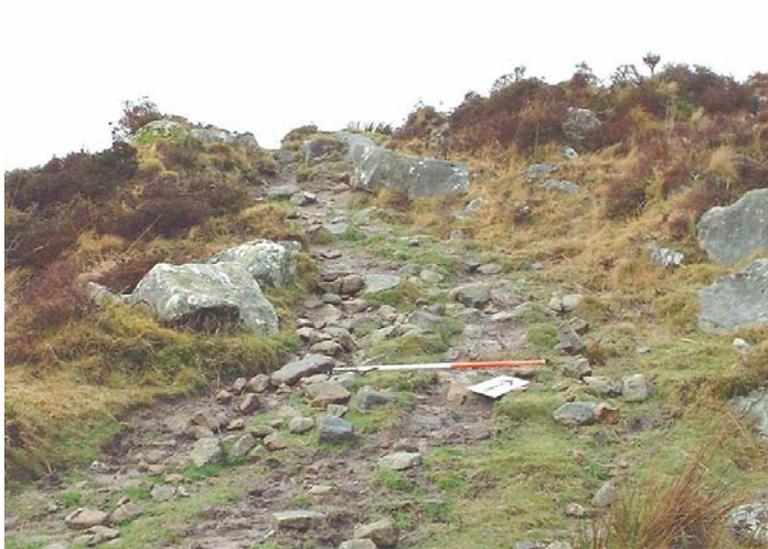
**1448375** Streamworks

This massive feature covers several hectares flanking the Narrator Brook and possesses relatively few crossing points. The main crossing lies at SX 59176921 and carries the bulk of human and livestock traffic across this part of the moor. At this point the sides and base of the working have been denuded of vegetation and, in

places, eroded. However, the affected area consists of a relatively thin strip of land the location of which is determined by local topography. There appears to be little chance of the damage spreading to adjacent areas and the gradual decline of this ribbon should be tolerated. The creation of alternative routes is impractical in this area.

**Fig 10** Footpath erosion on the northern bank of the Narrator Brook. At the time of investigation, 4<sup>th</sup> February, hoof prints greatly outnumbered footprints

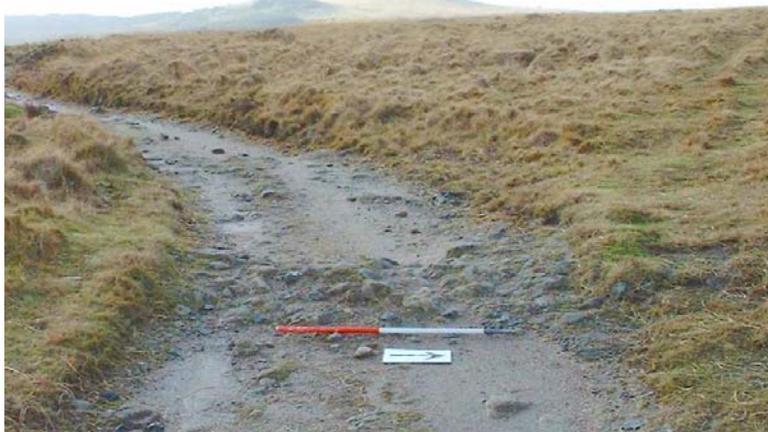
**1450575** Reave

This low stony bank is only visible where exposed by the Nosworthy to Peat Cot track and it appears to be a remarkably robust feature. There is no evidence to suggest any deterioration since it was first recorded and photographed by English Heritage in August 2006. The track carries a large number of pedestrians and is occasionally used by vehicles servicing the surrounding area. It should be noted that the strength of this feature rests on its integrity; once stones are loosened or removed its disintegration will probably follow quite rapidly.

**Fig 11** 1450575. Reave at threat from vehicle damage

The condition of this reave should continue to be monitored and, in the event of any deterioration a small excavation should be considered.

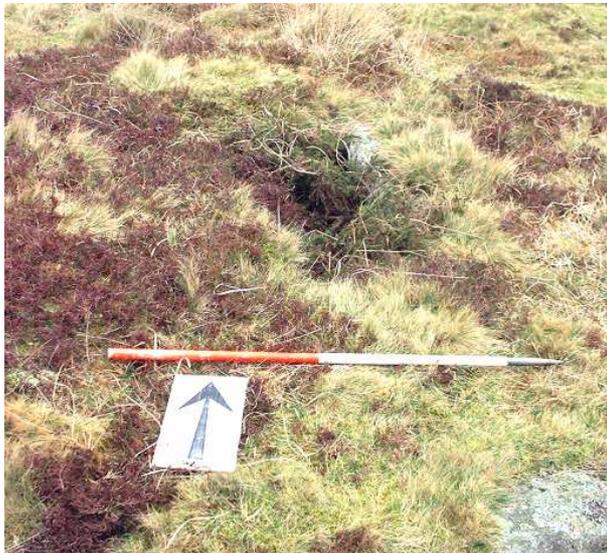
#### 438861 Three cairns containing cists

This unusual cluster of prehistoric sepulchral monuments was threatened by small scale gorse encroachment. In particular the easternmost cist was occupied by a young gorse bush which, if allowed to mature, would severely disrupt any surviving deposits. A second, larger bush was removed from the northern cist. Despite being depicted on all current maps of the area these features are difficult to locate and are not deemed to be subject to any additional threats.

**Fig 12** The eastern cist before gorse removal

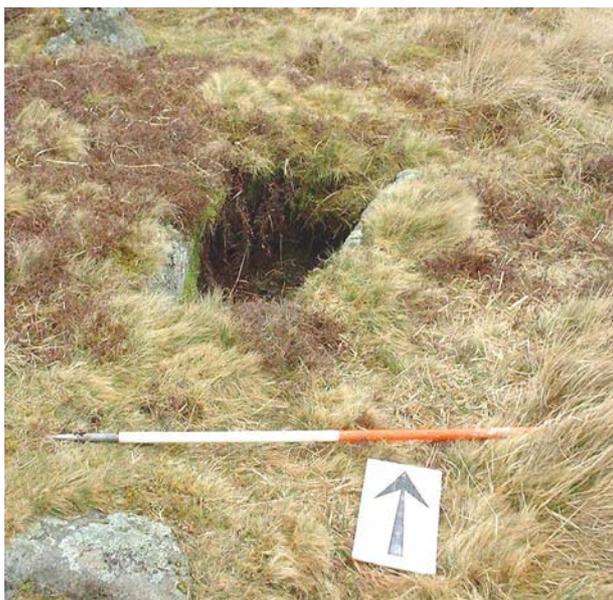
**Fig 13** The eastern cist after gorse removal

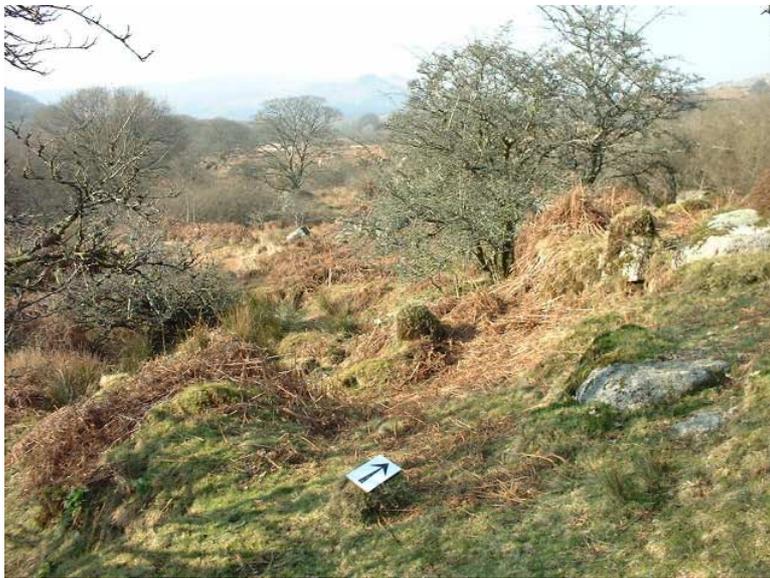
**438999** Combeshead Mine

The stability of the processing area of the former Combeshead tin mine was threatened by three mature thorn trees rooted in structural elements of the site. Two trees lay in the north wall of the site overhanging the dressing floor, the third in the wheelpit.

**Fig 14** The site of Combeshead Mine before clearance. The tree in the middle left occupies the former wheelpit

The trees were reduced to stumps and the brash deposited beyond the northwestern boundary of the site. A large amount of rubbish, mostly drinks cans and bottles were removed from the site by the clearance contractors.

This site lies adjacent to the main footpath between Deancombe and Combeshead Tor and as such makes it vulnerable to interference and accidental damage. It would be advisable to monitor the condition of this site on an occasional basis and remove any further litter.

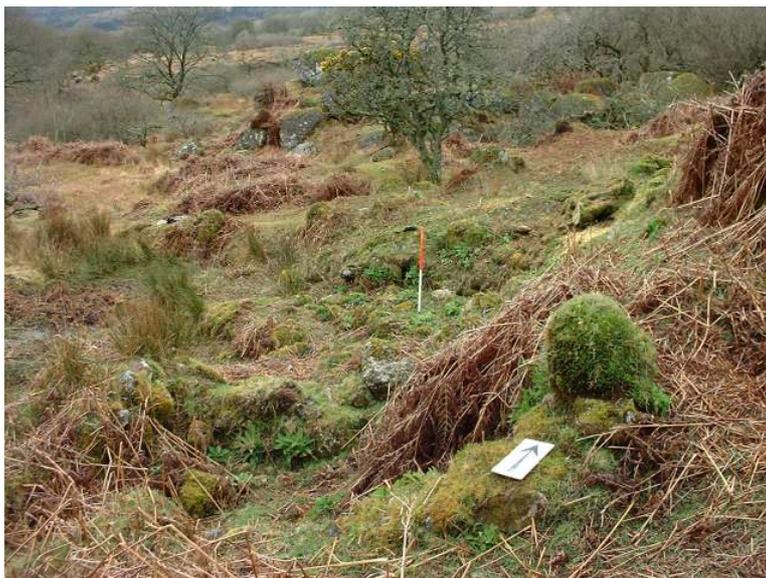
**Fig 15** Combeshead Mine, view of processing area after clearance

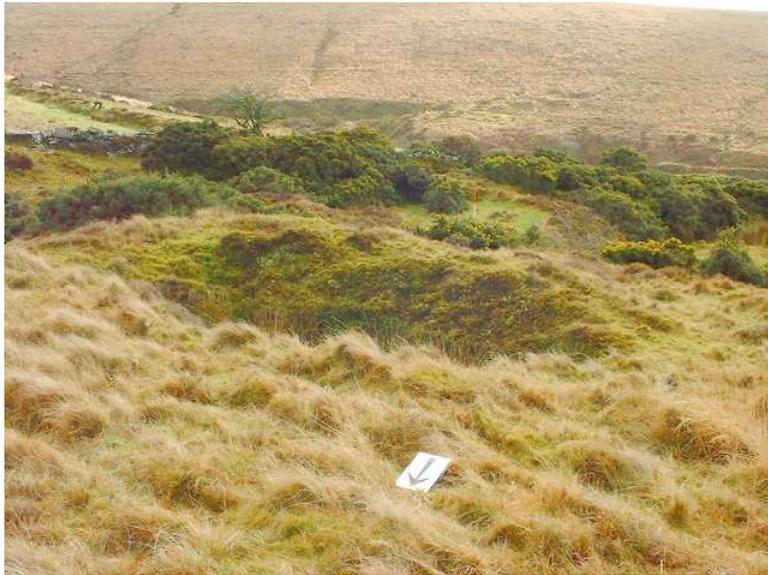
**1446155** Tinworks

Three hectares of probable post-medieval tinworks northeast of Newlycombe Farmstead are largely obscured by gorse. The majority of the visible remains appear to consist of shallow shafts, water channels and linear spoil heaps, typical of monuments of this type on Dartmoor. However, amongst these earthworks were traces of an 18<sup>th</sup> or 19<sup>th</sup> century whim platform and associated shaft.

**Fig 16** 1446155 before clearance. Whim platform, middle distance, and shaft middle left

Clearance of the entire site would serve little benefit and it was decided to concentrate on the more salient later features. The gorse was cleared to expose the whim platform and shaft and the brash removed from the site.

The exposed features are robust earthworks distanced from footpaths and are not subject to any potential threats. This area should be flagged for further archaeological investigation following a controlled or accidental burn.

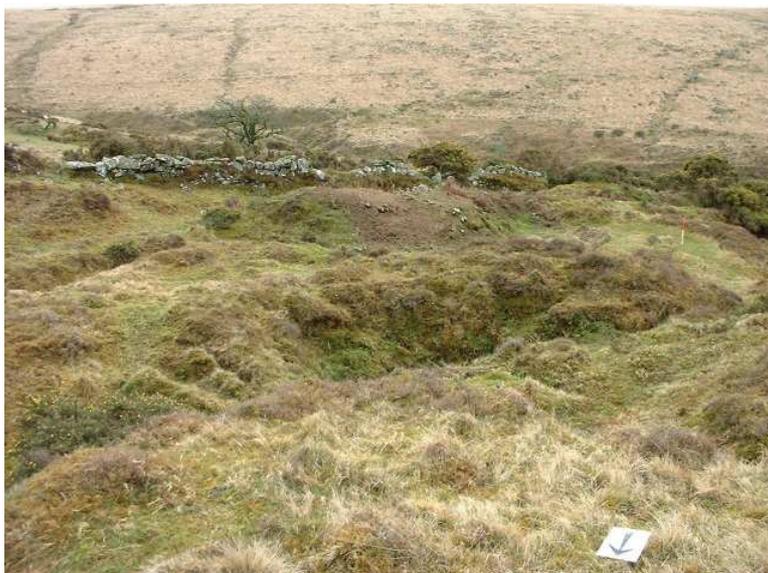
**Fig 17** 1446155 after clearance

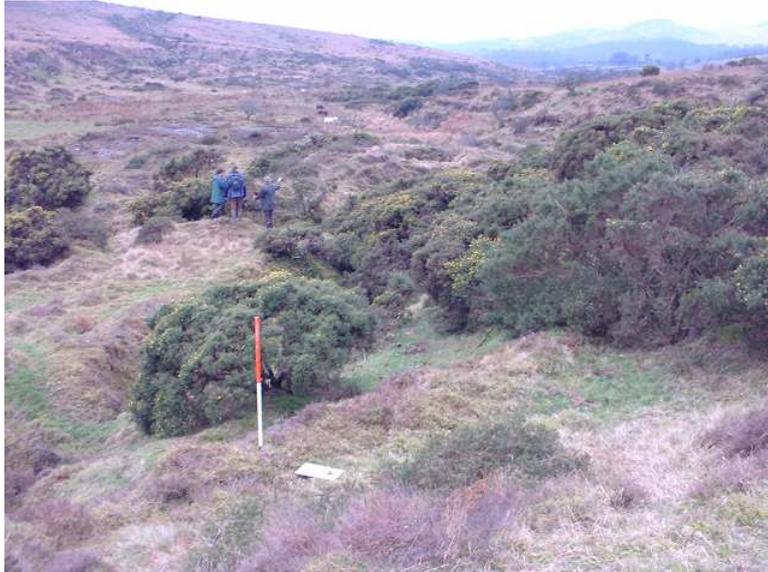
**1446207** Plym Consols Mine

The main shaft, processing area and mine building of Plym Consols tin mine were largely obscured by mature gorse at the time of the English Heritage survey. The structural integrity of the stonework forming several of these features was potentially threatened by the vegetation which also served to hamper the investigation of the remains.

**Fig 18** Plym Consols Mine before clearance

An area of approximately 0.2 hectares was cleared of gorse exposing the wheelpit, shaft, drainage channels and dressing floor. The mine building, to the north of this complex, was also cleared of gorse.

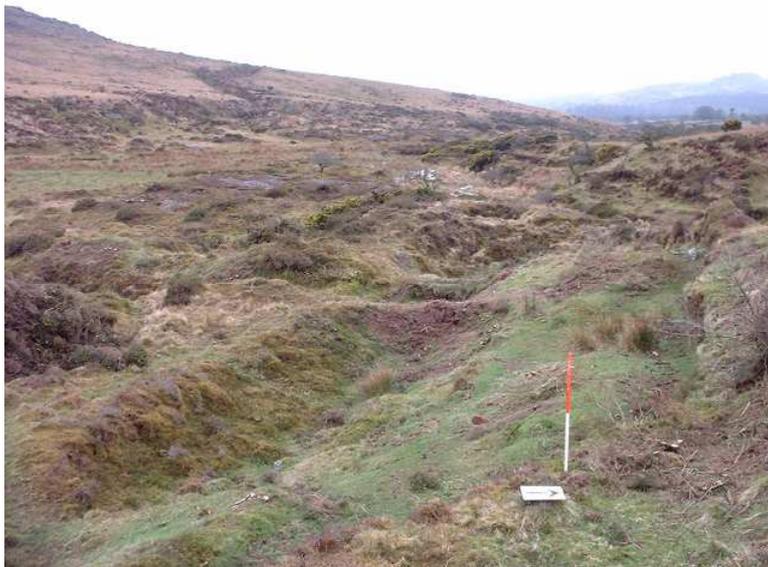
Potential threats to this site have been removed.

**Fig 19** Plym Consols Mine after clearance. Processing area and wheelpit in centre of photograph, shaft and bob pit beyond

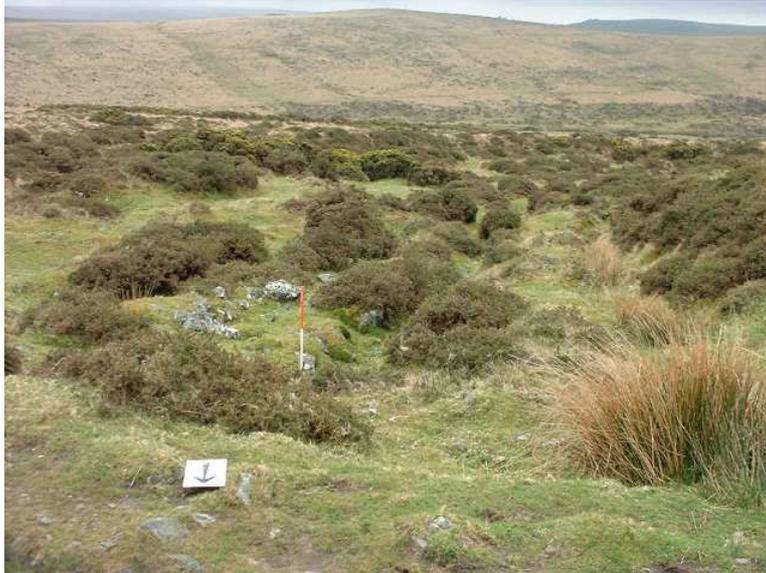
**1446217** Tinworks

Approximately 3.5 hectares of tin Streamworks on the north side of the Newleycombe valley are obscured by gorse. The earthworks are similar in form to 1446155 above but do not appear to contain any features of significance. In this case the gorse is acting as a barrier to interpretation rather than as a threat to the heritage resource, its clearance would present little short term benefit. This site should be flagged for re-examination if the area is subject to a controlled or accidental burn.

**Fig 20** Streamworking remains 1446217. Gorse obscuring the characteristic water channels and linear spoilheaps

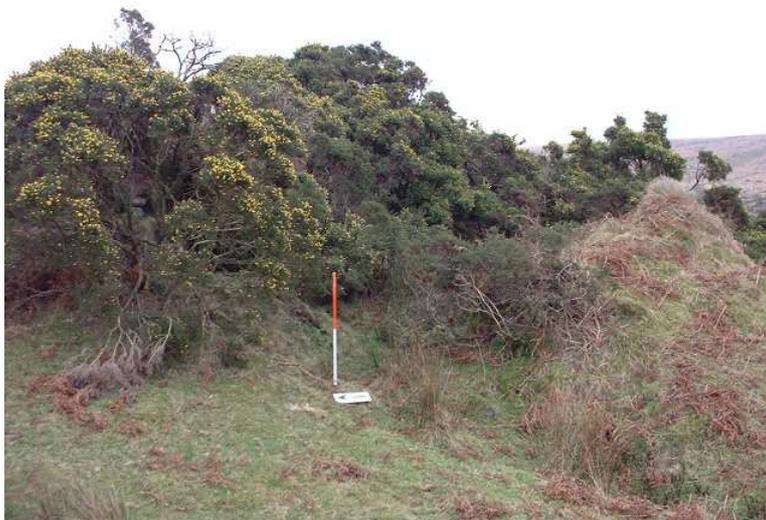
**1448366** Dressing Floor

A tin dressing floor and associated structure on the north bank of Newleycombe Lake had become overrun with gorse prior to the English Heritage survey. The walls of the structure were threatened by root action while the dressing floor was becoming obscured with a potential threat to sub-surface deposits.

**Fig 21** 1448366 The associated structure before clearance

Both elements of this site were cleared, the brash deposited beyond the east and west boundaries of the site.

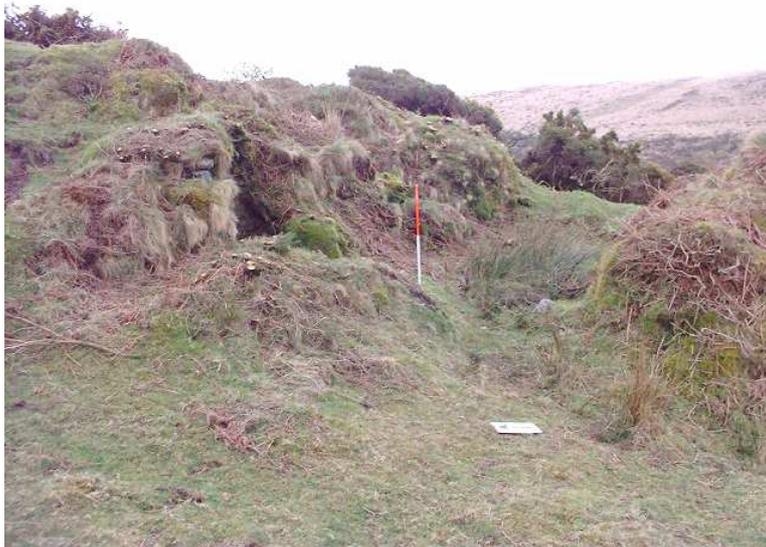
This monument is divorced from the footpath network and no longer subject to potential threats.

**Fig 22** 1448366 The structure after clearance
