Rail Accident Investigation Branch

# Rail Accident Report

## **Collision between a train and a car at Jetty Avenue level crossing, Woodbridge, Suffolk 14 July 2013**

Report 28/2014  
December 2014

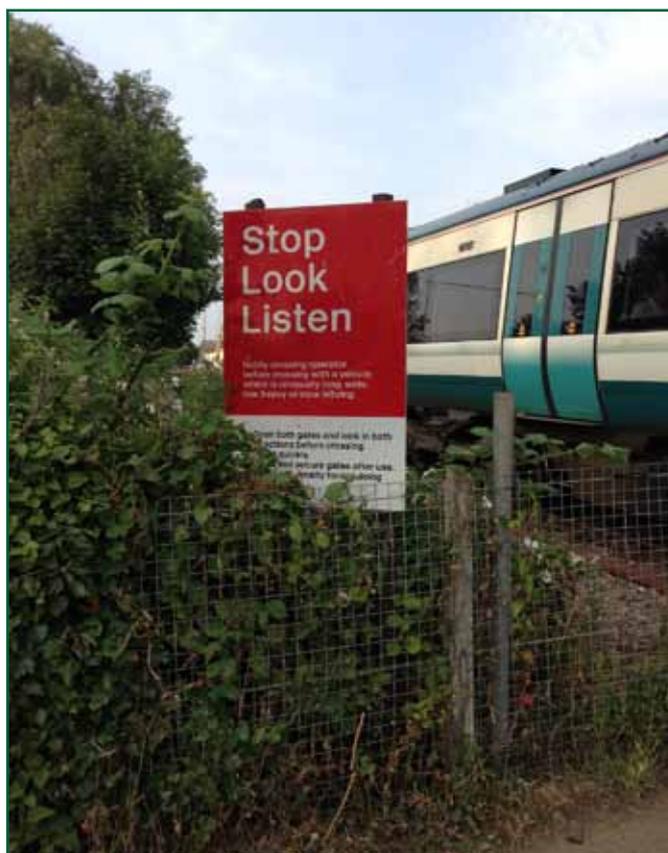
- 17 A sign at the crossing, partly obstructed by vegetation (figure 5), instructed vehicle users to:

Figure 5: 'Stop Look Listen' sign to car driver's left  
(photograph courtesy of Network Rail)

- 66 A vehicle driver stopping behind the sign in the manner of a normal road 'stop' sign would have found it difficult to see approaching trains from either direction due to vegetation and other obstructions (figures 5 and 10).

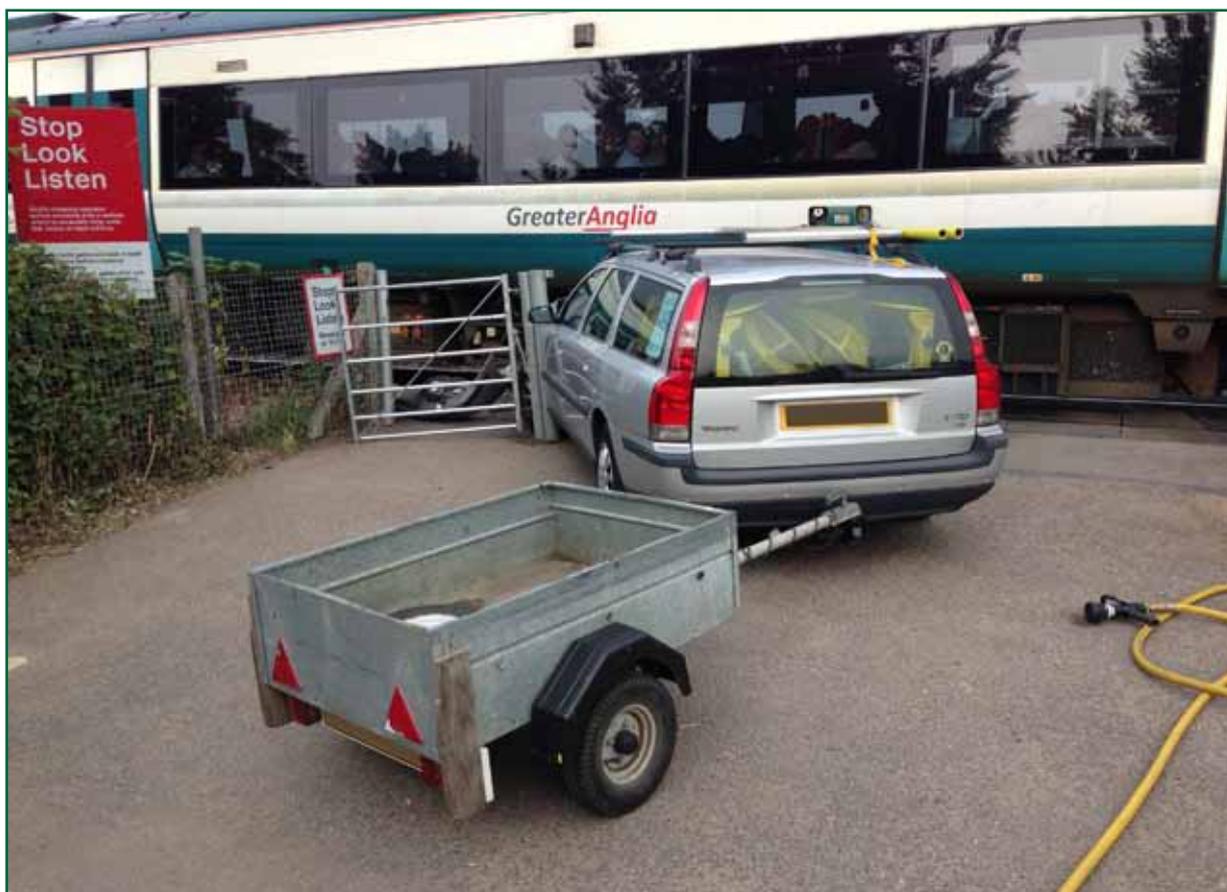
- 31 Minor damage was caused to the train, but the car was seriously damaged and the car driver suffered minor injuries.

Figure 6: Collision between car and train (photograph courtesy of Network Rail)

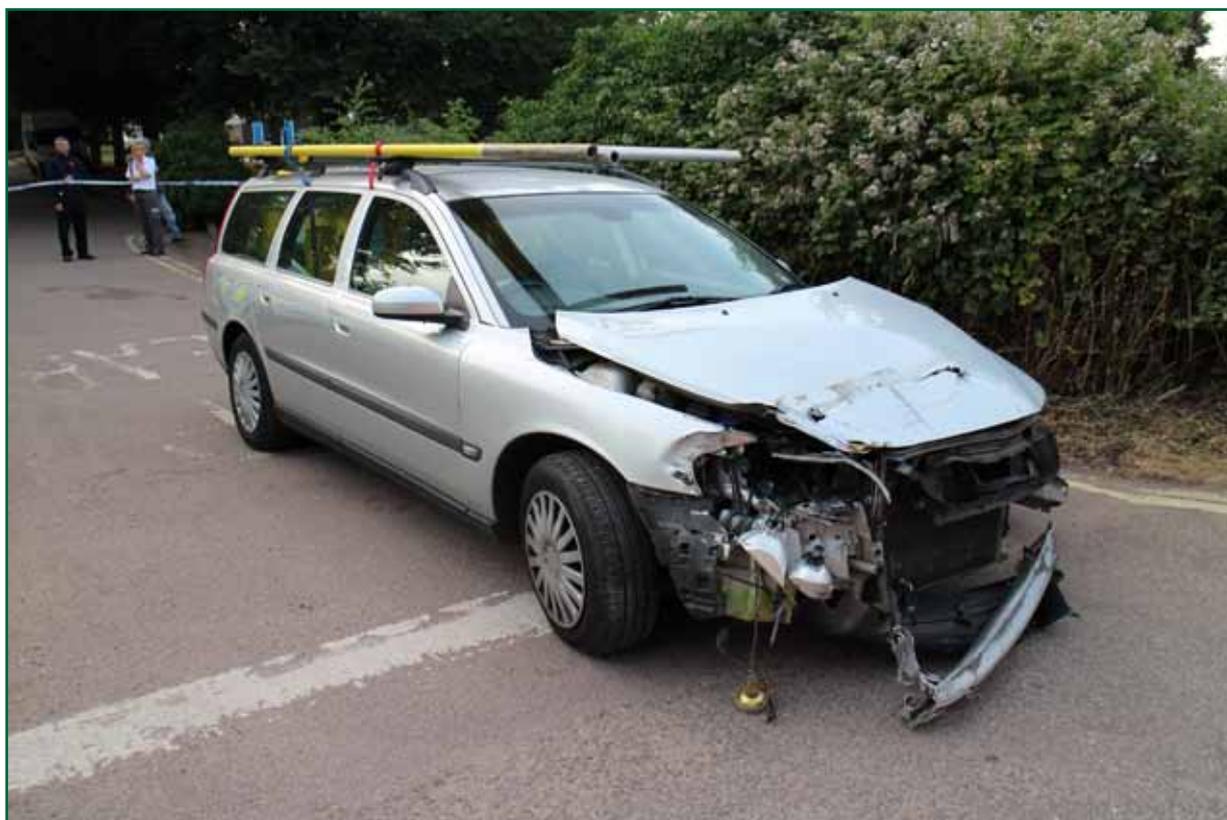
Figure 7: Damage to front of car (photograph courtesy of Network Rail)

- 61 Damage to the front of the car (figure 7) indicates that the first 0.5 metres of the car was foul of the train at the moment of collision. As the car did not reverse and the train overhung the rail by about 0.5 metres (paragraph 47), this indicates that the front bumper of the car had stopped approximately above the first rail encountered by the car (figure 12). The car driver's viewing (eye) position was between 2.1 and 2.4 metres behind the front bumper (depending on whether he was leaning forwards in his seat).

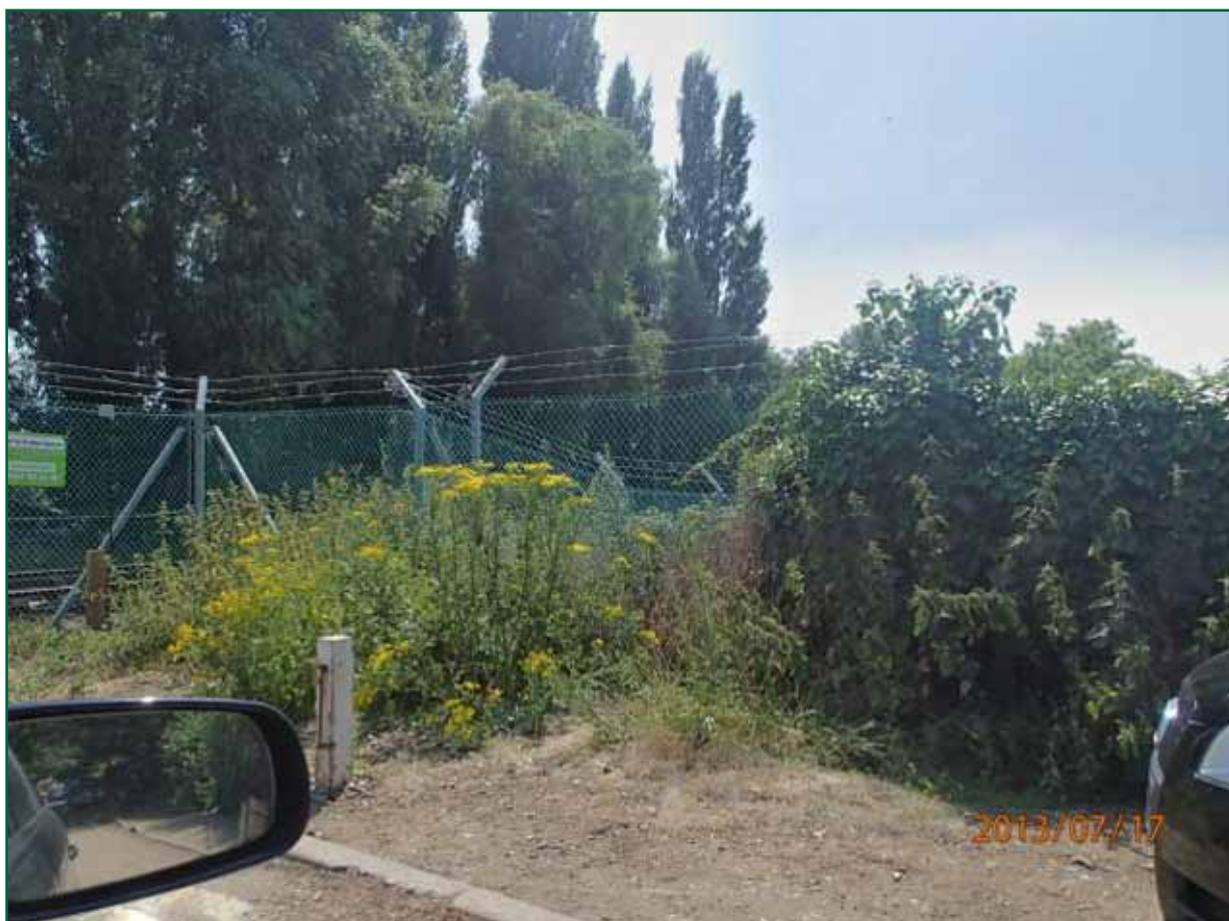
Figure 9: Car driver's view from behind stop line, 8 metres from the nearest rail

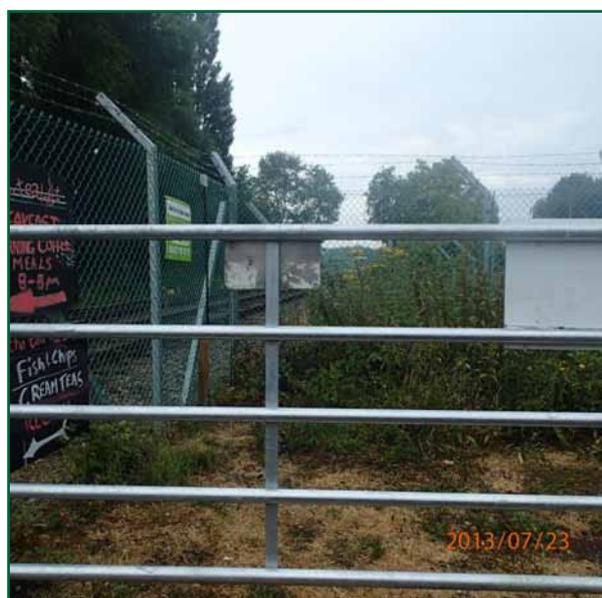
Figure 10: Car driver's view of railway approximately 4 metres from the nearest rail

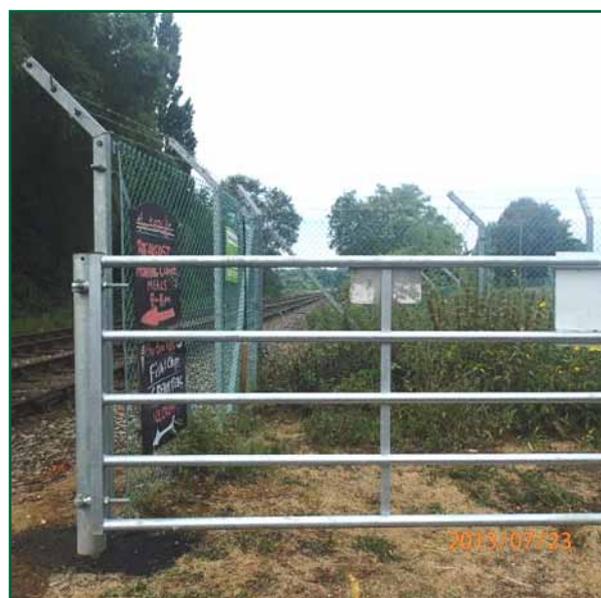
Figure 11: Car driver's view of railway approximately 3 metres from the nearest rail

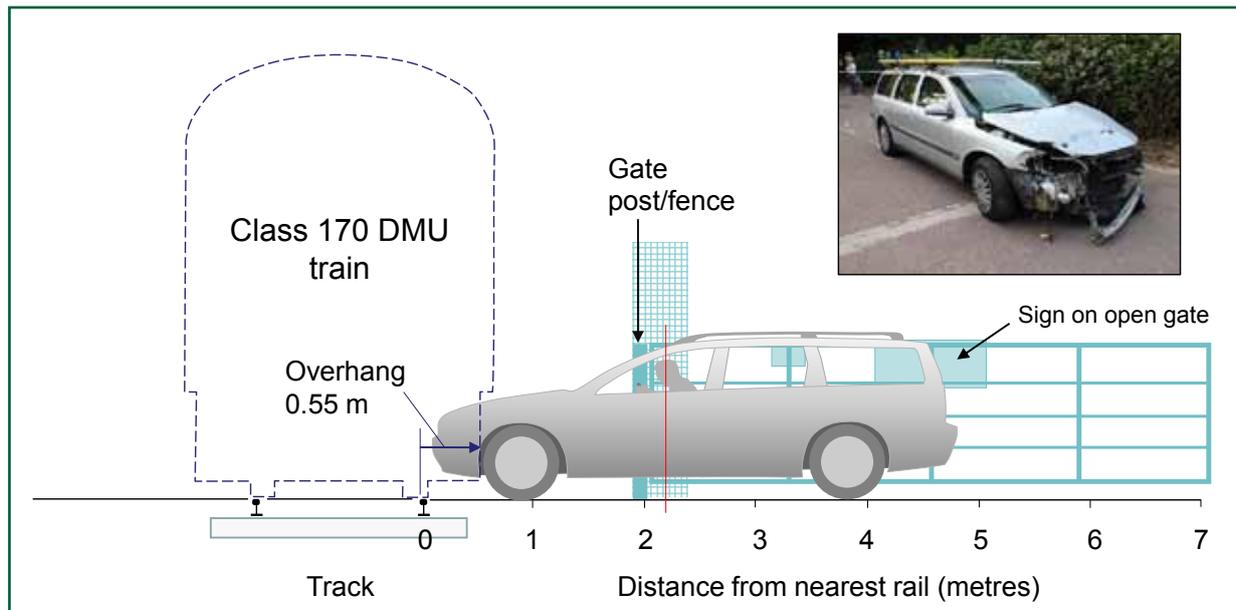
Figure 12: Diagram showing position of car at moment of collision

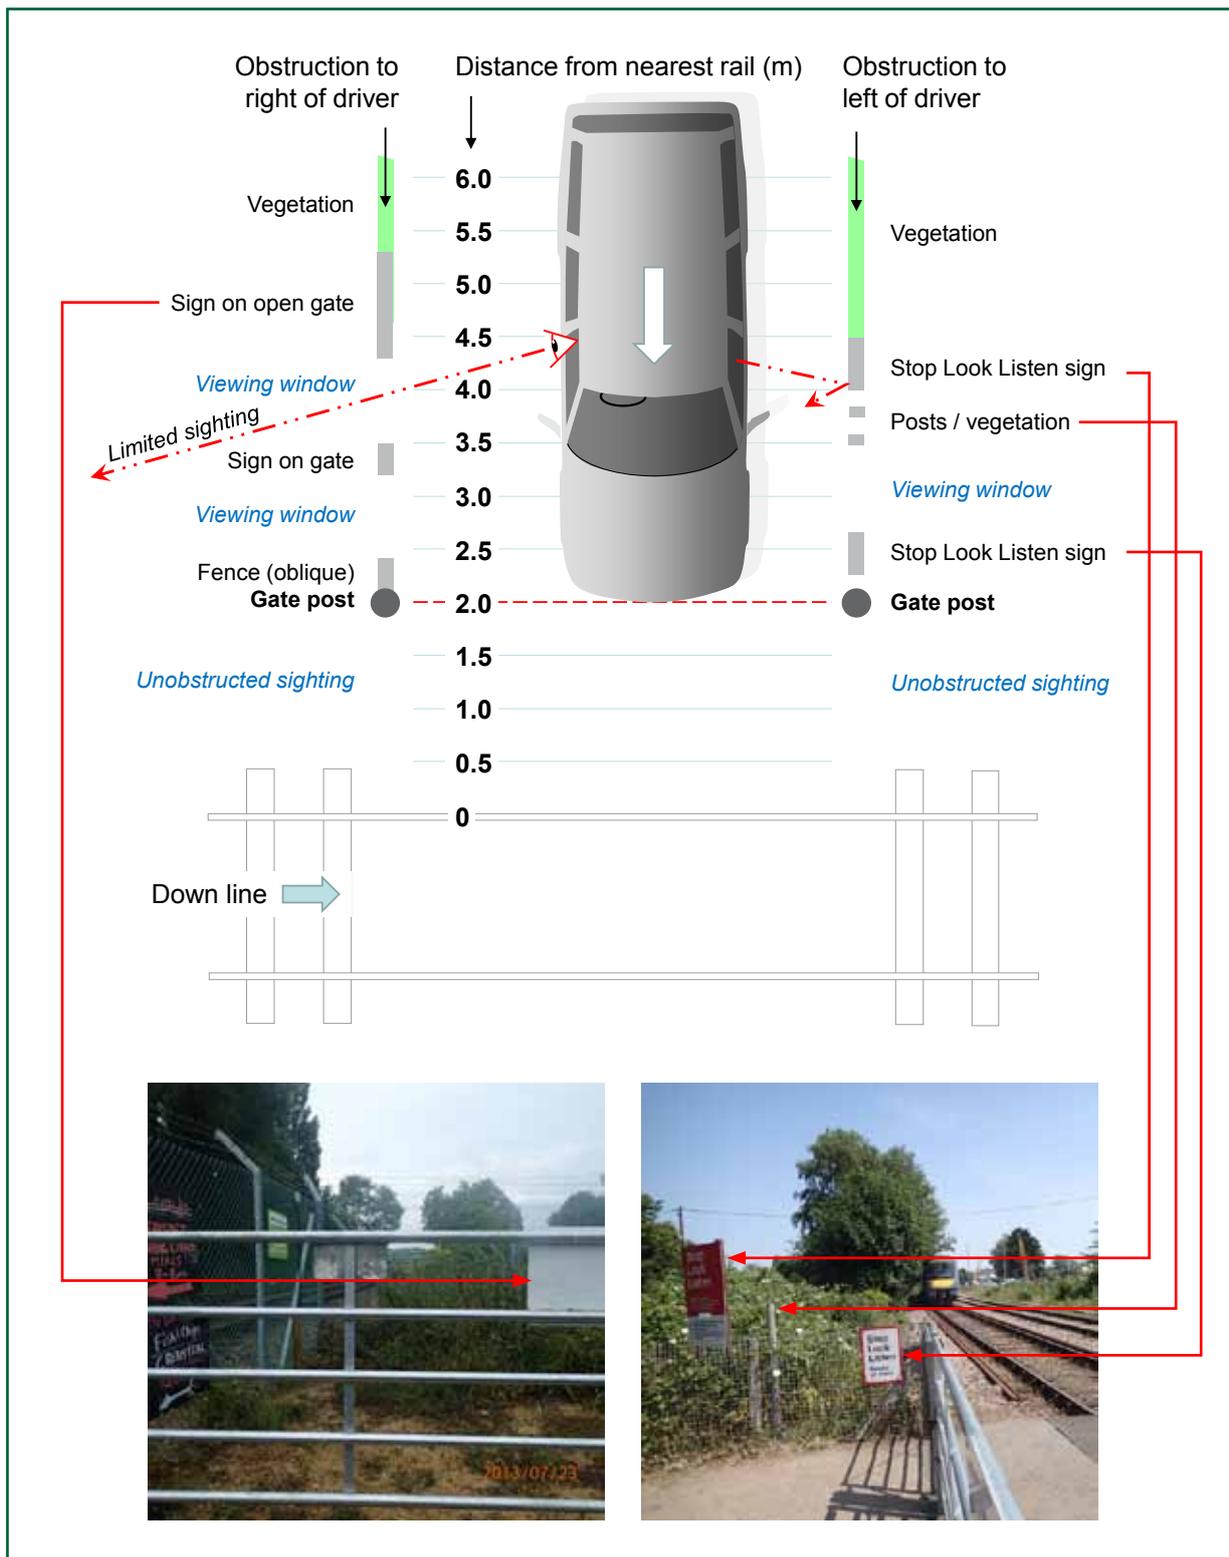
- 84 A car driver using Jetty Avenue UWC at the time of the accident and applying the leaflet guidance would have stopped in a position where their view of approaching trains was obstructed or inadequate (figure 17). Looking to their left, the view would have been obscured by a 'stop look listen' sign and vegetation. Looking to their right, drivers would have had a restricted view between signs giving a sighting distance of about 100 metres (paragraph 60). This is significantly less than the 157 metres sighting distance required for the crossing to be compliant with Network Rail standards (appendix D).

Figure 17: Schematic diagram showing features obscuring a car driver's view of the railway from the down (west) side of crossing with the front of their vehicle two metres clear of the line
