# Rail Accident Report

## **Derailment at Liverpool Street station, London 23 January 2013**

Report 27/2014  
December 2014

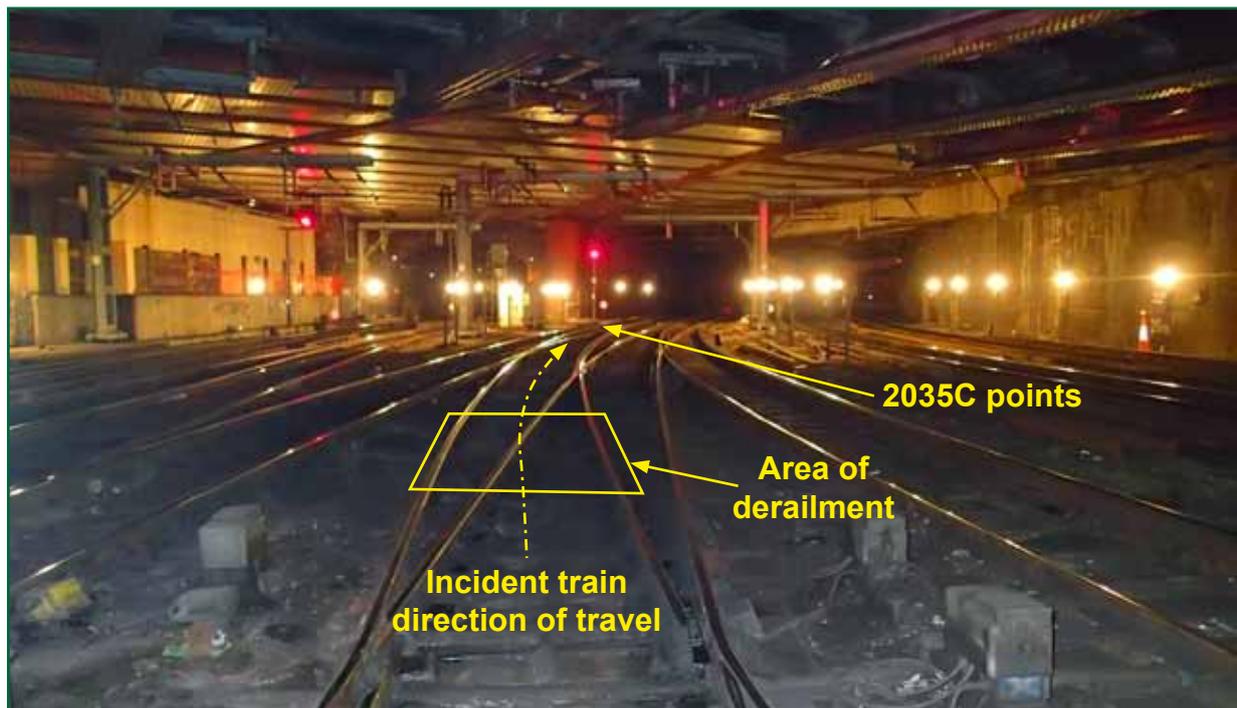
Figure 2: Derailment site showing path of train 1P18 (2035B points in centre of image)

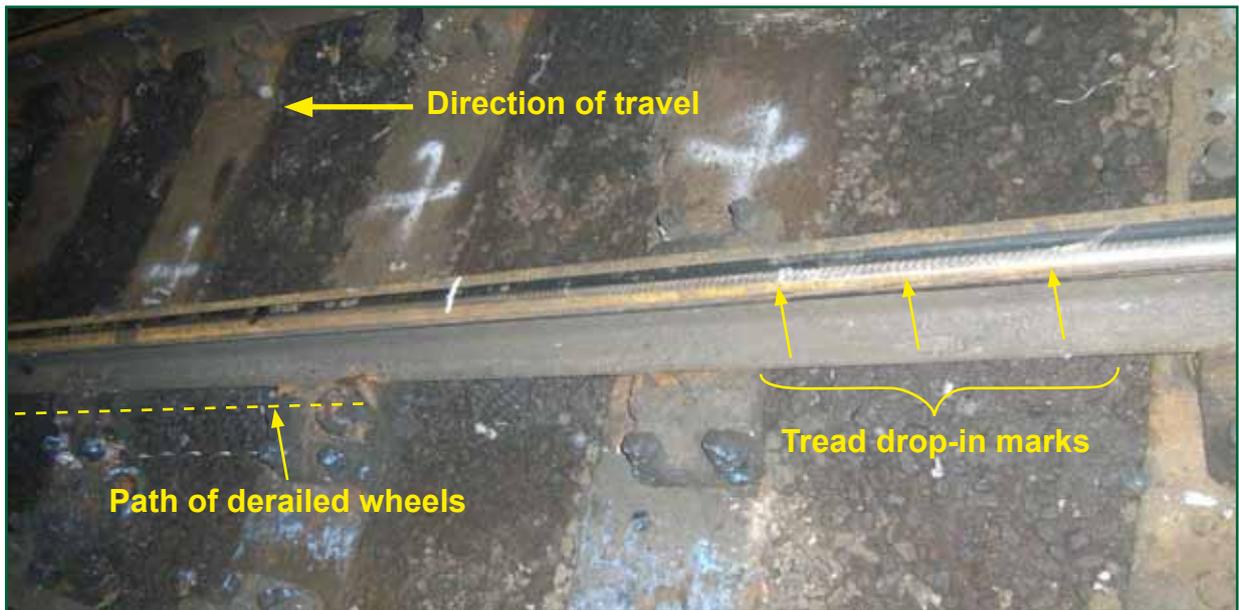
63 The derailment evidence comprised closely spaced marks on the right-hand rail indicating that all the derailed right-hand wheels of the train had dropped inside this rail approximately five metres beyond the *tip* of the moveable rail (figures 8 and 9). The RAIB has concluded from the wheel face (the outside face) damage on the train, and a lack of derailment marks elsewhere on the right-hand rail, that the 17 right-hand train wheels derailed in turn as they reached this location. At the point of initial derailment the track is on a right-hand curve and the left-hand wheels were running along a section of rail that should be fixed.

Figure 9: Wheel tread drop-in marks and damage caused by derailed wheels

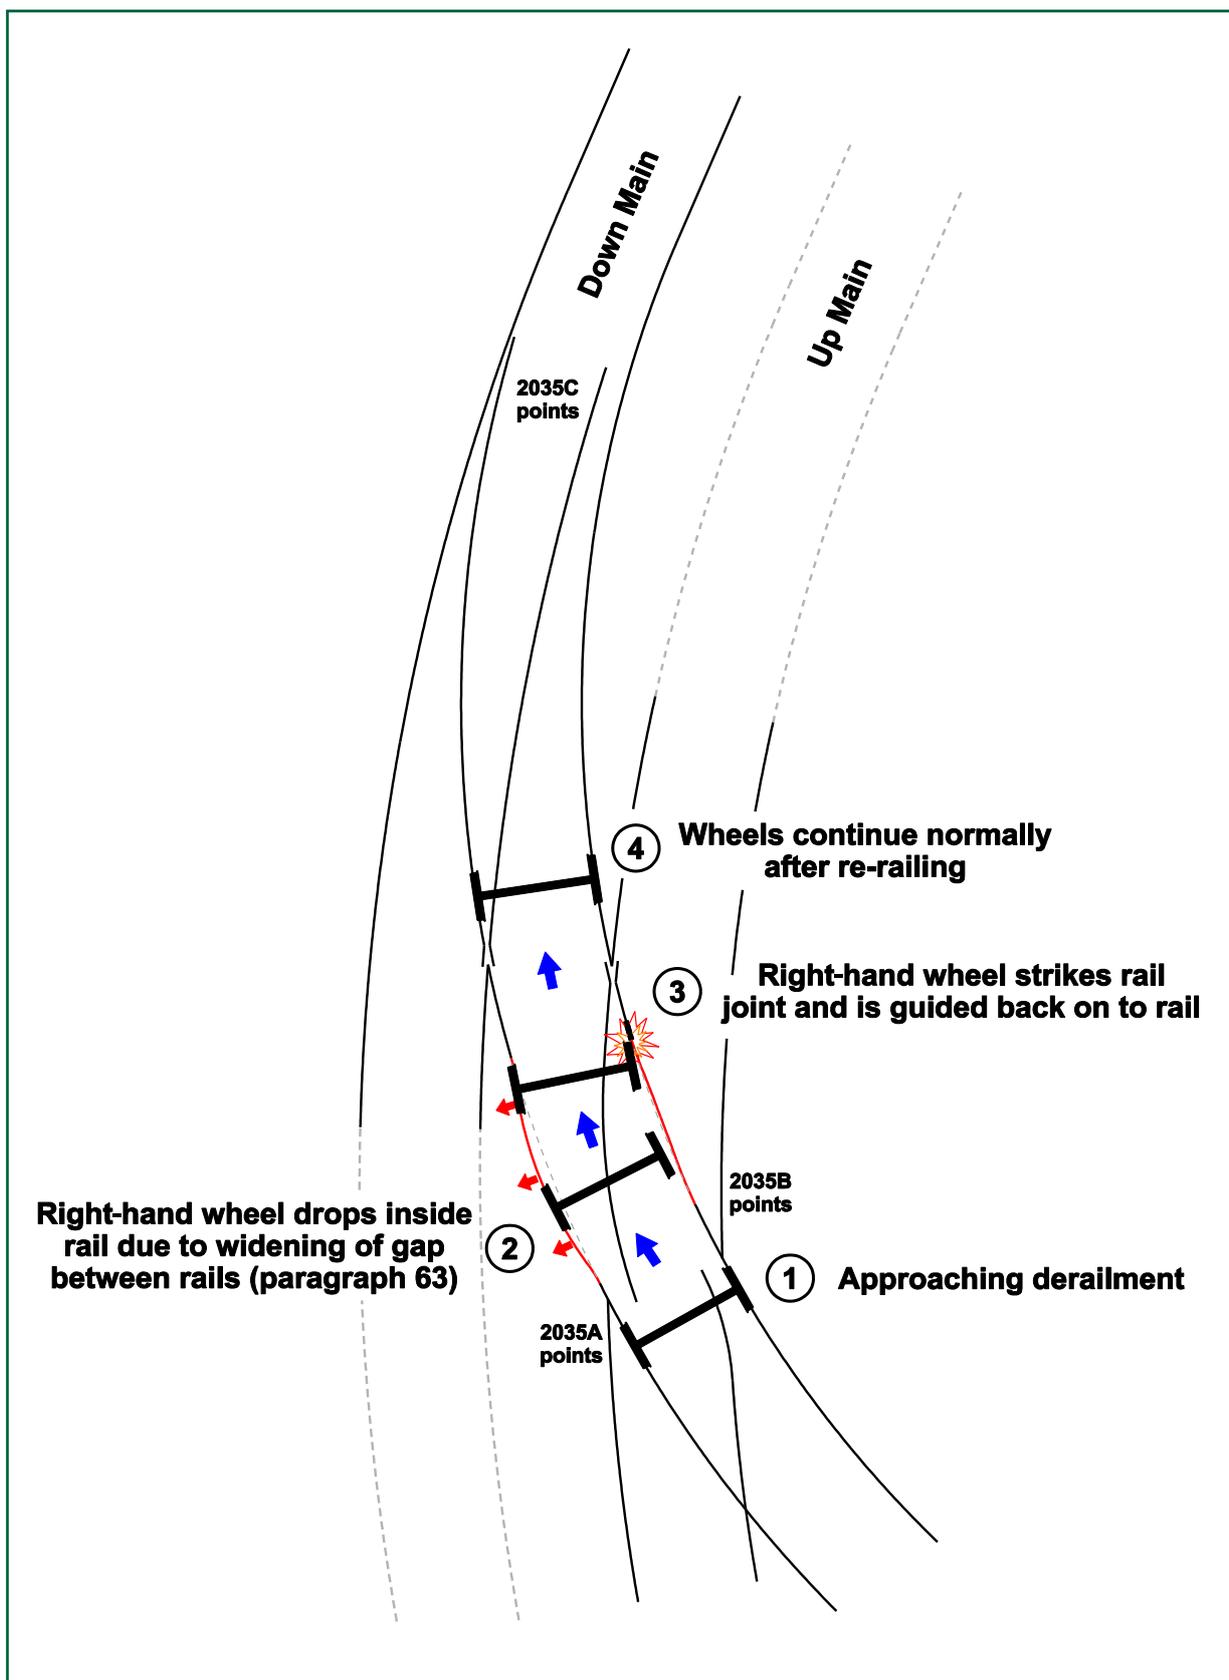
64 The first of the wheelsets exhibiting wheel face damage were on the *trailing bogie* of vehicle 3 (figure 5). Damage to the track fixings of the right-hand rail (figure 9) and the absence of damage on the left-hand wheels of this bogie show that these wheelsets continued with the right-hand wheels dropped inside the right-hand *running rail* while the left-hand wheels remained on the rail. Damage to the track fixings indicate that these wheels ran derailed for about 4.5 metres before encountering a *fishplate* forming part of a rail *joint*. As they struck the fishplate, the wheels were raised back up to rail level and guided back on to the running rail (figures 10 and 11).

Figure 10: Derailment mechanism (excepting leading bogie of vehicle 4)

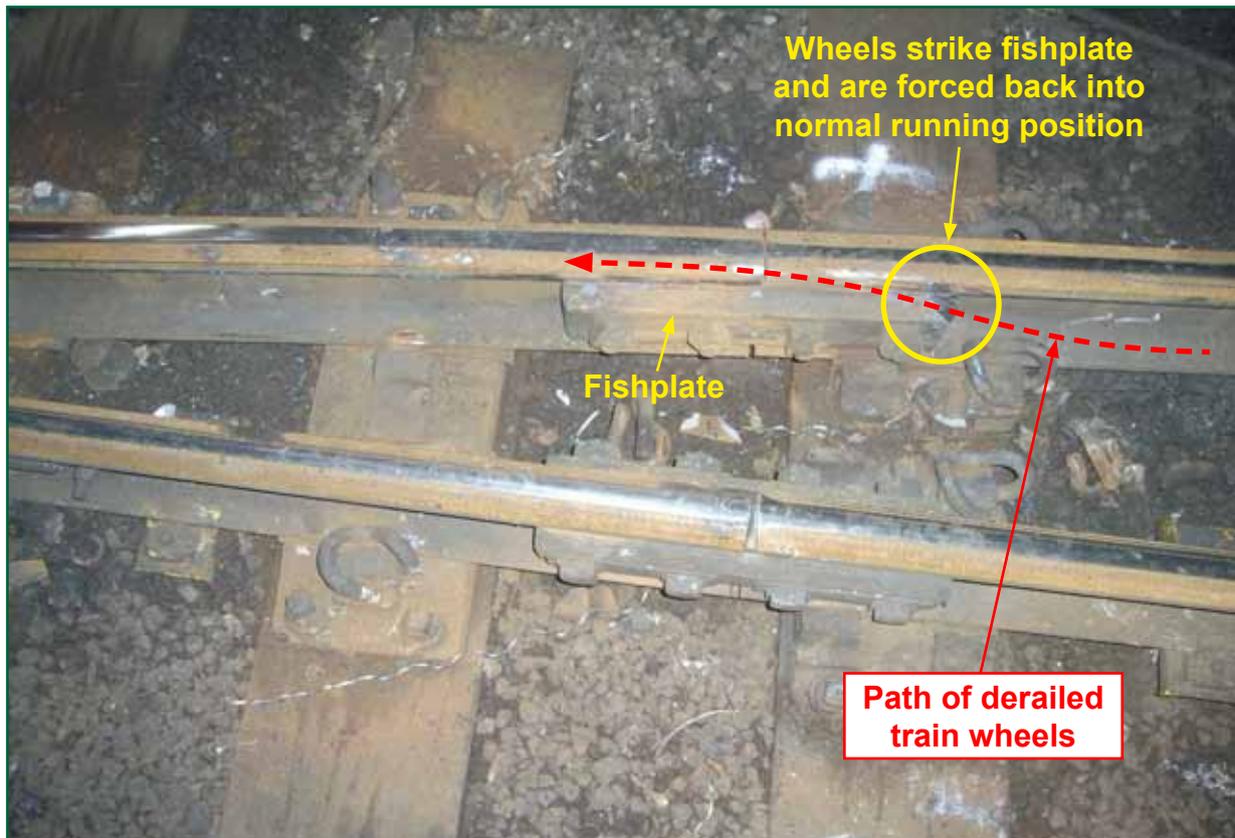
Figure 11: Rail joint which re-railed some wheels

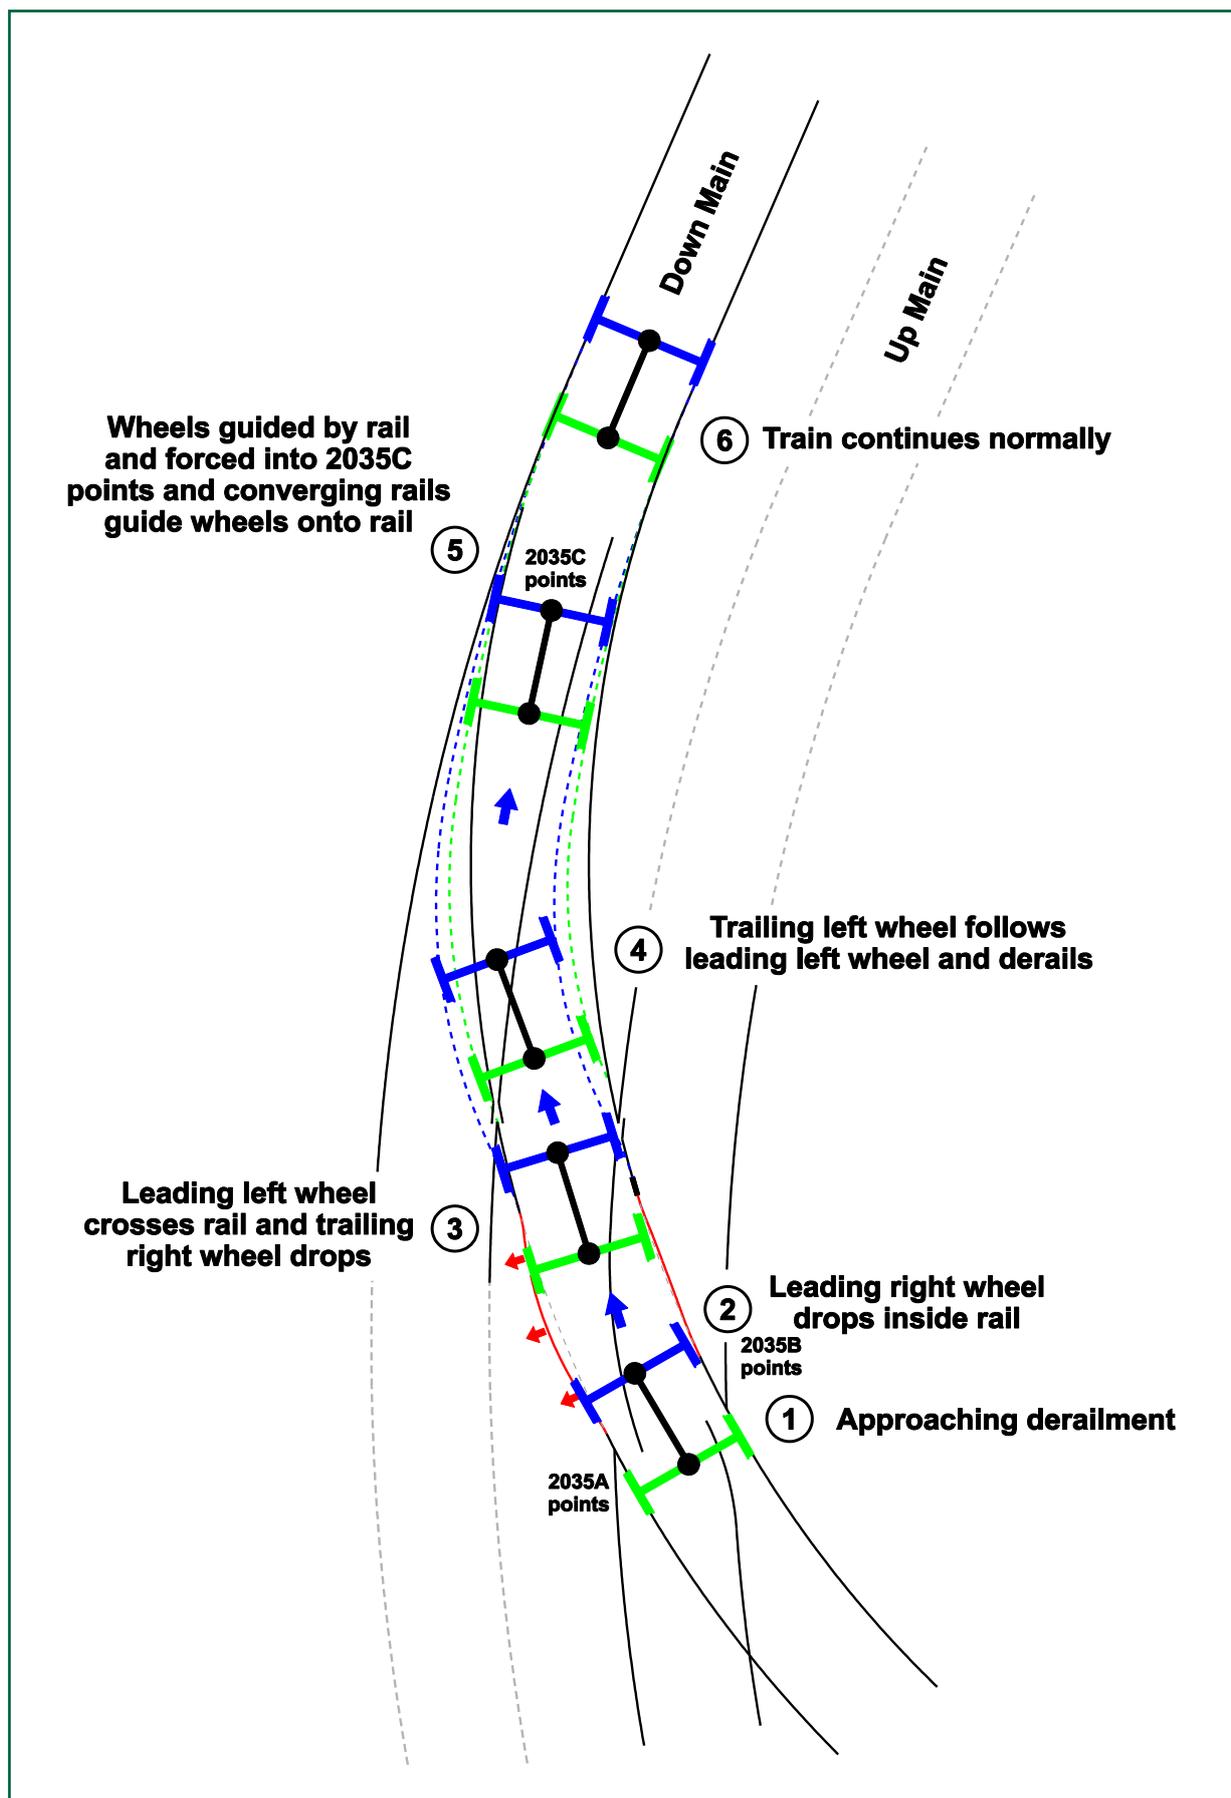
- 65 Damage to all wheels on the *leading bogie* of vehicle 4 indicate that this bogie fully derailed. Rail head marks (paragraph 63) and marks on the right-hand wheel faces show that the right-hand wheels initially followed the same path as vehicle 3. However, instead of the right-hand wheels re-railing at the rail joint, the left-hand wheels climbed over the left-hand rail. This is evidenced by damage to the flanges of the left-hand wheels, marks left across the left-hand rail head and damage to the track fixings on the outside of the left-hand rail.

- 66 The extent of damage to track fixings shows that all wheels on this bogie then continued in a derailed state for approximately 40 metres until converging rails at 2035C points forced the wheels to run through the closed points and guided them back into a normal state on the running rails (figure 12).

Figure 12: Derailment mechanism for vehicle 4 leading bogie

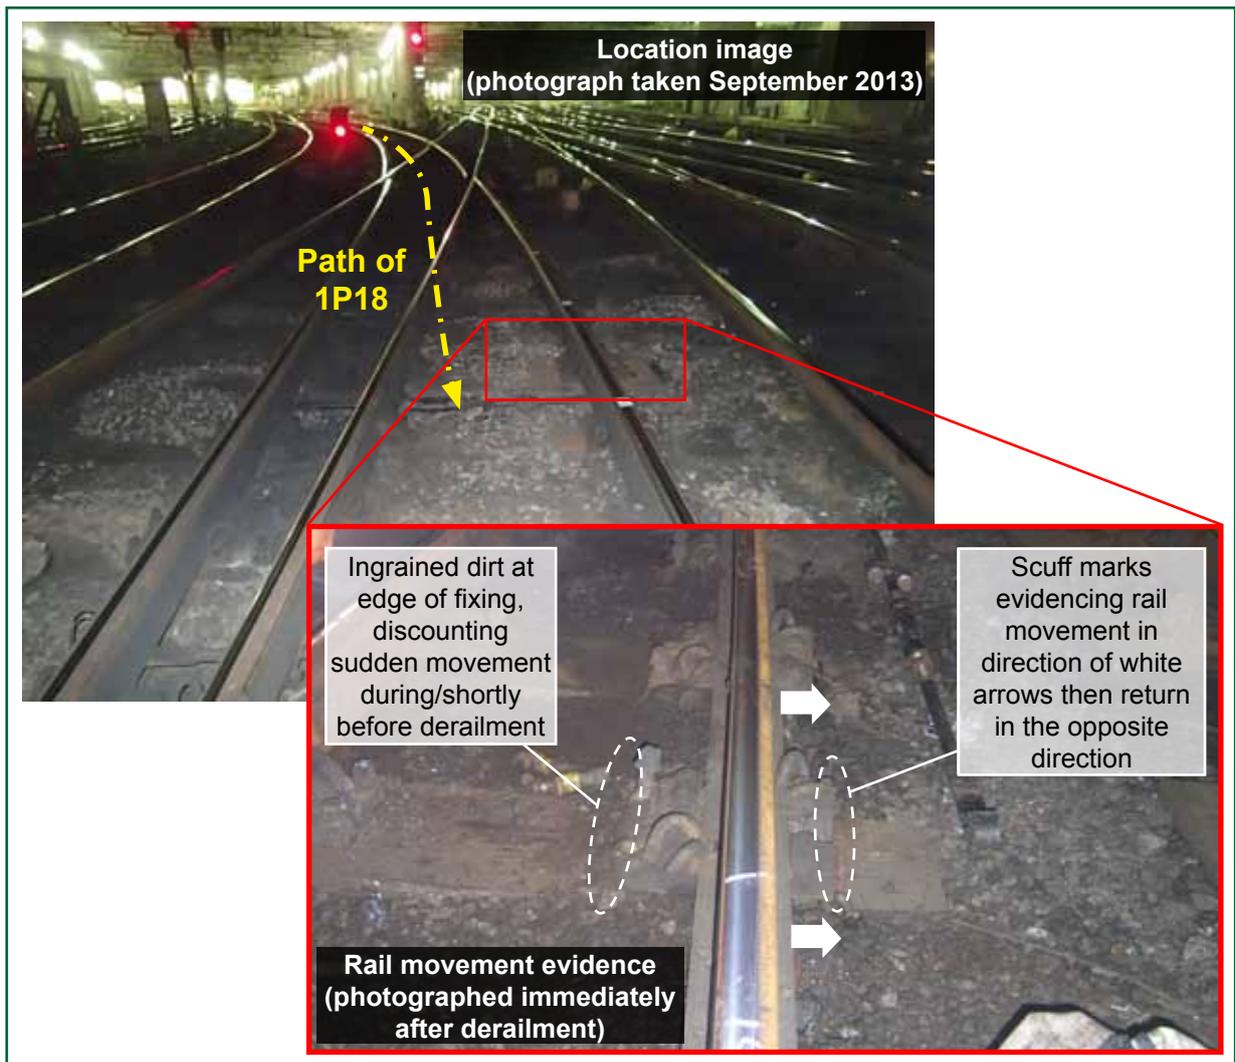
Figure 15: Wide gauge rail fixing with ingrained dirt around baseplate discounting possibility of recent movement

- 79 The static track gauge was measured throughout the derailment site immediately after the derailment and a value of 1474 mm was found at the drop in (derailment) marks. If found during routine inspection, Network Rail standard NR/L2/TRK/001 would require remedial action within 36 hours. Although gauge was not measured immediately before the derailment, the build up of dirt immediately behind the baseplate (figure 15) discounts the possibility that the baseplate first moved during, or shortly before the accident. Network Rail records show that the static gauge was measured on March 2012 and found to be less than 1455 mm (paragraph 122) indicating that significant deterioration had occurred over the following ten months.
- 80 The inspection regime intended to detect, and trigger correction of, excessively wide static gauge at Liverpool Street is described in paragraph 102.

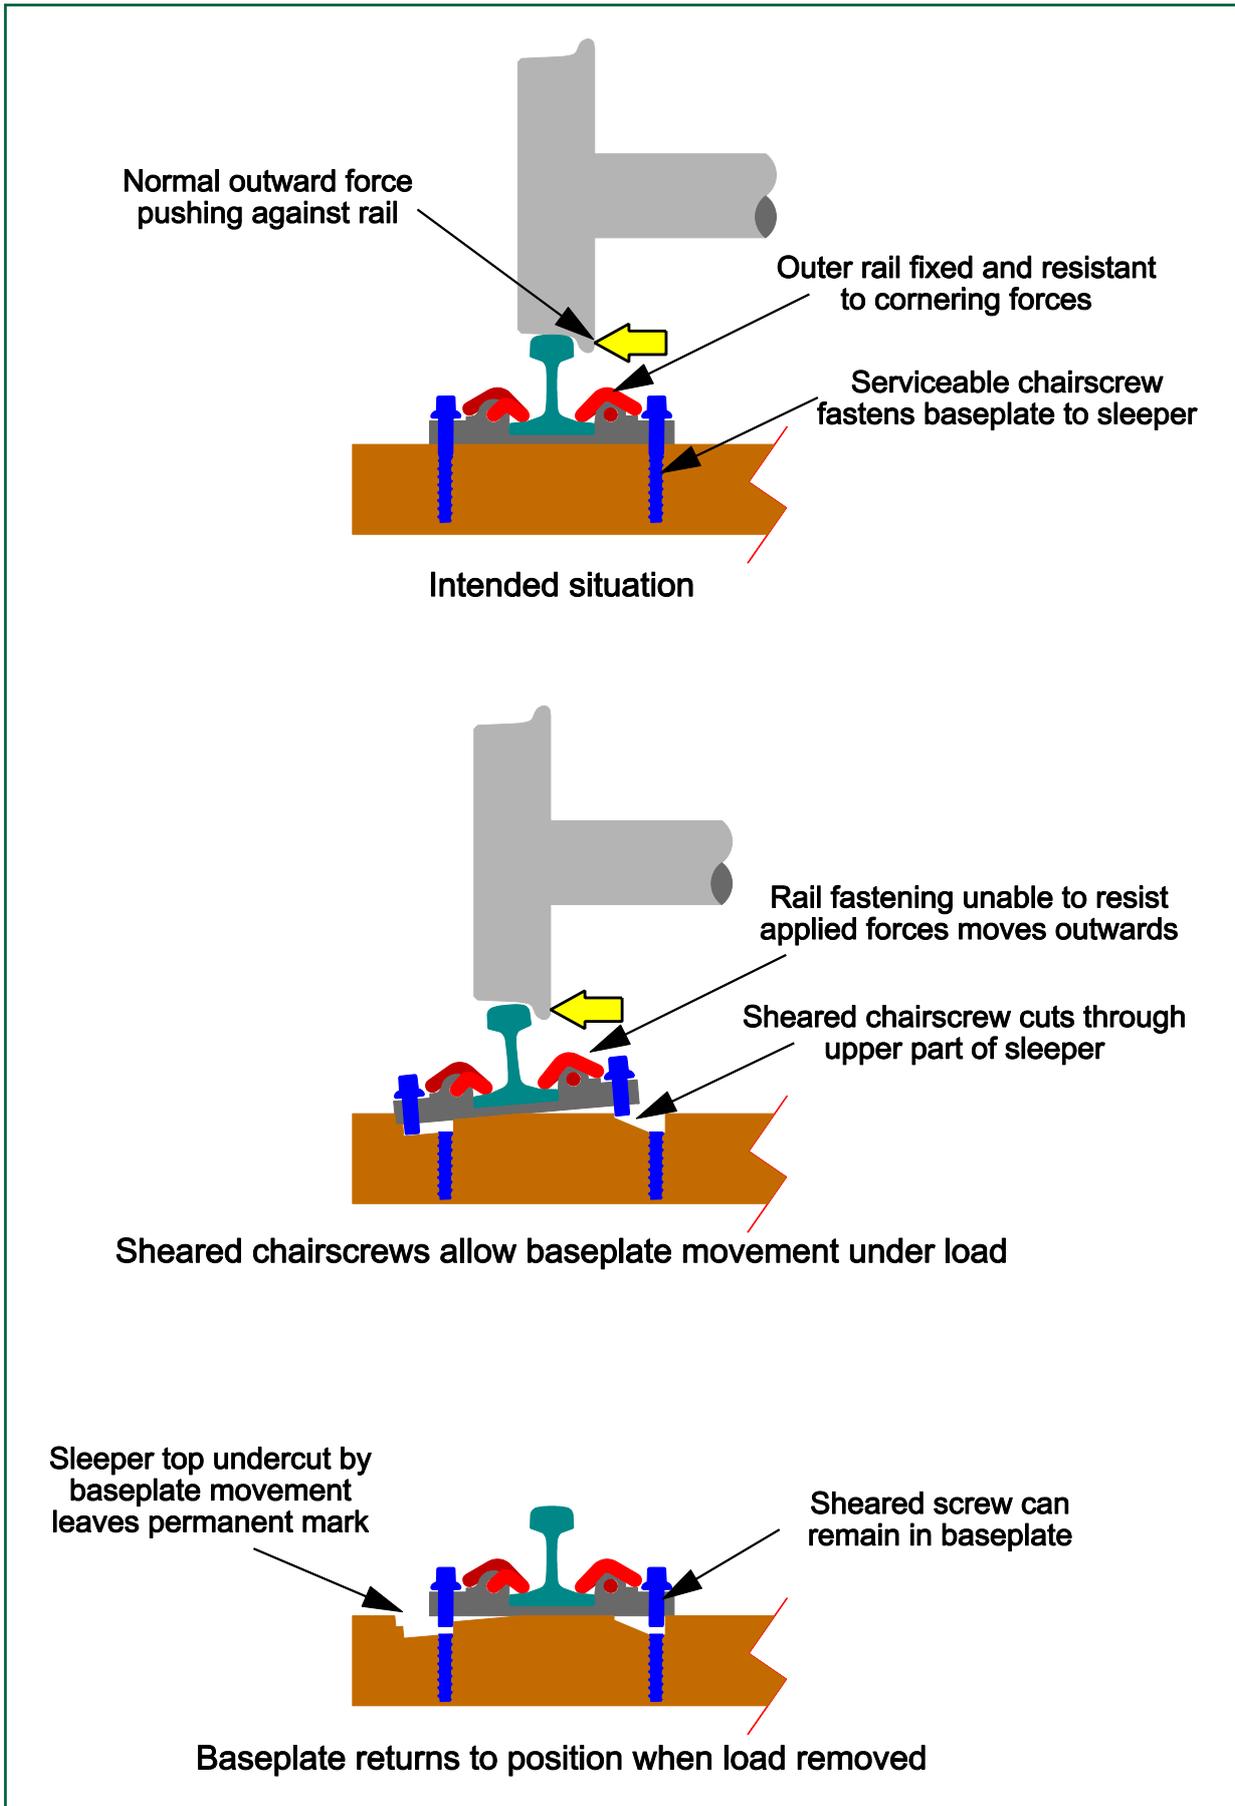
- **maintenance delivery**, the workforce directly responsible for ensuring safety of the infrastructure and implementation of inspection and maintenance activities.

- 45 The asset management function is intended to use technical expertise, experience and records of asset deterioration to decide whether maintenance or renewal would best meet the safety and operational requirements of the railway. The team is split into specialist disciplines and covers the whole Anglia route. The track team responsible for Liverpool Street were based in offices near to Liverpool Street station, but have since moved to offices in Stratford.

Figure 16: Baseplate shuffle and sleeper marks

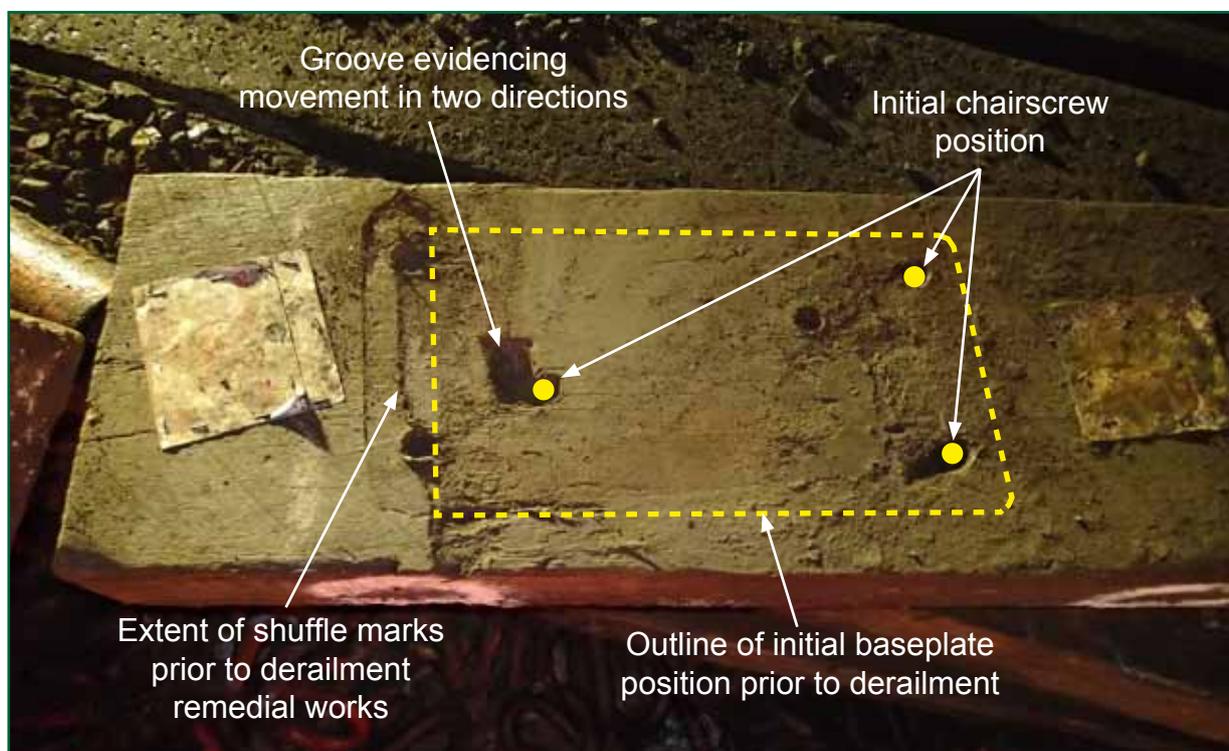
- 46 The RAM[T] leads the Anglia route track asset management team responsible for the cost-effective management of track assets. The RAM[T] also provides technical assistance and mentoring to the route TMEs. He reports through the director of route asset management (DRAM) to the RMD.

- 47 The RAM[T] is also responsible for arranging the briefing of local maintenance staff about technical standards information originating from the Network Rail national centre in Milton Keynes.

Figure 17: Marks caused by pre-derailment shuffle (post-derailment marks shown on figure 18)

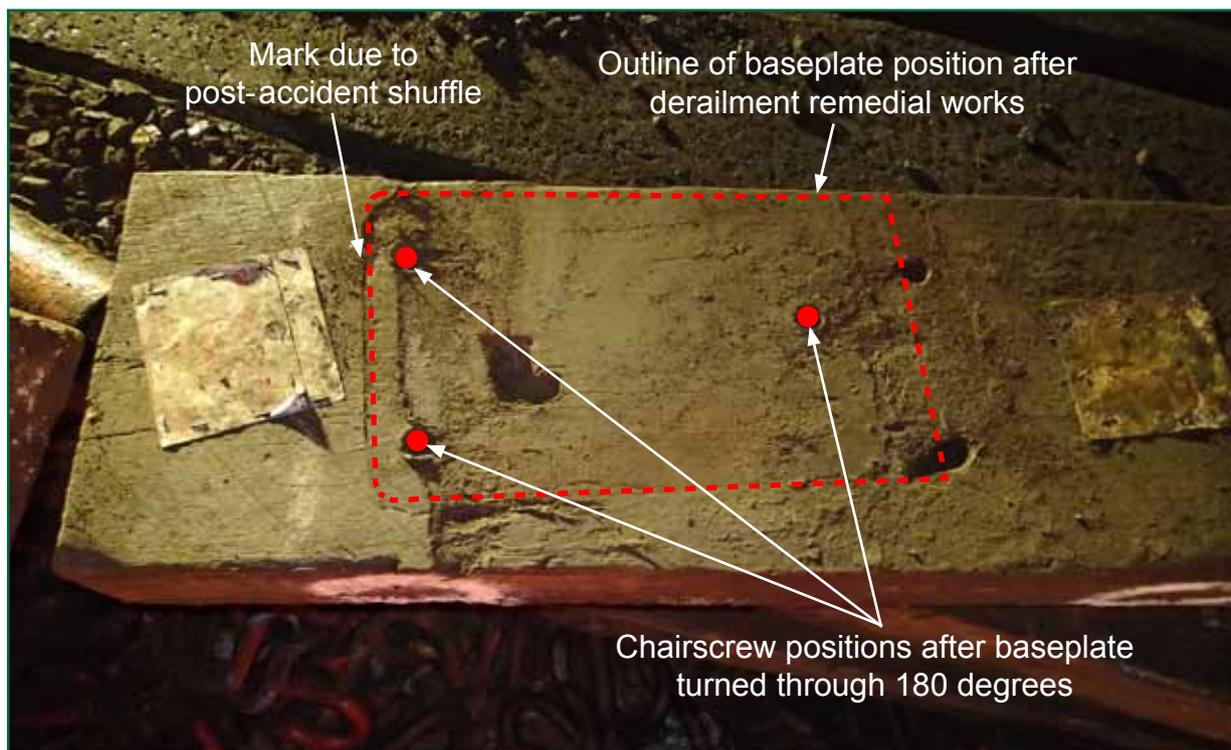
- 51 The Romford infrastructure maintenance engineer (IME) reports to the IMDM and is responsible for managing the staff who ensure the railway remains safe for operational use within the MDU area. His remit covers all engineering disciplines. Discipline-specific maintenance engineers report to him, including two track maintenance engineers. One of these covers the Fenchurch Street, Tilbury and Southend lines and the other covers the Liverpool Street to Chelmsford area, including the accident site.

Figure 18: Marks caused by post-derailment shuffle (pre-derailment marks shown on figure 17)

- 93 As part of the repairs undertaken immediately after the derailment, Network Rail turned the existing baseplates through 180 degrees and re-fixed them to the existing sleepers. The asymmetrical chairscrew hole pattern in the baseplate meant the chairscrews were then screwed into a previously unused part of the sleeper. Turning the baseplates also meant that the baseplate edges were in a slightly different position on the sleeper. It was therefore possible for the RAIB to distinguish between the effects of shuffle before and during the derailment and that which occurred later.

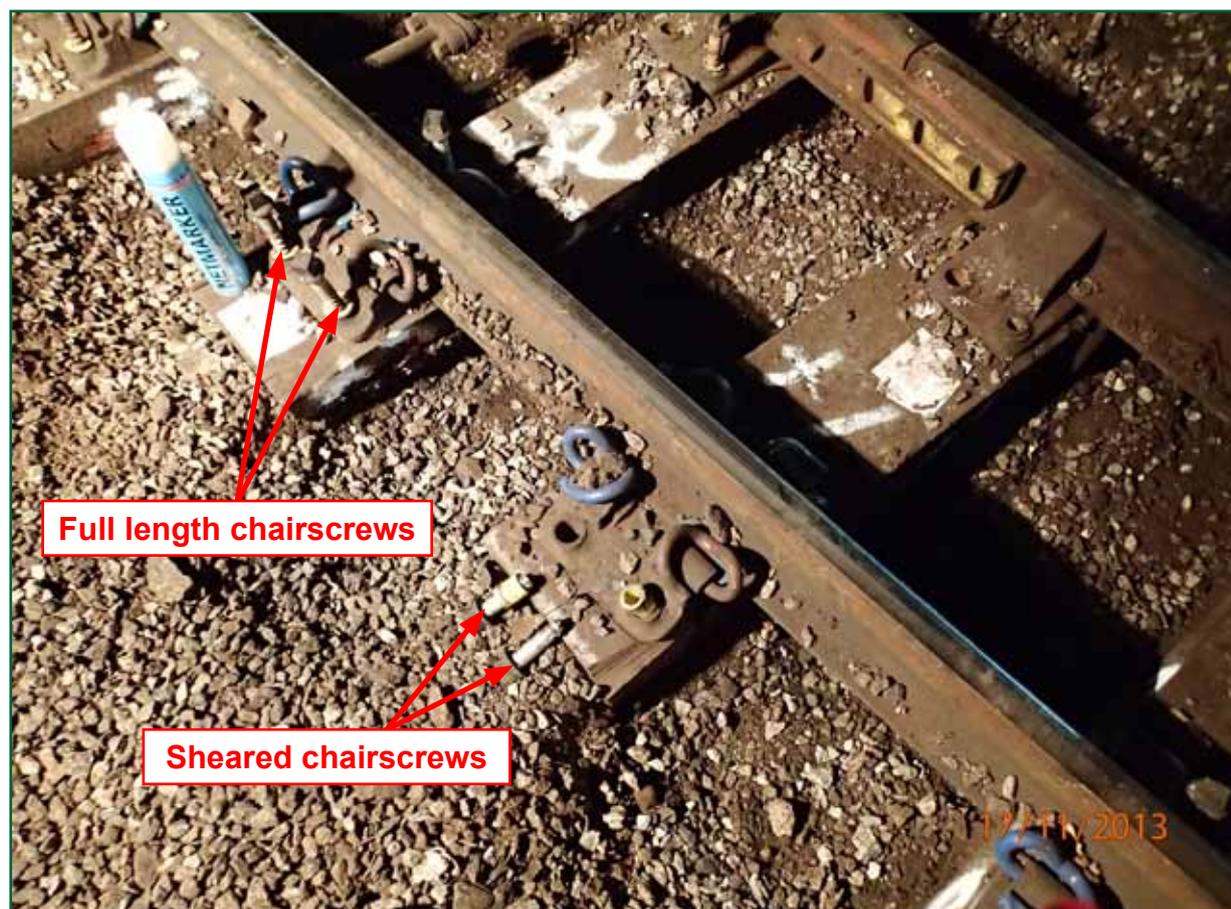
- 48 The Anglia route maintenance teams are divided into geographical areas and specialist disciplines. For the track at London Liverpool Street the maintenance is undertaken by the maintenance delivery unit (MDU) based at Romford.

- 49 The Romford MDU is responsible for the infrastructure on the lines from London Fenchurch Street to Tilbury and Southend, and from Liverpool Street to Chelmsford on the main line to Norwich. The MDU works in accordance with Network Rail standards, Network Rail guidance and local knowledge to develop an inspection and maintenance regime. This is intended to ensure the safe operation of the railway and to meet the reliability and performance targets set by the RAM[T].

Figure 19: Sheared & intact chairscrews

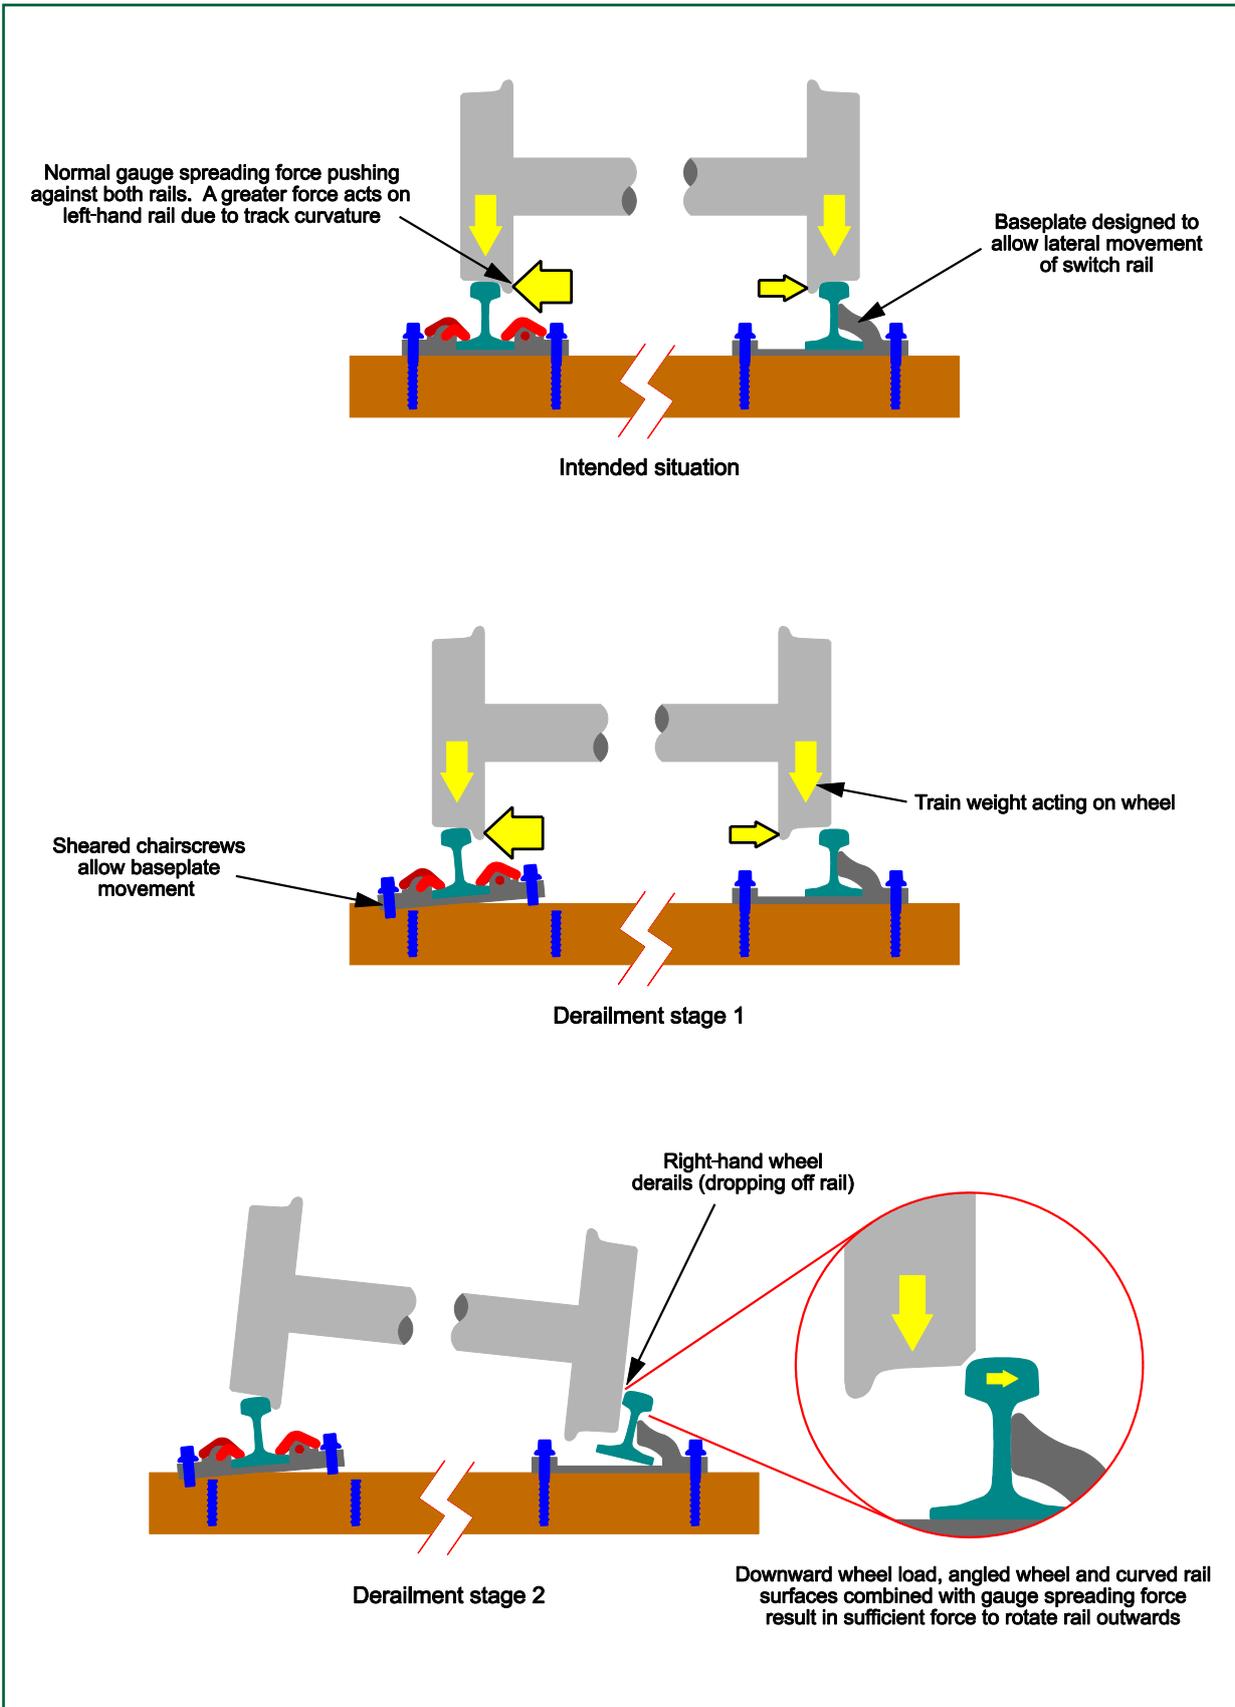
Figure 20: Derailment sequence

- 97 The right-hand switch rail is intended to move laterally according to the direction in which 2035B points are set (figure 7). The rail support system allowing this movement does not prevent the top of the right-hand rail moving outwards due to rotation at the foot of the rail. The right-hand rail is not normally subjected to sufficient gauge spreading force (paragraph 69) to cause movement of this type. However, in this instance, it is likely that the displaced position of the left-hand rail meant that the outer edges of the right-hand wheels were running on the inner edge of the switch rail. In this position, the downward load from the wheels, the angled shape of the wheels and the curved rail head combining with the gauge spreading force would result in the top of the switch rail being pushed outwards (figure 20, inset).

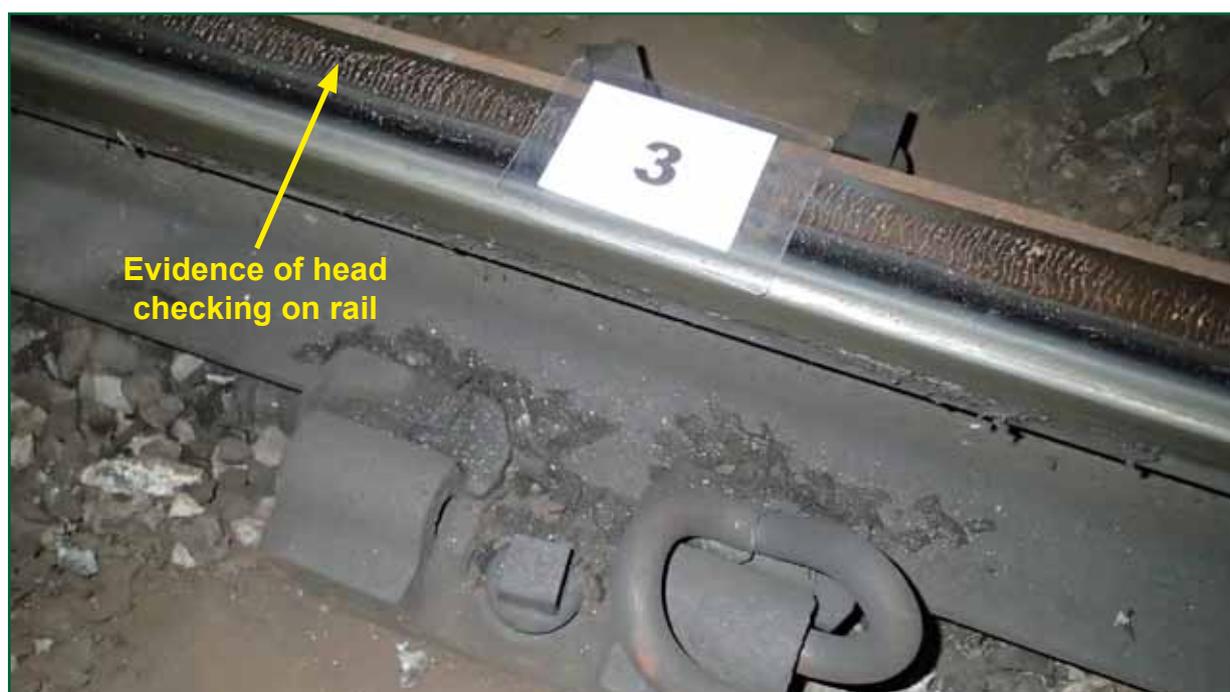
- 131 Irregularities and very small cracks in the surface of the rail head, known as *head checking*, were found during an examination by the RAIB in September 2013 (figure 22). Head checking was not seen immediately after the accident, but the surface had been smoothed by recent *rail head grinding*, a process intended to grind off the metal containing small cracks before these grow large enough to cause a broken rail.

- 132 Head checking is caused by the transfer of forces along the track at the wheel/rail interface and is commonly found in terminal stations as a result of traction and braking forces acting longitudinally along the rail. Head checking can also occur on the rail head of tight radius curves at other locations, due to wheels slipping on the rail head. This slipping happens because wheels on the inner and outer rails rotate together, but the distance travelled along the inner rail is less than that along the outer rail. The RAIB made enquiries with other Network Rail engineers who stated that they would not enhance the inspection regime due to head checking alone, but would consider doing so if there were also other indicators of high lateral forces such as shuffle or broken fastenings.

Figure 22: Head checking found on the running rail ten months after the derailment
