Rail Accident Investigation Branch

RAIB Bulletin 05/2013

Track worker struck and seriously injured at West Drayton, 22 March 2013

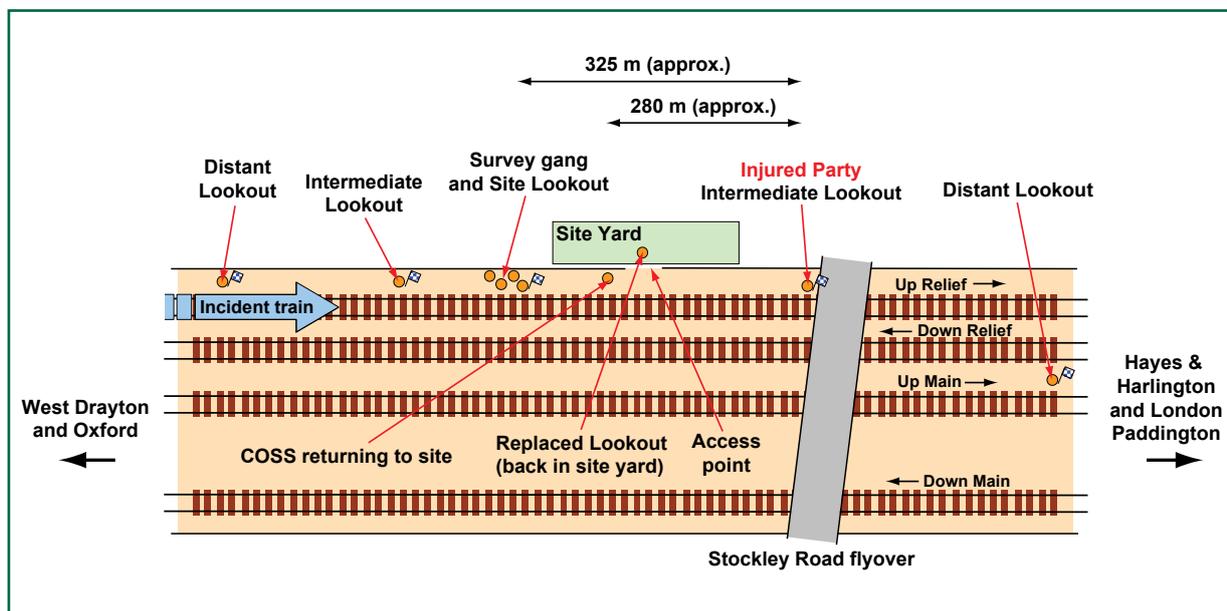
- 2 The accident took place about 0.9 miles (1.5 km) from West Drayton station in an area where there are four tracks. From the north to the south these are named the Up Relief³, Down Relief, Up Main and Down Main (figure 1). The up lines are used by trains travelling from West Drayton towards Hayes & Harlington and London; the down lines are used by trains heading in the opposite direction. A site yard lies adjacent to the Up Relief line and allows access to the railway line close to the area where the work was being carried out. This work required people to work on both the Up and the Down Relief lines.

Figure 1: Positions of track workers at the time the incident train passed through the site

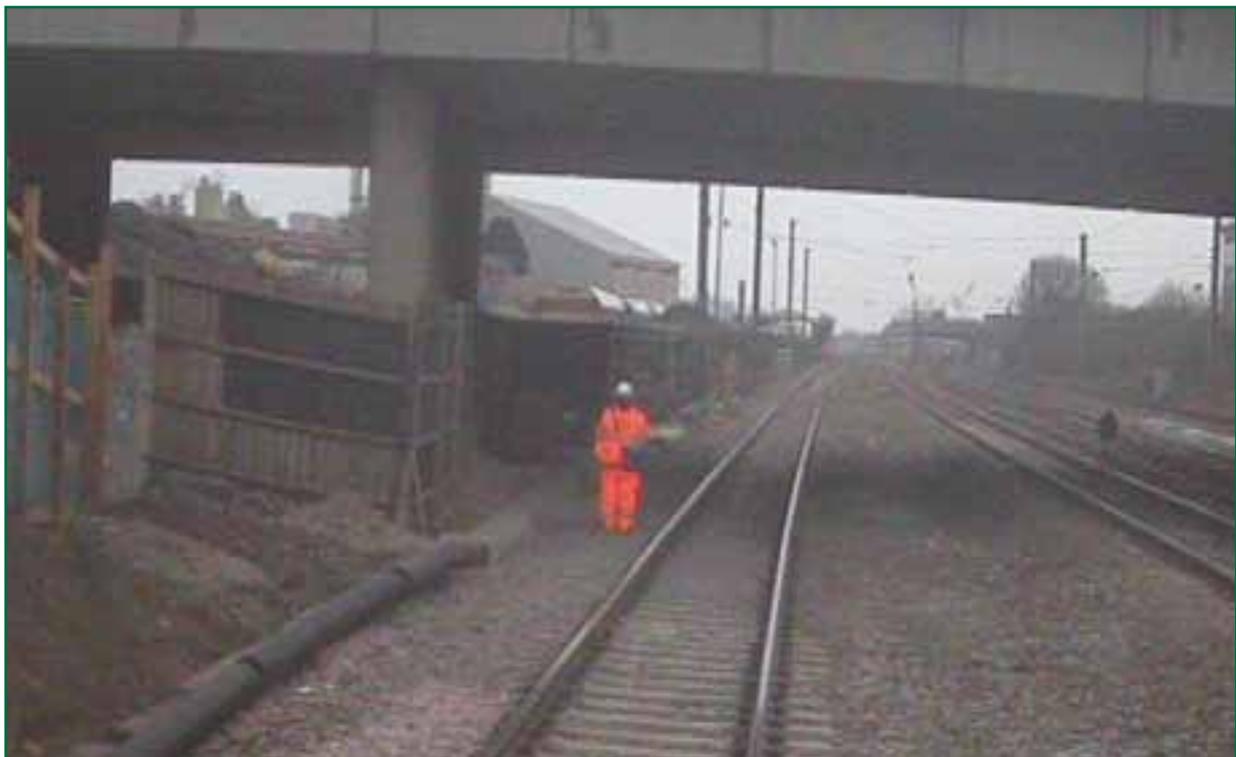
Figure 2: Injured Party standing beside the track immediately before the accident (image from train FFCCTV)

- 25 FFCCTV images taken from the train moments before the accident shows the injured party looking towards London with his body at a near right-angle to the track while holding his flags rolled together in his left hand (figure 2). In this position he was facing directly away from trains approaching on the adjacent Up Relief line. This difference from his normal working practice could indicate that he had not fully engaged with the duties of a lookout.

- 26 The injured party understood that his position of safety was in the cress at least 1.25 metres from the nearest rail. He did not stand in this position, probably because he was not concentrating on his lookout duties.

- railway staff working on or near the line must focus on the task in hand and not be distracted by other thoughts or use of a mobile phone. If any staff feel that they cannot concentrate on this task, they must move to a position of safety and tell the person in charge that they cannot do the job safely and ask to be relieved; and

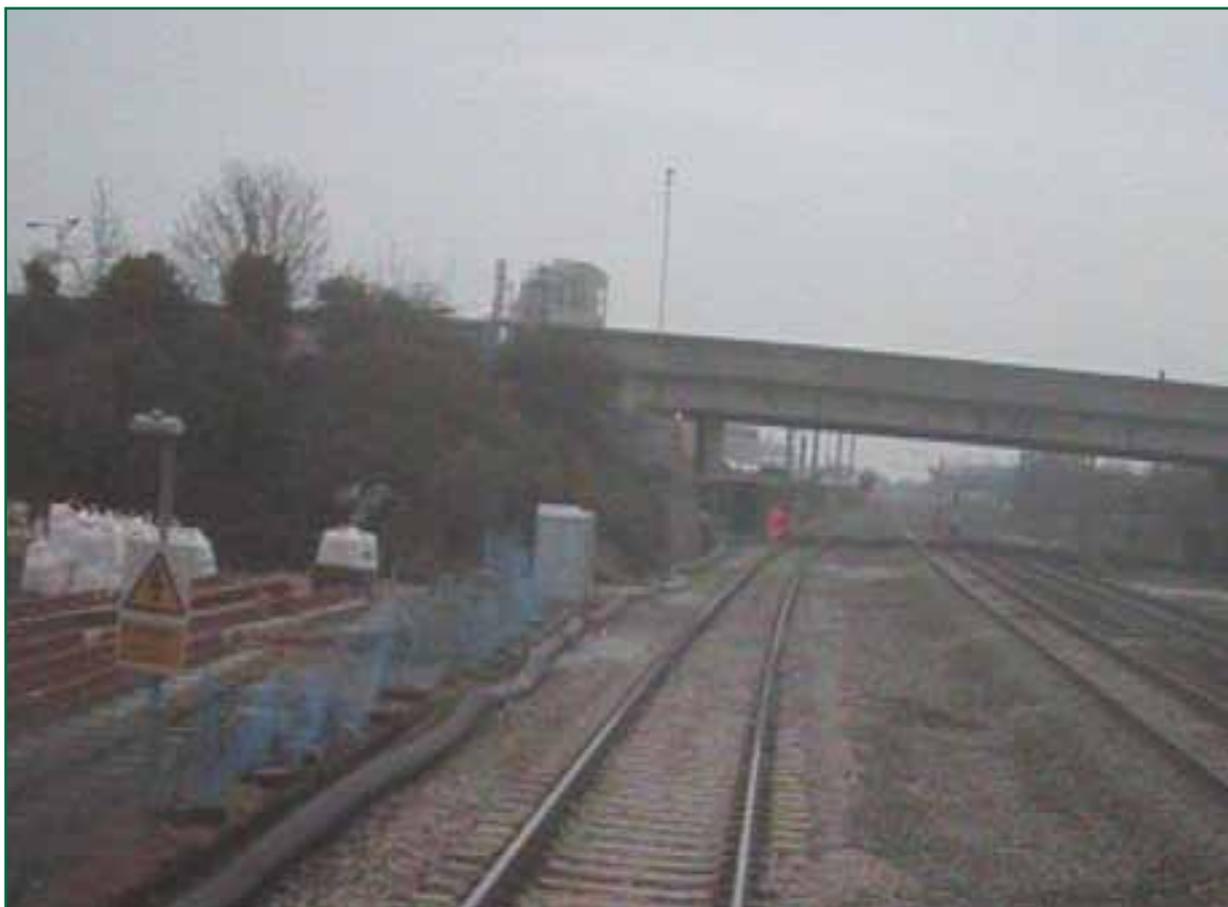
- 34 The train was on a curved section of track as it approached the injured party and in these circumstances it can be difficult for a driver to be certain whether somebody is clear of the track until the train is close to that person⁷ (figure 3). The FFCCTV recording does not show the lookout moving into an unsafe position so it is probable that he was already in this position before the train approached. As the train travelled around the right-hand curve it would be difficult for the train driver to judge the clearance between the track and the injured party's position on the left-hand side of the track.

Figure 3: Injured party seen from some distance away on the curved approach

- train drivers approaching track workers in areas of curved track should appreciate that it can be difficult to see whether these people are in a position of safety until they are close to the individual concerned. If there is any doubt a warning should be sounded.
