Rail Accident Investigation Branch

# Rail Accident Report

**Accidents involving a wheelchair rolling onto the track at Southend Central, 28 August 2013; and a pushchair rolling onto the track at Whyteleafe, 18 September 2013**

Report 17/2014  
August 2014

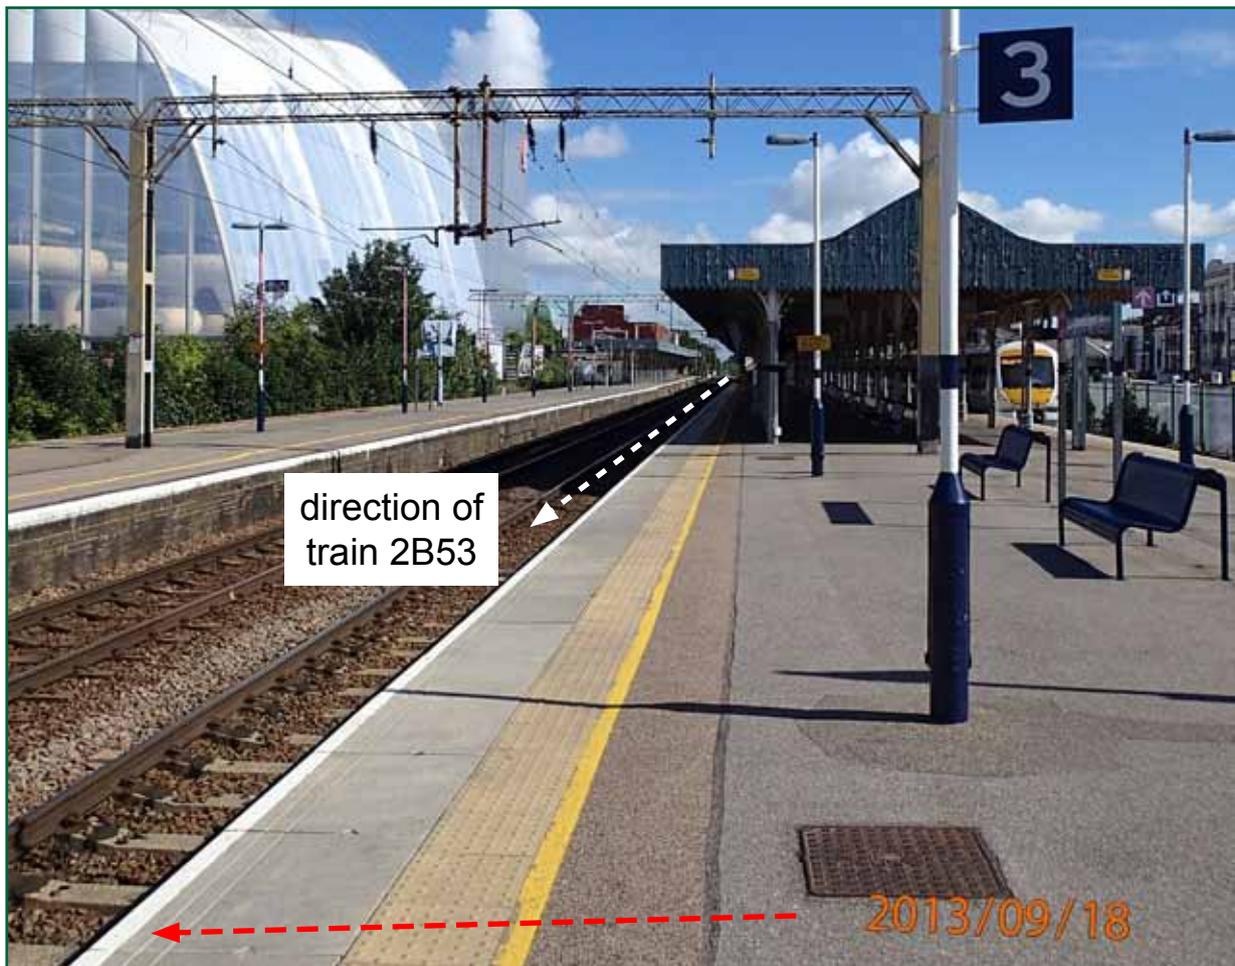
- 7 Shortly before 18:13 hrs, a wheelchair user and her carer were escorted onto platform 3 by a member of station staff. The carer, who was pushing the wheelchair, and the member of station staff awaited the imminent arrival of train 2B53, the 18:05 hrs Shoeburyness to London Fenchurch Street service, which was due to stop at Southend Central at 18:15 hrs. The carer did not apply the parking brake on the wheelchair, and before the arrival of the train the carer became distracted. Neither the carer nor the member of station staff noticed the wheelchair start to move slowly forward towards the platform edge (figure 2). The wheelchair and its occupant, who was strapped in, rolled forward approximately 2.6 metres before falling off the platform and onto the railway line. The wheelchair occupant sustained a fractured hip and shock.

Figure 2: Southend Central station platform 3 showing position of the wheelchair when stationary, and its route (red dotted line)

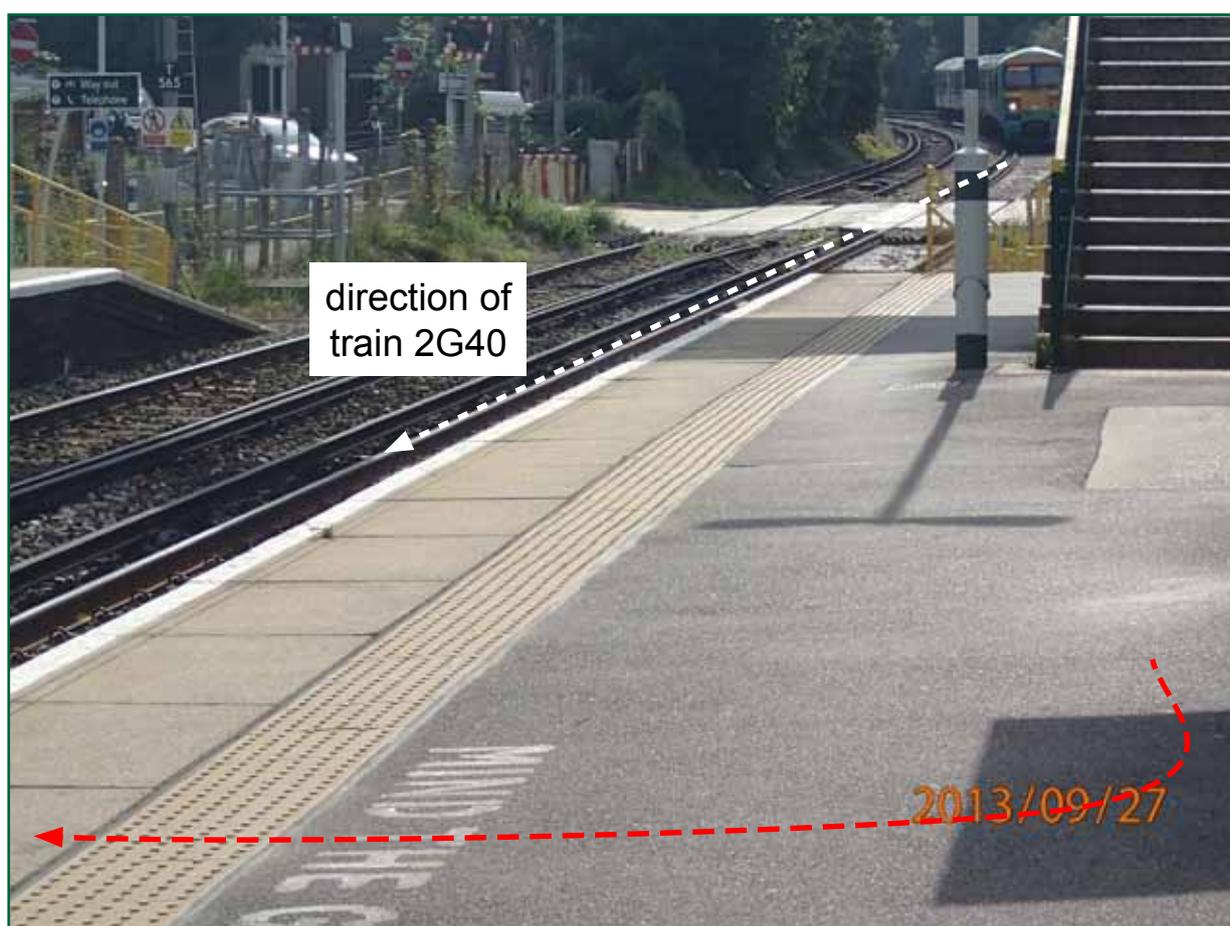
- 8 At 10:39 hrs, a mother and her two children (a baby strapped into a pushchair and a toddler walking beside her) walked onto platform 1, the London-bound side of Whyteleafe station, intending to travel on train 2G40, the 10:39 hrs Caterham to London Bridge service, which was on its way to Whyteleafe and due to arrive at 10:43 hrs. The mother stopped the pushchair while she operated the ticket machine on the platform, but did not apply the pushchair's parking brake. While her attention was focused on the purchase of her ticket, she was unaware that the pushchair had started to roll slowly along the platform and had then veered to the right and towards the platform edge (figure 3). The mother was alerted by the toddler to the pushchair's movement, and turned to see it rolling towards the track. She tried to reach it before it fell onto the track, but was unable to do so. The pushchair narrowly missed the electrified *conductor rail*. The baby suffered minor cuts and bruising.

Figure 3: Whyteleafe station platform 1 showing position of the stationary pushchair and its route (red dotted line)

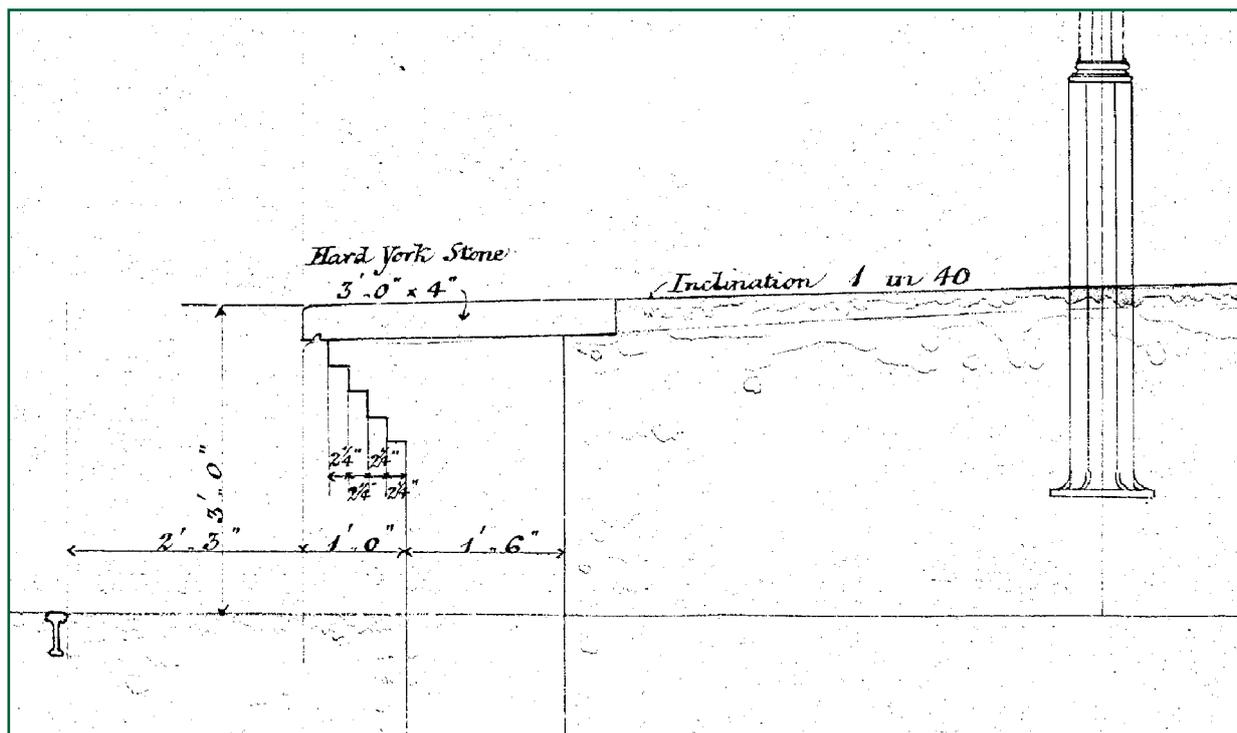
- 11 The platforms at Southend Central and Whyteleafe stations were originally designed with a 1 in 40 (2.5 %) slope, falling towards the railway (figure 4). This was to assist in the drainage of water from the platform onto the track. At the time of the accidents in 2013, each platform still had a slope falling towards the track.

Figure 4: Southend Central station – cross-section drawing from 1899 showing 1 in 40 slope on the platform, falling towards the railway

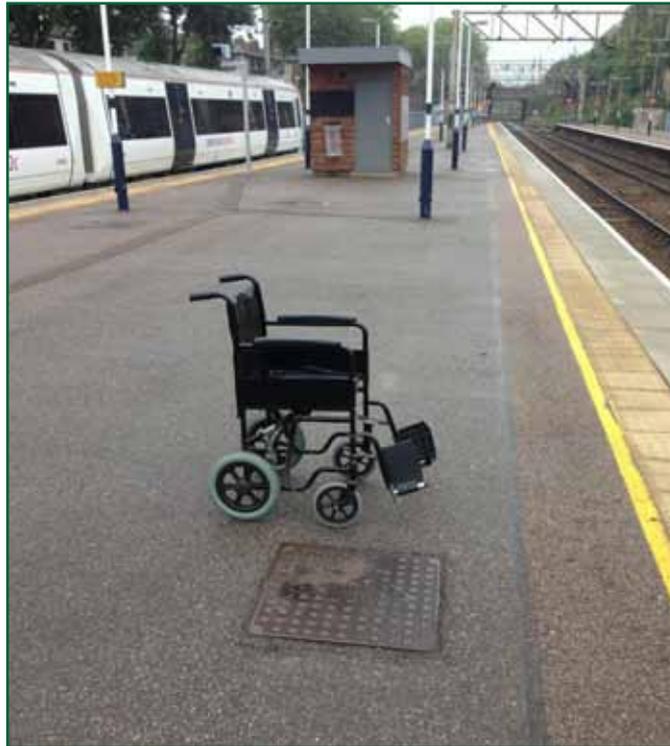
*Figure 5: Photograph showing the position (reconstruction) of the stationary wheelchair on platform 3 at Southend Central station before it started to roll forward (image courtesy of c2c)*

- 17 The wheelchair and its occupant rolled approximately 2.6 metres before falling off the platform onto the *up line* (figure 5). Members of public who were standing on the platform jumped down onto the railway, followed by the member of station staff (who was aware of the imminent arrival of train 2B53). The member of staff contacted the booking office clerk using his radio<sup>1</sup>, advising him of the accident and requesting that the line be blocked.

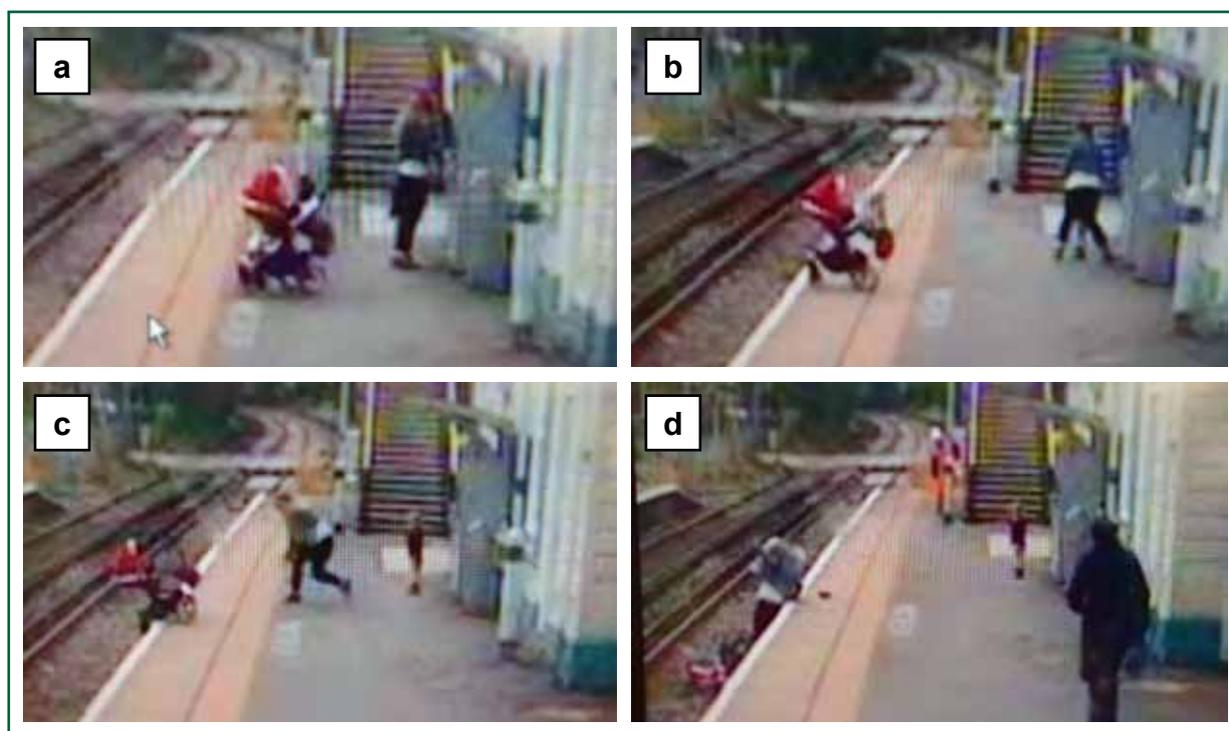
- 21 The pushchair initially rolled slowly and parallel to the railway, but the incline towards the track caused it to turn right and run towards the edge of the platform (figures 6a and b). The older child, who was standing to her mother's left, saw the pushchair moving towards the railway and alerted her mother (figures 6c and d). The mother turned and ran, attempting to grab the pushchair, but she was unable to prevent it rolling off the platform and onto the track. The mother shouted for help before jumping down onto the railway track to retrieve her baby.

Figure 6: Closed Circuit Television (CCTV) images showing the accident at Whyteleafe station. The configuration of the CCTV system resulted in periodic gaps of a few seconds at a time when no recording was made<sup>2</sup>.

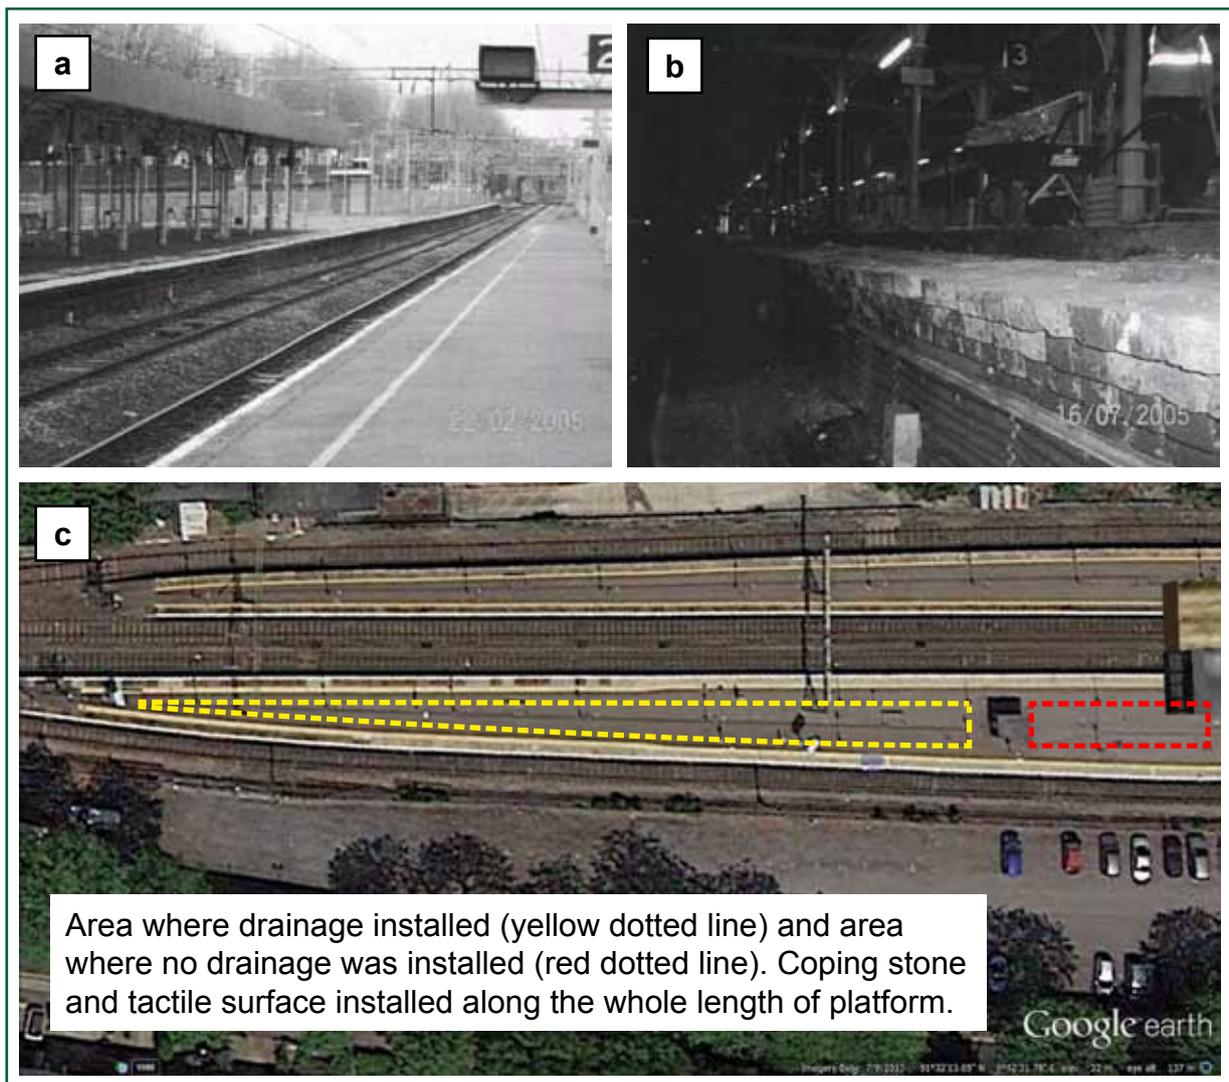
- 44 Work was undertaken on platform 3 at Southend Central between 2005 and 2007, including installation of coping stones and tactile surfaces over the whole length of the platform and the refurbishment of the island part of the platform where it adjoins platform 4 (paragraph 9). Part of the refurbished platform sloped away from the track and towards a new central drain (marked in yellow at figure 7c). However, the works on the portion of the island platform where no central drain was installed (marked in red at figure 7c) resulted in the existing slope towards the track becoming steeper. The gradient falling towards the railway at the location where the accident occurred (figures 7a and b) increased from the 'as-designed' 1 in 40 (2.5%) to 1 in 28 (3.5%) with some sections being 1 in 8 (12.5%) (figure 8). The RAIB has been unable to establish why this happened.

- 45 The RAIB considers that the extent of the work undertaken on the platform at Southend Central (installation of coping stones and tactile surfaces throughout and the installation of central drainage) could have constituted a reasonable opportunity to bring the whole length of the platform into compliance with Railway Group Standard GI/RT7016, which would then have entailed removal of the falling slope towards the track.

Figure 7: Refurbishment work undertaken on platform 3 (a and b) at Southend Central station and Google Earth image

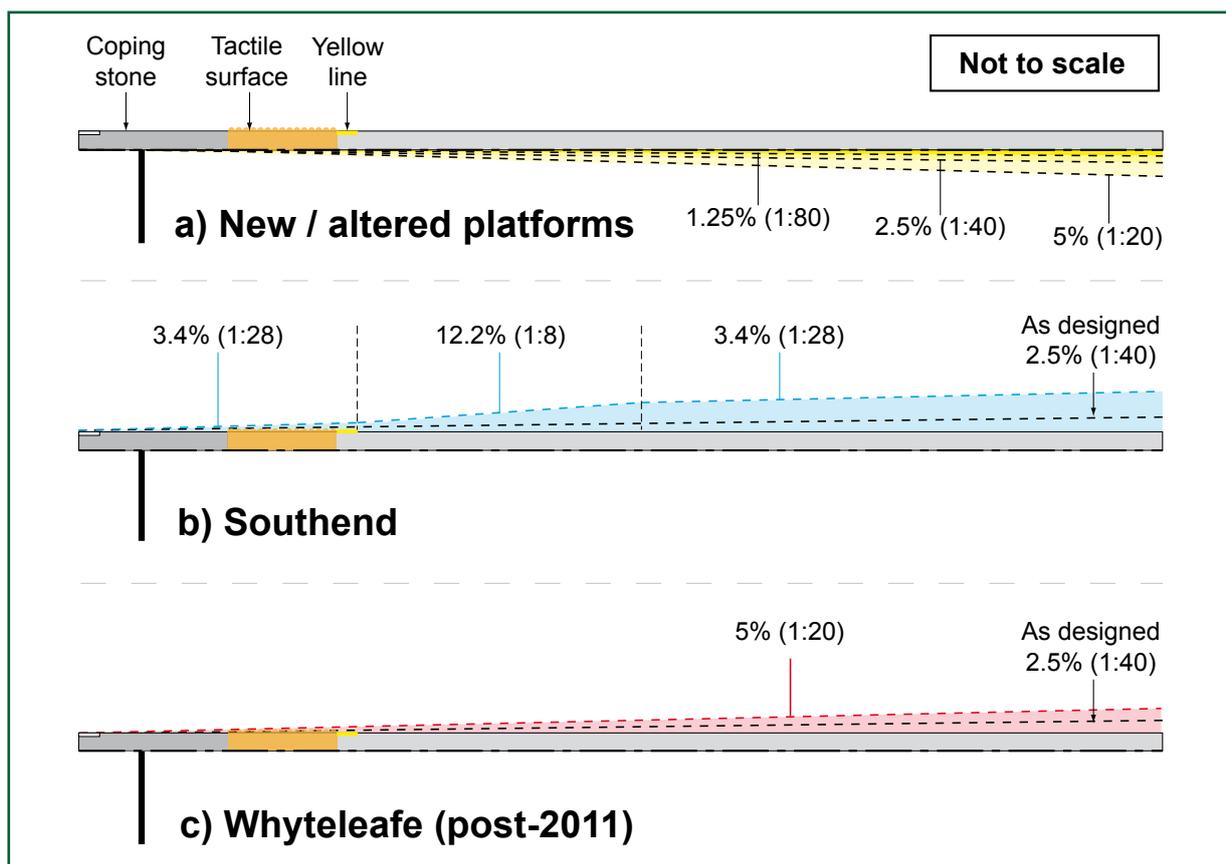
Figure 8: Diagrams showing standard gradient against gradients at Southend Central and Whyteleafe stations

- 47 The RAIB considers it possible that the work at Whyteleafe resulted in the gradient towards the railway increasing from the originally designed 1 in 40 (2.5%) to around 1 in 20 (5%) at the location where the accident occurred. In other areas the platform sloped at 1 in 14 (7%) towards the railway (figure 8). The RAIB has been unable to identify any other works on the platform that could have caused the change in gradient.

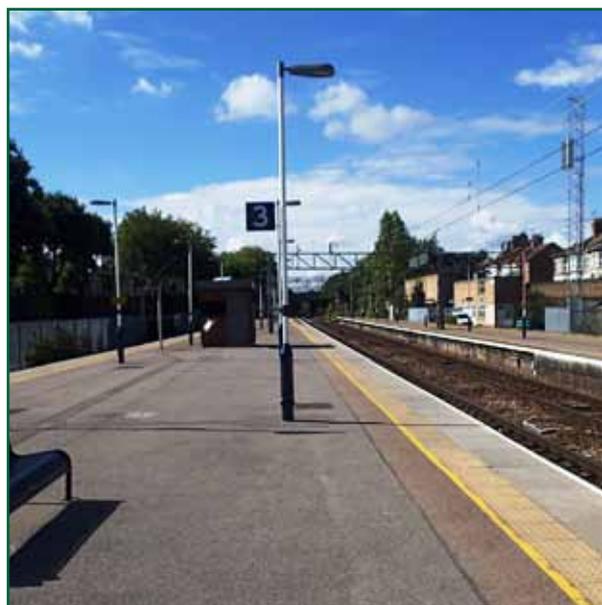
Figure 9: Southend Central station

- 55 An individual's interpretation of slant is affected by their perception of the orientation of the surface they are standing on relative to the objects and structures within their line of sight. An individual's perception of optical slant will vary as their line of sight changes. The nature of the intersections between the structures in their line of sight affects how easy it is to identify slant; it is easier to see slant where there is a rapid change in angle or intersection (figures 11 and 12). Other than the ticket machine at Whyteleafe and a station lighting column at Southend Central, there were no structures intersecting the platform surface in the immediate vicinity of the places where the accidents happened. The lack of intersection with the platform surface would have made the optical identification of the slope more difficult.

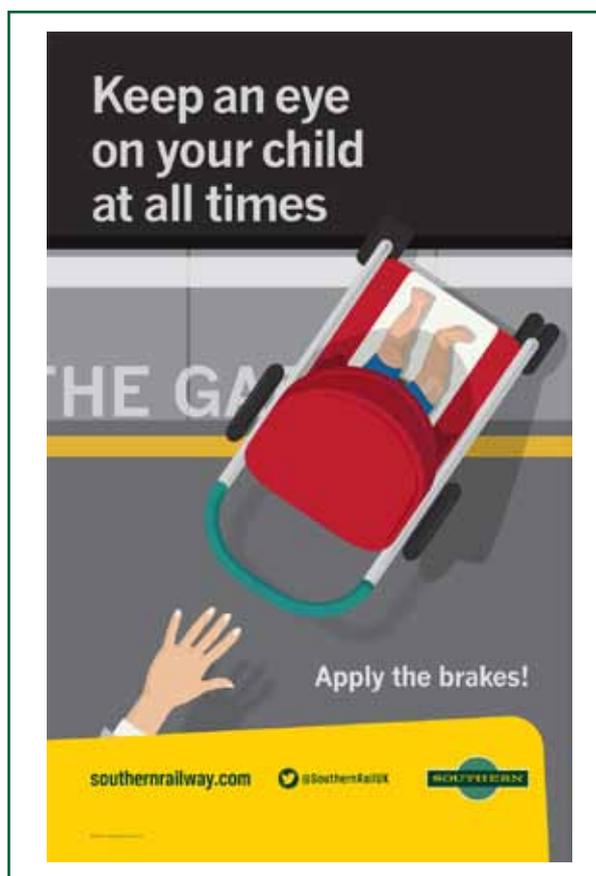
Figure 14: Southern platform poster introduced on platforms with slopes towards the railway

- 77 Southern Railway has reported that it has:
- started to survey and risk assess stations to identify platforms sloping towards the track, focusing in particular on the location of platform furniture (seats, ticket machines, help points, vending machines);
  - introduced a poster to warn passengers of the risk of pushchairs rolling away (figure 14);

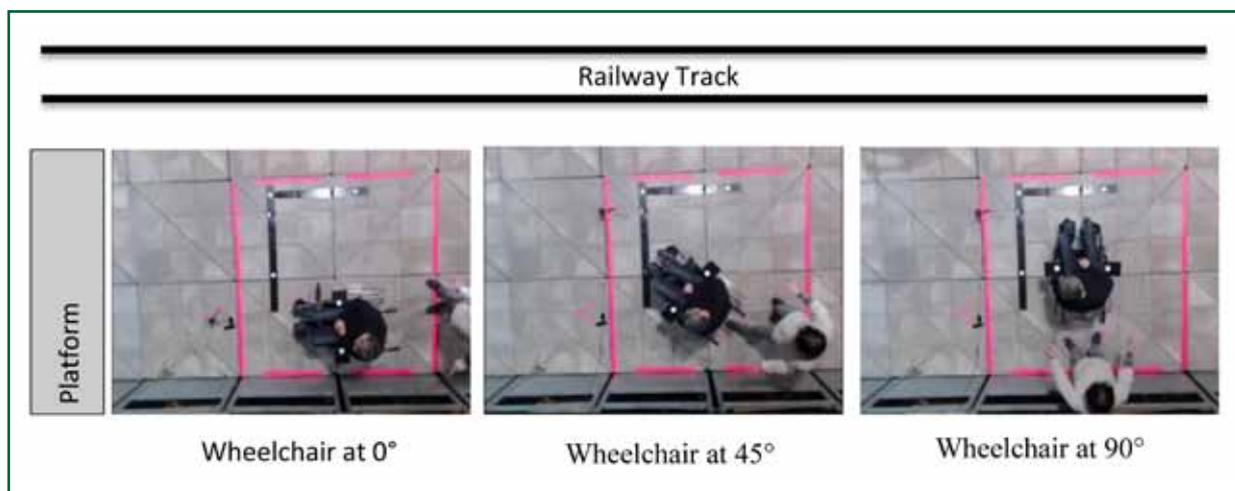
The PAMELA platform was set-up with a 2.4m x 2.4m area on a slope. Two slope gradients were investigated: 2° (1:28 or 3.5%) and 5° (1:11 or 9%). The initial position of the wheelchair was adjusted so that its orientation relative to the edge of the slope was in one of three positions (figure F1):

Figure F1: Wheelchair positions relative to the slope which runs downhill towards the top of the picture. The term '0°' refers to chair and/or wheels being side-on to the slope, while the term '90°' refers to the chair and/or its wheels facing down the slope.)

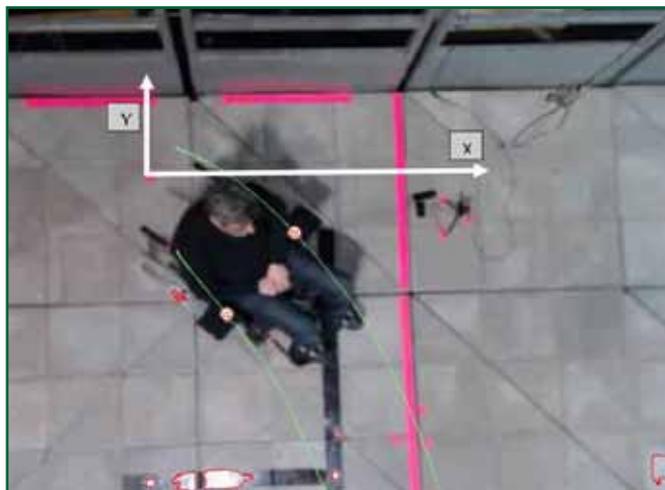
A detailed description of a single run from what is theoretically the ‘best case’ scenario in terms of safety of the wheelchair user with wheelchair at 0° and casters at 90° is analysed in detail for this initial investigation. The trajectory of the wheelchair for the 1:28 (3.5%) slope is shown in figure F2 and the trajectory for the 1:11 (9%) slope is shown in figure F3.

Figure F2: Tracked wheelchair (green lines) as it rolls down a 2° (1 in 28) slope

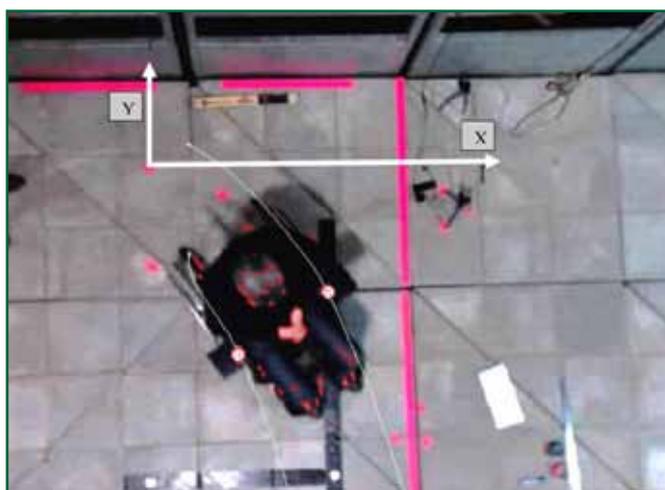
Figure F3: Tracked wheelchair (green lines) as it rolls down a 5° (1 in 11) slope

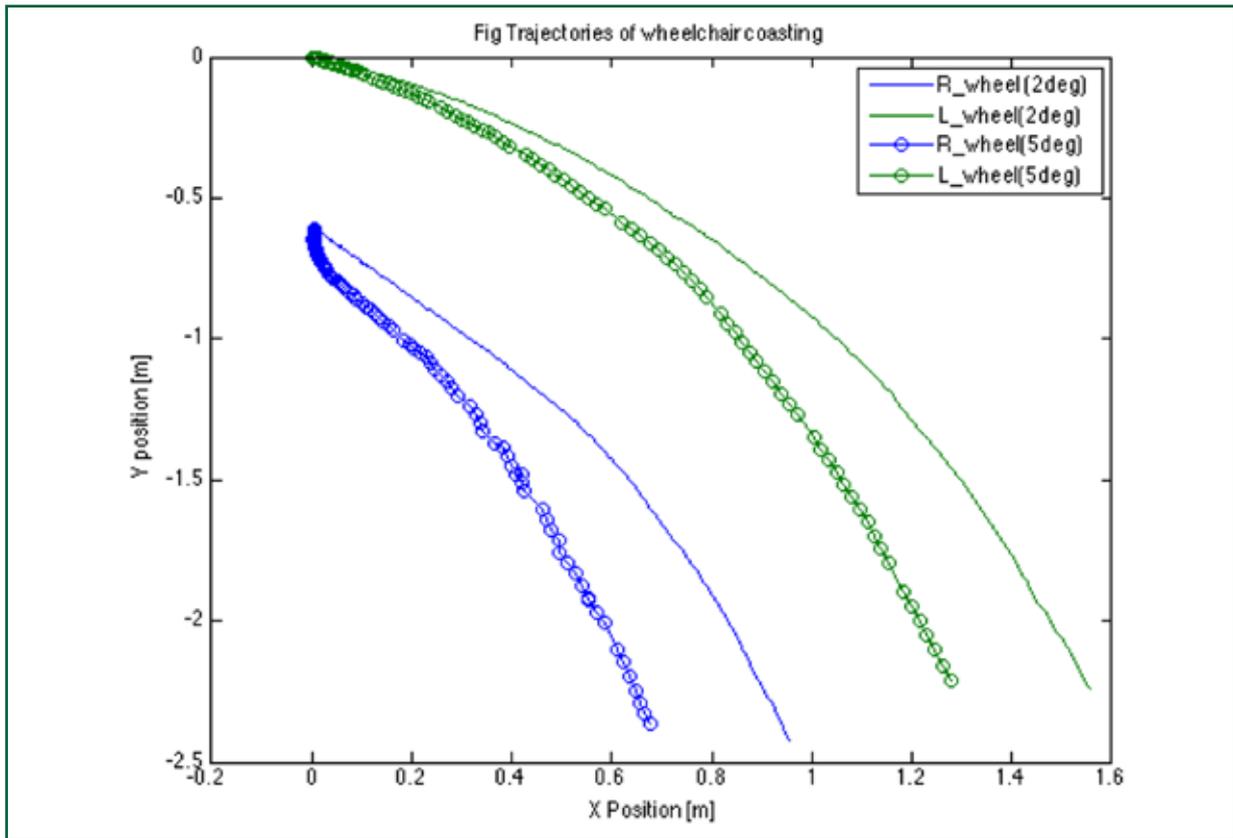
The trajectories for both slopes are also shown in figure F4, with the left wheels shown in green and right wheels in blue. The 1:11 (9%) slope (circles) resulted in a much tighter turning circle of the wheelchair compared with the 1:28 (3.5%) slope (solid lines).

Figure F4 details the trajectories of the left and right wheels of the wheelchair as indicated by the tracked markers. Y position is in the direction of the (imaginary) railway tracks. X position is travel along the length of the platform.

Figure F4: Trajectories of the left and right wheels of the wheelchair as indicated by the tracked markers

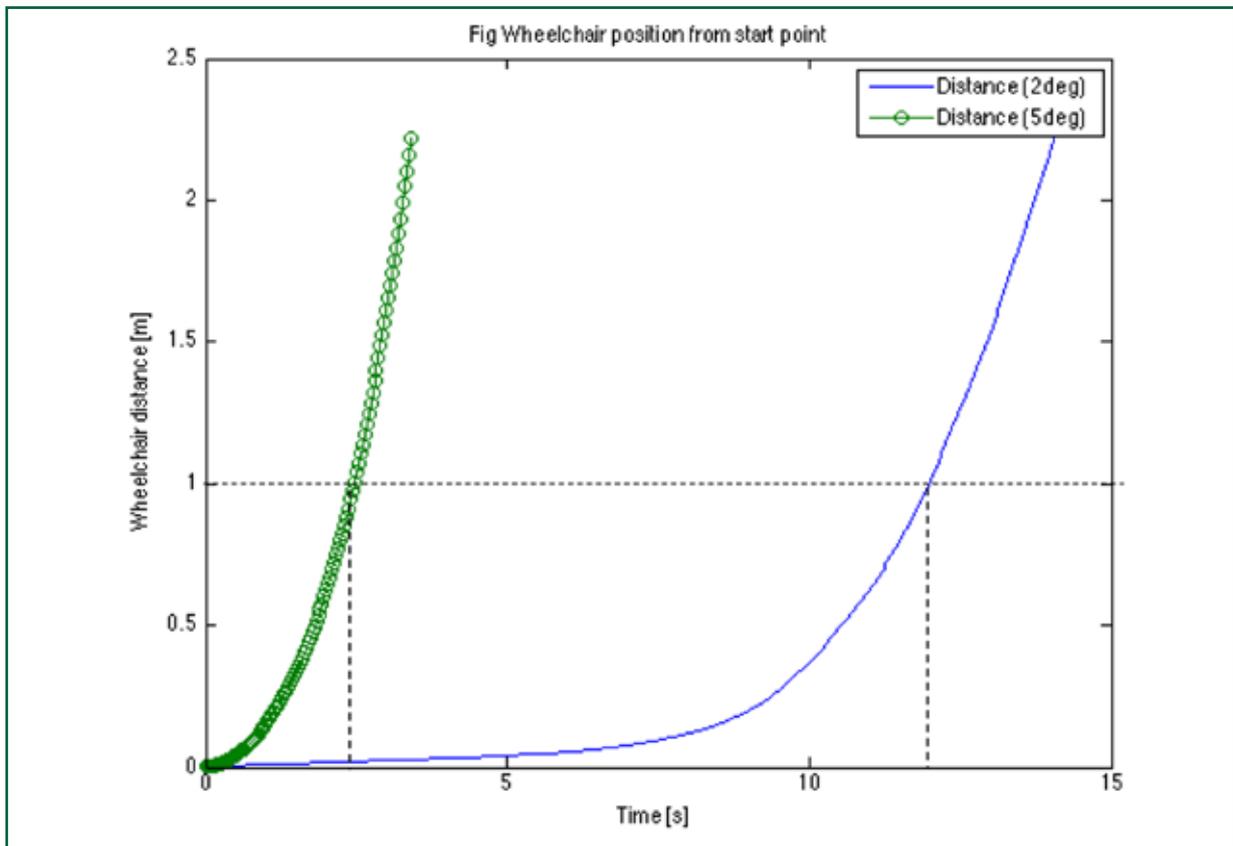
Figure F5 shows the distance travelled by the wheelchair against time. On a 1:11 (9%) slope the wheelchair begins to move within a second and has travelled 1m (shown as a black dashed line) in approximately 2.5 seconds. On the 1:28 (3.5%) slope the wheelchair takes longer to begin to move and takes approximately 12 seconds to move 1m, having moved very slowly for the first 7 seconds.

Figure F5: Time series plot of wheelchair movement as indicated by the tracked markers. Y position is in the direction of the (imaginary) railway tracks. X position is travel along the length of the platform.
