Rail Accident Report

Accident at Charing Cross station 24 November 2012

Report 10/2013
July 2013

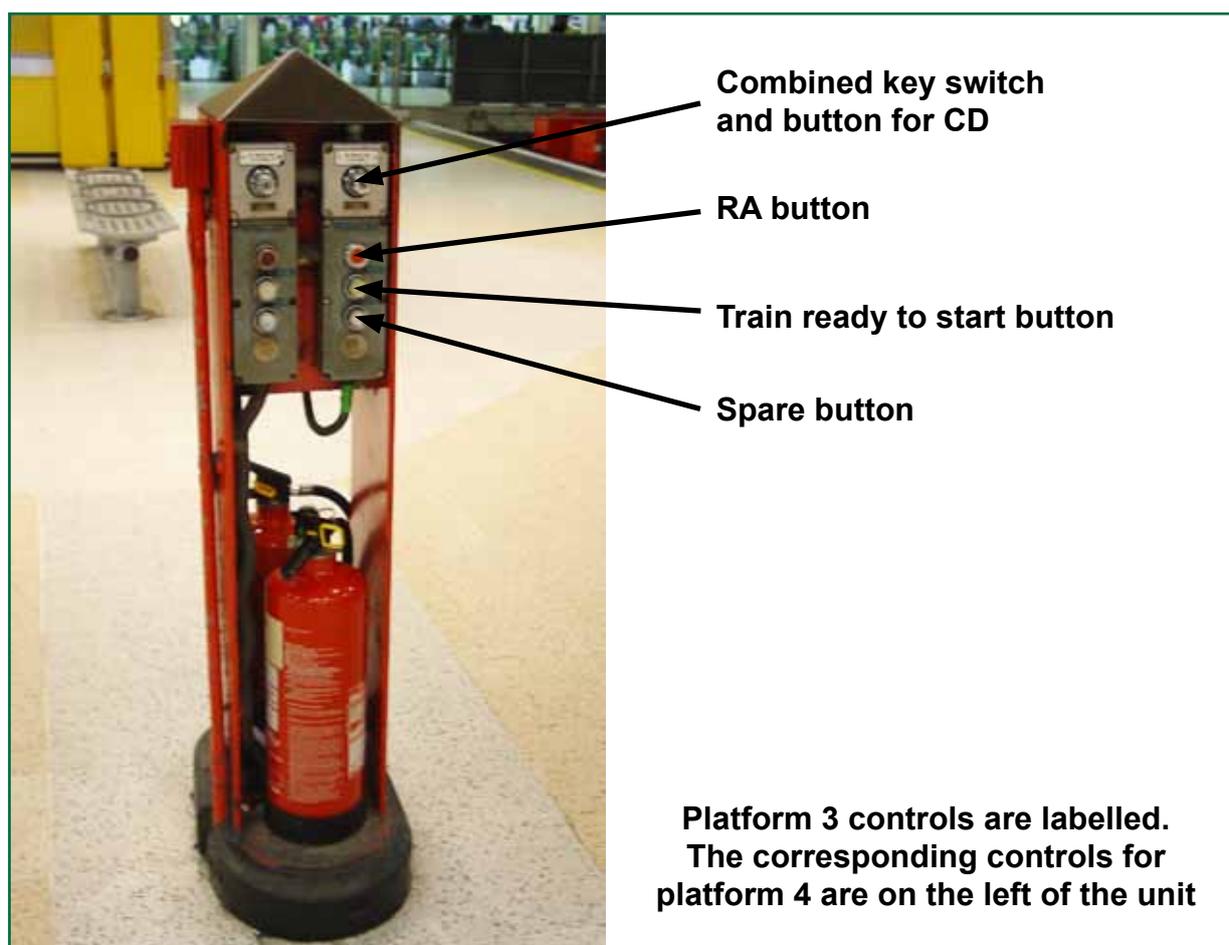
Figure 3: Dispatch controls for platforms 3 and 4 at Charing Cross

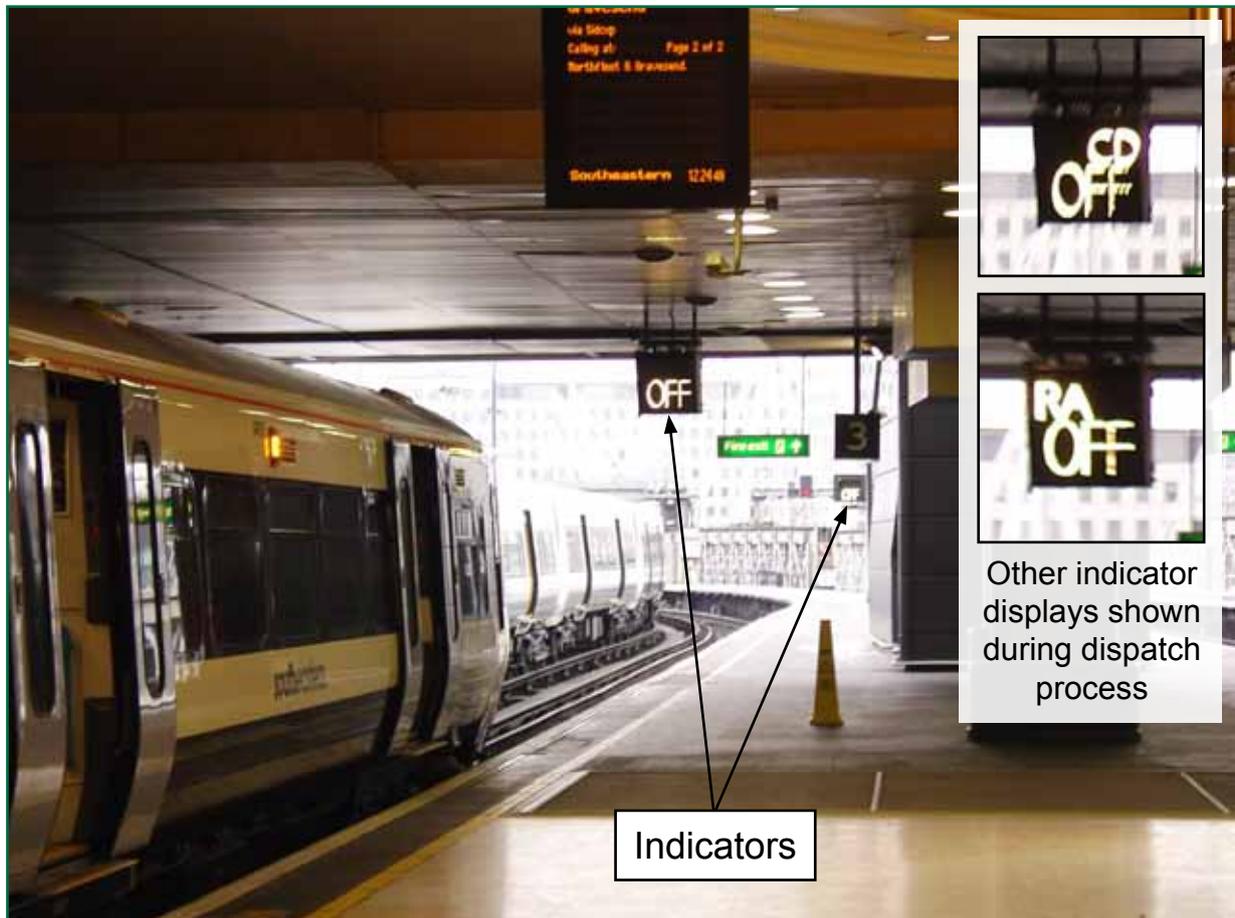
Figure 4: Dispatch indicators on Charing Cross platform 3

- 52 Once the 'RA' control has been operated, the platform staff have no ability to cancel it, and the indication remains illuminated until the train passes the signal at the end of the platform, at which time the signal returns to red and the 'OFF/RA' indication (figure 4) goes to blank.

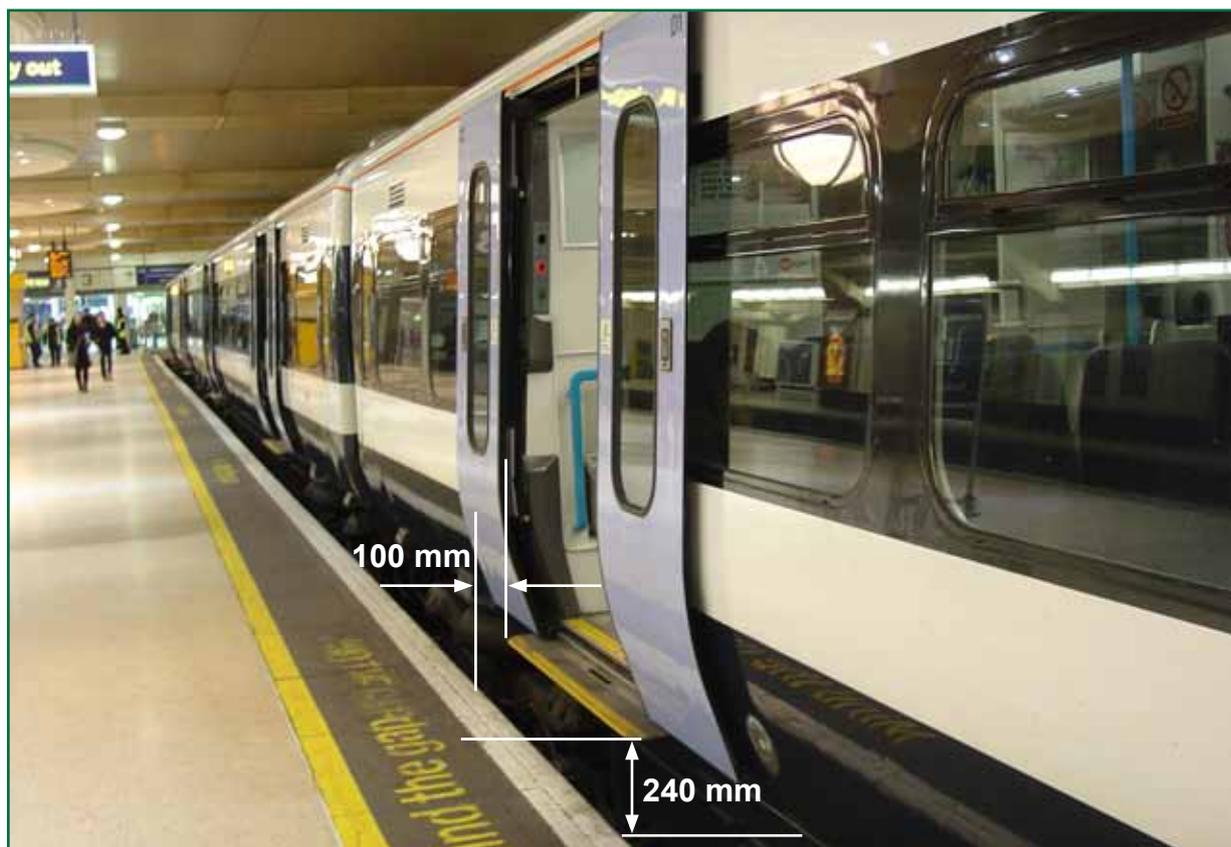
- 42 The RAIB examined a class 465 train in platform three at Charing Cross. Class 465/466 trains have protruding steps at each doorway (figure 5). When these trains are alongside platform 3 at Charing Cross, the edge of the step is 100 mm horizontally clear of the platform edge, and the surface of the step is 240 mm above the level of the platform (figure 5).
- 43 Between the doors, the gap between the platform edge and the body of the train is 360 mm wide (figure 6). Below the edge of the platform there is a recess about 300 mm deep, which, although it is partly obstructed by cables, can provide a refuge clear of the train for a fallen body.

Figure 5: Class 465 train at Charing Cross platform 3

- 44 The maximum stepping distance between platforms and trains is defined in Railway Group Standards⁶. This maximum dimension is intended to take account of considerations of safety and accessibility. At Charing Cross the step position for this type of train, relative to the platform, is compliant with the relevant standard (GI/RT7016) (figure 5 and table 1).

FOOTSTEP TO PLATFORM EDGE	Charing Cross platform 3 (mm)	Maximum permitted in standard (mm)
Platform edge to footstep: vertical	240	250
Platform edge to footstep: horizontal	100	275
Platform edge to footstep: diagonal	260	350

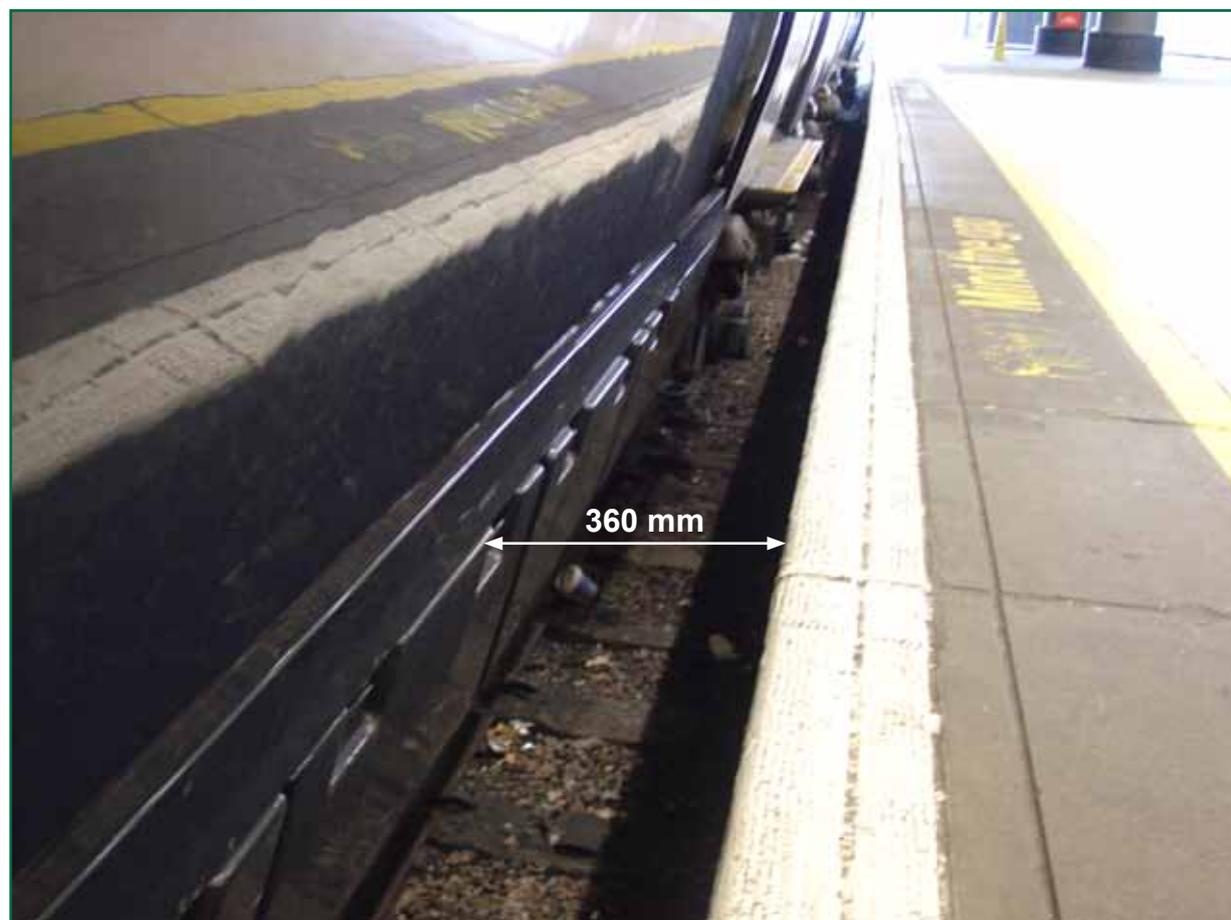
Figure 6: Bodyside of class 465 train in platform three at Charing Cross
