# Rail Accident Report

## **Accident involving a pantograph and the overhead line near Littleport, Cambridgeshire 5 January 2012**

Report 06/2013 v2  
November 2013

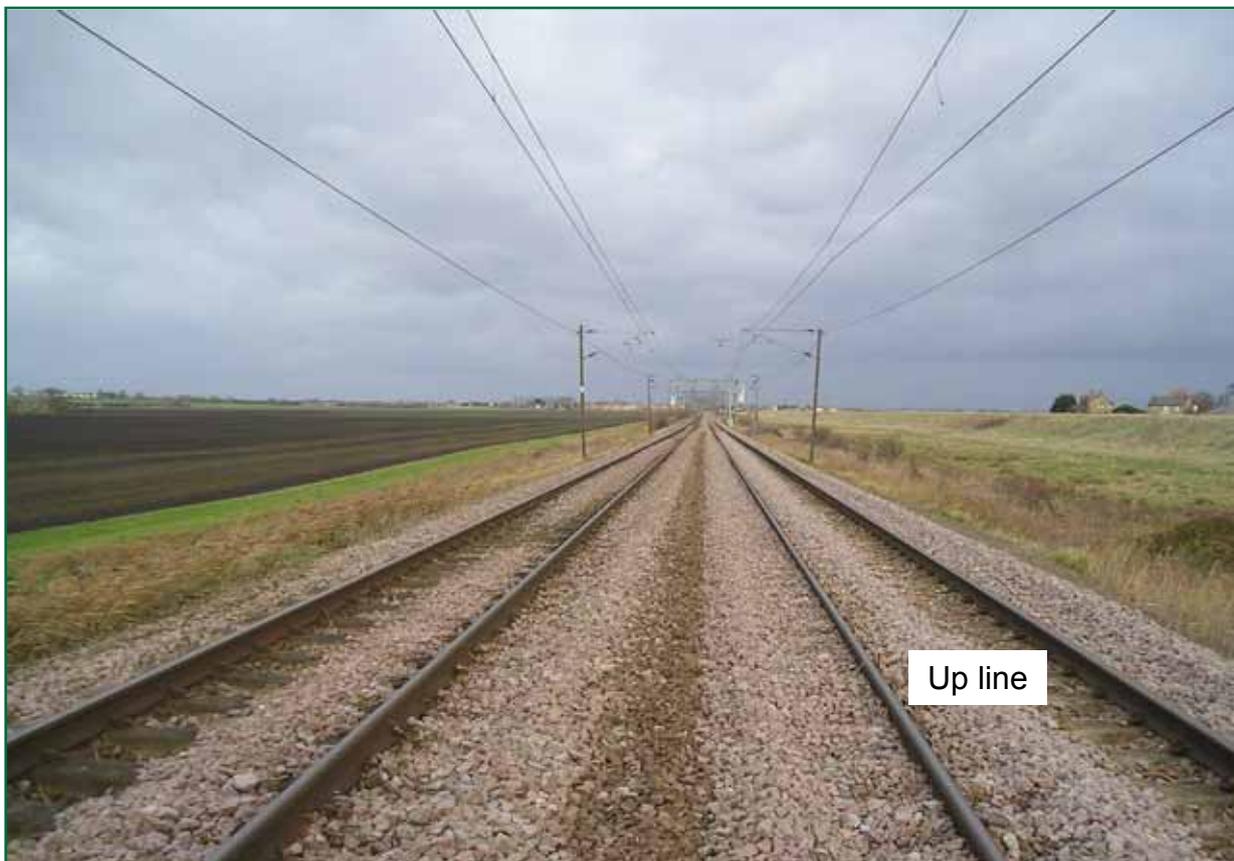
Figure 2: General view of accident location (Courtesy of First Capital Connect)

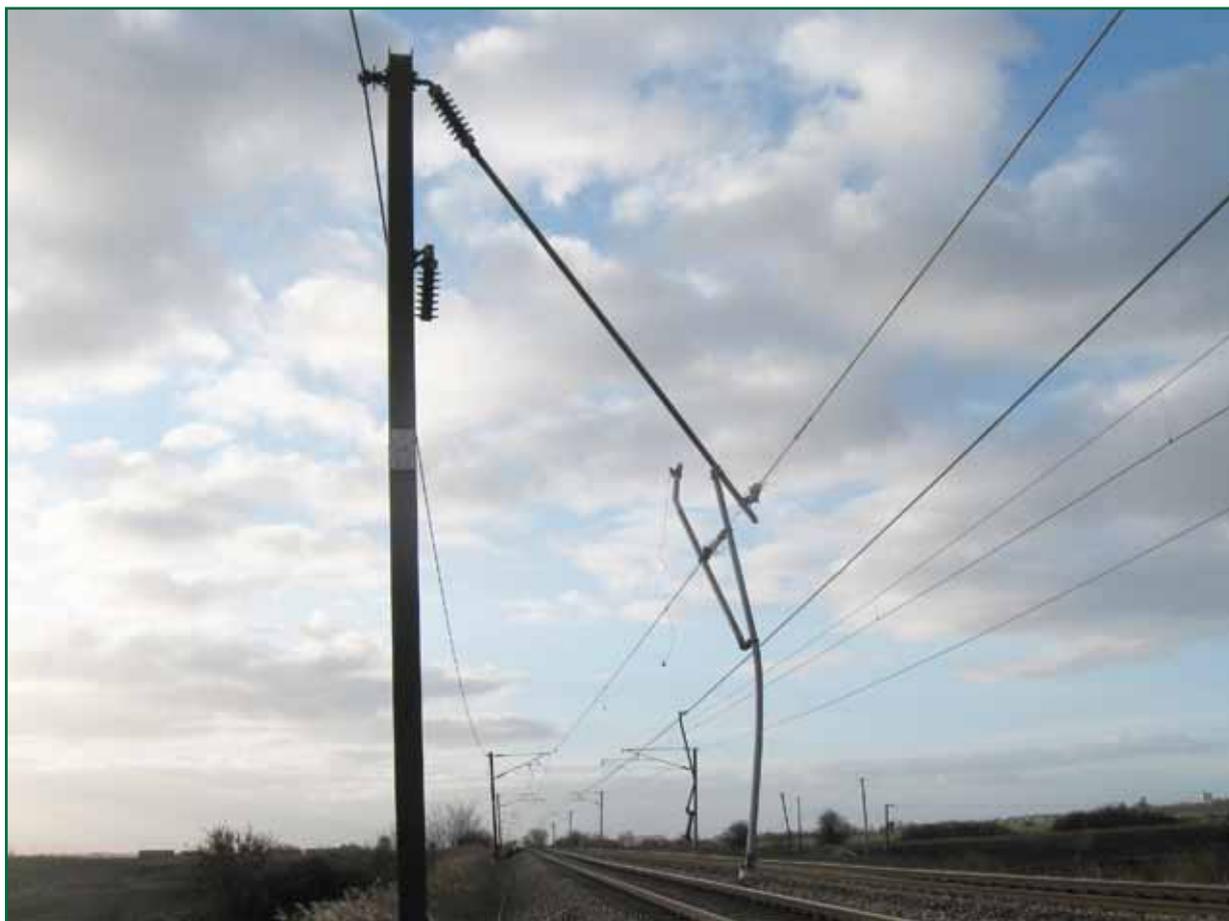
Figure 4: Support structure hit by the pantograph, at mast C118/32 (courtesy of Network Rail)

- 75 The pantograph assembly, which weighs around 225 kg, was travelling at 80 mph (129 km/h) when it hit the cantilever structure at mast C118/32. This would have resulted in a sudden large impact loading. RAIB calculations have shown that an impact load in excess of that required to break each of the insulators was likely to have resulted from the collision between the pantograph and the cantilever structure. The pantograph manufacturer also considered that it was possible that such an impact loading would cause the insulators to break.

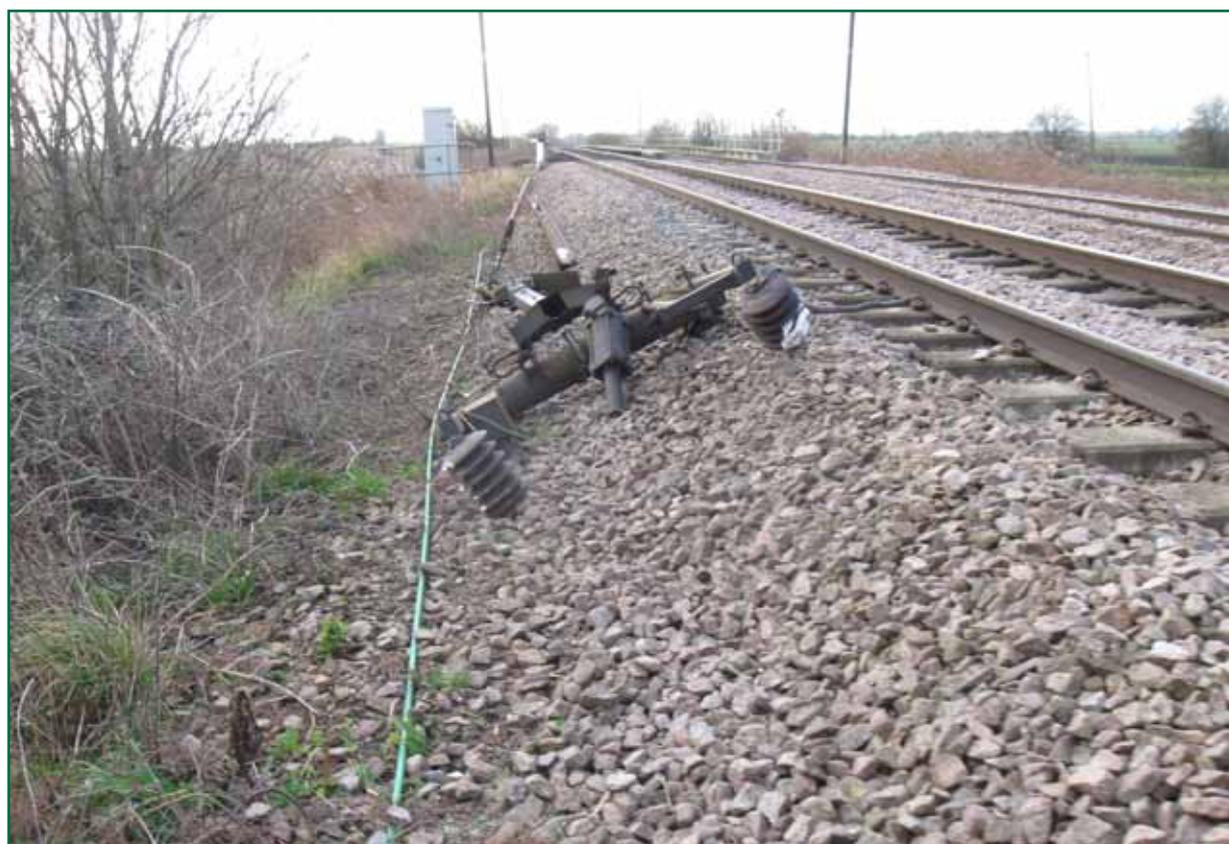
Figure 5: Remains of the pantograph in the cess (courtesy of Network Rail)

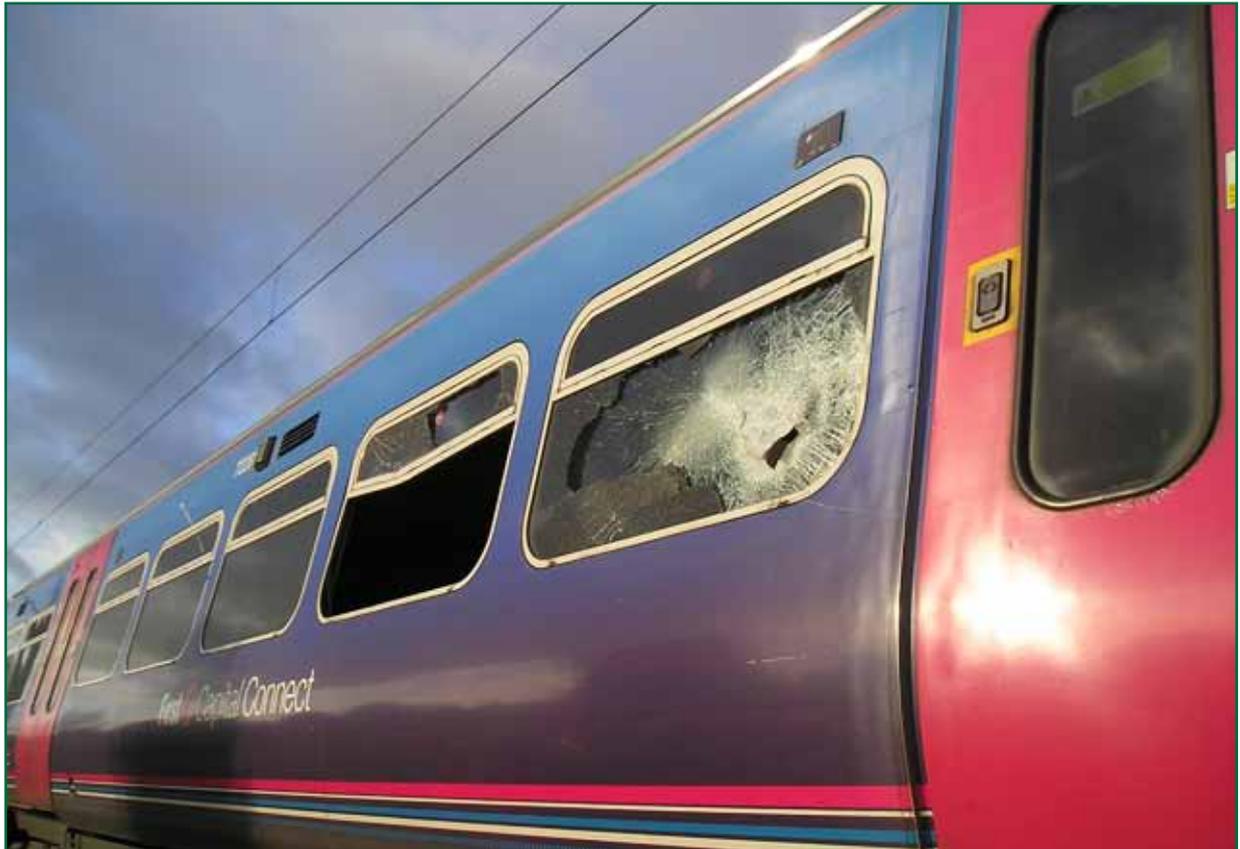
- 13 Two of the train's windows were broken. There was superficial damage to the roof and side, and extensive damage to the pantograph assembly.

Figure 6: External damage to the train (courtesy of First Capital Connect)

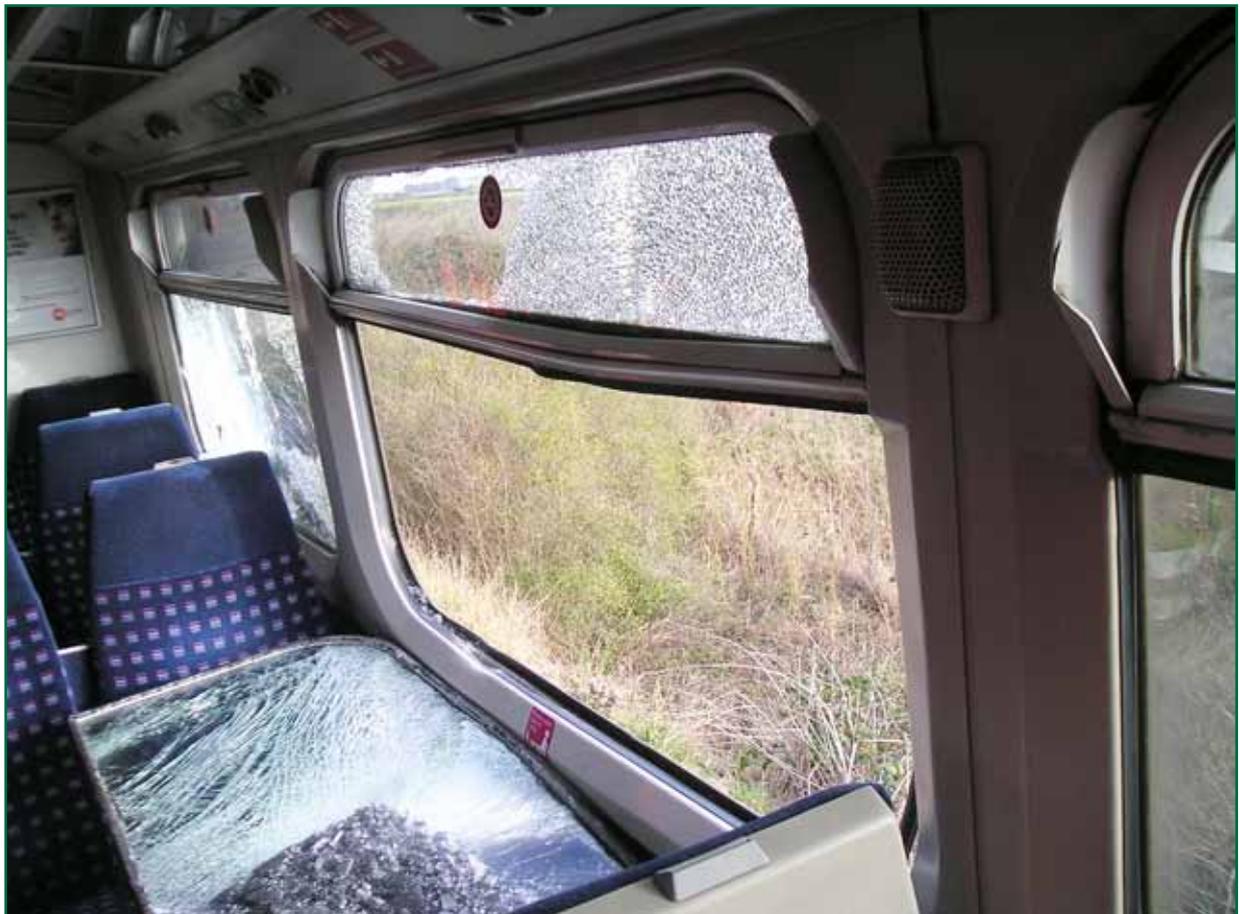
Figure 7: Window after falling into passenger area (courtesy of First Capital Connect)

- 82 The window was forced into the train by impacts from the pantograph assembly.**
- 83 The pantograph was mounted towards the rear of the second coach of the train. Scrape marks on the train roof show it was displaced onto the roof of the third coach, before falling down the left side. As the pantograph fell, it impacted the left side of the third coach several times. This caused scrape marks to the coach bodywork, showing that the pantograph was moving backwards relative to the moving train. There were signs of impact on the frames and panes of the sixth and seventh windows (out of nine) on the left side of the third coach. These impacts resulted in the pane of the sixth window falling onto the adjacent table inside the coach (figure 7).

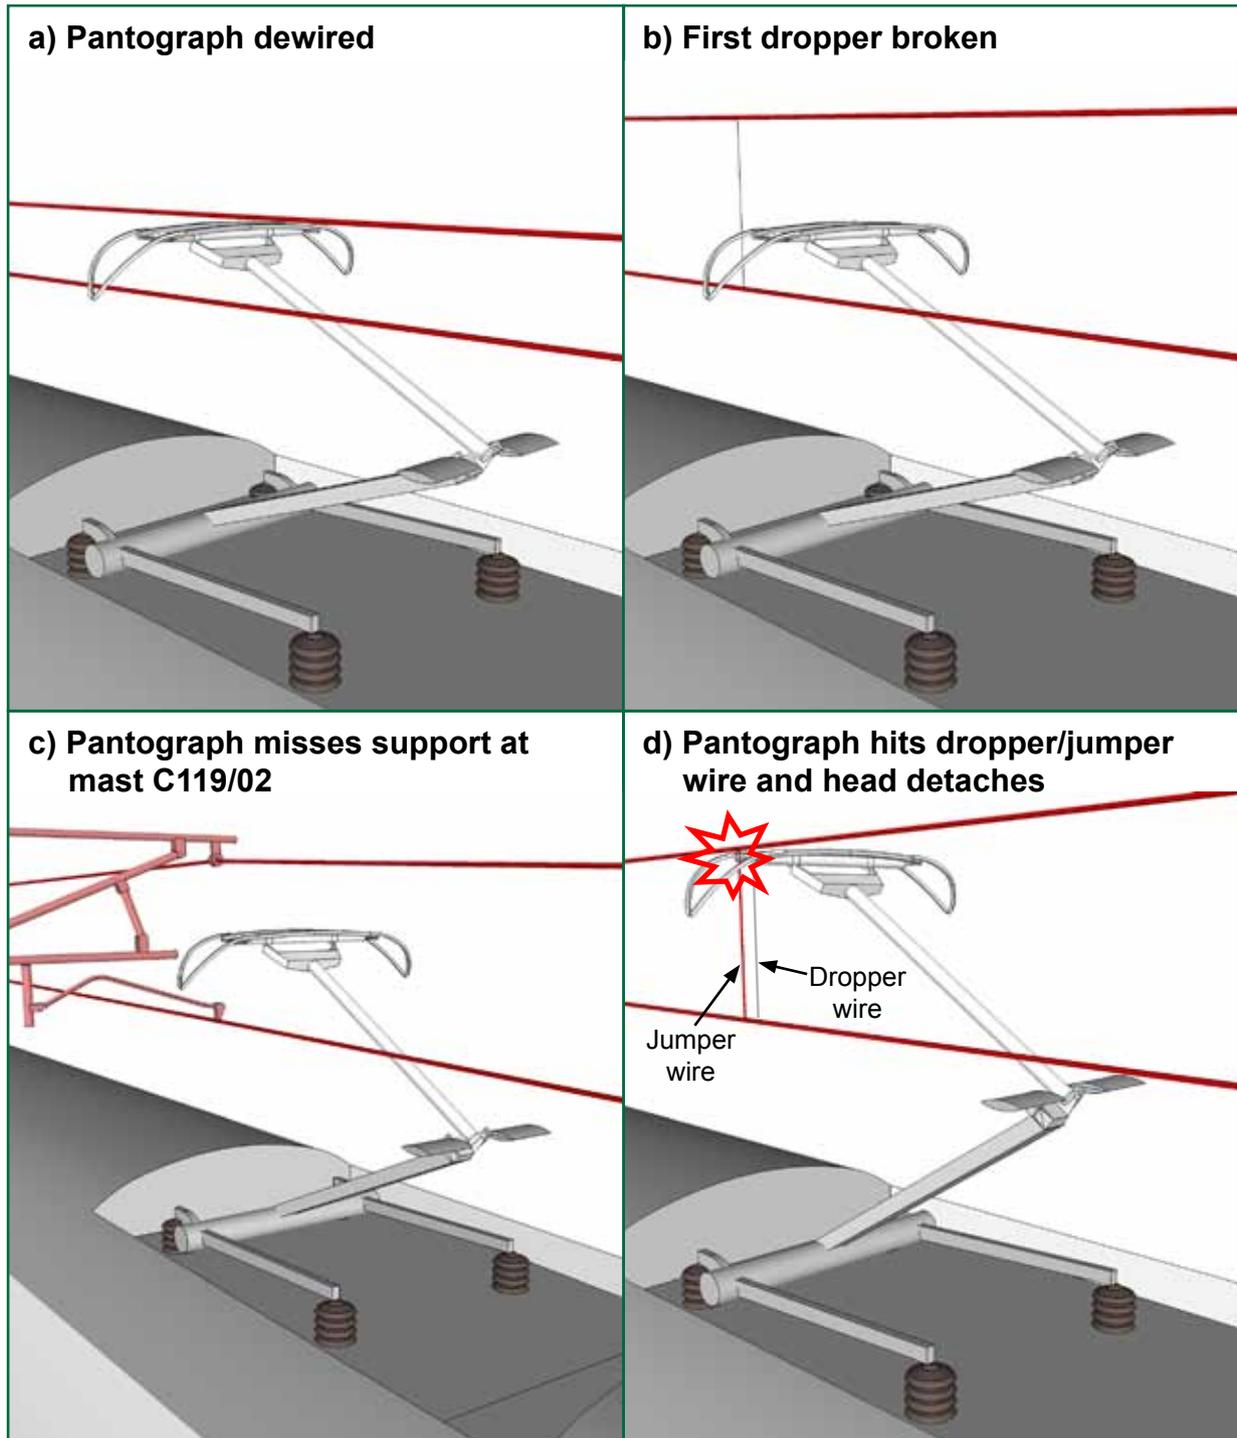
- 69 The pantograph head, still between the contact and catenary wires, hit the first dropper wire after mast C119/02 (figure 14d). Adjacent to this dropper wire was a jumper wire, which had a much bigger cross section (it was designed to make a good electrical connection between the catenary and contact wires, rather than to provide mechanical support). It is likely that the pantograph head became detached from the arm as a result of hitting the jumper wire. The next five dropper wires, up to mast C118/32, remained intact as the pantograph arm passed to the right of them.

Figure 14: Illustration of pantograph failure sequence

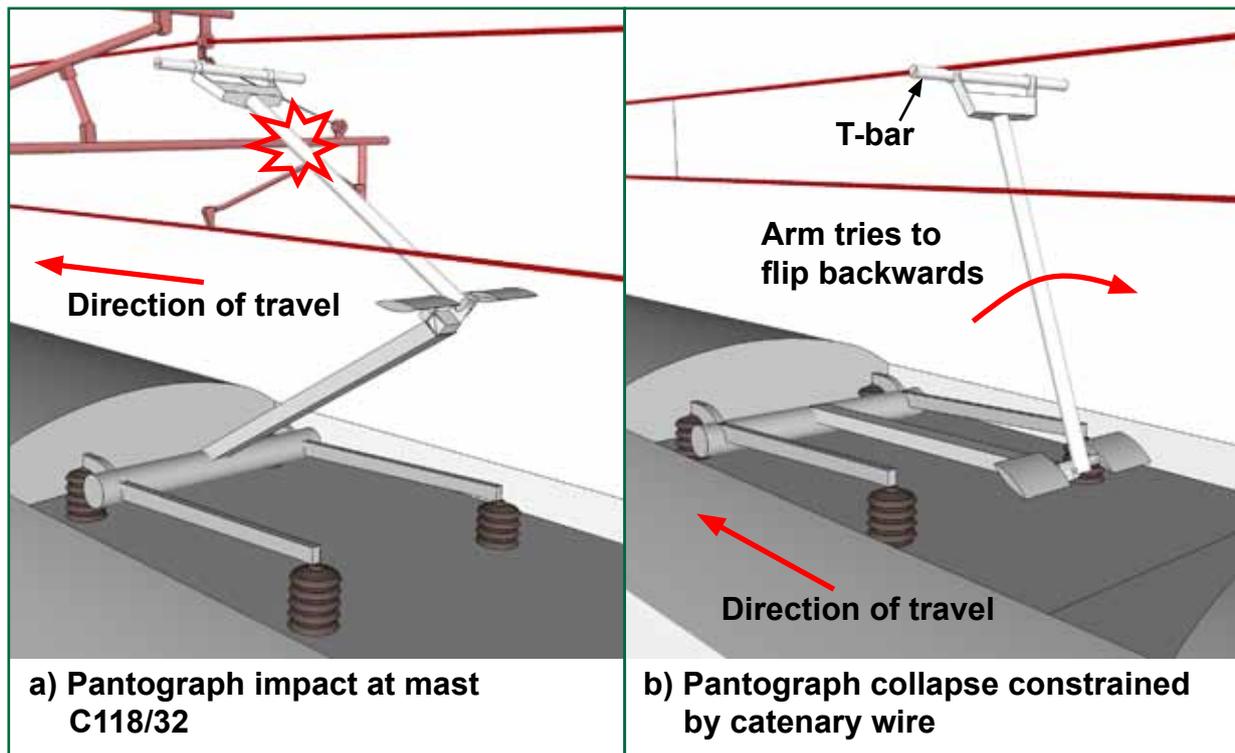
70 At mast C118/32, the overhead line was supported from the right side, meaning that the cantilever structure was hit by the pantograph arm, which was still positioned to the right of the contact wire (figure 15a).

- 79 Because it was constrained vertically, the T-bar was pushed along the underside of the catenary wire as the train continued to move at 80 mph (129 km/h). This resulted in the T-bar breaking a number of dropper wires after mast C118/32. The catenary wire was also damaged by the T-bar dragging along it.

Figure 15: Illustration of pantograph failure sequence (continued)

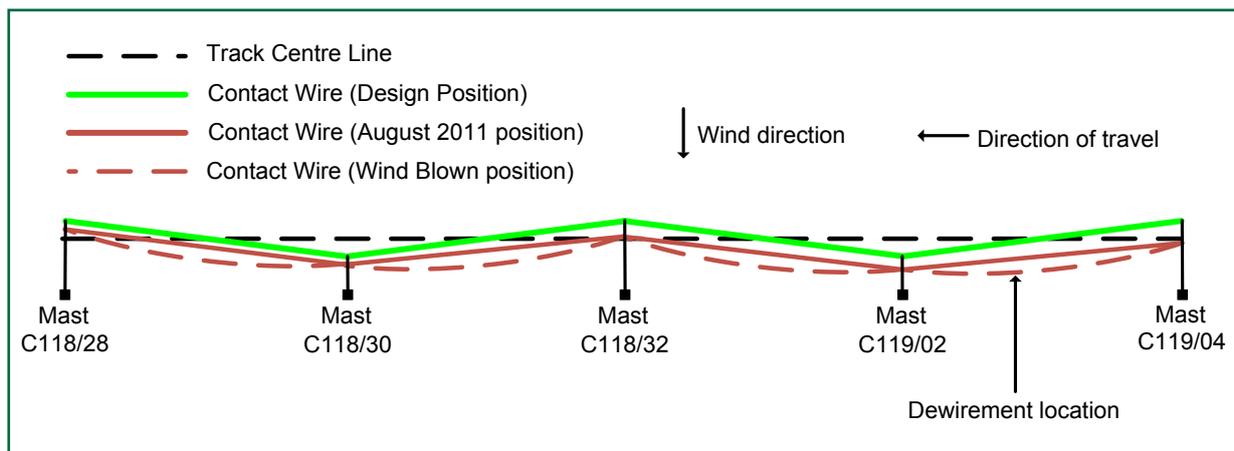
- 94 Extrapolation of site measurements taken by Network Rail between 2007 and 2011 (paragraph 126) indicates that movement of mast foundations had caused the contact wire to be offset by approximately 230 mm from the track centre at the mid-span between masts C119/04 and C119/02.
- 95 The design drawings for the overhead line showed that the mid-span position of the overhead line was intended to be directly above the track centre line (figure 16).

Figure 16: Overhead line alignment at accident location (plan view not to scale)

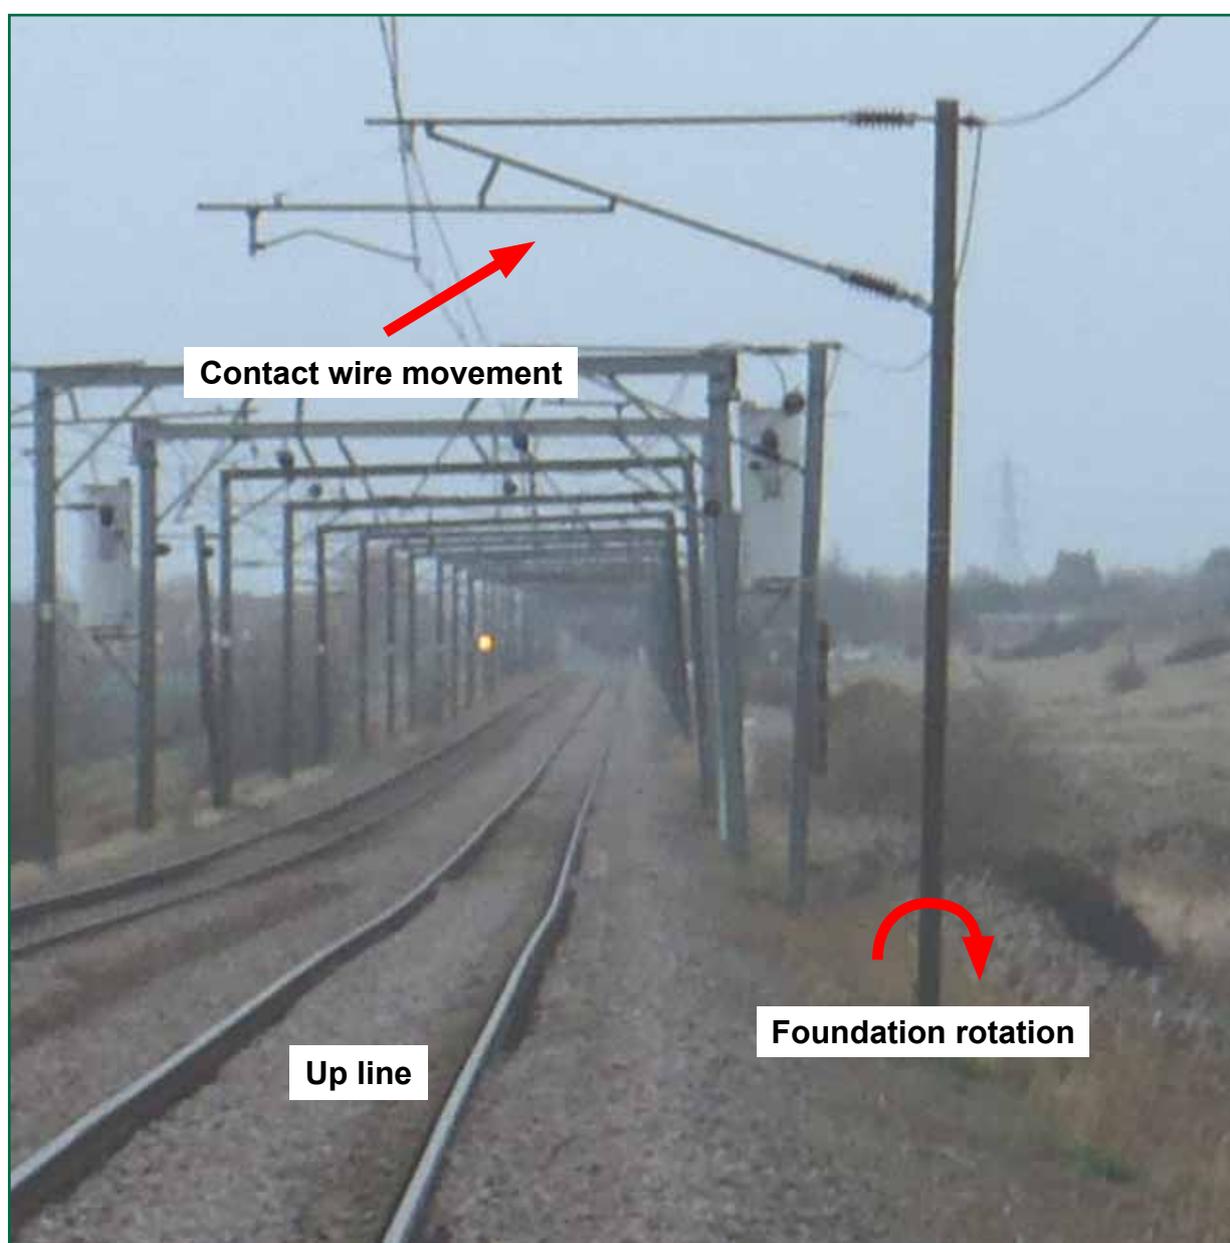
**120 Movement of the OLE mast foundations rotated the overhead line away from the centre line of the track.**

121 The accident occurred at a location where the railway embankment is crossing fenland, an area in which weak natural soils often result in embankment and foundation movements. This is the probable explanation for mast rotation at the accident location, which has pulled the overhead line away from the track, towards the cess, and vertically upwards (figure 23). Movements of this type are additional to short term mast deflection caused by wind loading (paragraph 98).

Figure 23: Masts at the accident location, showing results of foundation movement (courtesy of First Capital Connect)

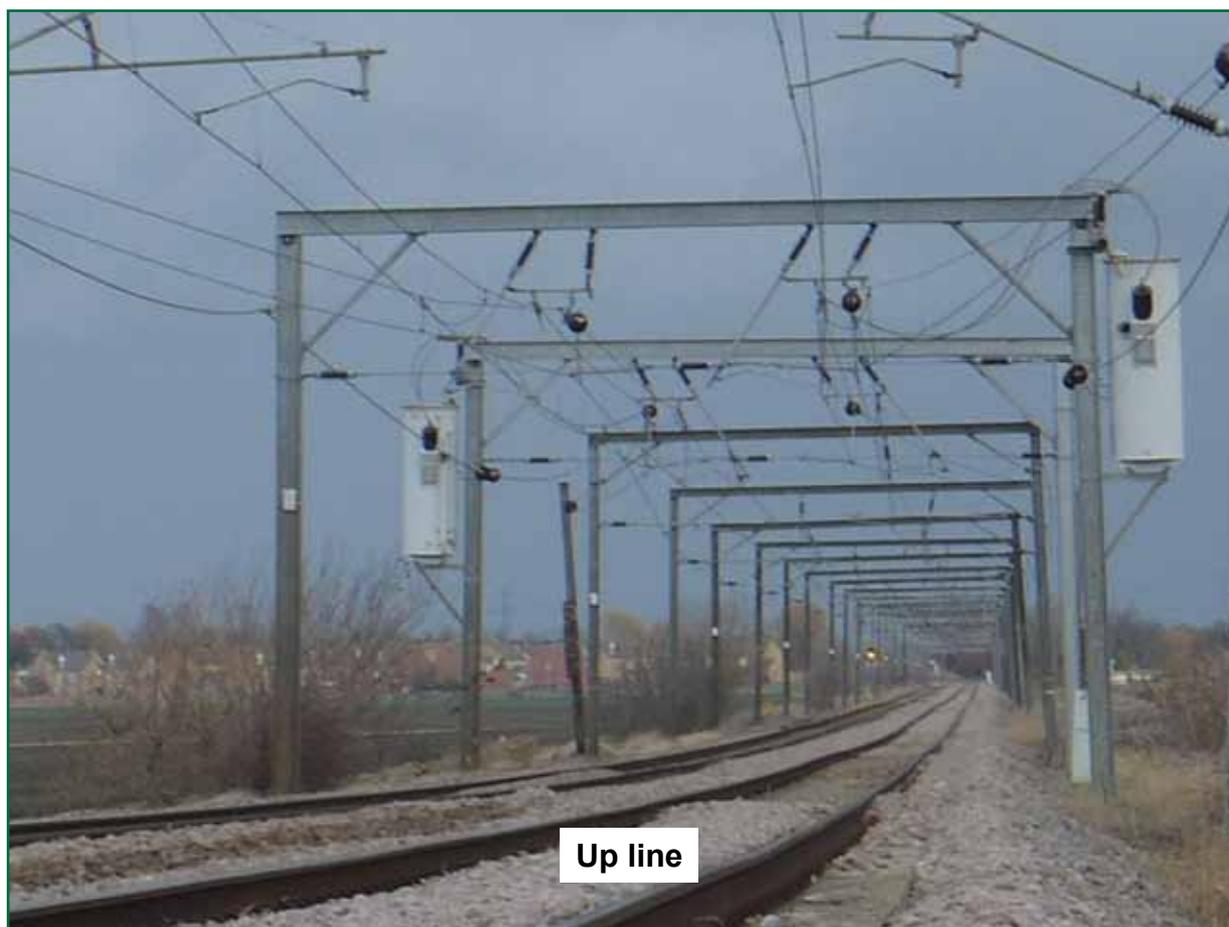
122 Portals, where the two masts on either side of the line are connected together by an overhead structure, are more resilient to this type of movement. Figure 24 shows an example of portal structures. The overhead line up to 200 metres before the accident was supported on portal structures. After this point, separate masts were used.

Figure 24: Portal structures immediately before mast C119/04 (courtesy of First Capital Connect)

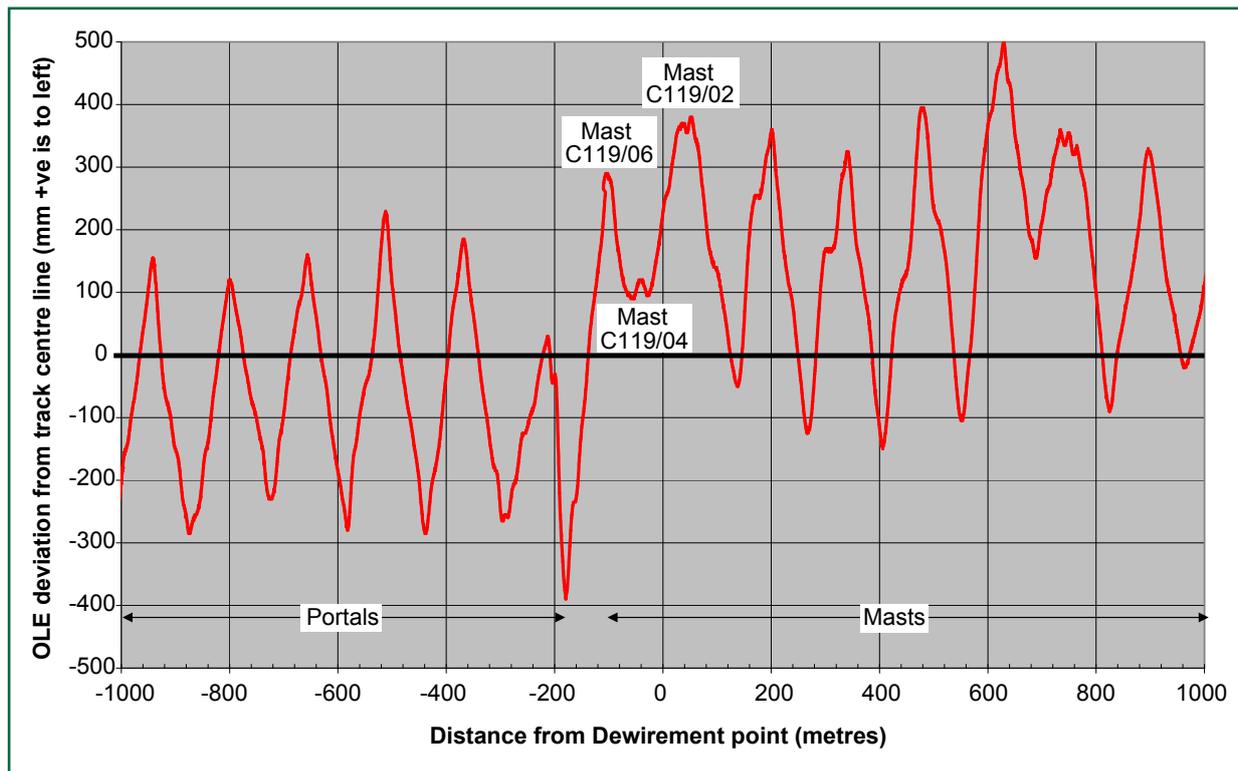
123 The horizontal alignment of the OLE contact wire on the up line in the vicinity of the accident is shown in figure 25. This data was collected by the 'MENTOR' overhead line measurement coach in November 2011, and adjusted by the RAIB to take account of known inaccuracies in the method of measurement<sup>8</sup>. These inaccuracies included calibration differences that led to inconsistencies between successive recordings, and the absence of compensation for dynamic movement (sway) of the coach during recordings. The position of the contact wire is seen to alternate from one side of the track centre line to the other, whilst supported by portal structures. However, where the OLE is supported by separate masts, the alignment of the contact wire is seen to be predominantly left of the track centre line.

Figure 25: Overhead alignment recorded by MENTOR coach

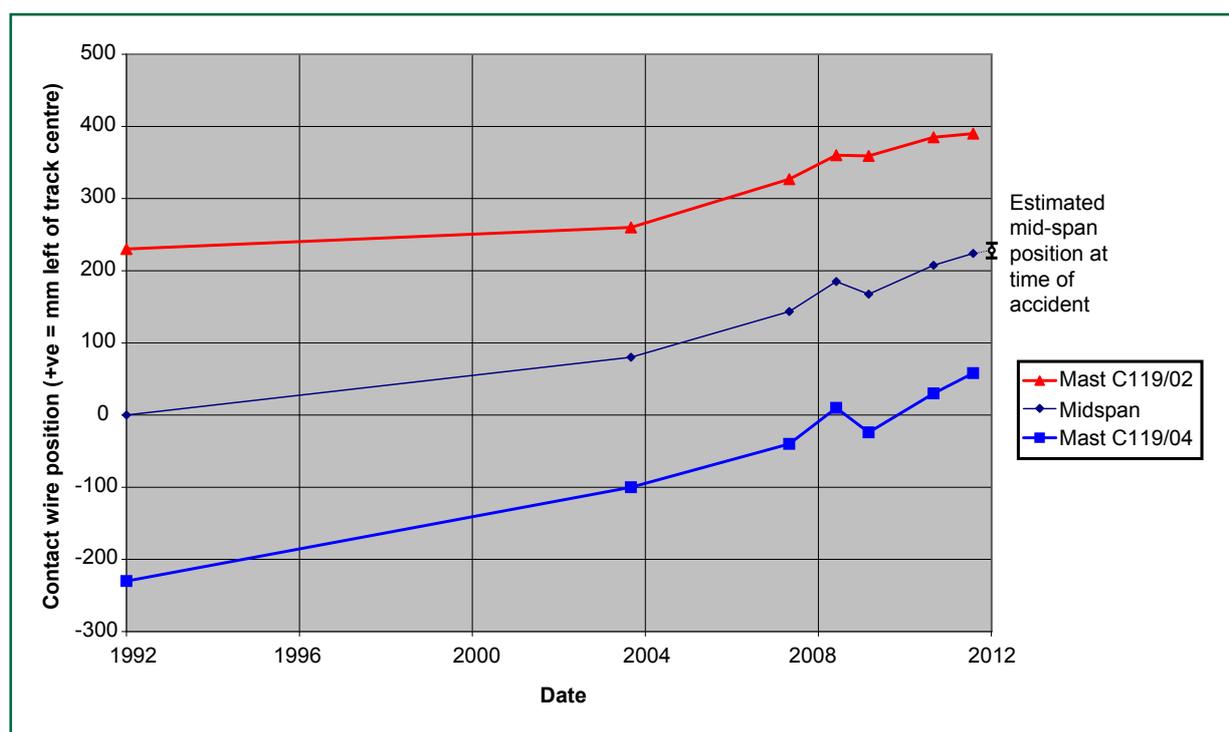
126 The slipping structure monitoring had been undertaken annually since 2007. The RAIB has extrapolated this data to estimate that the contact wire at mid-span was likely to have been 230 mm ( $\pm 15$  mm) left of track centre at the time of the accident (figure 26). It is probable that this movement consists of both a long term trend and seasonal fluctuations.

Figure 26: Movements of OLE at masts C119/02 and C119/04, and at mid-span

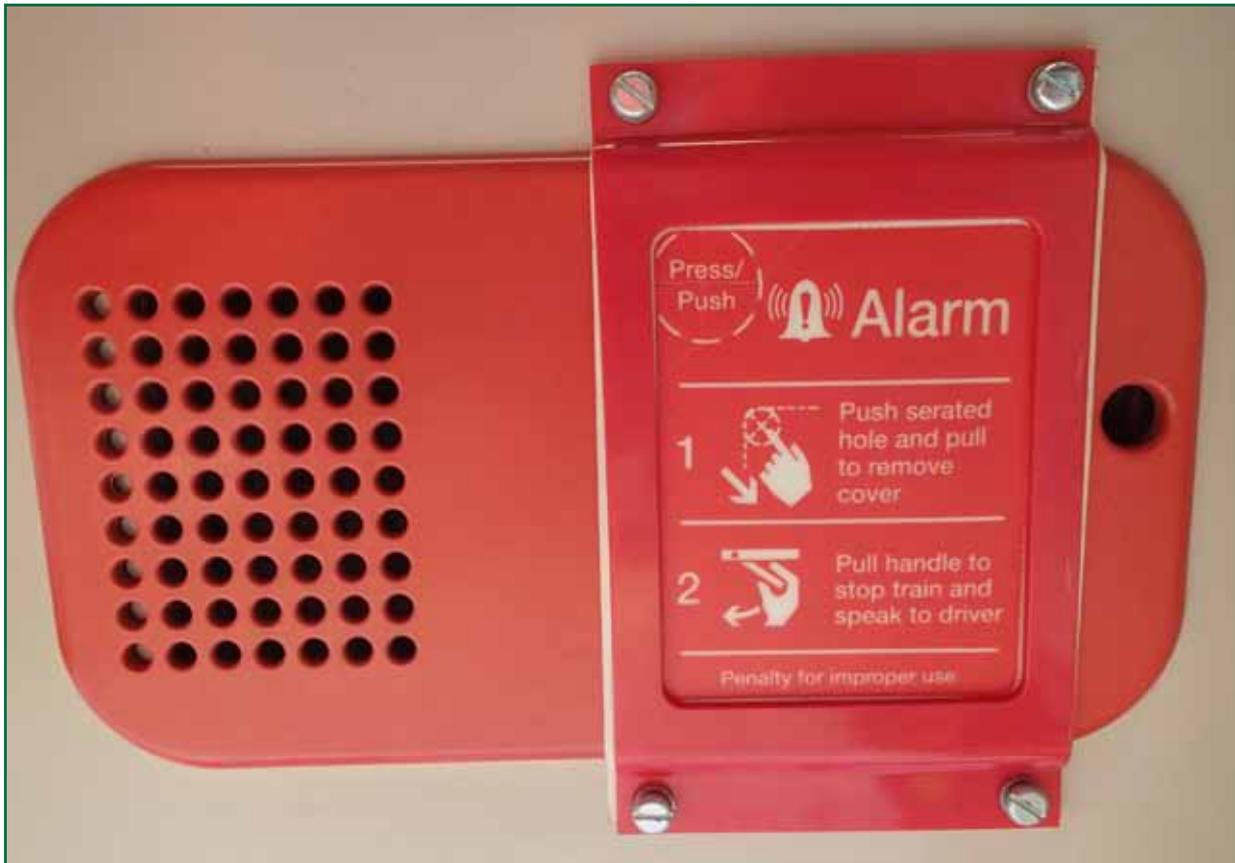
- A11 First Capital Connect stated that the covers had been fitted to the class 365 fleet between 2009 and 2010, in an attempt to reduce the numbers of non-emergency PEA operations. Similar covers had been fitted to other types of rolling stock operated by First Capital Connect, but these trains had wall mounted PEA handles, and the covers had a 'ring-pull' type handle to assist removal. First Capital Connect believed that this design was inappropriate for use on the class 365 PEA handles, because the ring pulls would hang down from the ceiling in a position which could encourage passengers to pull them.

Figure A2: PEA handle cover, showing instructions for removal
