Rail Accident Report

**Fatal accident at Kings Mill No.1 level crossing,
Mansfield, 2 May 2012**

Report 01/2013
January 2013

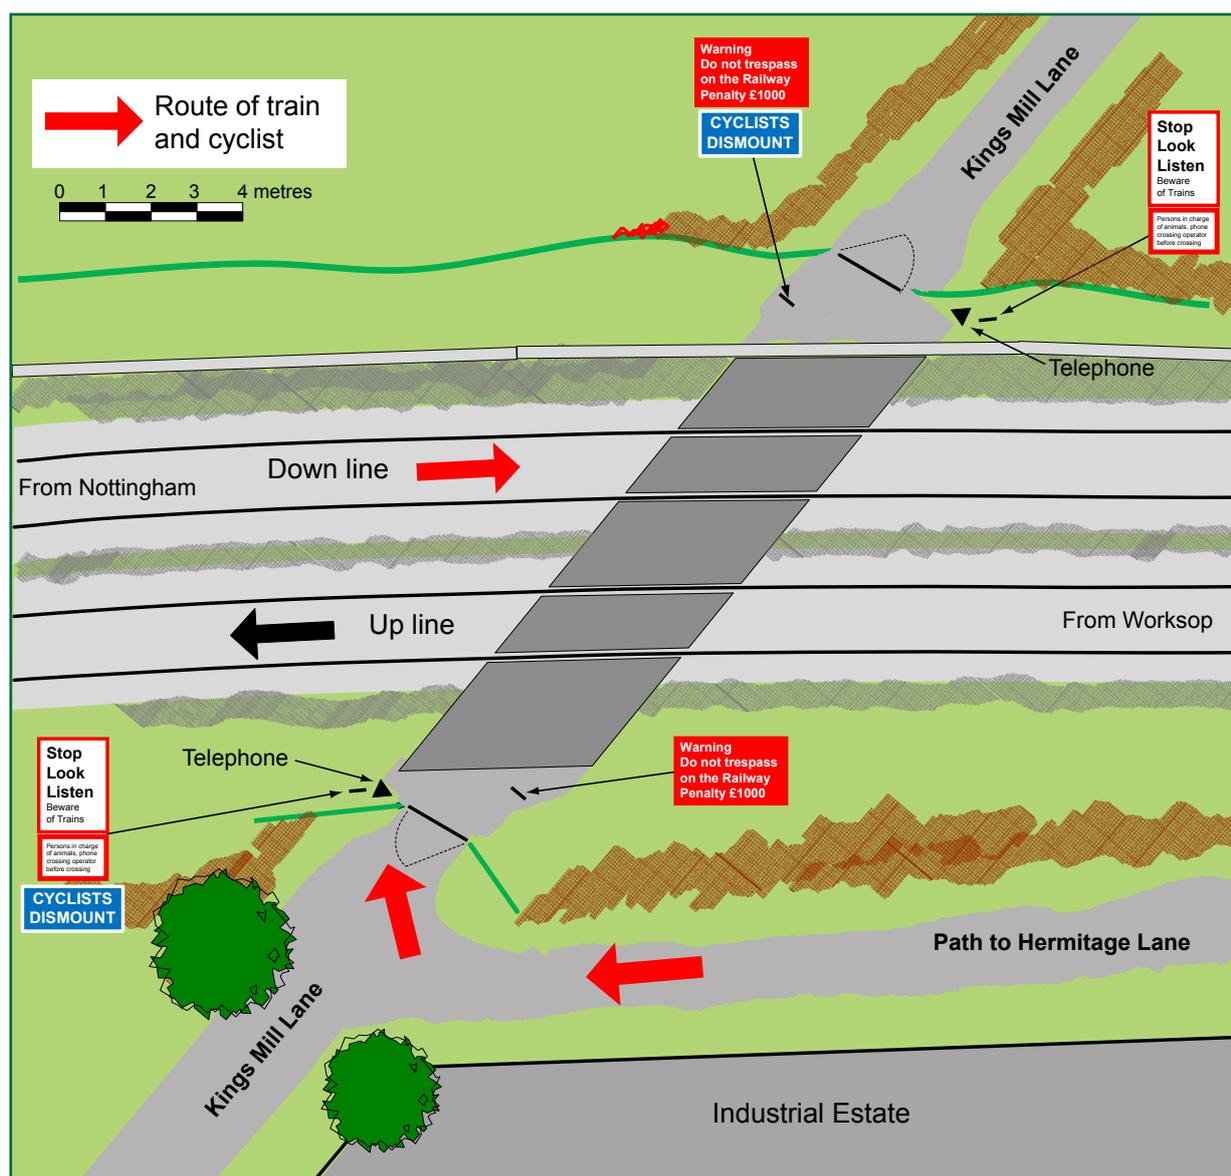
Figure 3: Plan of crossing

- 32 This description relates to the crossing as it was at the time of the accident. It has since been re-aligned to cross the railway at right angles (paragraph 84). There are two approaches to Kings Mill crossing from the up or south-east side of the line. Kings Mill Lane runs almost due north towards the crossing, and another path runs parallel to the railway, behind the industrial estate east of the crossing, and joins the lane immediately south of the crossing.
- 33 The lane crossed the railway at an angle of about 40 degrees.

- 36 At the time of the accident, the crossing was constructed across the railway on the line of Kings Mill Lane, at the angle at which the lane and railway intersect. This increases the length of the crossing deck and the time taken to traverse it, as compared with a crossing at right angles to the line, by about 40%.

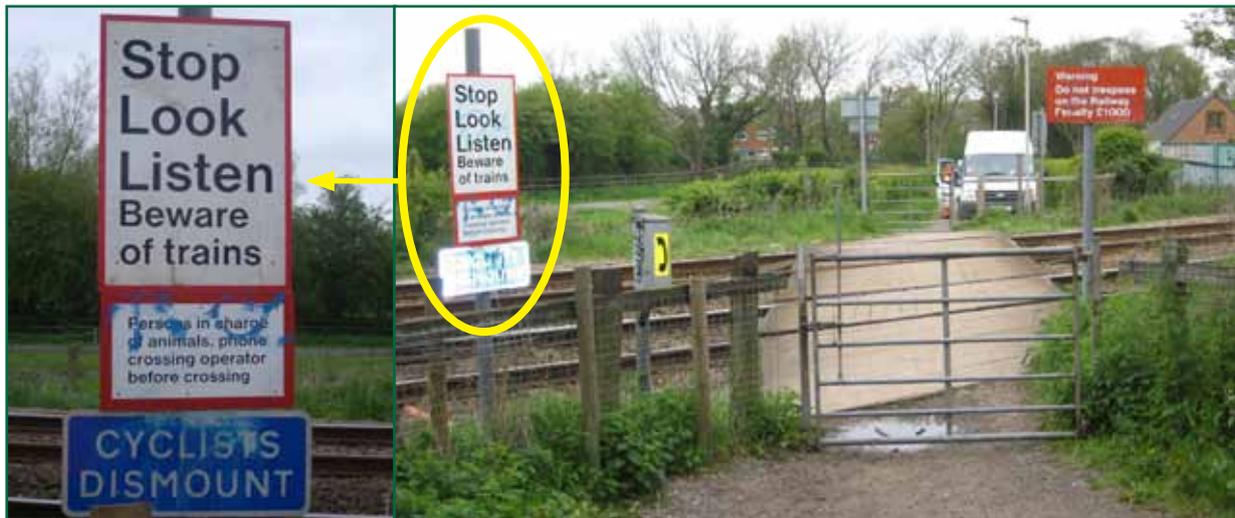
Figure 4: Signs on up side of line

- 34 There were signs to the left of the crossing gate giving instructions on its use (figure 4).
- 35 The sign instructing people in charge of animals to phone the crossing operator is a standard sign at bridleway crossings. The 'Cyclists Dismount' sign was added to the other signs at Kings Mill in 2009 (paragraph 115). The signs and gates, on both sides, are approximately three metres from the nearest rail. This is the position, for this type of crossing, at which a user should be able to make a decision on whether it is safe to cross (see paragraph 66).

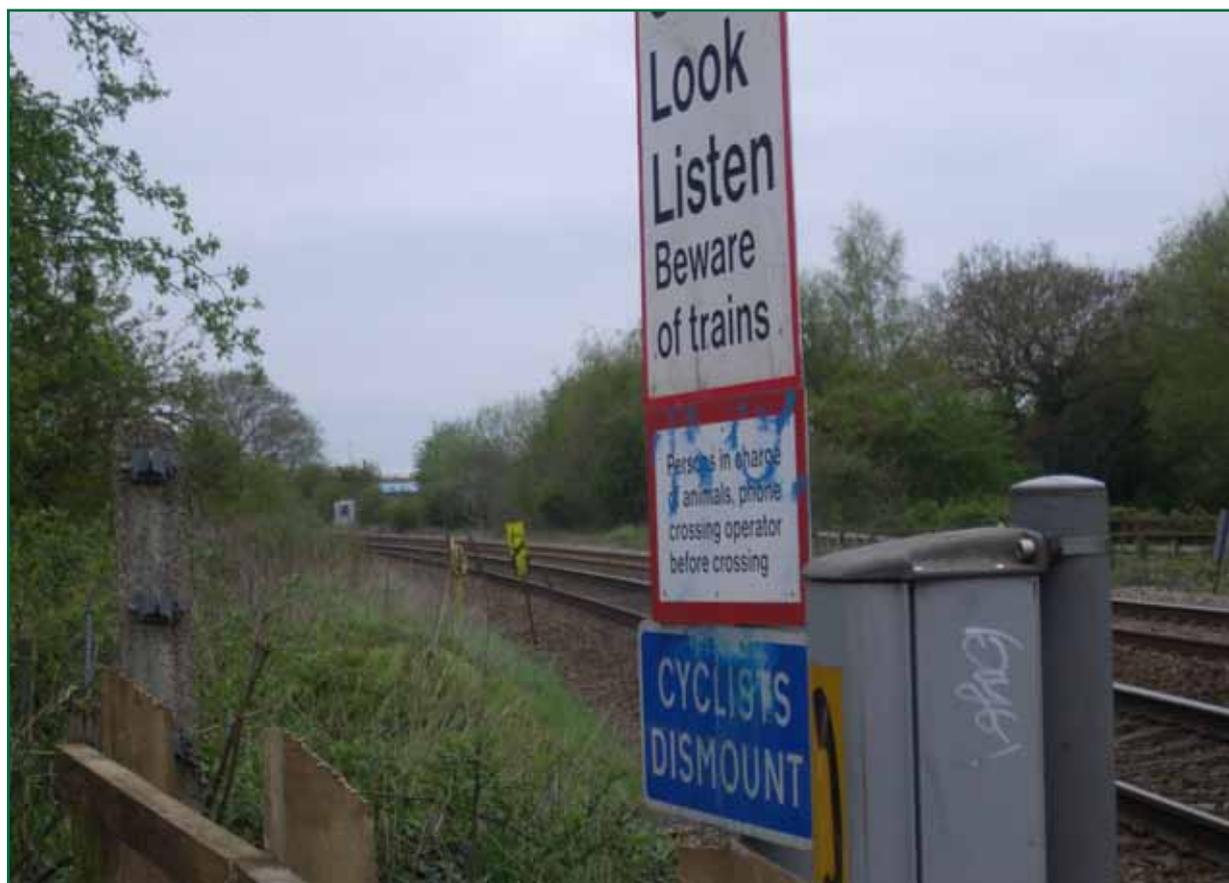
Figure 5: View from up side of crossing looking south-west (towards down trains)

52 The sighting of down trains (those heading towards Mansfield) from the up side at Kings Mill is limited by the curvature of the line.

53 Safe use of Kings Mill crossing relies on the user hearing the warning horn sounded by an approaching train, because the curvature of the line and rising ground combine to obscure the view of trains for people crossing from the up (south-east) side (figure 5).

- 54 The RAIB measured the distance at which an approaching train becomes visible to a person standing at the up side gate at Kings Mill crossing (3 metres from the line) to be 171 metres. A train travelling at 57 mph (92 km/h or 25.5 metres/second) will cover this distance in 6.7 seconds. The forward facing CCTV shows that Mr Dawn was struck by the train approximately five seconds after he started to cross the line. The curvature of the line means that there is little increase in the available sighting of down trains as a user moves closer to the track.
- 55 If Mr Dawn looked up the line while he was opening the gate, he would not have been able to see the approaching train until less than two seconds before he started across the line, at which time he was likely to have been concentrating on manoeuvring his bicycle round the gate and onto the crossing.
