RAIB Bulletin 04/2013

Member of staff struck by train near Poole, Dorset, 12 July 2013

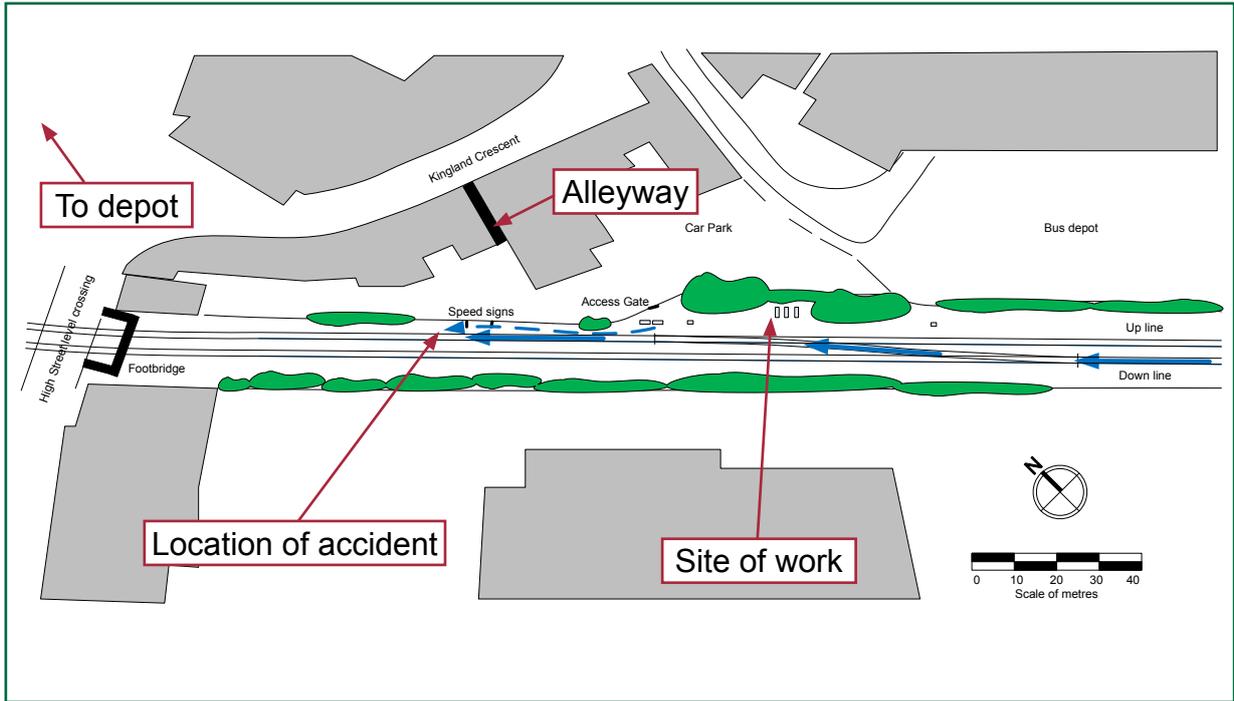
Figure 2: Plan of the site of the incident

- 18 The team leader legitimately chose to walk along the lineside because he believed that this would save time and a considerable detour in his route back to the depot. In fact, there is an alleyway between shops (figure 2) that would have enabled him to reach his destination almost as directly as the lineside route, but he was unfamiliar with the area and unaware of its existence.

- The need to be vigilant at all times when walking or working close to the line.
- The importance of using authorised access points to get on or off the railway, and thus minimising the distance people need to walk alongside the line (Rule Book, Handbook 1, section 3.1).

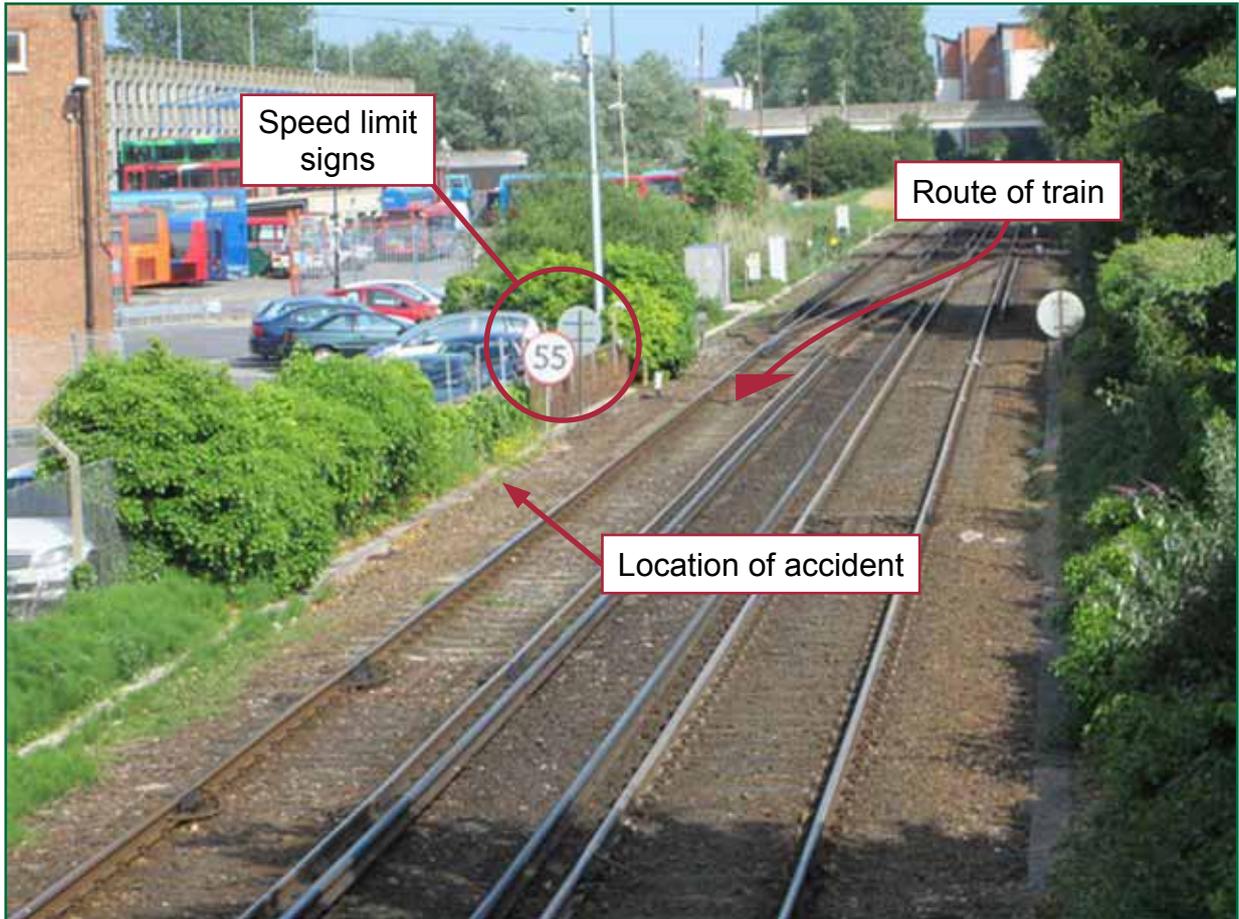
Figure 3: Location of the accident showing vegetation that was present at the time (image courtesy of Network Rail)

- 17 The team leader had to follow an erratic path to avoid obstacles close to the line, such as vegetation and lineside signs (figure 3). If the vegetation had been cut back (as was done after the accident) he would have had to spend less time in a position where he was foul of an approaching train.

- The importance of controlling vegetation close to the track which may obstruct the safe walking route along the cess.
