AAIB Bulletin

3/2015

Published 12 March 2015

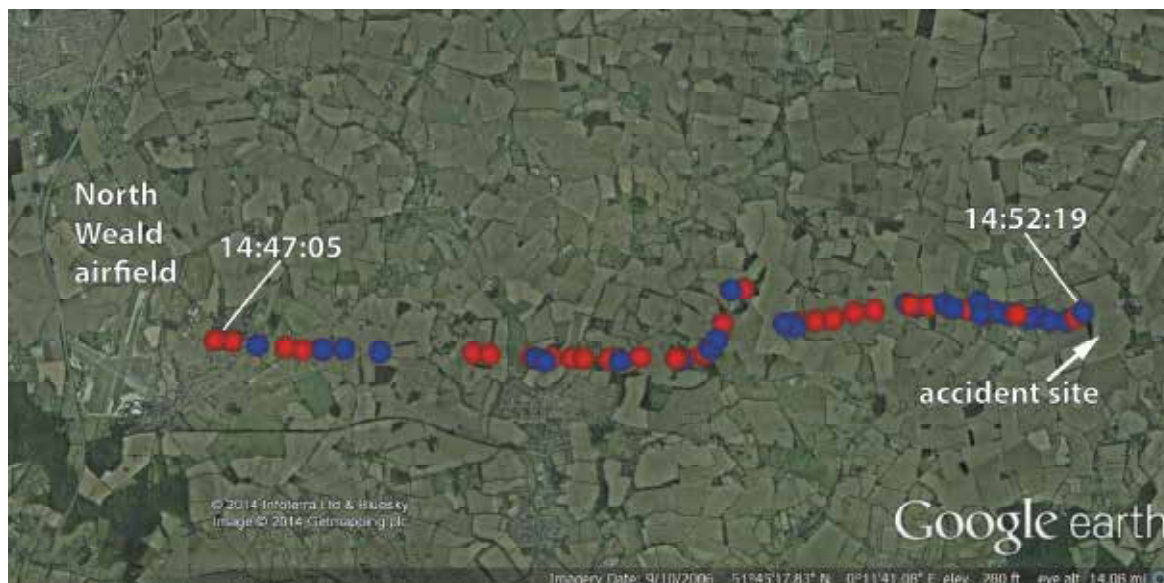
Figure 1

Radar data for the accident flight was available from the Debden and Stansted radar heads, 16 nm and 10 nm north of the track respectively (Figure 1).

Debben (red) and Stansted (blue) radar ground tracks for the accident flight

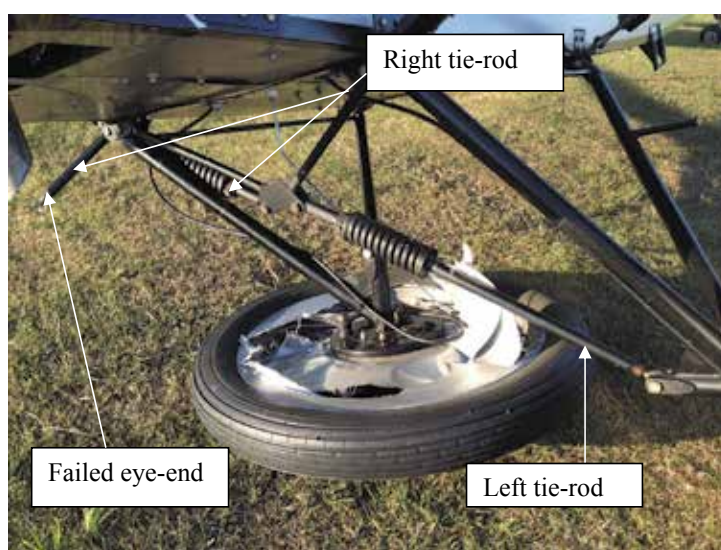
Initial examination of G-ECVB showed that the rod-end bearing connecting the right mainwheel struts to the right tie-rod had failed, allowing the landing gear to collapse, Figure 1. The failed rod-end did not incorporate a grease nipple.

Figure 1
Failed landing gear

A detailed examination was carried out by the LAA which determined that the rod-end was of a lower specification to that specified in the production drawings and that the failure appeared to have been as a result of progressive deterioration in-service. As a result of the investigation the LAA published details of the incident and findings in Light Aviation magazine.

Feedback received by the LAA as a result of the article indicated that a number of other aircraft showed evidence of rod-end deterioration. After examining a number of these rod-ends the LAA published Airworthiness Information Leaflet (AIL) LAA/MOD/047/009 Issue 1 in November 2014 which required inspections of Cub type landing gear rod-ends to confirm that the correct parts were fitted and that there was no evidence of deterioration. In addition the AIL introduced a 100 flying hour life for the rod-ends. Publication of the AIL was highlighted in LAA Airworthiness Alert LAA/AWA/14/13.
