Rail Accident Investigation Branch

Rail Accident Report

Derailment at Archway 2 June 2006

Report 24/2006
December 2006

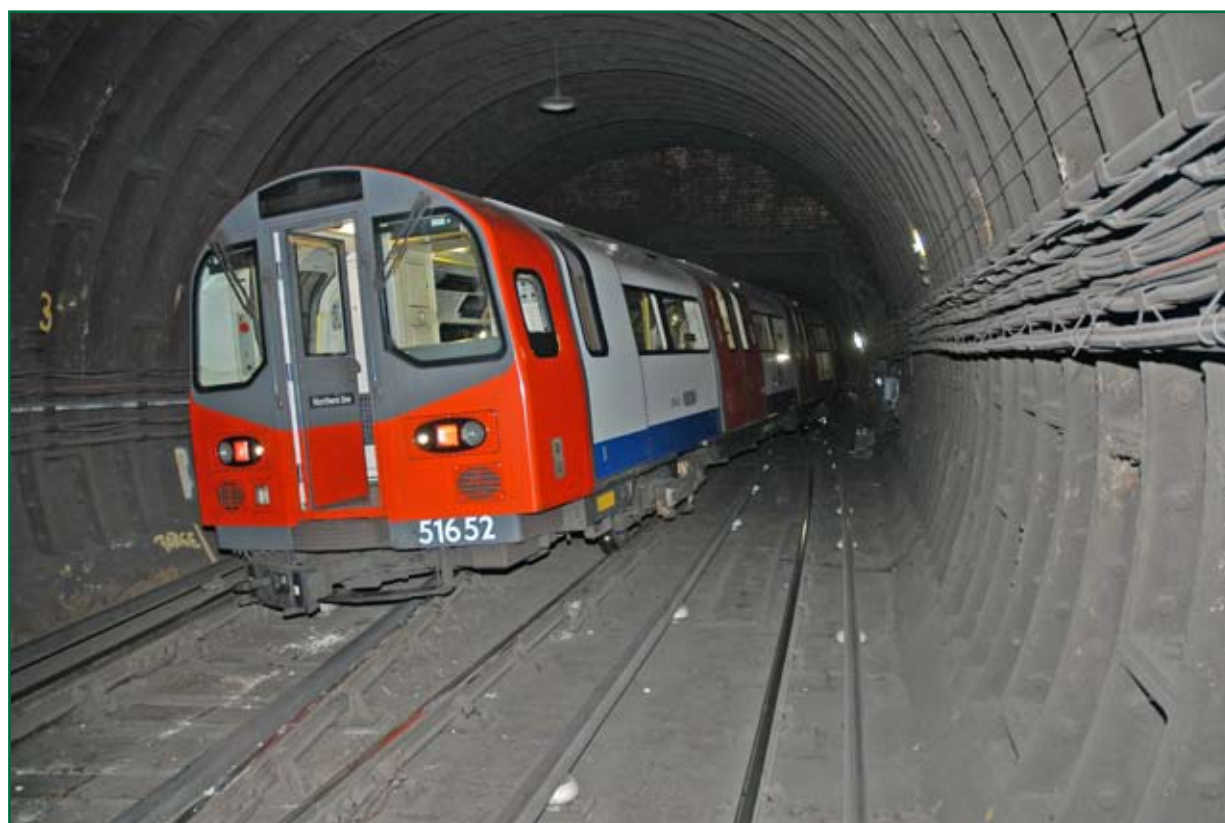
Figure 2: The derailed train seen from the rear.

- 49 The last two wheels of the train, however, appear to have been forced to the left on hitting the broken rail end, to the extent that their flanges climbed the opposite (left-hand) switch rail (Figure 5). These wheels passed over the top of the left-hand switch rail and dropped down to run along the northbound main line. The increasing angle between the front and rear bogies exerted a substantial lateral force on these wheels, and after a short distance their flanges climbed the right-hand rail and the bogie became derailed to the right of the northbound running line. It displaced the negative conductor rail and damaged some cables in the tunnel before the last car became wedged in the entrance to the siding tunnel, stopping the train (Figure 2).

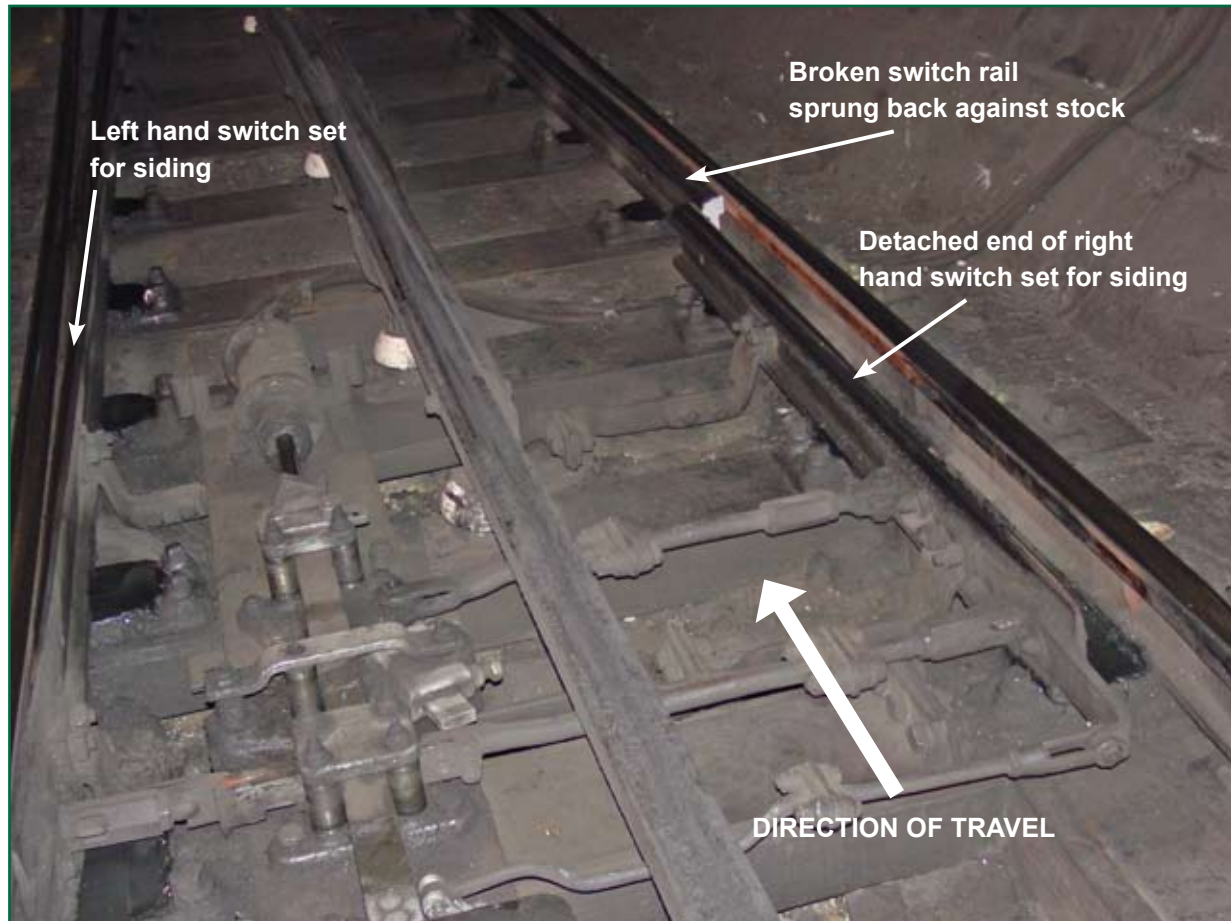
38 Following the derailment, the state of points 8A is shown in Figure 4.

Figure 4: Points 8A as found after the derailment, showing broken switch rail.

- 39 The broken switch rail was the immediate cause of the accident. The position of the switches combined with the extensive bruising of the running-on end of the broken switch and the absence of any marks on the other portion, showed that the wheels of the train had been following the correct path before encountering the broken end of the switch.

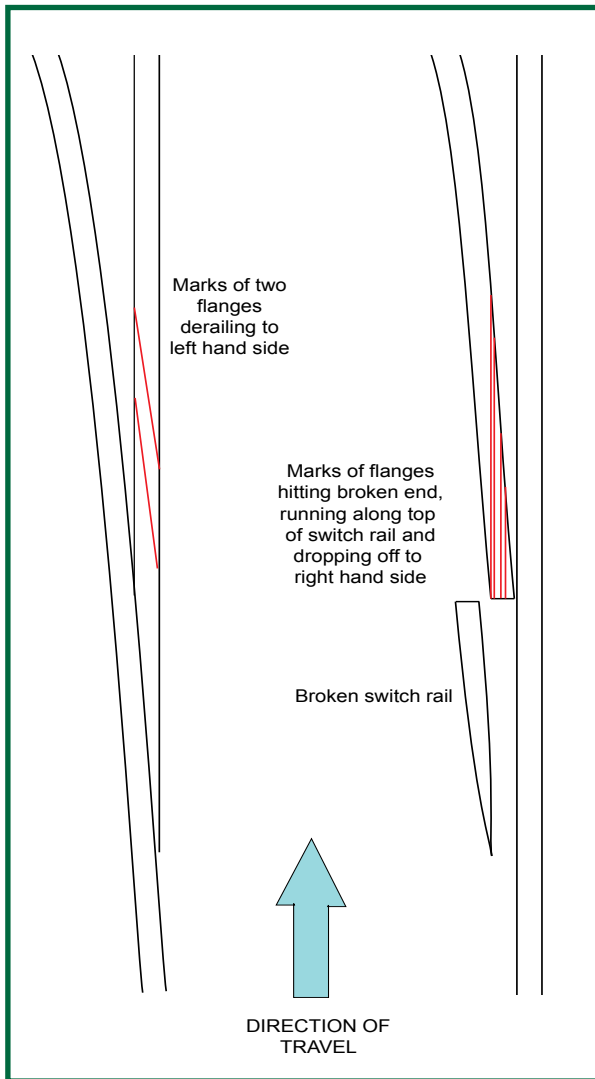
- 40 There were marks on the broken switch consistent with wheel flanges running along the top surface of the rail, and then dropping off on the right hand side, beginning with the leading wheels of the train. The remainder, except for the last bogie, followed the path taken by the wheels in front (Figures 5 and 6).

- 41 On the left hand switch there were marks of two flanges climbing over the rail and derailing to the left, corresponding to the trailing bogie of the last car which was found derailed after the accident (Figure 5). It is probable that these wheels were able to be diverted to the left because there were no further vehicles behind to restrain the bogies in line.

Figure 5: Derailment marks on the rails of points 8A.

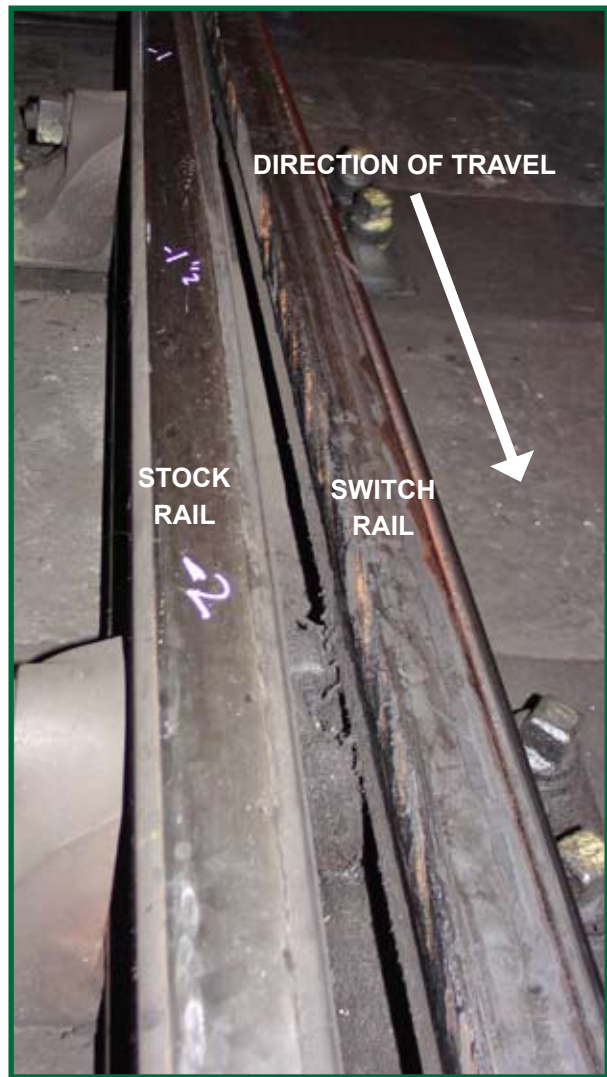
Figure 6: Right-hand switch rail showing wheel marks.

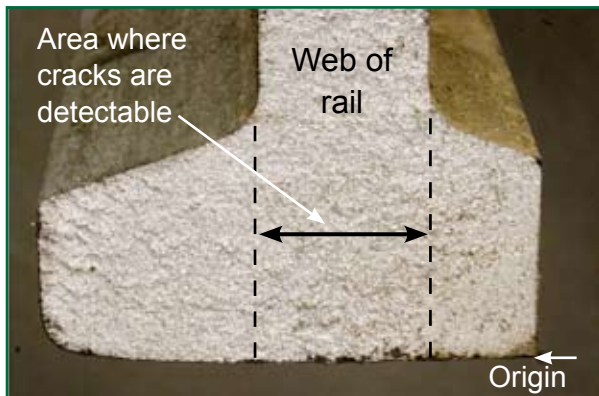
- 19 The switches were supported on timber bearers, set in a concrete base in accordance with the usual practice on tube (bored tunnel) sections of LUL.

The train

Figure 7: Broken end of rail showing fracture origin and limits of area in which crack detection is possible.

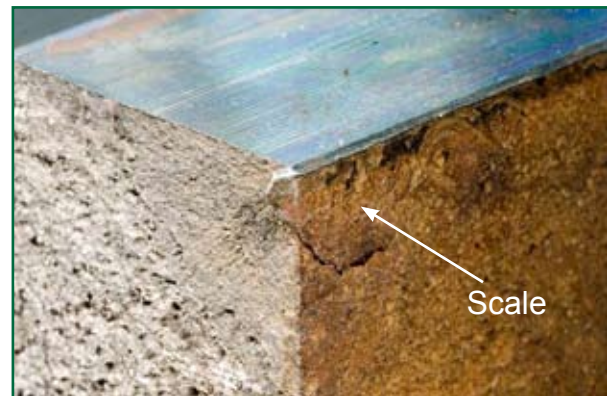
Figure 8: Detail of fracture origin and adjacent 'scale' at edge.

- 62 The originating point for the fatigue crack was the sharp edge at the lower back of the switch rail. If this sharp edge were replaced by a chamfer or radius the stress concentration in this area would be reduced, and hence fatigue cracks would be less likely to originate there (**Recommendation 1**). Flat-bottom switches in use on LUL already have a chamfer for this purpose.

- 1 LUL should modify their design specification for bullhead switch rail to include a chamfer or other means of reducing the likelihood of stress raisers occurring on the machined lower edge of the rail (paragraph 77).
- 2 LUL should assess the risk arising from the continued use of unmodified bullhead switch rails in junction work (particularly facing points) and replace such rails where appropriate (paragraph 77).
- 3 Tube Lines should carry out a review of their track inspection system to ensure that faults are being consistently detected and correctly identified, and the appropriate level of remedial action is being programmed (paragraph 78).

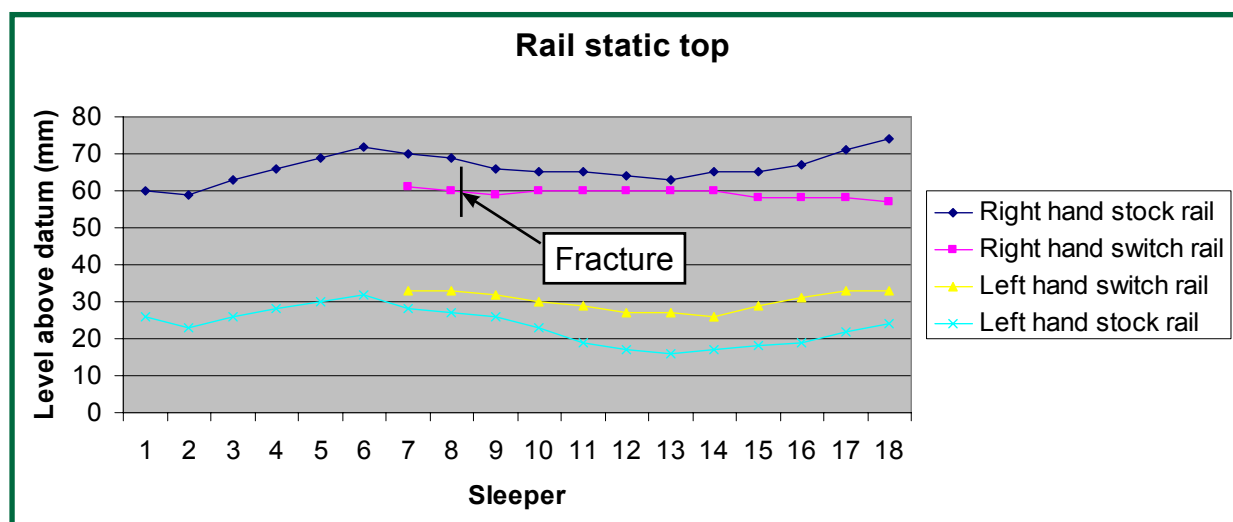
Figure 9: Rail height, points 8A.

- 51 Figure 9 shows that the head of the right hand switch rail was 7 mm below the head of the stock rail at the point where the rail broke. High dynamic loadings occurred as wheels dropped from the stock rail onto the lower head of the switch rail. Void measurements taken after the derailment indicate that there was about 5 mm gap beneath the bearer at the point where the rail broke. This, combined with the low height of the switch rail, would have reduced the impact experienced by the train operator when the right-hand wheel encountered the broken rail end. The total flange height is about 27 mm, and so there would have been a lift of about 15 mm (less some deflection of the rail end) when the flange of the leading wheel struck the broken end of the rail.
