Rail Accident Investigation Branch

Rail Accident Report

Wagon derailment at York station 18 January 2006

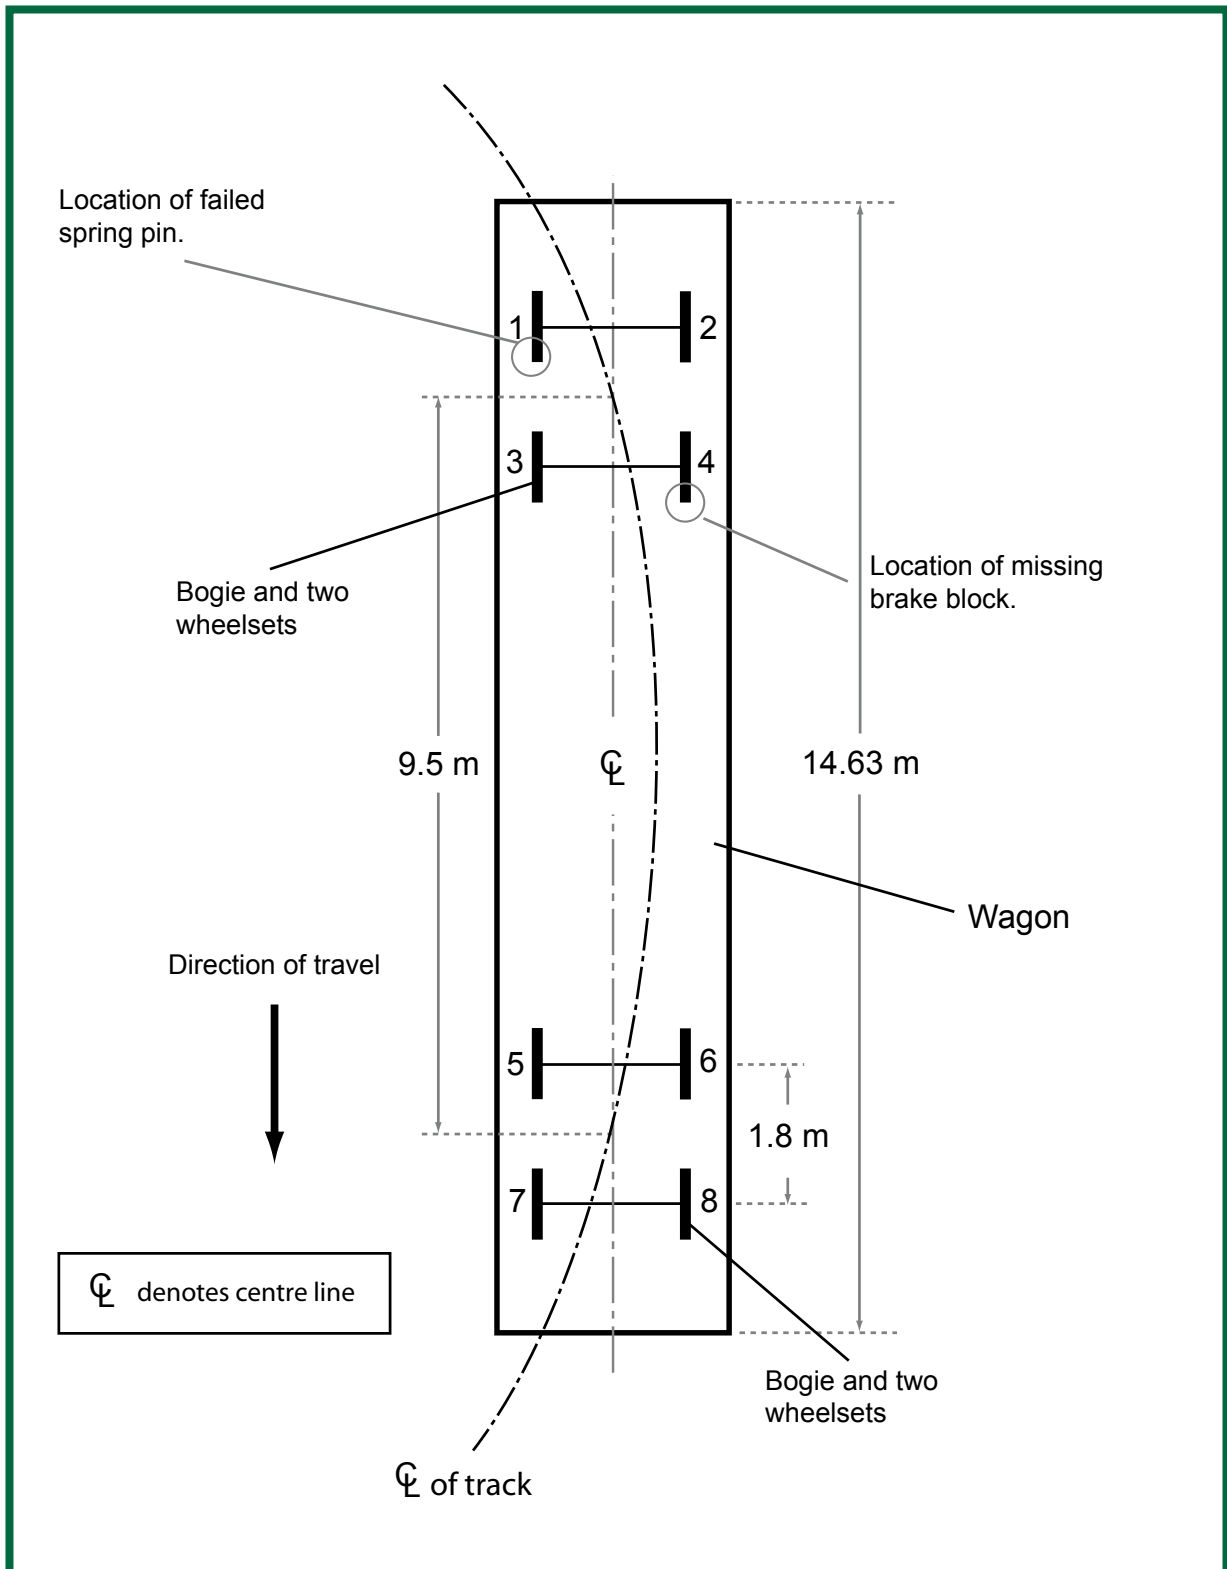
Figure 6: Plan view of wagon 7008990380 and the derailed wheelset

- 35 The driver re-examined the train with the Network Rail Mobile Operations Manager (MOM) who had arrived on site. They found a collapsed suspension at wheel one and a missing brake block at wheel four on bogie serial number 89 - see Figure 6.

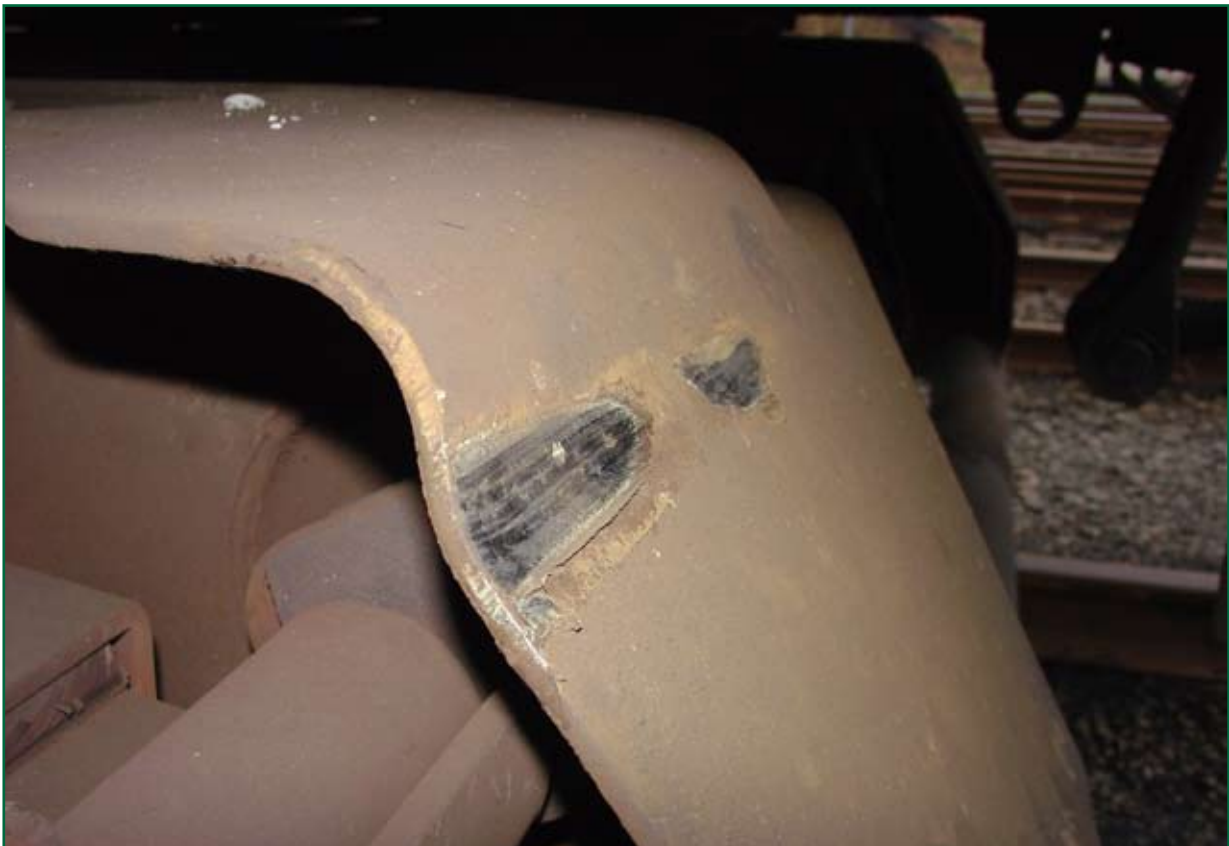
- 36 Damage to the wagon from the incident included: (i) deformation of the bogie frame due to impact by the suspension spring - see Figure 7; (ii) deformation of the bogie frame by the wagon structure due to excessive relative movement during derailed running – see Figure 8 and (iii) damage to wheel three from number 788 points check rail – see Figure 9.

Figure 8: Photograph of deformation of the bogie frame by the wagon structure due to excessive relative movement during the incident

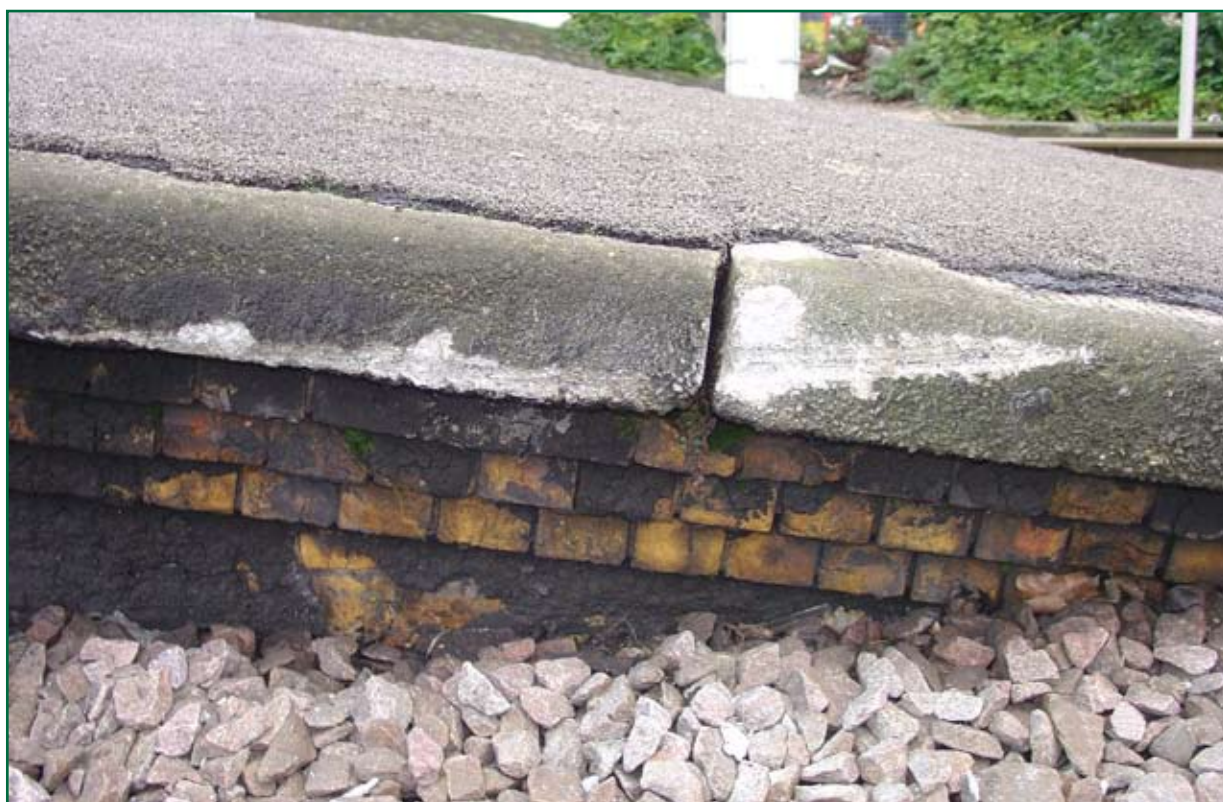
- 37 Infrastructure equipment damage extended over approximately 250 m and included: (i) approximately 400 *sleepers*; (ii) 20 *Pandrol* clips; (iii) 18 *bearers*; (iv) 8 track circuit cables; (v) *Train Protection and Warning System* (TPWS) equipment mounting bars and (vi) check rail and *fish plates* at number 788 points. The coping stone at platform three was misaligned and scored by impact with the bogie as shown in Figure 10.

Figure 10 Platform three coping stone misaligned by impact with bogie

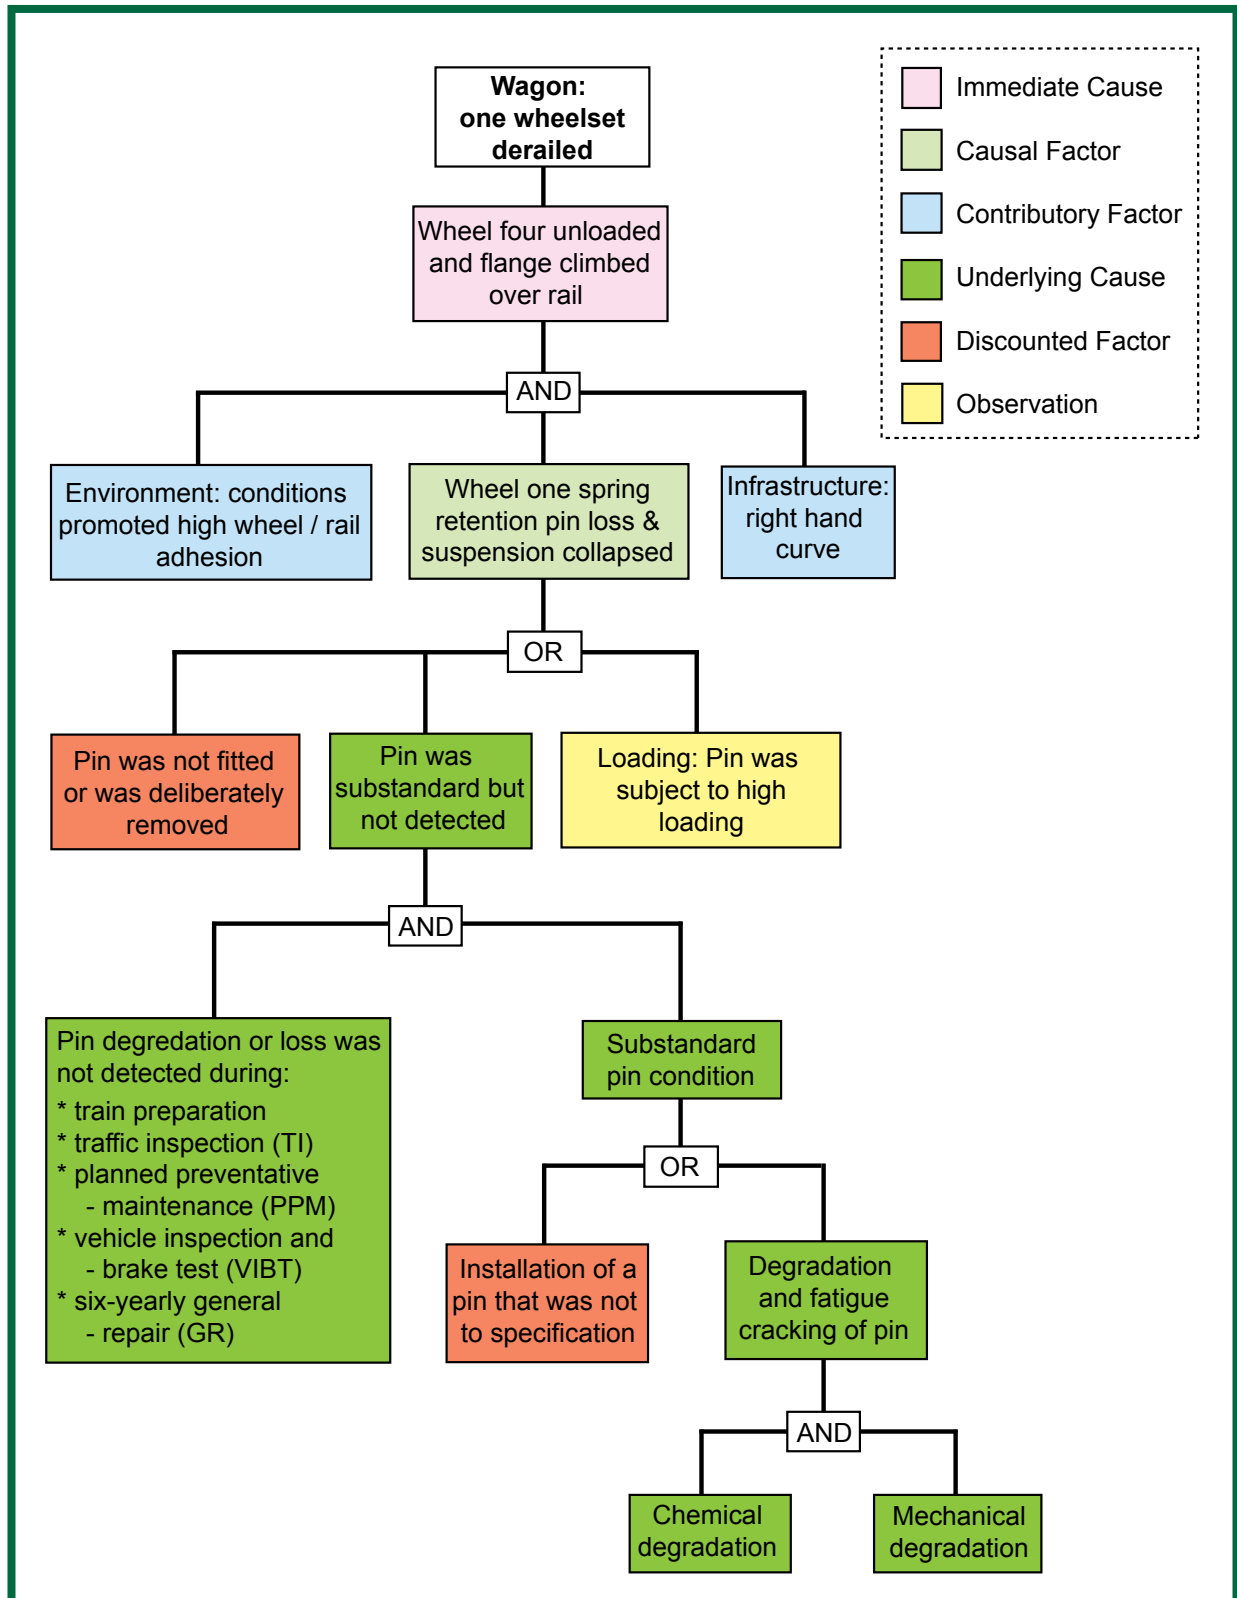
Figure 11: Causal Analysis

42 The incident was analysed to determine the immediate cause, causal factors, contributory factors and underlying causes - see Figure 11.
