Rail Accident Report

Derailment at Phipps Bridge, Croydon Tramlink 21 October 2005

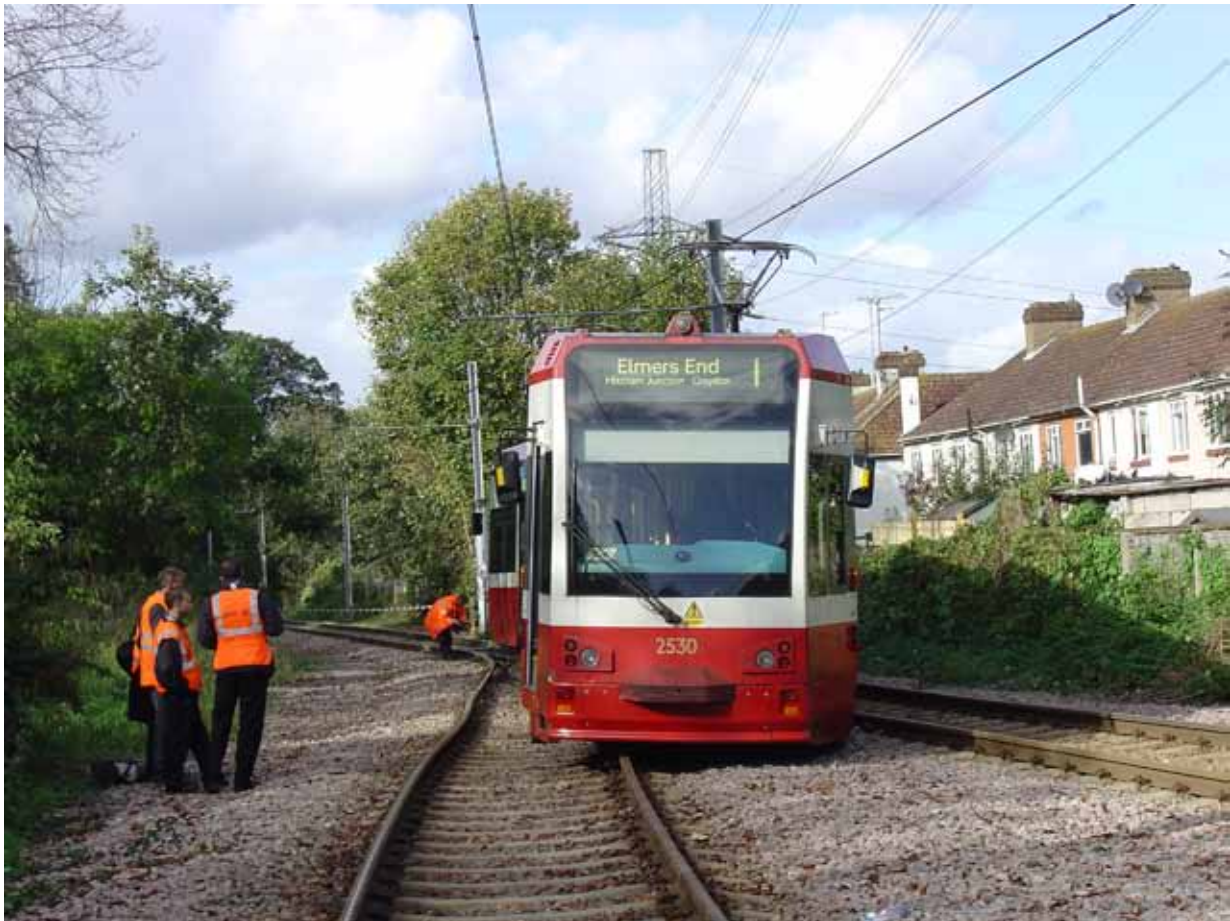
- 19 The leading bogie of the tram became derailed at the points. The left-hand wheels, facing the direction of travel, passed between the *switch blade* and *stock rail*. The right-hand wheels then dropped into the *four foot*. The tram then slid as its traction motors and other underbody equipment rode on the rail head over the crossing of the points until the inside of the right hand leading wheels came into contact with the rail head. The left hand wheels then rode over the right hand running rail and dropped into the *ballast*, and the tram came to a stop. The front of the tram came to rest 25m from the point of derailment, and 37m from the tips of the *switch blades* (see the photographs, figure 4 and 5). Following the accident, the driver made an emergency radio call to the control room and appropriate steps were taken to deal with the situation.

Figure 4: The derailed tram from the front, showing distortion of the track

- 22 The lateral forces involved in the derailment were sufficient to cause minor displacement of both tracks. These required realignment and minor repairs before the line was reopened for normal services at 21.10 hrs the same day. There was no damage to the points mechanism.

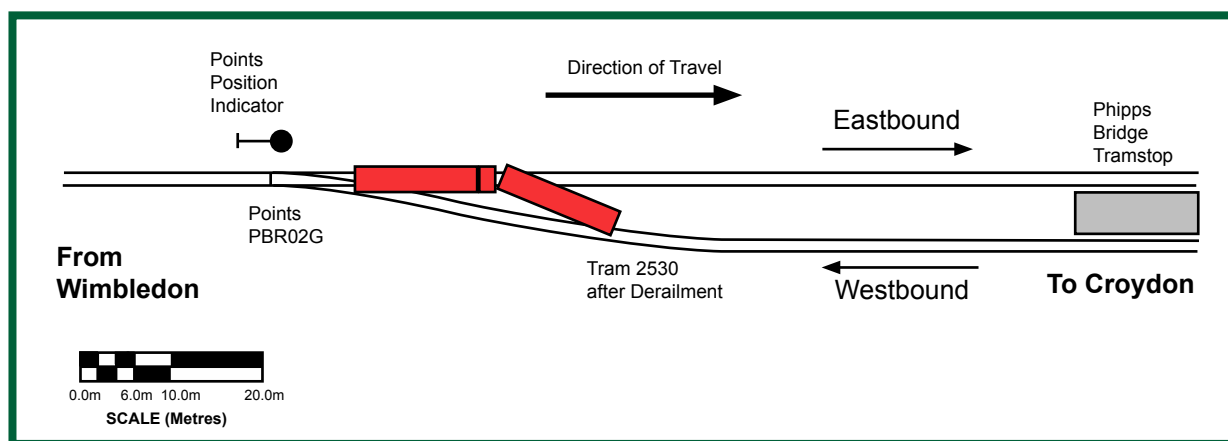
Figure 6: Site plan of the derailment

28 The evidence of the control room alarms and the CCTV on the tram shows that at about 10:32hrs, when the previous westbound tram passed over them in the *trailing direction*, the points at Phipps Bridge failed to self-restore to *normal* and remained stuck, lying for the right-hand, westbound, route. The PPI therefore showed a single white light to the driver of tram 2530 as it approached eastbound. The driver did not react to this warning until the tram was about to pass the PPI, and by the time he applied the emergency brake the tram was passing over the points. The shock of the tram passing over caused the points to spring back to their *normal* position, lying for the *normal* route, where they were found after the accident. Consequently the leading bogie was derailed, and the centre and trailing bogies of the tram were diverted to the left. The tram stopped 37m after reaching the points. It is notable that although this derailment occurred at almost the maximum speed permitted for trams passing over spring-operated points, there were no injuries to passengers or crew and relatively little damage to the tram and the track.
