Rail Accident Investigation Branch

Rail Accident Report

**Passenger train collision with a road vehicle at
Swainsthorpe level crossing, Norfolk**

13 November 2005

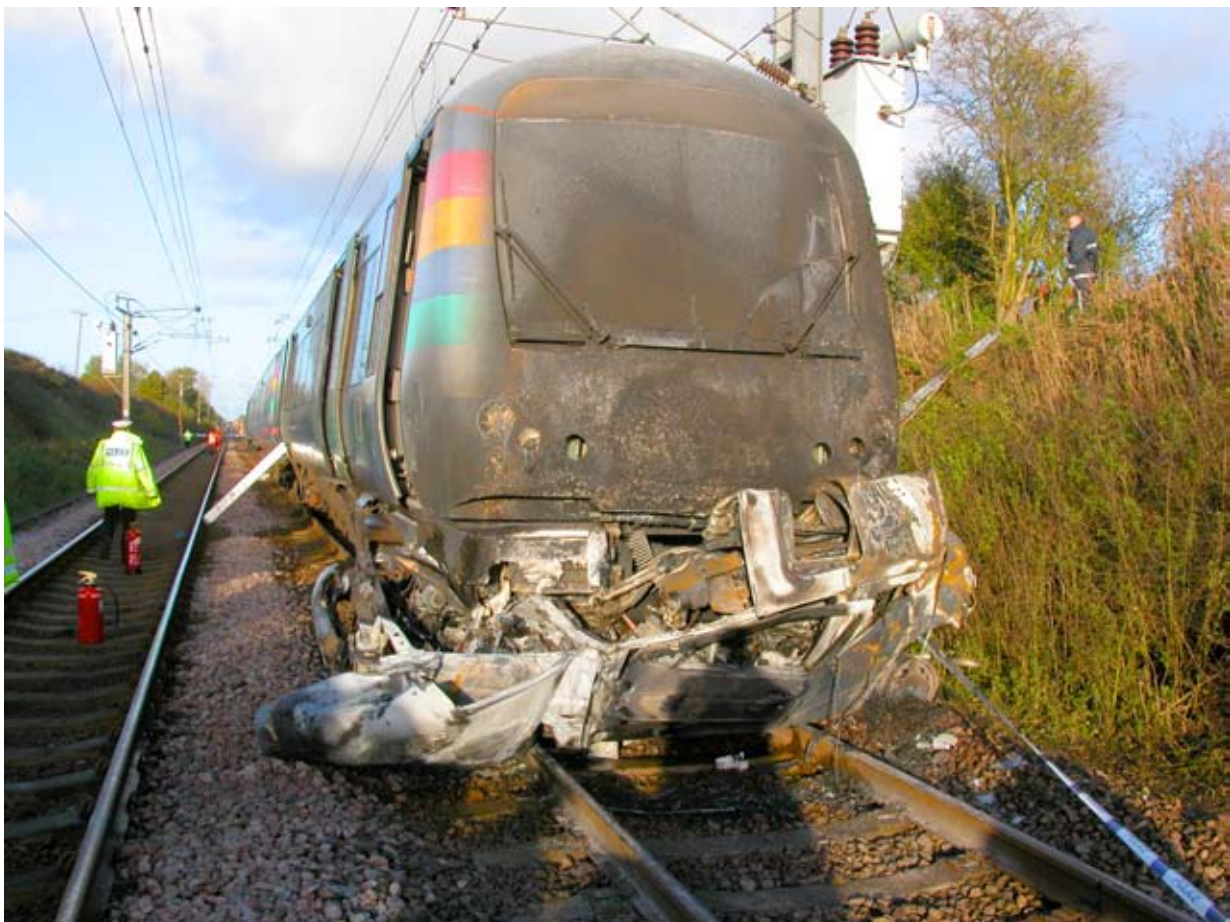
Figure 2: Damage caused to class 170 170207 as a result of the collision (courtesy of Norfolk Police)

26. The car was trapped under the front of the unit after it was struck by the train. It appears that the obstacle deflector prevented the wrecked car from reaching the wheels of the train and greatly reduced the risk of the train derailing. Subsequent examination of the

train showed that most of the damage occurred to the driver's side cab area of the leading vehicle due to the fire. There was no distortion of the bodyshell structure, and little other mechanical damage – the trailing vehicle suffered some minor bodyside and body structure damage, as well as damage to the power bogie. This is thought to be impact damage from components of the car that became detached as a result of the collision.

27. After the impact, the car caught fire. The fire burnt fiercely as the petrol in the car's petrol tank ignited. As well as the considerable exterior fire damage to the train driving cab and body structure forward of the leading wheelset, the fire penetrated the cab back wall cubicle containing electrical wiring behind the driver's seat, causing significant damage. This issue was examined by AEA Technology on behalf of the vehicle manufacturer, Bombardier, who concluded that the wiring in the cab back wall cubicle probably ignited due to the fact the self-ignition temperature of the insulation was 330 C, whereas temperatures close by had exceeded 660 C – the melting point of aluminium. The performance of wiring insulation is covered by British Standards BS4066 and BS7622, and the fire experienced gave rise to temperatures well in excess of the performance required.

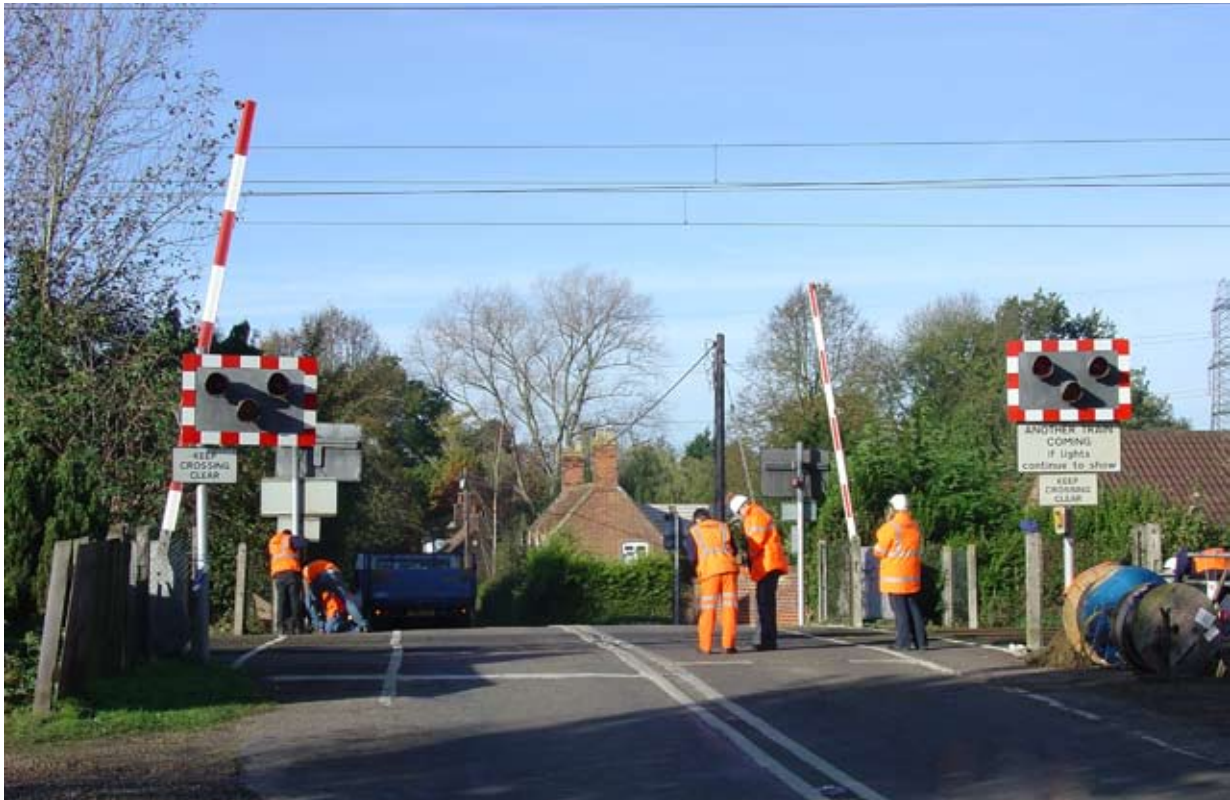
20. The railway between Norwich and Diss consists of double track and is signalled with colour light signals and continuous *track circuiting* controlled from the signal box at Colchester. The AHB level crossing (shown in Figure 3) is located at 109 miles 54 chains from Liverpool Street Station and comprises standard flashing road traffic light signals, audible alarms and lifting booms that close off the nearside half of the carriageway width in each direction. Assuming normal operation, for trains running at the maximum permitted speed of 100 mph (161 km/h), the lights illuminate at least 27 seconds before a train's arrival, and the booms are fully lowered at least eight seconds before a train's arrival. Emergency telephones are fitted on the offside of the crossing on both sides that connect to Colchester signal box. An 'Instead' 64 datalogger is fitted which monitors and records the operation of the level crossing. Located 183 m before the crossing on the *Up* line, there is a *two-aspect colour light signal* which the level crossing datalogger indicates was showing green as the train approached it

Figure 3: General view of the eastern (*Up* side) approach to Swainsthorpe level crossing

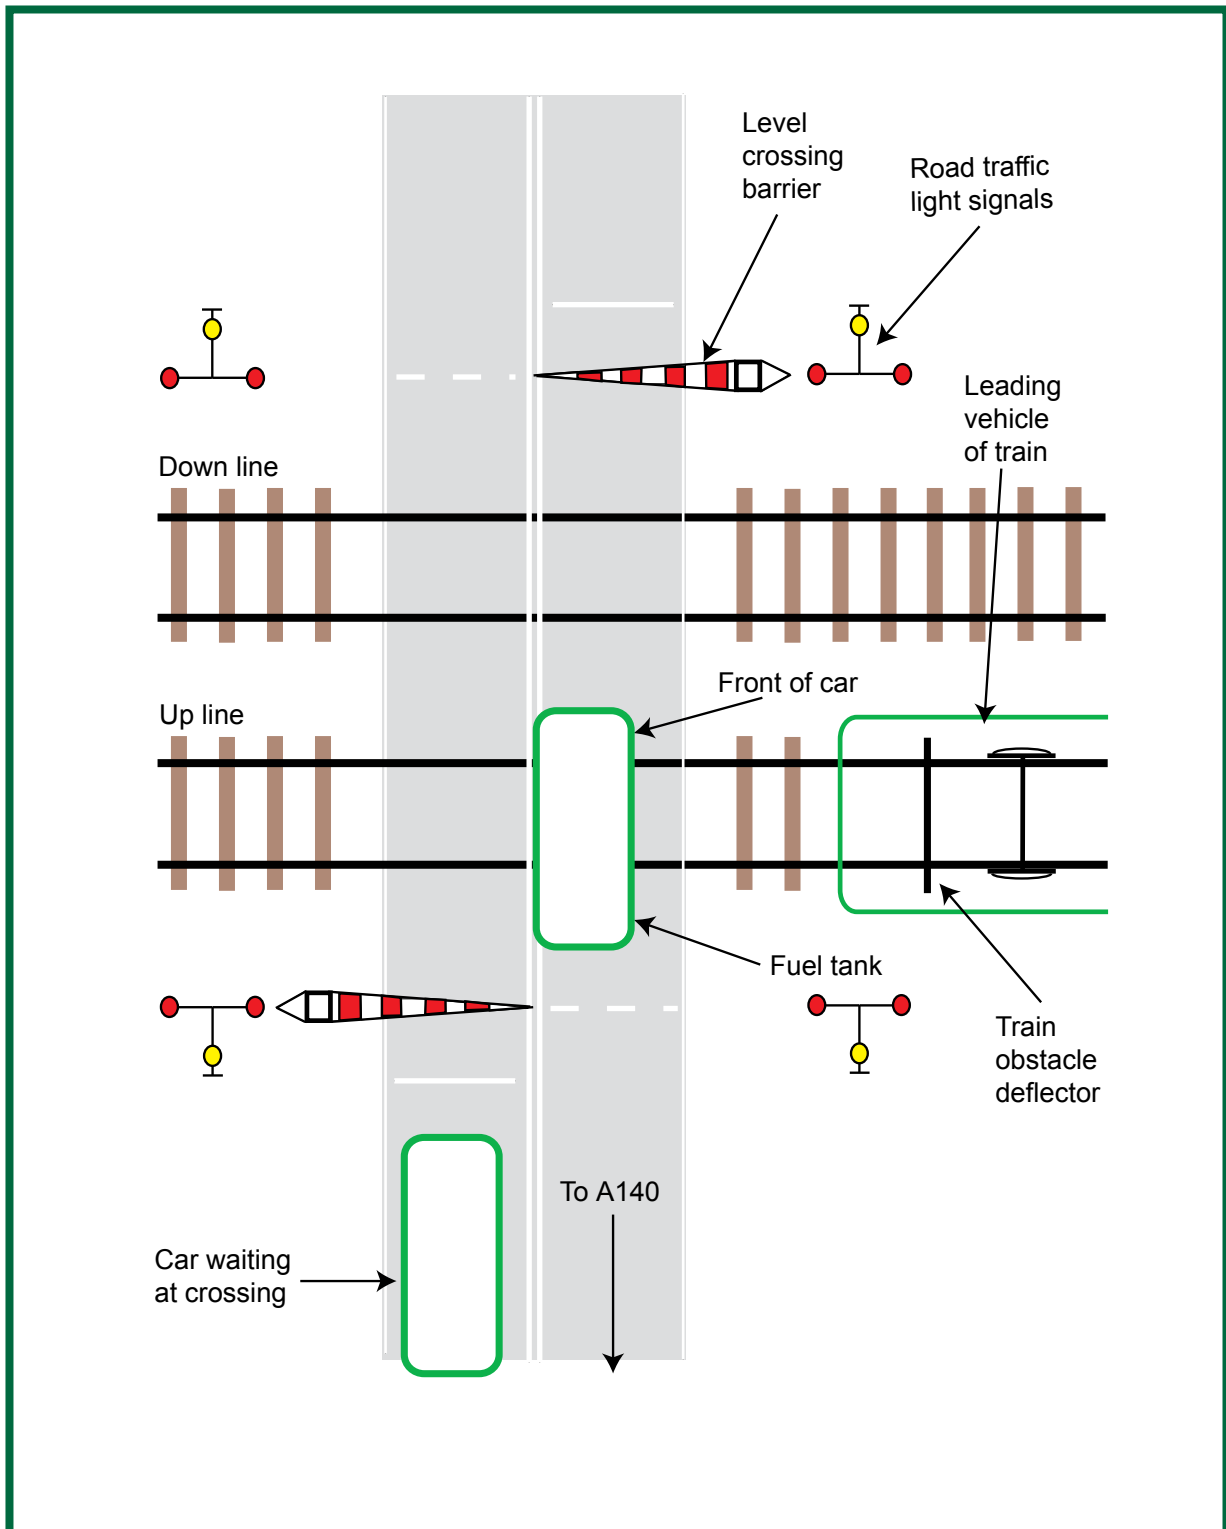
16. Appendix B Figure 4 shows the relative positions of the car that was positioned on the crossing and the car that was correctly waiting before the flashing road lights on the east side of the crossing just before the collision occurred.

Figure 4: Diagrammatic representation of relative positions of train and cars at impact

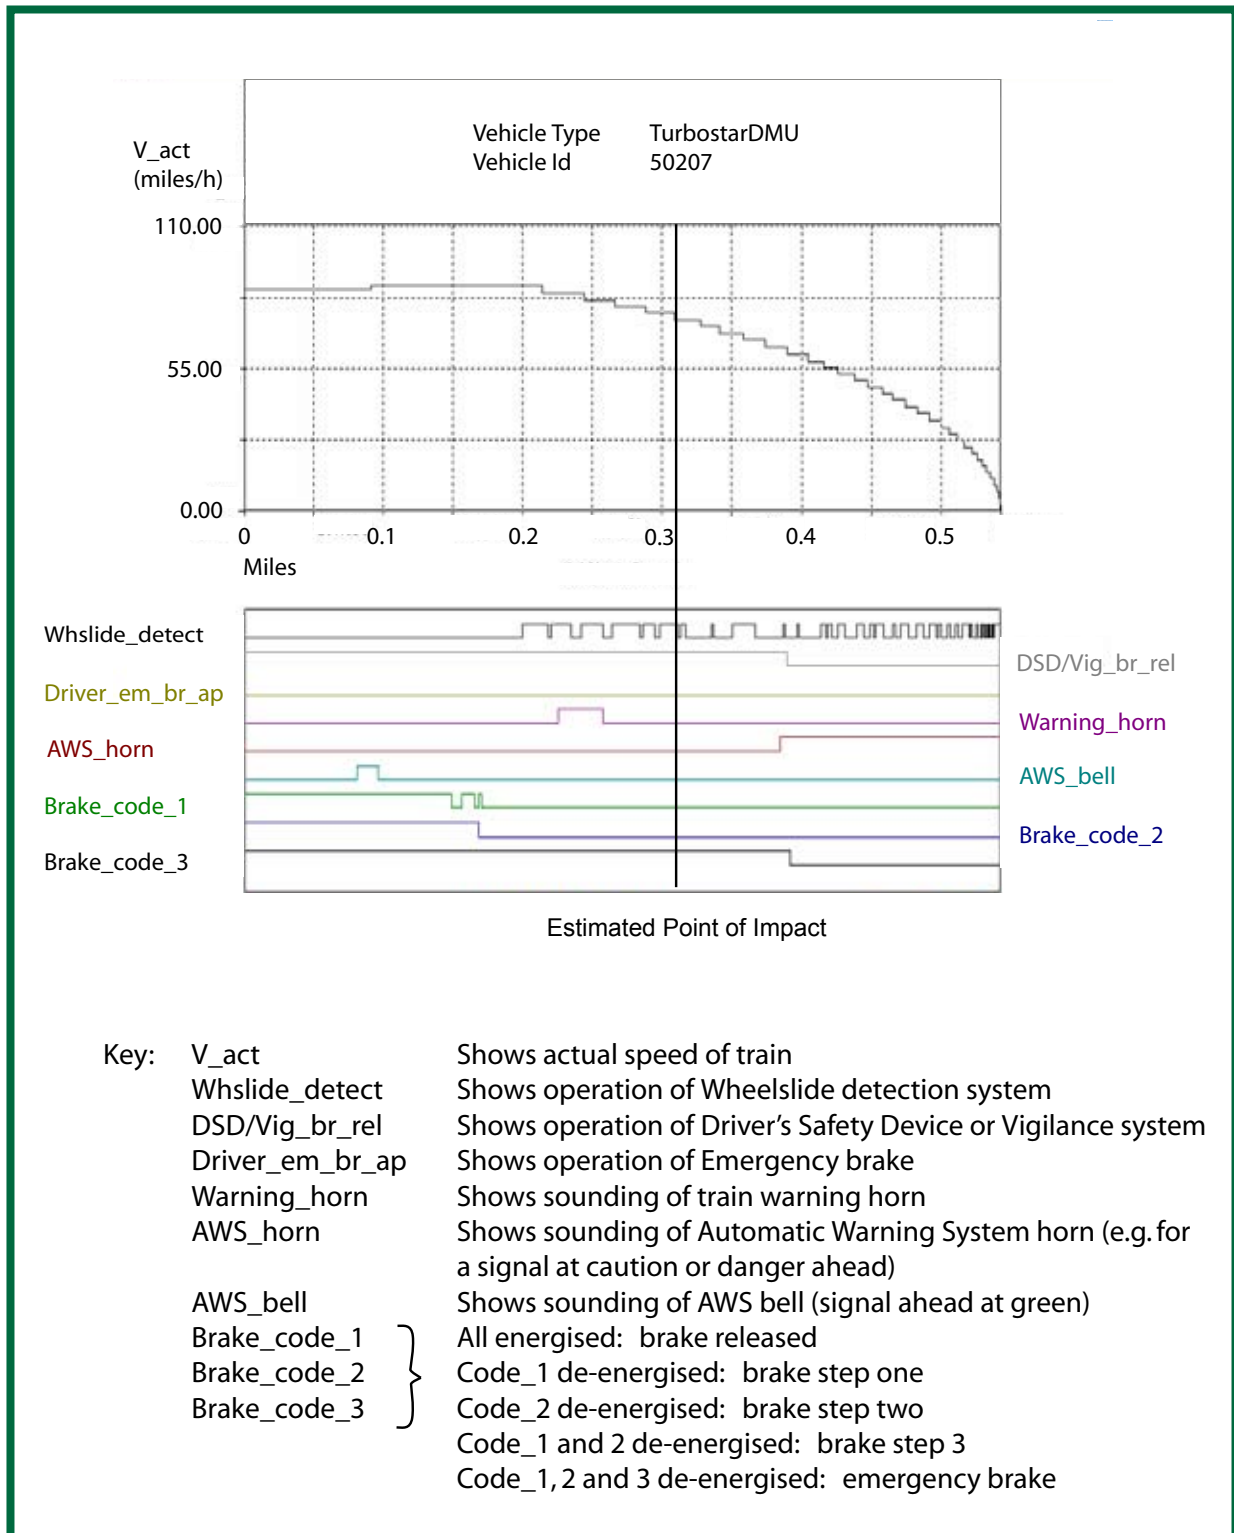
23. The RAIB oversaw the downloading of the train data recorder, and this shows that from the point the driver first made a continuous brake application, the train took 602 m to stop. The data recorder also indicates that the continuous brake application was made 226 m from the crossing following which the horn was sounded 131m from the crossing. From the results of the train data recorder, it is estimated that the train hit the car at a speed of 77 mph (124 km/h).

24. Before the collision occurred, the train driver thought that he had applied the brake into the emergency position, whereas the data recorder indicates that he initially applied the brake into the 'Step 1' position, released it and then made a 'Step 3' full service brake application. The emergency position provides an enhanced braking capability. However, given the time for the brakes to apply following operation of the driver's brake handle, and the distance the train was from the crossing, calculation shows that an emergency brake application would have further reduced the speed of the train by less than 5 mph. It is unlikely therefore that this would have made any difference to the outcome of this collision. A copy of the data recorder download is in Appendix C, Figure 5.

Figure 5: Data Recorder download trace from the leading vehicle no. 50207 of train 1G33
