**OFFICIAL SENSITIVE – SERVICE INQUIRY**

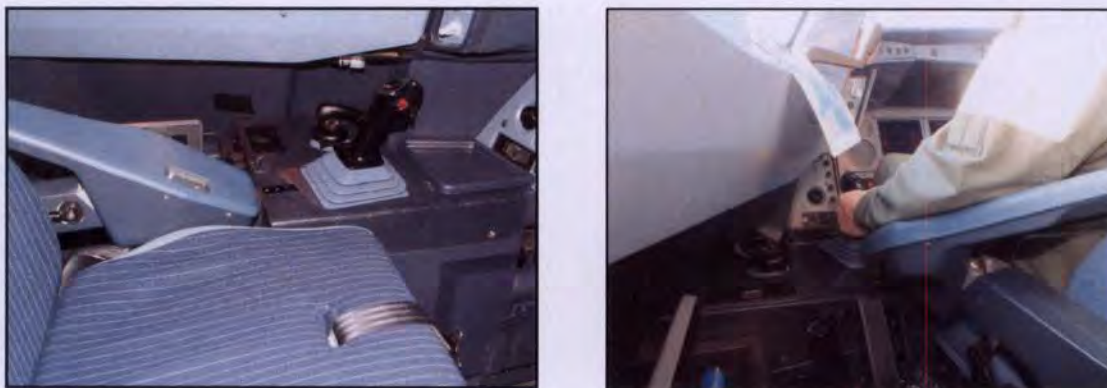
stick, increased the risk of the item becoming jammed. Moving the seat forward against a camera of a similar size to the Captain's with the armrest at different settings (to those in Figure 15) did not result in the side-stick being held forward. **The armrest setting was a contributory factor.**

Figure 15: Captain's seat and armrest configuration.

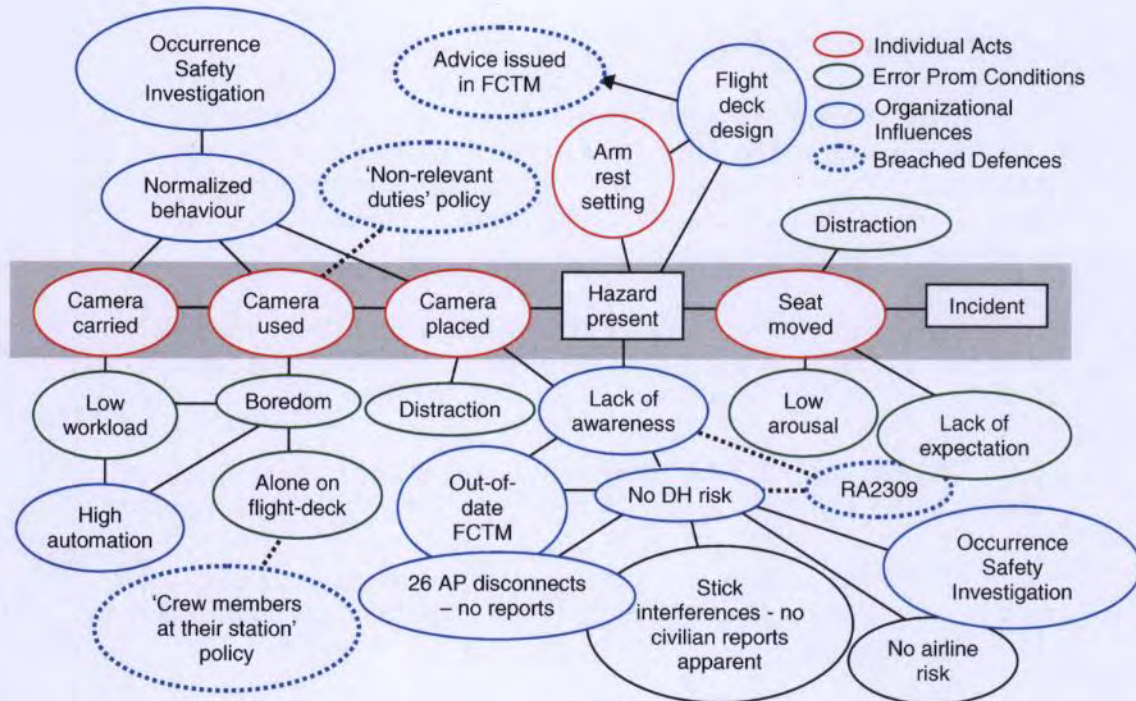
**Figure 10 (Repeated): Diagram of key factors leading to pitch-down command.**

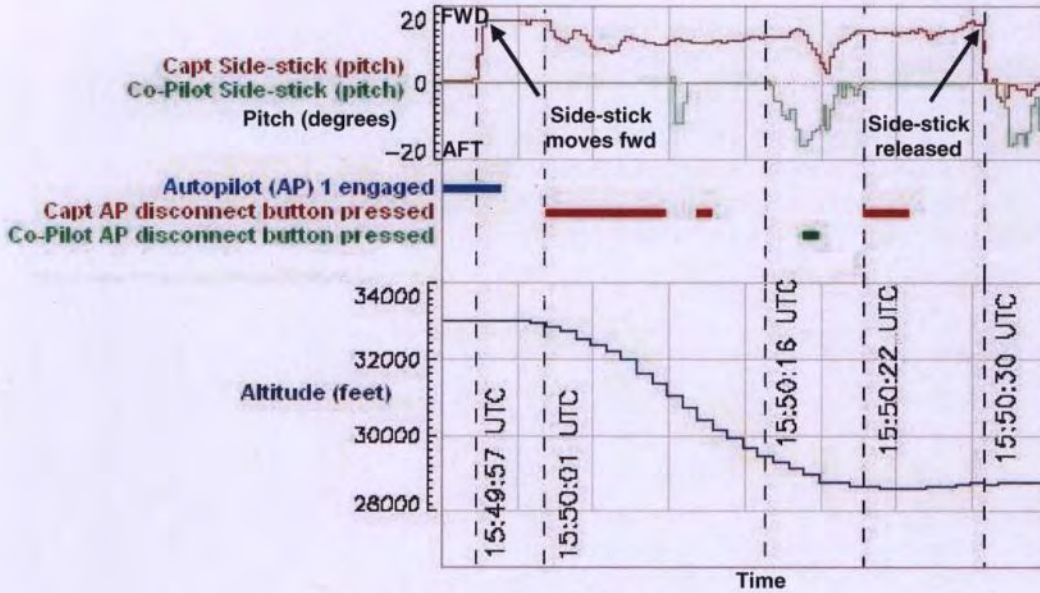
1.4.45 Approximately three seconds after the initial pitch-down (1550:01 UTC), the DFDR showed the Captain's side-stick moving rearwards by approximately five degrees from the fully forward position. It was assessed that this movement occurred as a result of the Captain pulling back on the side-stick. The rearward movement achieved, however, was not enough to fully regain control of the aircraft (Figure 17). It was assessed that the side-stick could not be moved fully because, at this stage, the camera and armrest restricted rearward movement. The Captain reported that he interpreted this lack of movement as the side-stick being stuck, thus leading him to believe that the autopilot was engaged.

Figure 17: Composite DFDR trace.

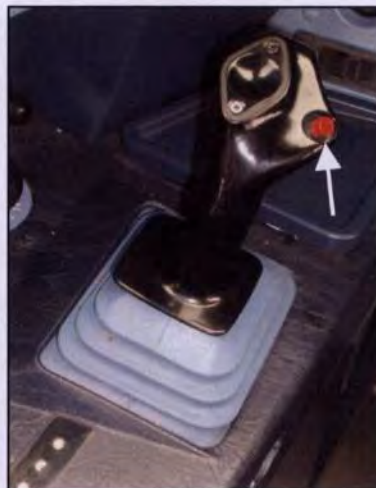
1.4.46 The normal method of disconnecting the autopilot is via the side-stick autopilot disconnect button (also known as the instinctive cut-out button), which is located next to the thumb's natural position on each pilot's side-stick (Figure 18). Disconnecting the autopilot using this button triggers an audio warning known as the 'cavalry charge' (because of its distinctive warble); the warning lasts for 1.5 seconds. Disconnecting the autopilot by any other means (for example, by a physical push on the side-stick of at least five deca-Newtons) is classed as an inadvertent disconnection. Such an action also triggers the 'cavalry charge', but as a *continuous* warning, and is accompanied by a flashing red 'master warning' caption in front of the pilot. As the pitch-down command began, a *continuous* 'cavalry charge' sounded and the red 'master warning' caption illuminated to indicate that the autopilot had been disconnected inadvertently.

Figure 18: Captain's autopilot disconnect button (indicated by arrow).

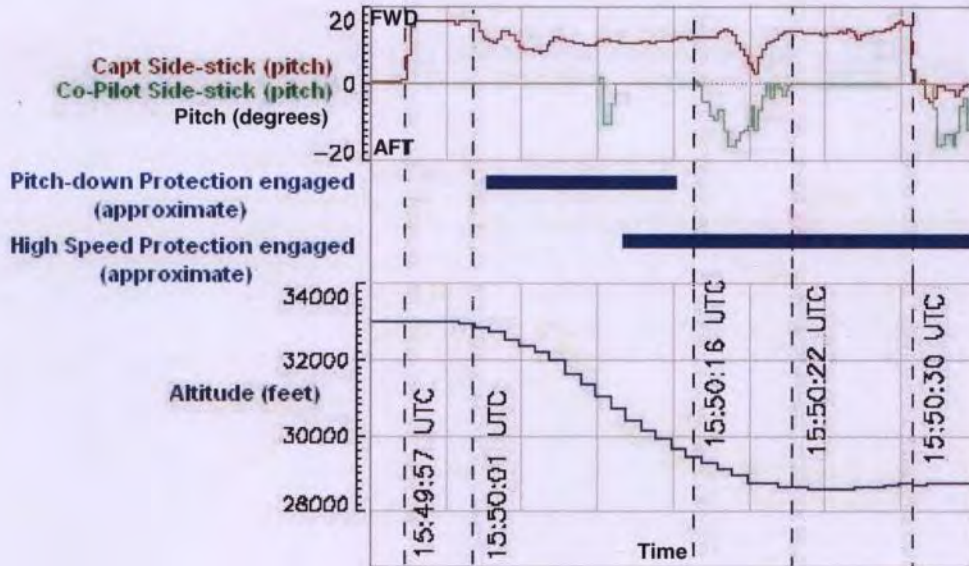
Figure 19: Composite DFDR trace.

a. Pitch-down protection was triggered approximately three seconds after the pitch-down command. A pitch limit of approximately 17 degrees nose-down was achieved as a result of the Captain's side-stick remaining significantly forward of the neutral position for over 30 seconds. As the 17 degree attitude was approached, the position of the elevators was automatically reduced towards zero.

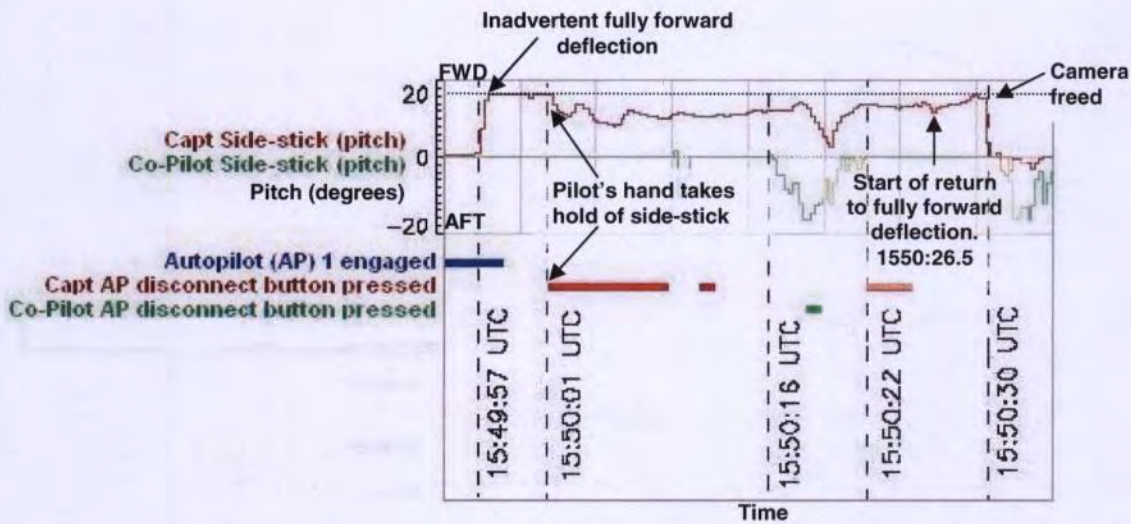
Figure 20: Composite DFDR trace.

1.4.54 Examination of the DFDR/CVR at the point the camera became free produced the following analysis:

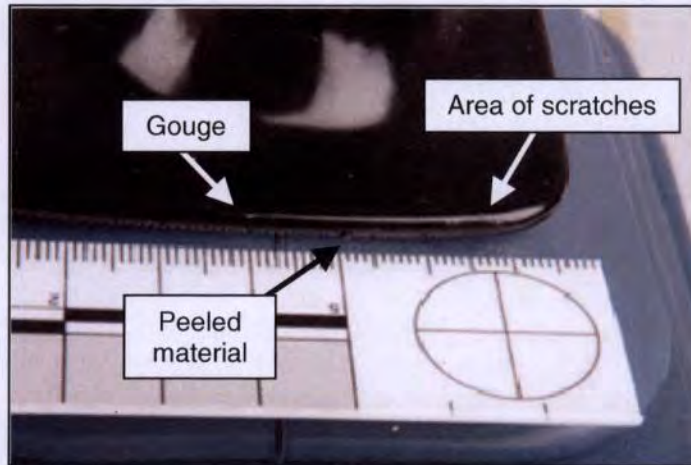
hard edge had been pressed into the flange and dragged sideways, peeling away small chunks of material (Figure 22).

Figure 22: Witness marks on rear right-hand area of side-stick.

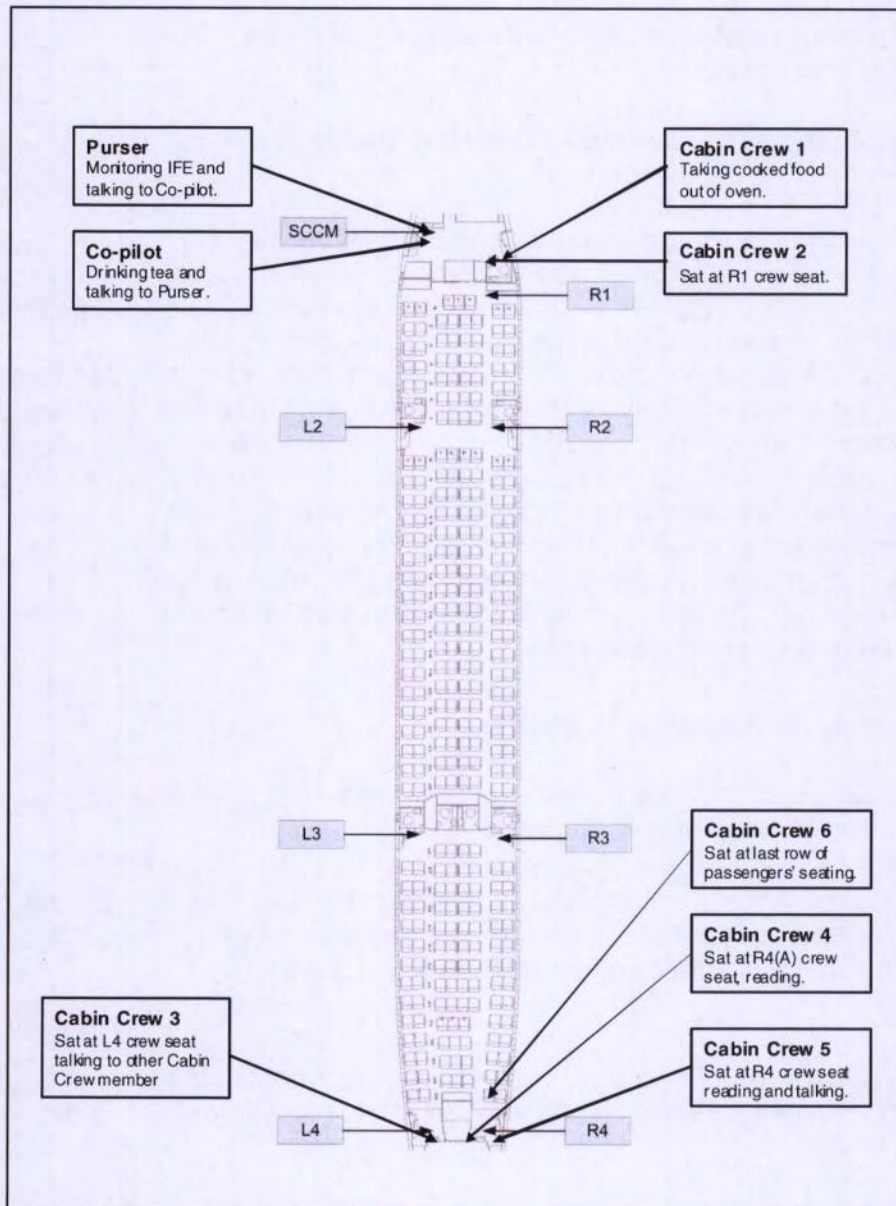
1.4.62 Amongst the 24 passengers who sustained physical injuries, there was a half-and-half split between those wearing a seatbelt, and those not wearing a seatbelt. All seven Cabin Crew reported physical injuries, of whom five were occupying seated positions, but not wearing a seatbelt. Of the remaining two Cabin Crew, one was standing in the forward galley area adjacent to the forward left door (position L1) along with the Co-pilot, while the other was in the forward galley adjacent to position R1 (Figure 23).

Figure 23: Cabin Crew positions at time of incident.
