# A453 Dangerous Occurrence – 20<sup>th</sup> January 2015

## Details

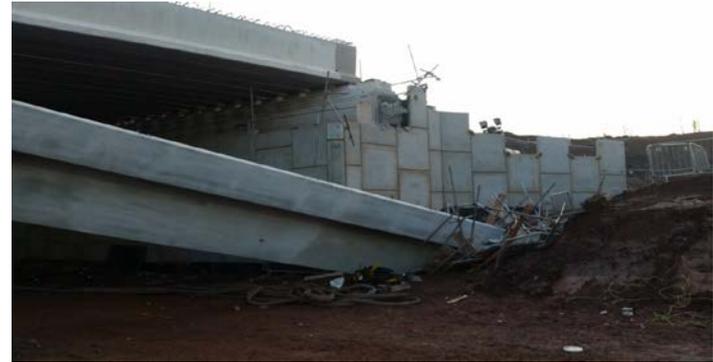
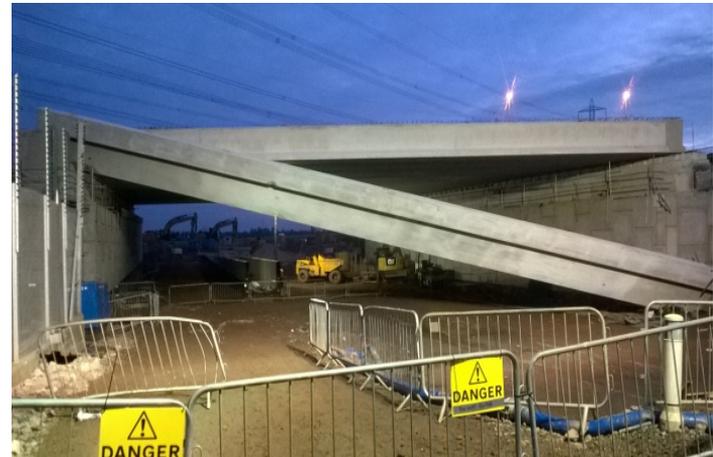
A precast bridge edge beam that had been in position for approximately 15 hours became destabilized following contact by a 13 ton excavator resulting in one end falling to the ground. There were no injuries sustained in the incident.

Ensure the restricted access permit for height is followed.

Improve the knowledge and understanding of the Prolec protection system on excavators to all members of the team. (Operators, Supervisors, Engineering team) .

Is Prolec System the appropriate mitigation (audible alarm for breach of height) or are physical restrictors required that would not permit the operator to override limits.

Prolec system is engaged at correct height and regular checks to ensure this is done (Supervisor, Foreman)

Improve the visual warning aids (e.g. GS6 goal posts) When approaching any structure.
