FLYER TO THE FISHING INDUSTRY

Ronan Orla: accident leading to a fatality on 30 March 2014

Marine Accident Investigation Branch
June 2015

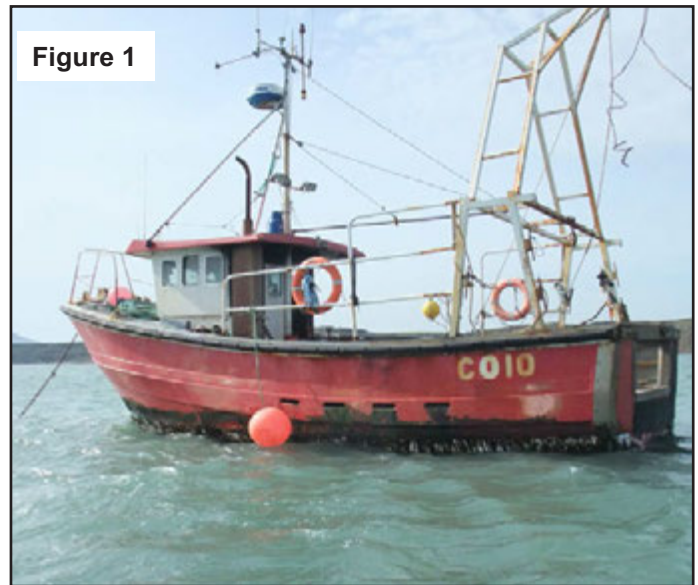
At about 1100 on 30 March 2014, the owner/skipper of the 9.98m scallop dredger *Ronan Orla* (**Figure 1**) was fatally injured when he became entangled on the starboard warping drum of the vessel's winch. The skipper was operating the vessel single-handedly and was attempting to recover his dredge gear on board when the accident happened (**Figure 2**). About 4 hours later, the crew of another scallop dredger noticed that *Ronan Orla* appeared to be in trouble. They came alongside *Ronan Orla* and a crewman climbed on board and stopped the winch. It was apparent that *Ronan Orla*'s skipper was deceased.

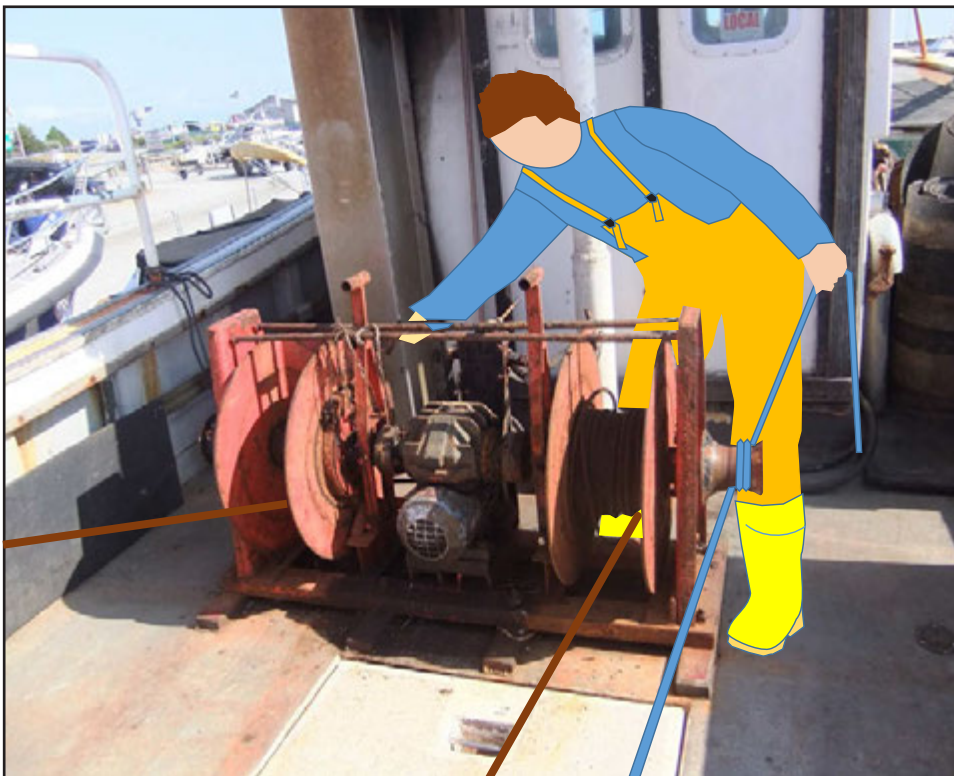
Figure 2
Simultaneous tensioning of pull-down rope and release of hoisting drum band brake

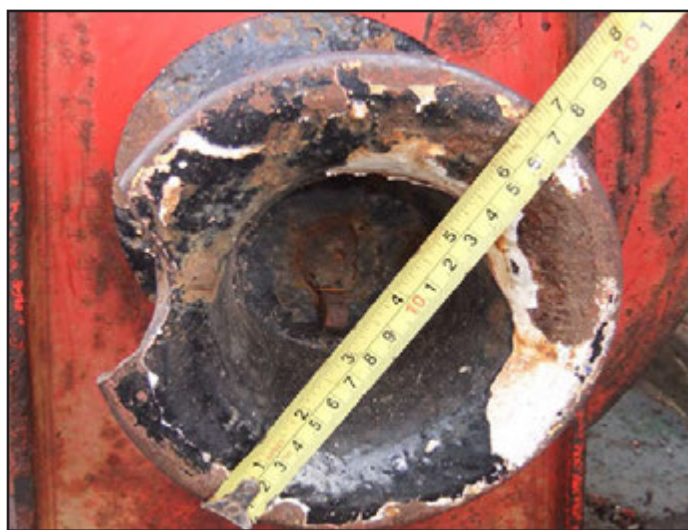
- The material condition of the winch was probably a contributing factor in the accident. Equipment that is allowed to deteriorate becomes unreliable and difficult to use, and may fail when least expected and least wanted. Maintenance is an investment to ensure costly breakdowns are rare, but it also provides the crew with a safer working environment and will improve vessel safety overall.

Figure 3: Chunk of cast steel broken from the rim of the starboard warping drum
