Rail Accident Investigation Branch

Rail Accident Report

**Train struck and damaged by equipment cabinet door in Watford Tunnel
26 October 2014**

Report 12/2015
August 2015

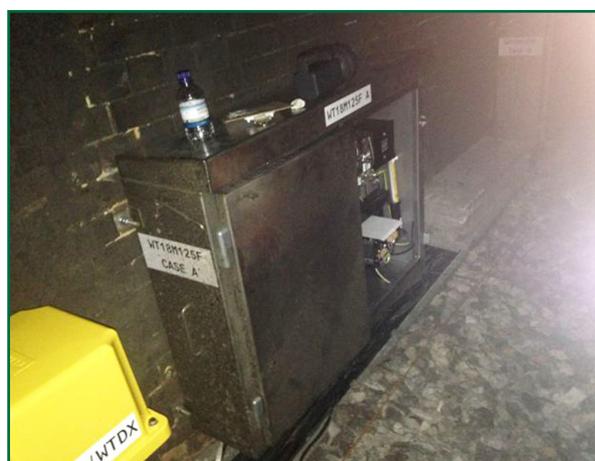
Figure 4: The cabinet as found after the accident with the right door missing

- 29 A mobile operations manager attended and examined the fast lines in Watford Tunnel. He discovered that one of the cabinets (Cabinet A) on the tunnel wall adjacent to the up fast line was damaged, and there was a damaged cabinet door in the cess next to the down fast line.

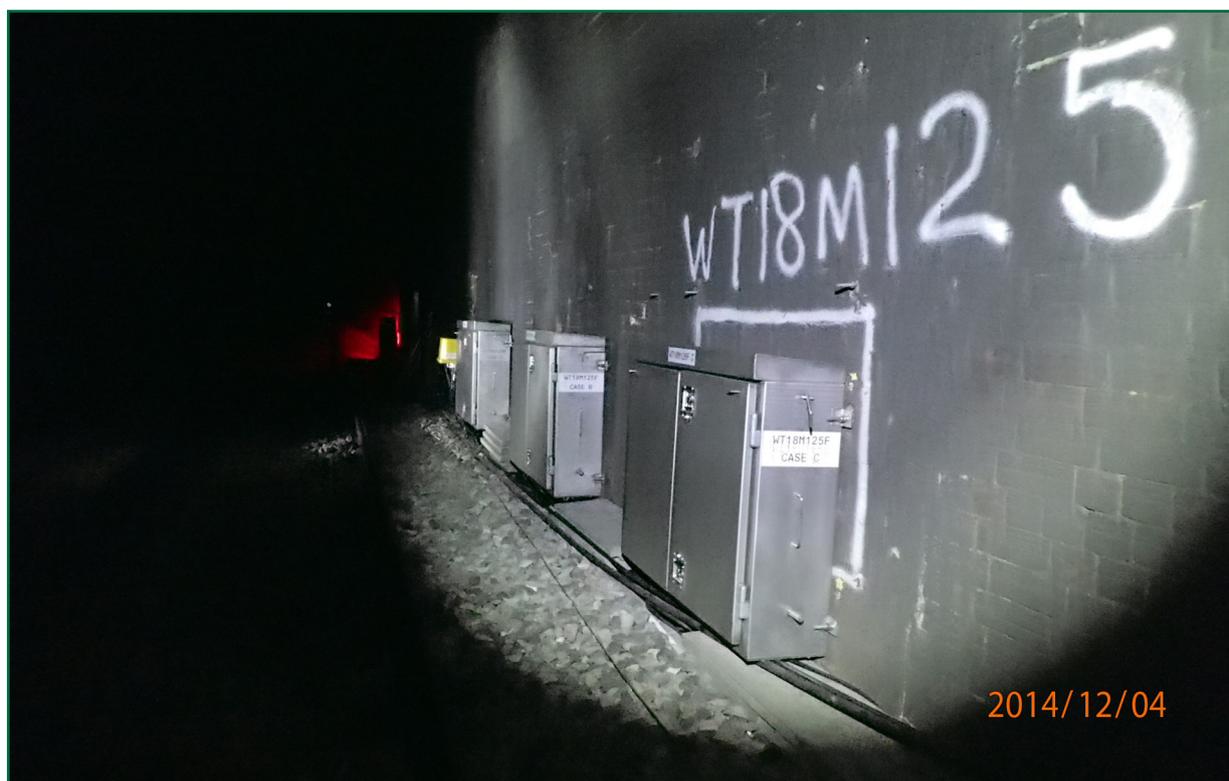
- 24 Cabinets WT18M125F 'A', 'B' and 'C' (referred to as cabinets A, B and C in the remainder of this report) were the three cabinets located on the tunnel wall adjacent to the up fast line. They housed the last items of equipment that were functionally tested before both groups of testers left the tunnel having completed their work. Cabinet A, the door of which was later struck by the train, was the most northerly of the three cabinets in the group (figure 5).

Figure 5: Cabinets A, B and C on the cess side of the up fast line

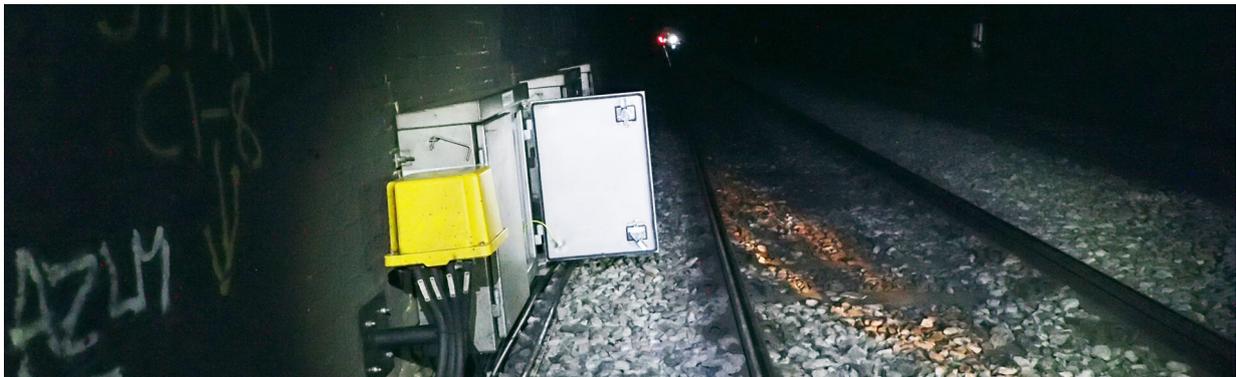
26 Shortly before 07:19 hrs, train 2K00 entered the north end of Watford Tunnel travelling towards London Euston on the up fast line at 88 mph (141 km/h). Carriages 1 and 2 of the train passed Cabinet A without incident. However, as carriage 3 passed Cabinet A, the right-hand door of the cabinet was struck by the train, having opened to become foul of the line (figure 6).

Figure 6: View from the cess adjacent to the up fast line looking towards London showing a reconstruction of the appearance of the door of Cabinet A fully open

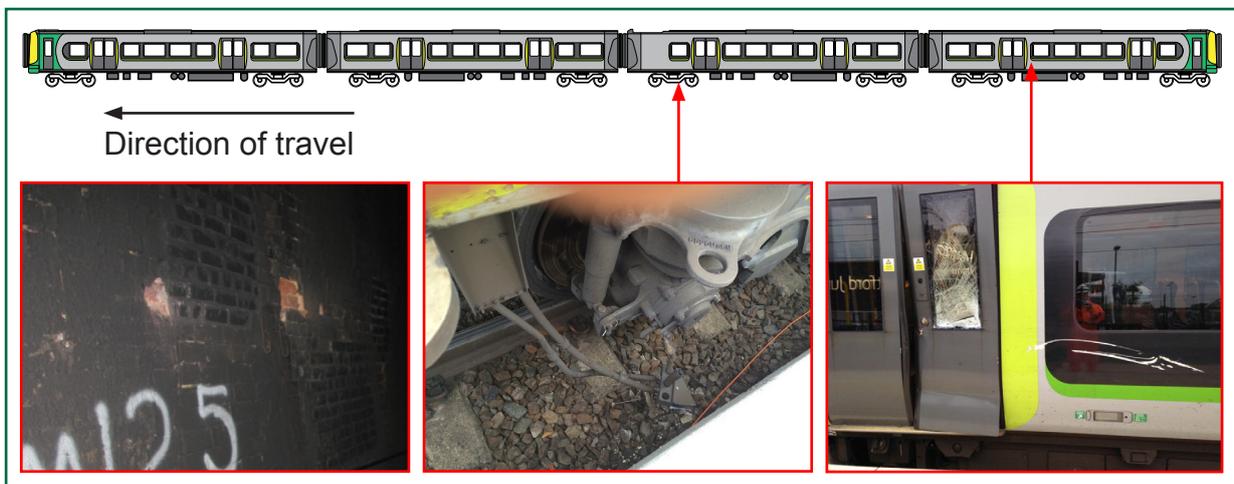
27 The leading bogie of the third carriage struck the cabinet door, which detached from its hinges and became airborne. The door struck the tunnel wall (figures 7 to 9), and then bounced between the tunnel wall and the train. It hit the leading set of passenger doors on the fourth carriage of the train, penetrating the door window and causing a shower of glass debris to enter the passenger compartment (figures 10 and 11). The safety circuits on the train detected that the door was no longer properly closed and automatically applied the train's brakes. At the same time, the driver observed a 'door open' indication in his cab.

Figures 7 to 9: (left to right) The initial impact damage on the tunnel wall, the equipment on the leading bogie of carriage 3 and damage to the door and body side of carriage 4

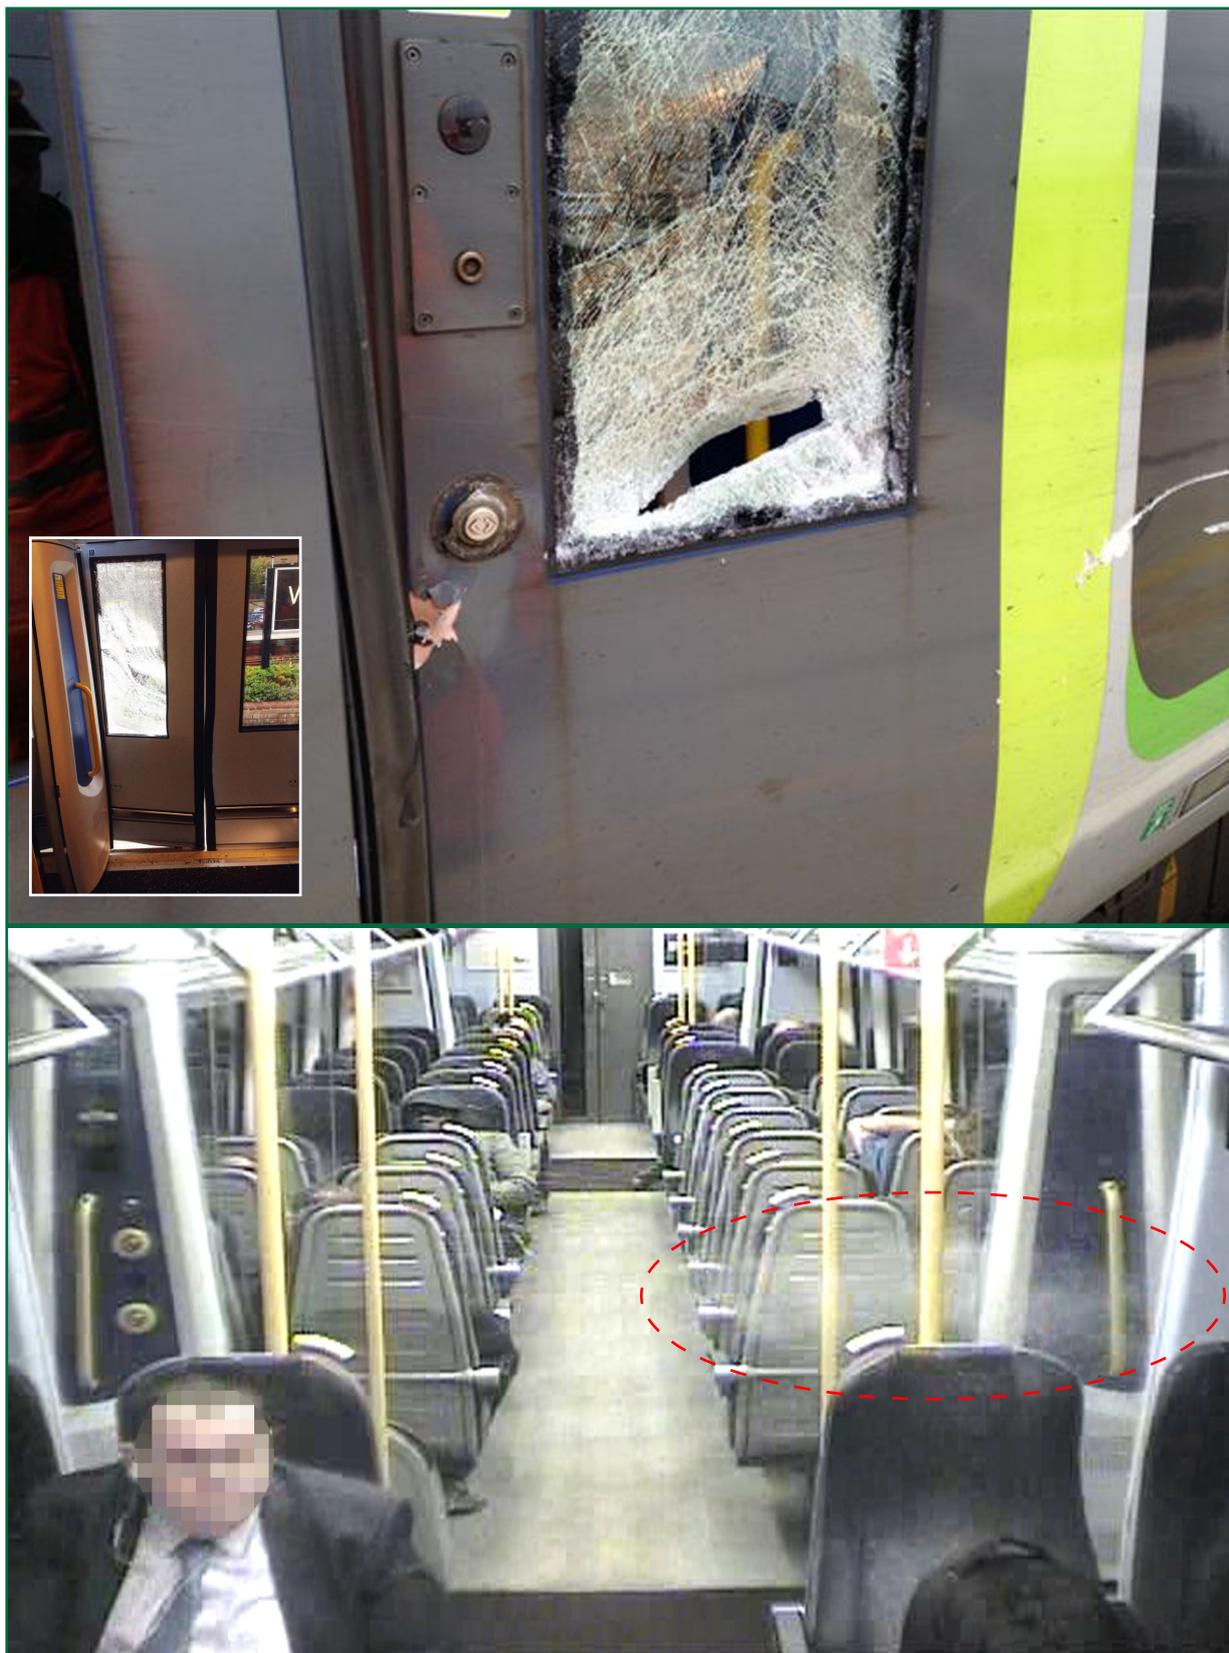
- 4 The train driver reported to the signaller that a door on the fourth carriage had been severely damaged and was potentially out of *gauge*. Passengers in this carriage also reported they had been showered by flying glass from the damaged door, although none reported any injuries.

Figures 10 and 11: The damage to the door of carriage 4 and internal CCTV images of the glass entering the passenger compartment

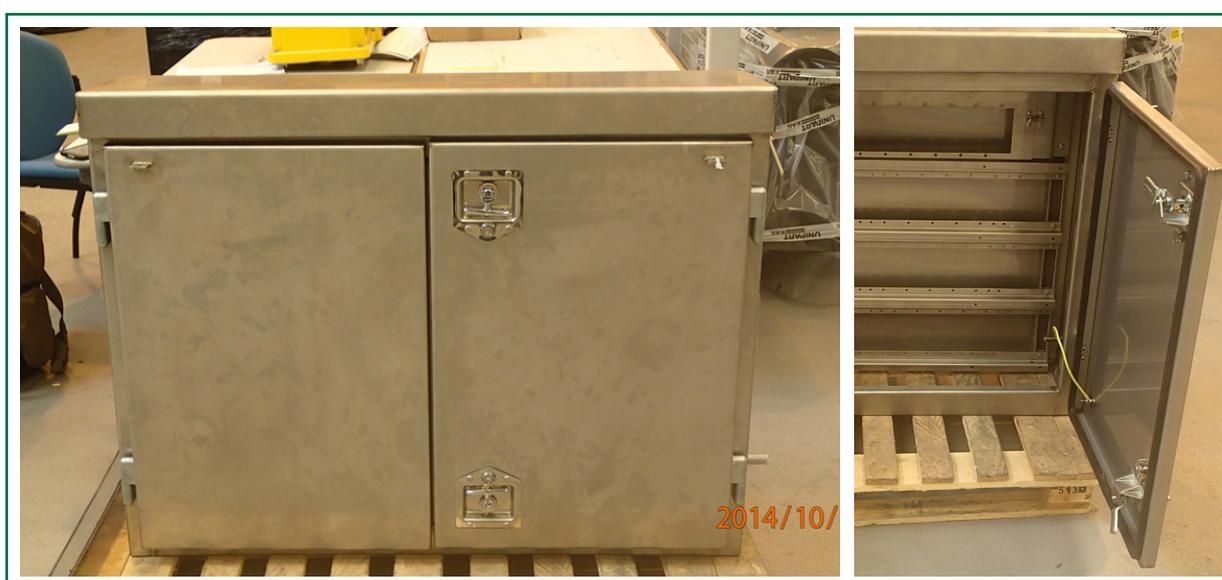
- 31 **One of the doors of Cabinet A opened to become foul of the up fast line, most likely as a result of aerodynamic forces, as train 2K00 passed through the tunnel.**
- 32 Figures 12 and 13 show a cabinet of the same type as Cabinet A and the arrangements for securing the door on Cabinet A in the closed position. The securing mechanism consists of a pair of levers which rotate to engage with the cabinet frame when the handle (figure 13) is turned, thus securing the door closed. It is then possible to lock the cabinet with a key.

Figures 12 and 13: (left) A cabinet of the same type as Cabinet A and (right) the right-hand cabinet door open, showing the securing mechanism

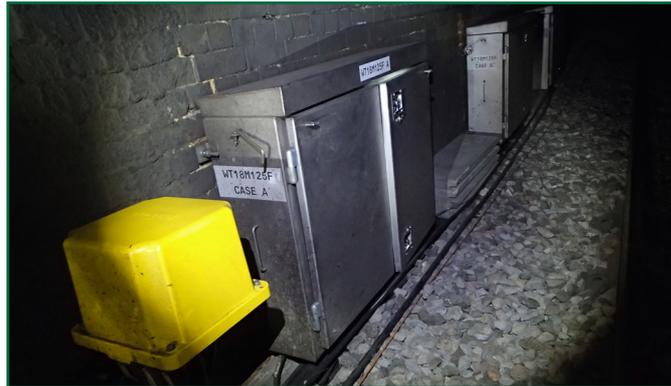
- *The door was closed, but left unsecured (ie the handle had not been turned)*. There are two possibilities: the right-hand door was fully closed, but the handle was not turned or the right-hand door was closed as far as was possible, but still slightly proud of the left-hand door³, as shown in figure 14. The air flow associated with the movement of train 2K00 through the tunnel would have created a pressure differential at the doors of Cabinet A, which could cause an unsecured door to open after the front of the train had passed. The RAIB considers this to be the most likely scenario. When Network Rail staff examined the cabinet after the accident (paragraph 30), the left-hand door was found to be closed but not secured.

Figure 14: View from the cess adjacent to the up fast line looking towards London showing a reconstruction of the appearance of the right-hand door of Cabinet 'A' slightly proud of the left-hand door

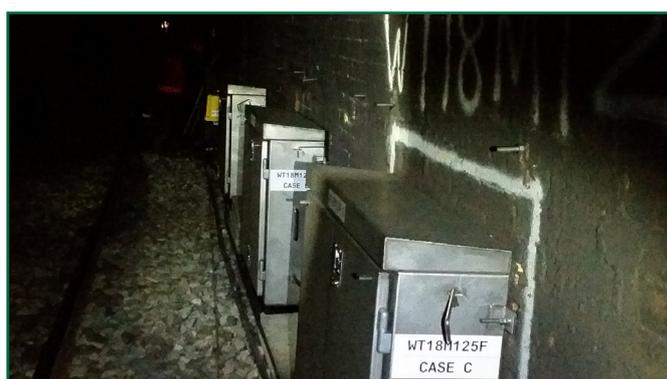
- 39 A reconstruction undertaken by the RAIB in Watford Tunnel showed that it is probable that, as the two groups of testers walked south (towards Watford) from the site of work, their head torches and handheld lamps did not illuminate the area sufficiently for them to see that the door of Cabinet 'A' was not secured (this would have been indicated by the position of the door handle). It would have been equally difficult to see if the door had not been completely closed (figure 15).

Figure 15: View from the cess adjacent to the up fast line looking north. Note that a door of Cabinet A (further from the camera) is in the same position as that shown in figure 14 and doors on Cabinet B (closer to the camera) are closed.

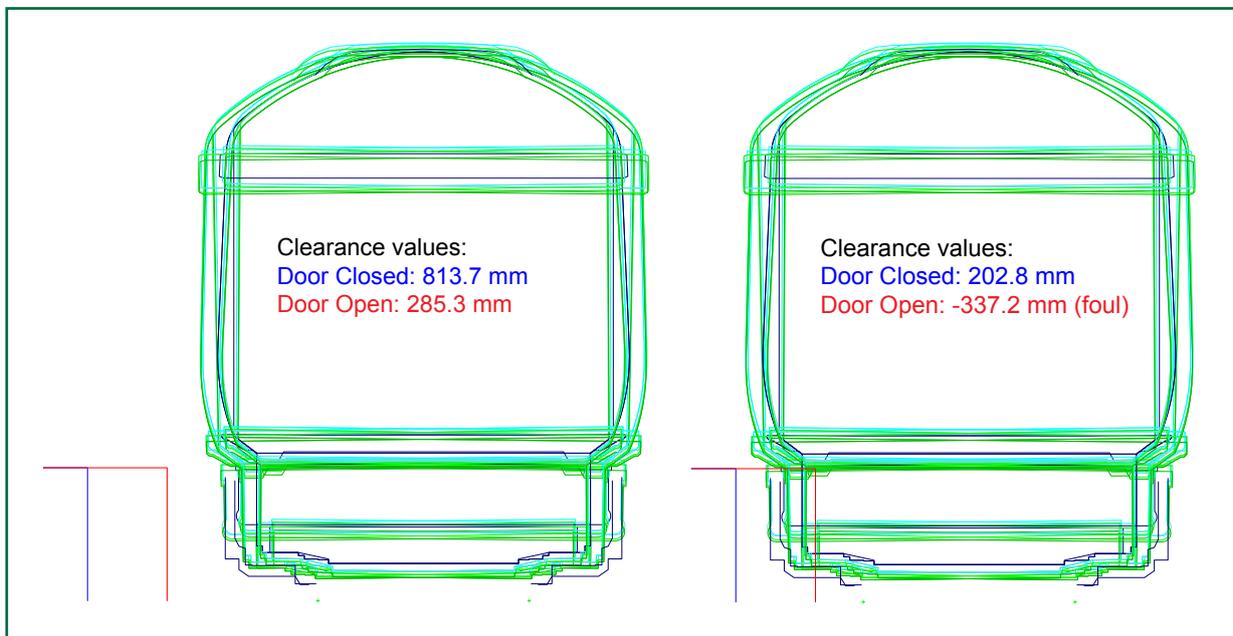
- 65 Siemens' proposal to use the refuges for housing the cabinets was not based on a recognised need to mitigate any risk associated with gauge clearance, but rather that it would be tidier to have the cabinets tucked away in refuges instead of on the tunnel wall. However, an open door on a cabinet positioned in a tunnel refuge would have been clear of a passing train (figure 16). Siemens did not confirm during the IDC/IDR meeting on 1 July 2013 whether using the refuges was acceptable. The Network Rail DPE did not notice the proposal to site the cabinets in the refuge contained in the notes at the end of the plan. The LAP schematic drawing does not show the exact positioning of cabinets nor the position of tunnel refuges, although Siemens stated that its designers had identified which cabinets were to be positioned in the refuges with a specific 'hash' mark and the note referred to in paragraph 64.

Figure 16 (left) typical clearance values of a slimline cabinet if it had been installed in the refuge (door open) and (right) typical clearance values with the cabinet attached to the tunnel wall with the doors open (diagrams provided courtesy of Network Rail). Note that the open door of a standard cabinet located in the refuge would not have infringed the gauge. The figure shows a number of different rolling stock profiles, but although the values may change from the typical values given, the effect of positioning the cabinet in the refuges and on the tunnel wall does not.

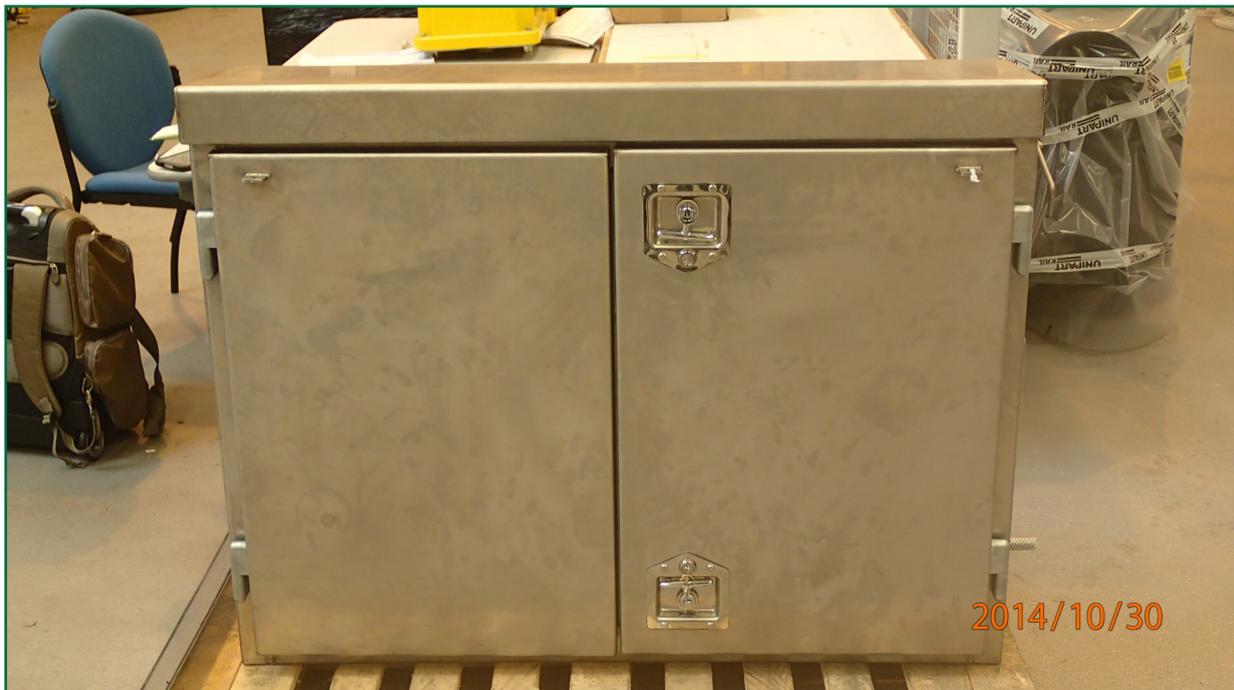
- 76 The design risk log shows that in April 2014 Network Rail requested Siemens to raise an additional Technical Query to risk assess the mounting specification for the new cabinets. Contractors acting on behalf of Siemens undertook a site visit to inspect how the new cabinets would be sited and mounted on the wall. The additional risk assessment for the mounting was completed in July 2014 and the response to the Technical Query (including a cabinet specification) was submitted on 14 July 2014 and authorised by the DPE on 31 July 2014. Witness and documentary evidence show that although the risk from aerodynamic forces was considered, it was confined to consideration of the cabinet in normal condition (ie with doors closed and secured).

Figure 19: The modified slimline cabinet

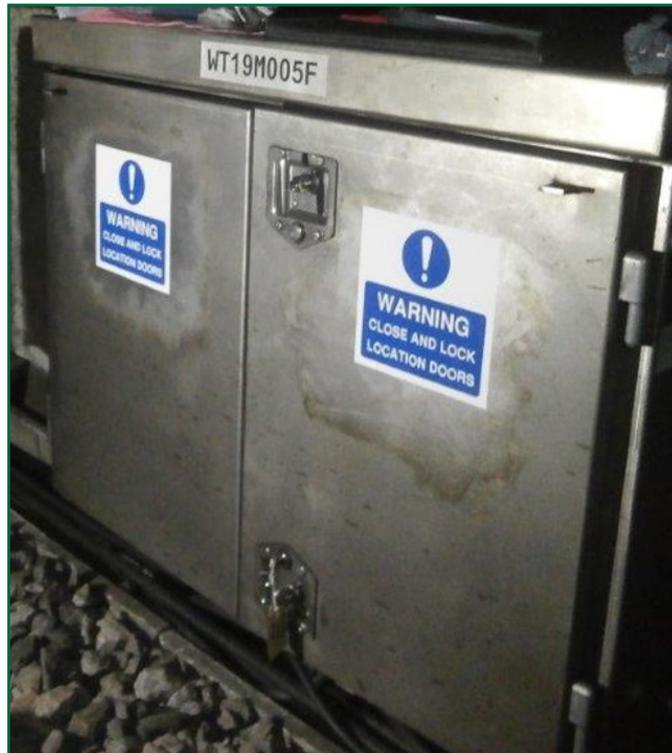
Figure 20: The cabinets within Watford Tunnel with safety notices placed on the doors

- ii. issued a safety alert to brief staff and contractors on the immediate cause of the accident and to remind them to make sure they close and lock lineside equipment on completion of work (paragraph 94a(ii)); and
