Drowning of a Passenger on *Sapphire Princess* East China Sea 7 August 2014

SUMMARY

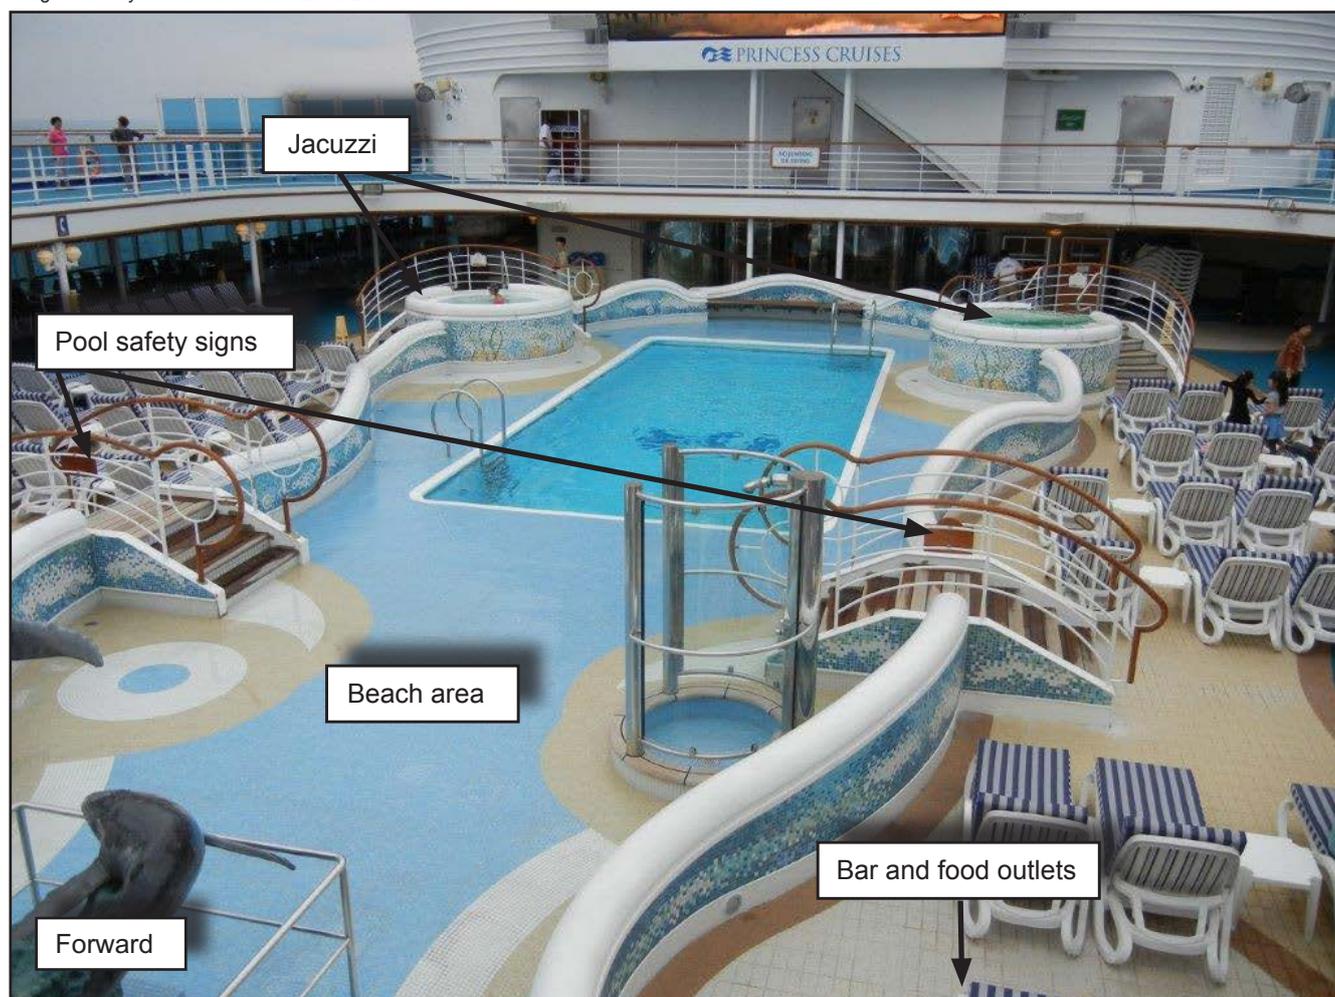
Figure 2: Photograph of Neptune Pool

Neptune Pool (**Figure 2**) was located on deck 14 forward. The pool was approximately 5m⁴ long by 2.5m wide with a depth of 2.21m at its deepest point and 1.65m at its shallowest point. There were two Jacuzzis at the after end of the pool and a large tiled 'beach' area at the forward end. Forward of the beach was a food area, which comprised a pizzeria, a bar and a grill. The pool was enclosed by a low wall (approximately 0.5m high) with seating and sun loungers on the adjacent deck area.

The lack of dedicated pool attendants potentially delayed the response to the incident in respect of raising an alarm and administering appropriate medical treatment. The monitoring of CCTV coverage of the area might have prompted an earlier response and would have given post-incident information.

- 2015/147 **Princess Cruise Lines Ltd** is recommended to improve safety in the use of ships' swimming pools throughout its fleet by:
1. Carrying out a suitable and sufficient risk assessment relating to the use of ships' swimming pools in compliance with The Merchant Shipping and Fishing Vessels (Health and Safety at Work) Regulations 1997, and then formally documenting it.

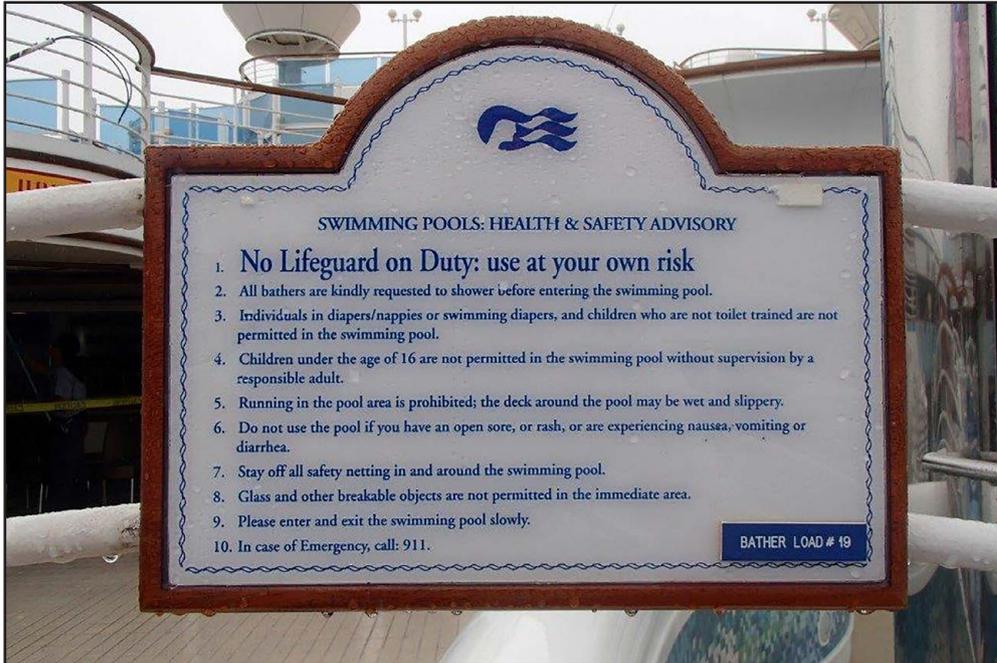
Figure 3: Photograph of advisory note

No formal documented risk assessment relating to hazards involved in the use of swimming pools had been produced. There were no designated attendants present or CCTV⁵ coverage of the pool areas. A parental advisory notice in the passengers' cabins warned those with children that there were no lifeguards on duty, and this notice had been translated into Chinese for the ship's relocation to the Asian market. Similarly, a health and safety advisory notice (Figure 3) near the pool, which also advised there were no lifeguards on duty, had been overlaid with a Chinese translation (Figure 4).

With no designated attendants at the vessel's pools, it was left to other pool users and bystanders to recognise that Ms Bayinhua was in need of urgent assistance and to raise an alarm. While the Health and Safety Advisory Note (**Figures 3 and 4**) warned that there was no lifeguard on duty and that children under the age of 16 should be supervised, had there been a dedicated pool attendant monitoring the passengers in the pool, the victim's situation could have been identified at the earliest possible opportunity.

Princess Cruise Lines Ltd has issued guidance to all passengers stating that lifeguards are not on duty around the pools and all persons using the pools do so at their own risk.
