AAIB Bulletin

4/2015

CONTENTS**SPECIAL BULLETINS / INTERIM REPORTS**

AAIB FIELD INVESTIGATIONS**COMMERCIAL AIR TRANSPORT****FIXED WING**

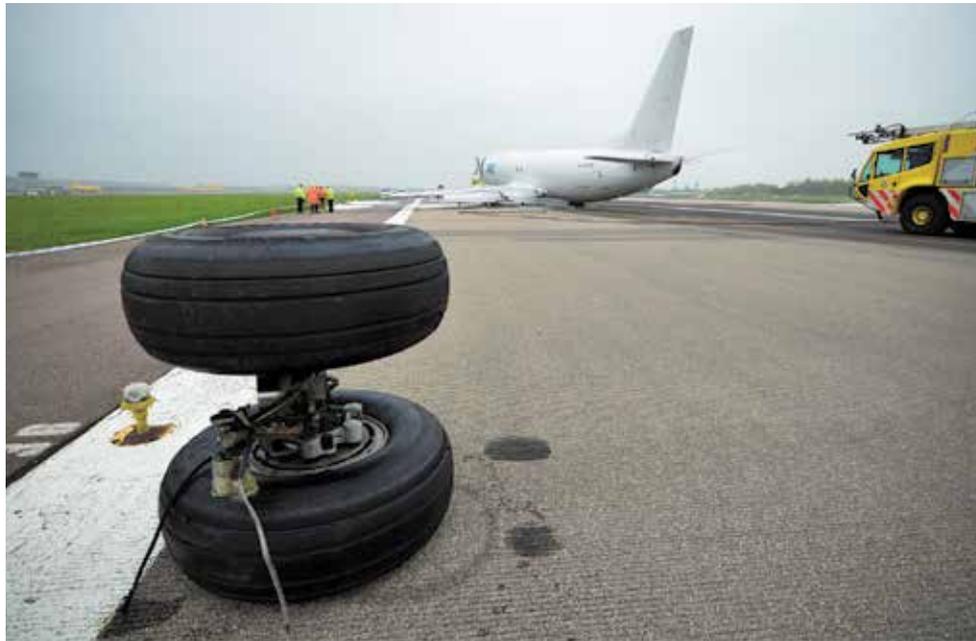
Figure 1

View of aircraft and detached section of lower left MLG

Marks and damage to the runway surface indicated that the aircraft had travelled 115 m with its weight on the left engine nacelle and left MLG outer cylinder, from the position where the left MLG had failed. A debris trail, consisting mainly of composite material, was deposited on the runway, along with a large oil stain where the MLG lower section had detached. The aircraft’s path described a gentle curve diverging to the left, away from the runway centreline. The aircraft had come to rest with its nosewheel off the ground and its weight borne on the right MLG, the remains of the left MLG and the underside of the left engine nacelle.

The left MLG inner cylinder had fractured through the chrome portion approximately 75 mm above the axle. The fracture was horizontally across the full diameter of the inner cylinder and exhibited a discoloured thumbnail-shaped feature on its surface. This feature was on the forward face of the MLG, approximately in line with the level at which the inner cylinder protrudes from the outer cylinder with aircraft weight on wheels. The upper torque link arm had failed and the antiskid system wiring harness, conduit and brake pipes had parted. The left mainwheels, brake units and axle assembly came to rest approximately 27 m behind the aircraft, to the left of the centreline.

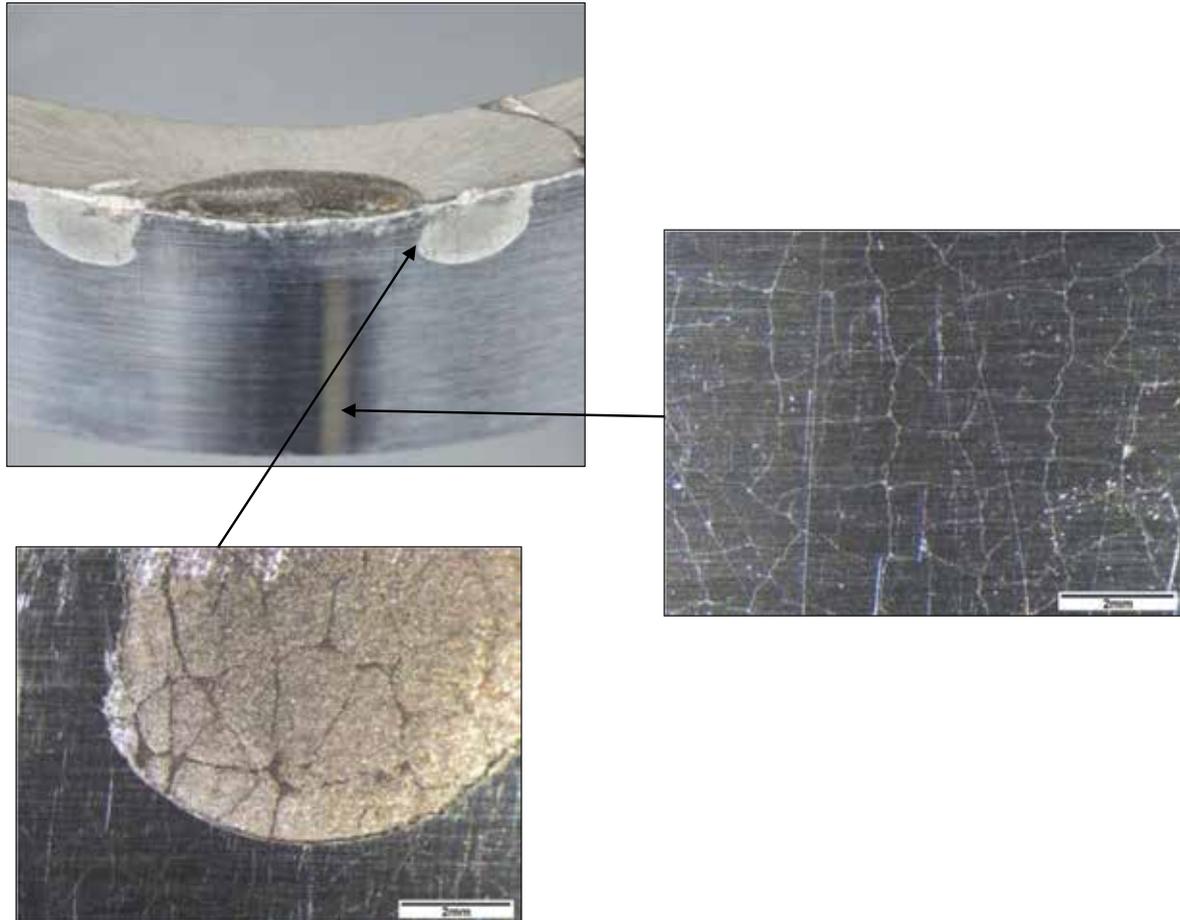
Figure 3

The visual examination under magnification of the outer chrome plated surfaces of the inner cylinder revealed extensive crazing of the chrome plating. This phenomenon is known as 'chicken wire' cracking and was apparent over the majority of the surface. Small flakes of the crazed chrome plating had detached from the substrate material at the edge of the fracture face, leaving an imprint of the crazing in the form of ferrous oxide tracks (Figure 3).

Chrome plate flake area and ferrous oxide tracks left by the chicken wire cracking

Daily MLG checks and the inspection carried out two days before the accident did not reveal any defects with the MLG. Whilst chicken wire cracking can in some circumstances be seen with the naked eye, it is very difficult to detect without significant magnification and a suitable light source held at a suitable angle. It is even more difficult to detect in situ because only a relatively small portion of the inner cylinder chrome surface is visible with the aircraft weight on wheels and this area is usually covered in oil residue, brake and runway dust and grit. It is therefore not surprising that the cracking was not detected prior to the accident.

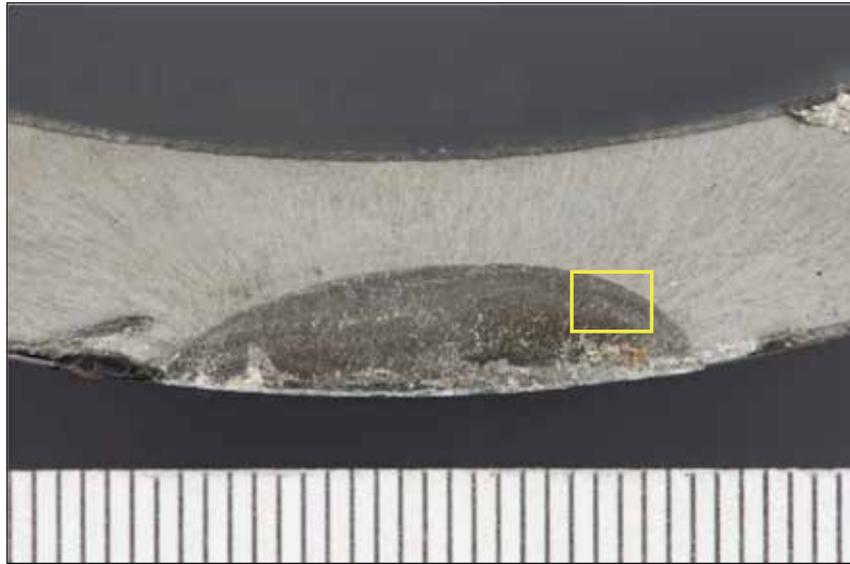
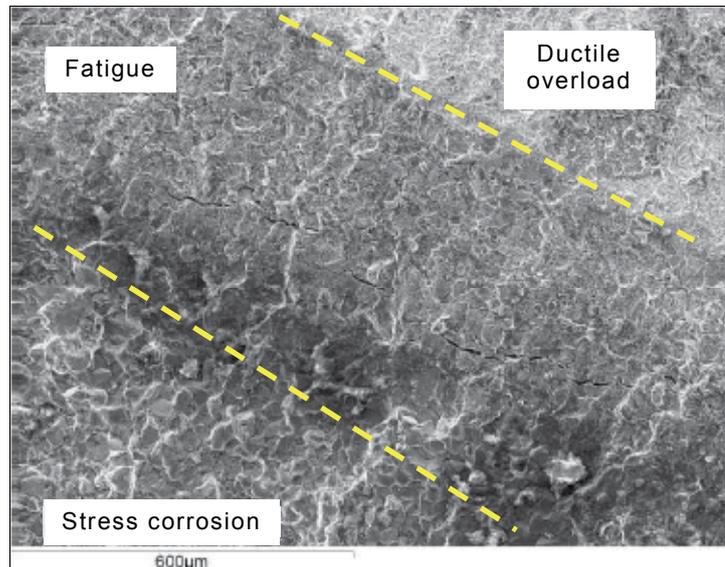
Figure 4
Fracture surface map

The cause of the fracture was stress corrosion cracking and fatigue propagation within the high strength steel substrate, leading to ductile overload failure. This was as a result of a small but significant area of localised heat damage to the chrome plating, leading to the exposure of the substrate to a corrosive environment. The exact source of the heat could not be determined.

The fracture face showed three distinct failure mechanisms in the grey 'thumbnail' area of the fracture (Figure 4). The majority of this area exhibited stress corrosion. Further into the material there was evidence of fatigue and the remainder of the fracture face showed the characteristics of ductile overload.

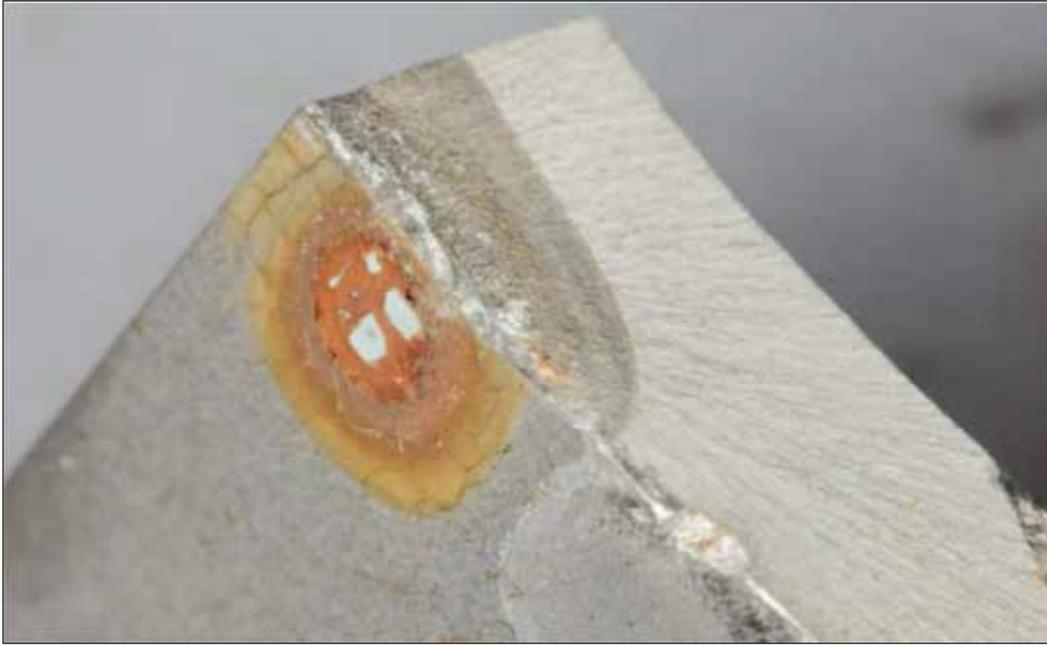
Figure 5

With the chrome plating removed, a very distinctive area of ferrous oxidation became apparent on the surface of the steel, just beneath the area of fatigue cracking (Figure 5). In addition, in the same area, there was also evidence of chrome combining with the steel.

Ferrous oxidation on the substrate beneath the chrome plating
(after longitudinal microsection)

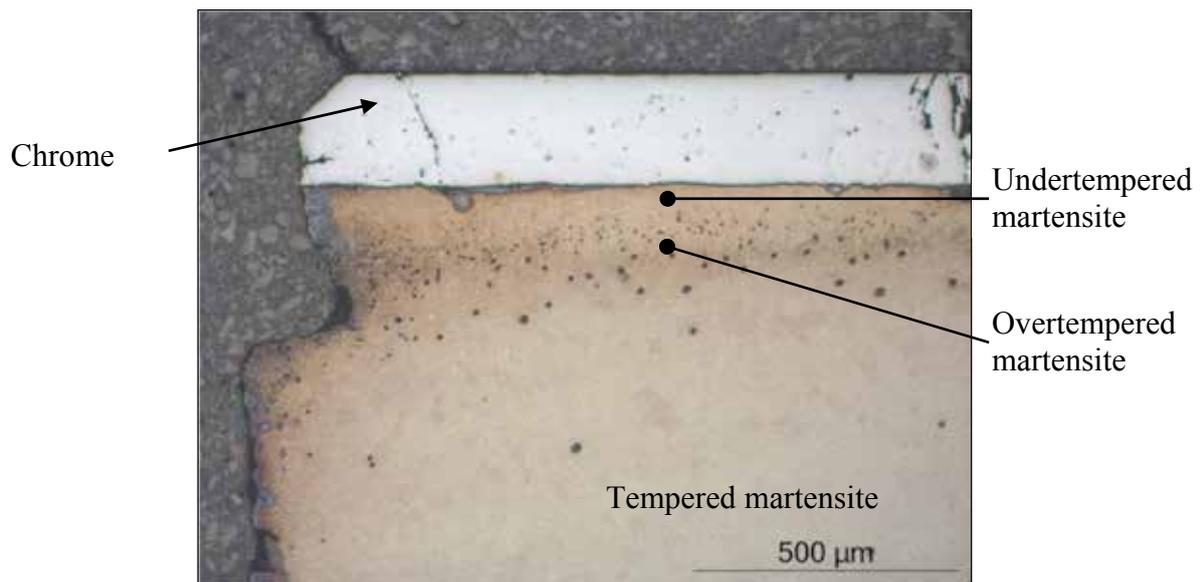
Metallurgical examination of the microsection through the fracture face showed an area in the substrate steel of over and undertempered martensite, consistent with localised heating. The hardness profile through this section also confirmed this finding. Prior to removal of the chrome, hardness checks were carried out; these showed that the chrome decreased in hardness in the vicinity of the fracture face. Figure 6 shows the disposition of the martensite.

Fracture surface metallurgy

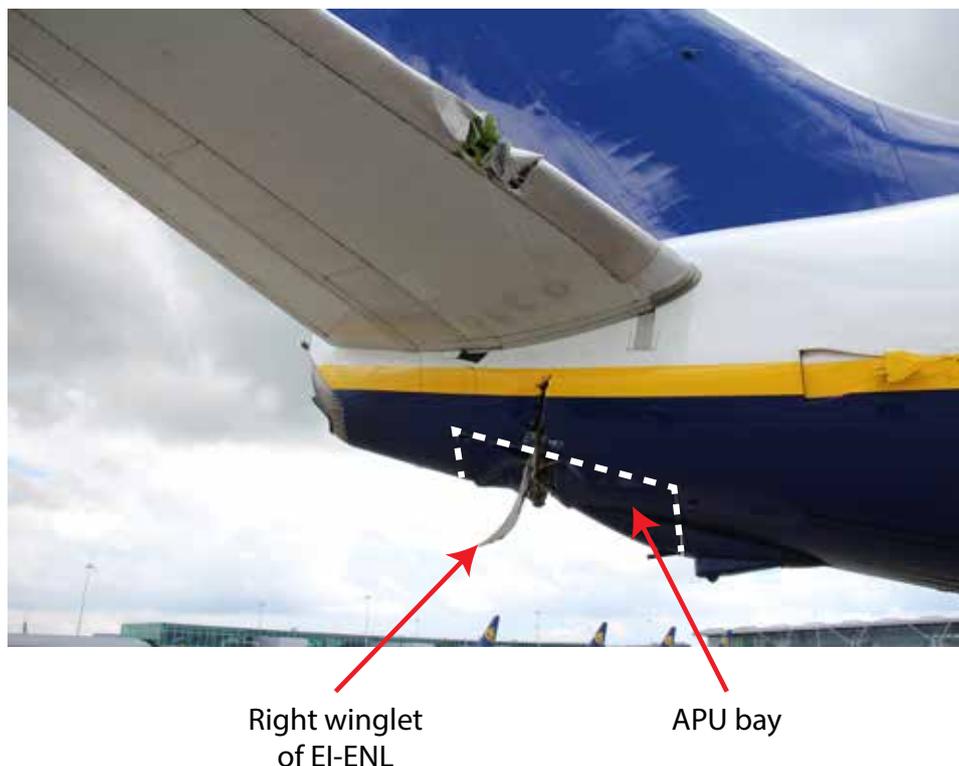
Figure 5

The right winglet of EI-ENL had struck the right tailplane of EI-DLJ before piercing its APU bay and severely damaging the APU. The winglet detached and remained embedded in the bay (Figure 5). The APU's automatic shutdown⁵ process operated and closed the fuel shut-off valve on the forward bulkhead of the APU bay, preventing a fuel leak which would have been substantial.

Right winglet of EI-ENL embedded in the APU bay of EI-DLJ

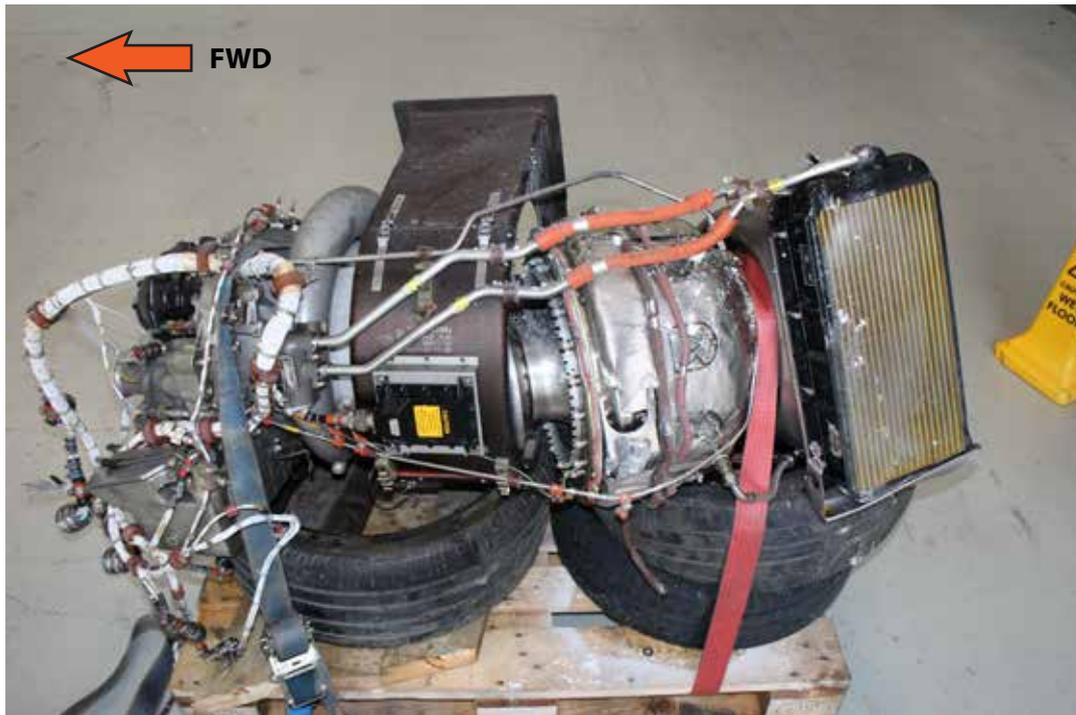
Figure 6

Underside of APU after removal, showing extent of the damage

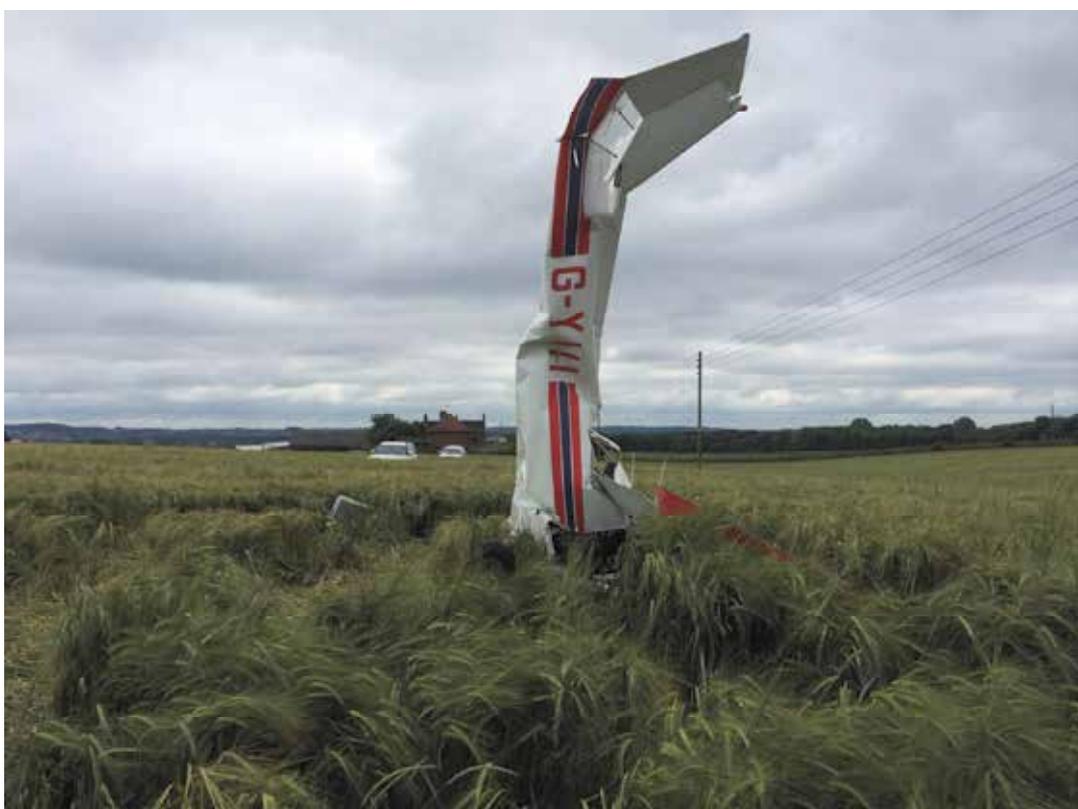
Figure 4

The aircraft came to rest in a crop field approximately six metres from a line of overhead cables in a near vertical attitude, (Figure 4). It was resting on its nose and there was no evidence that it had made contact with the ground prior to this point.

Accident site on AAIB arrival
