Dangerous occurrence at Wootton Bassett junction - web site update and supplementary information

Signal passed at danger (SPAD) on the approach to Wootton Bassett junction, Wiltshire, 7 March 2015

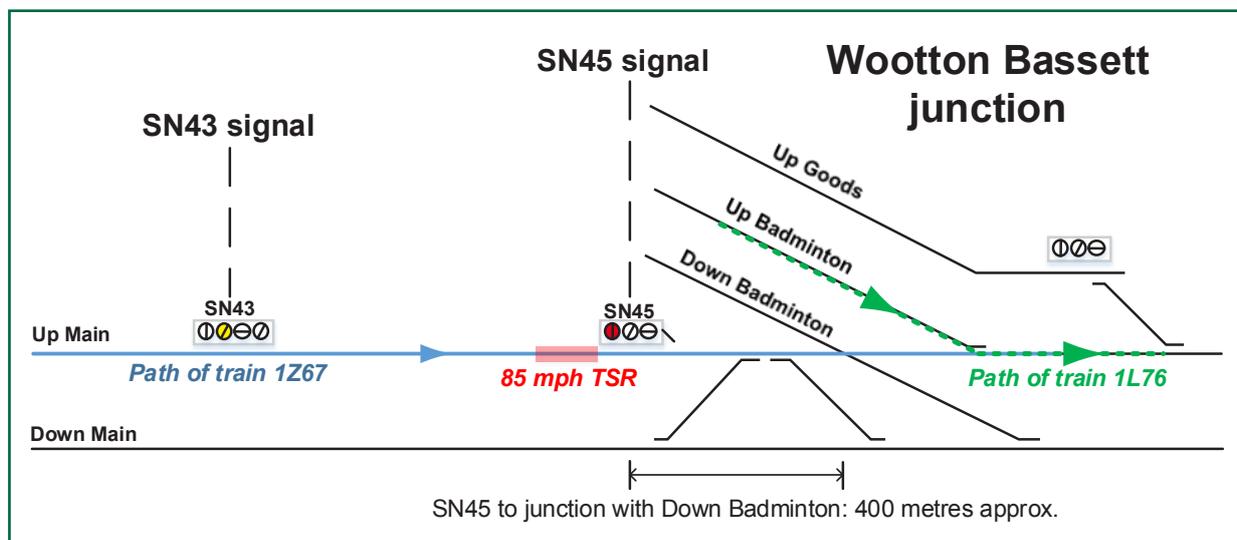
- 3 Wootton Bassett junction is located between the stations at Chippenham and Swindon. It is a double track high speed junction joining the up and down Great Western main lines which run to and from Bristol Temple Meads to London Paddington (via Bath) with the up and down Badminton lines which run to and from Cardiff. The junction also has two low speed crossovers between the up and down main lines (figure 1).

Figure 1: A diagram of the layout of Wootton Bassett junction – note that some features have been omitted for clarity (not to scale)

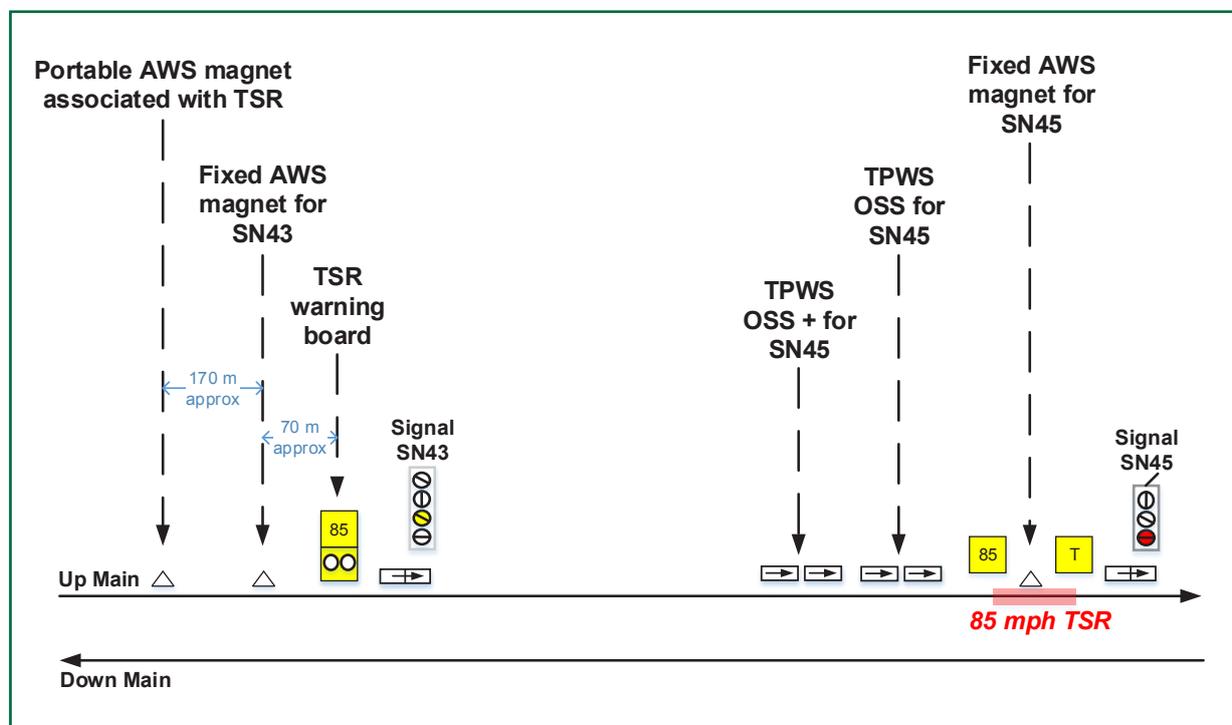
- 5 The maximum permitted line speed for trains approaching the junction on the up main line from Chippenham is normally 125 mph (201 km/h). However, on 7 March 2015, a temporary speed restriction (TSR) of 85 mph (137 km/h) was in place on the approach to signal SN45 due to the condition of the track. The associated TSR warning board and portable AWS magnet for the TSR had been placed on the approach to signal SN43 (figure 2).

Figure 2: A diagram of the arrangements implemented for the TSR (not to scale)

- 6 The portable AWS magnet was positioned so that there was less than four seconds running time (for trains travelling at the maximum permitted line speed of 125 mph) between it and the fixed AWS magnet for signal SN43. In addition, the TSR warning board was placed between the fixed AWS magnet for SN43 and the signal itself. The position of the portable AWS magnet and the TSR warning board did not meet the requirements relating to TSRs contained within the railway rule book and other Railway Group Standards.

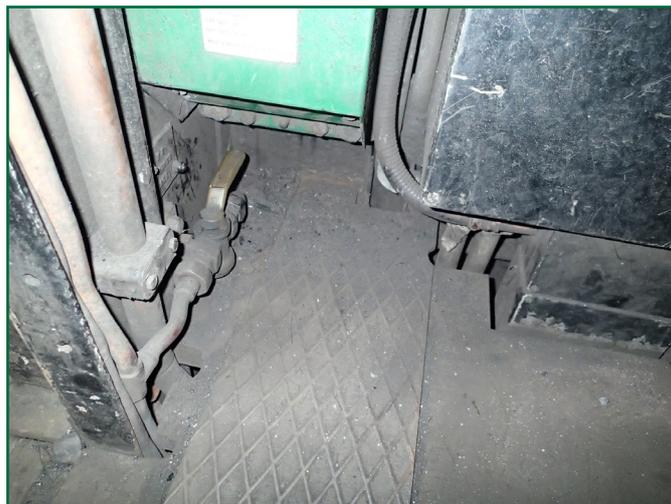
- 10 An AWS shut down cock is located to the rear of the driver's seat. The AWS shut down cock is normally left open in service; if closed, it will pneumatically and electrically isolate the AWS system. An AWS isolating cock is also situated to the rear of the driving position, close to the cab floor plates (figure 3). The AWS isolating cock is normally left closed in service; if opened it will admit air into the electro-pneumatic valve and lock it into the 'ISOLATED' position. Once the electro-pneumatic valve is locked in this position, any brake demands made by the AWS/TPWS control unit will be rendered ineffective.

Figure 3: The AWS isolating cock

- 11 The AWS isolating cock is intended to allow Tangmere to maintain a functioning automatic air brake pipe in certain operational circumstances where the AWS shut down cock has been operated eg where there has been an AWS system fault or where the locomotive is to be hauled by another traction unit. If the AWS isolating cock is opened without the AWS shut down cock also being closed, the TPWS and AWS system will lose their ability to command a brake application but will otherwise appear to function normally.

- 18 The driver indicated to the fireman that an AWS brake demand had occurred. His expectation was that the fireman would open the AWS isolating cock in order to by-pass the AWS brake demand and release the brakes. The fireman has stated that he believed that he was following the driver's instructions when he subsequently crossed the cab and opened the AWS isolating cock. Witness evidence suggests that the AWS isolating cock was not sealed before the fireman opened it.

- 20 However, in this case, the train was not brought to a stand and instead continued on its journey. OTDR data shows that the brake demand made by the AWS system ceased to be effective around 12 seconds after it was initiated. The brief brake application which resulted from the AWS brake demand before it was by-passed reduced the train's speed by a total of 8 mph (13 km/h). Witness evidence and OTDR data show that the AWS isolating cock remained open during the remainder of the incident; this had the effect of making any subsequent AWS or TPWS brake demands ineffective.

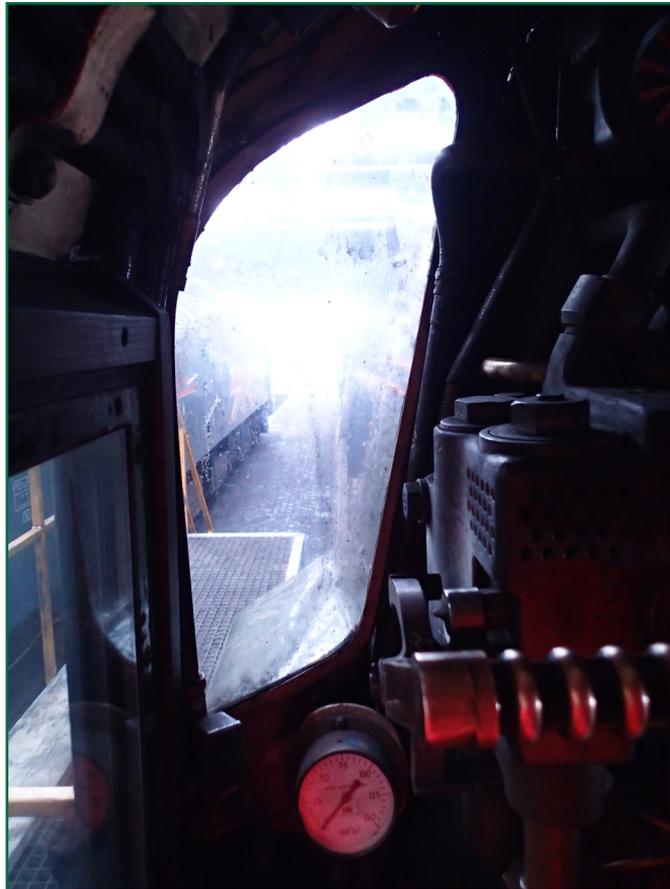
Figure 4: The driver's windscreen on Tangmere – note this image was taken after the incident with the train at a stand and does not show the extent of driver's visibility on 7 March 2015
