## FLYER TO THE FISHING INDUSTRY

### Fishing vessel *Stella Maris*, capsized and sinking, 28 July 2014

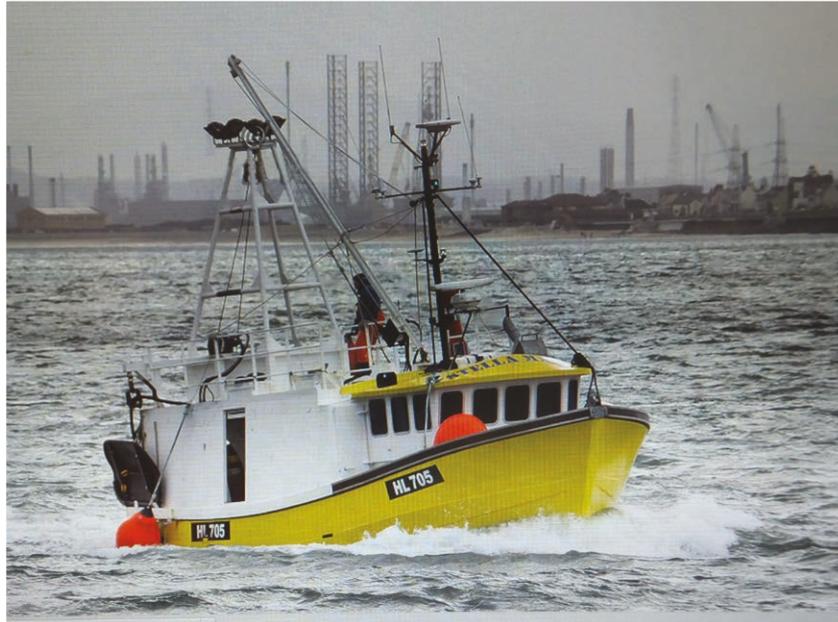
At around 0910 BST on 28 July 2014 the 9.9m trawler *Stella Maris* capsized and sank while attempting to lift a heavy cod end of fish and debris. The two crew successfully abandoned the boat without injury and were rescued about 7 hours later from their liferaft.

The investigation found that *Stella Maris* capsized as a result of insufficient stability due to an overweight cod end being lifted from a high 'A' frame gantry by an excessively powerful gilson winch.
