Failure of Philips Luma 3 luminaire upper canopies

Incident Description

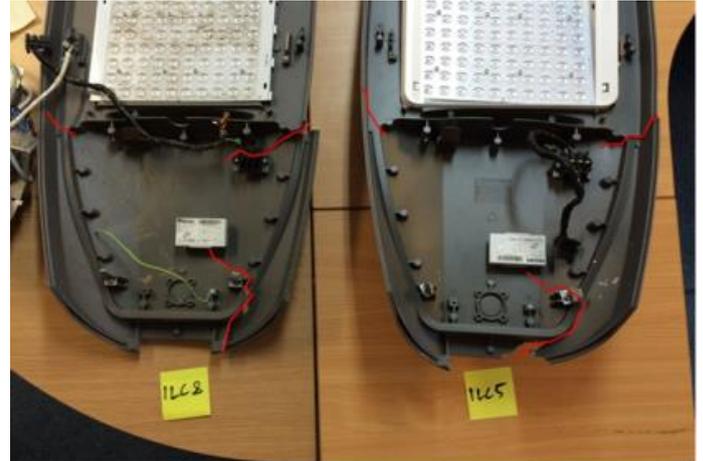
During high winds on Sunday 21st February 2016, the upper canopy of a Philips Luma 3 lighting luminaire mounted on a 15m high column broke free from its lower frame housing, landing in a live lane of the M1 Motorway carriageway.

Further investigation identified that a second canopy unit had broken free at an unknown time prior to Wednesday 10th February, when the light was reported as out. In this instance the upper canopy landed behind the permanent vehicle restraint system (VRS) in the verge.

The upper canopies are made from die-cast aluminium and both units show possible material failure in the same three locations (as shown in photo 1) as well as impact damage.

Photo 1: Underside of canopies marked in red to highlight possible material failure

As an additional temporary measure, heavy duty plastic zip ties have been fitted to all remaining units, to prevent upper canopies working free from the lower frame.

- Full survey of all Philips Luma 3 luminaires installed on the M1 J39-42 project
- Removal of further units where hinge pins were not present
- Installation of two heavy duty cable ties on all remaining units to further secure canopy to lower frame
- Philips have taken the four units without hinge pins away for further testing to review cause failure
