Rail Accident Report

Tram collision with pedestrian near Market Street tram stop, Manchester 12 May 2015

Report 06/2016
April 2016

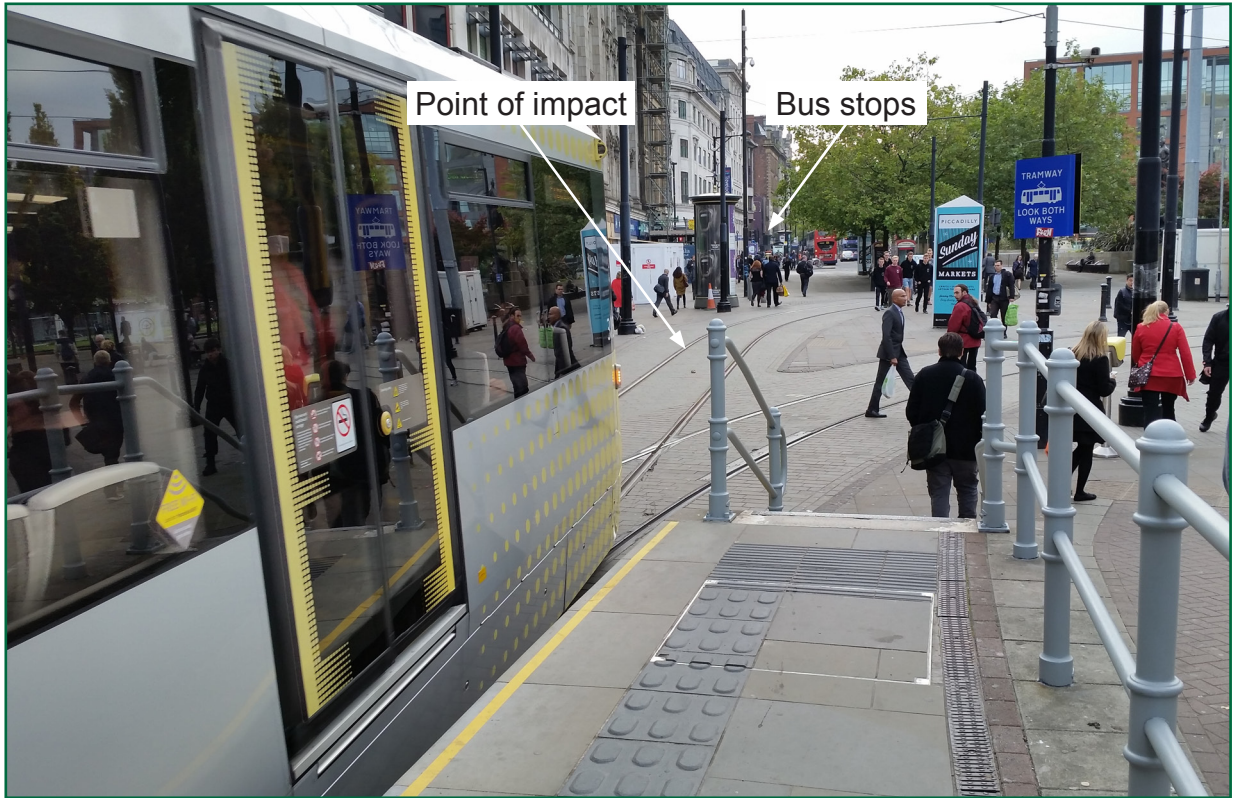
- 4 The pedestrian had alighted from the same tram at the Market Street stop and was walking along the track towards Piccadilly (figures 2 and 3). He suffered serious injuries as a result of the collision; no-one else was injured.
- 5 Tram services were suspended for approximately 45 minutes following the accident.

Figure 2: Market Street tram stop showing initial route of pedestrian after alighting from the tram

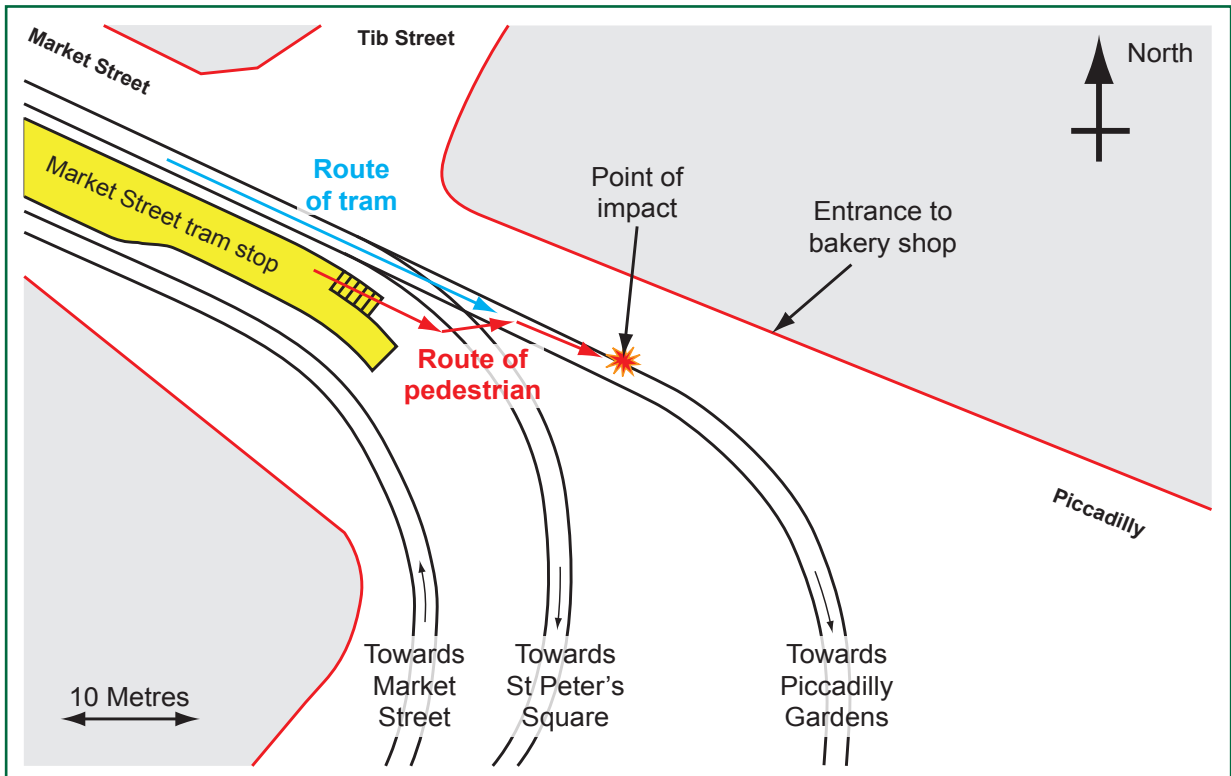
Figure 3: Plan view of Market Street

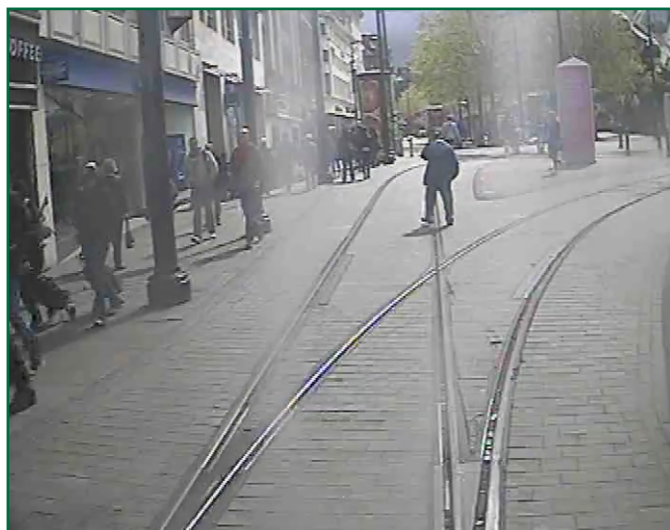
- 15 The day was clear and there was bright sunlight at the time of the accident (paragraph 46); this is evident from the strong shadows that are visible in the forward facing closed circuit television (CCTV) recording from the tram (figure 6). This is discussed at paragraph 46. A weather report for Manchester airport (8.5 miles / 13.7 km south of Market Street tram stop) records that there were 'scattered clouds' at this time.

Figure 6: Cropped image from the forward facing CCTV on tram No. 3034

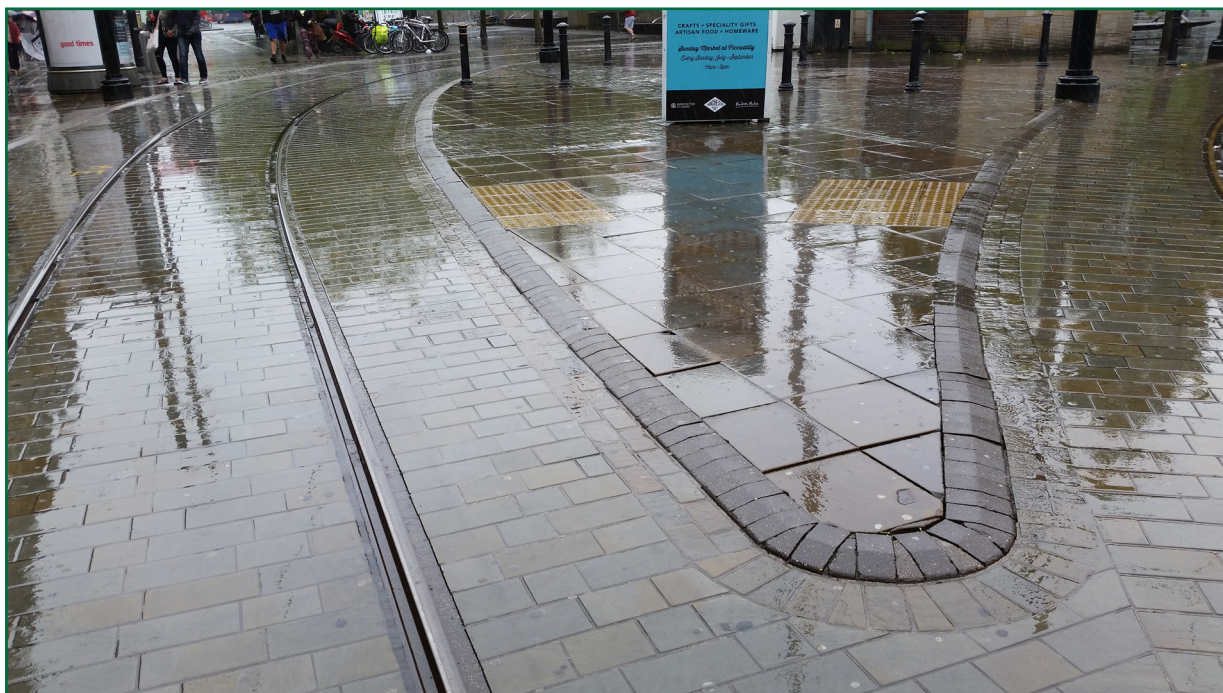
Figure 7: Demarcation of tramway (view in opposite direction from figure 5)

31 With respect to a pedestrian’s awareness of the tramway, RSP2 states that ‘the path of an on-street tramway should be marked where it is not apparent from the carriageway or kerbs, and where it would be useful either to tram drivers or other road users to do so.’ It also states that, to help visually-impaired people, ‘the preferred method of marking the tramway path in pedestrian zones is for it to be slightly lower than that of the surrounding area, and for there to be a suitable colour contrast between surfaces. The tramway path and the surrounding areas should be demarcated using a battered kerb.’ Figures 5 and 7 show that, while the design of the tramway near the location of the accident conforms with some aspects of the guidance, there is no effective colour contrast to assist with demarcation. For reference, a 1984 artist’s impression showed a clear colour contrast between the tramway and the surrounding area (figure 8).

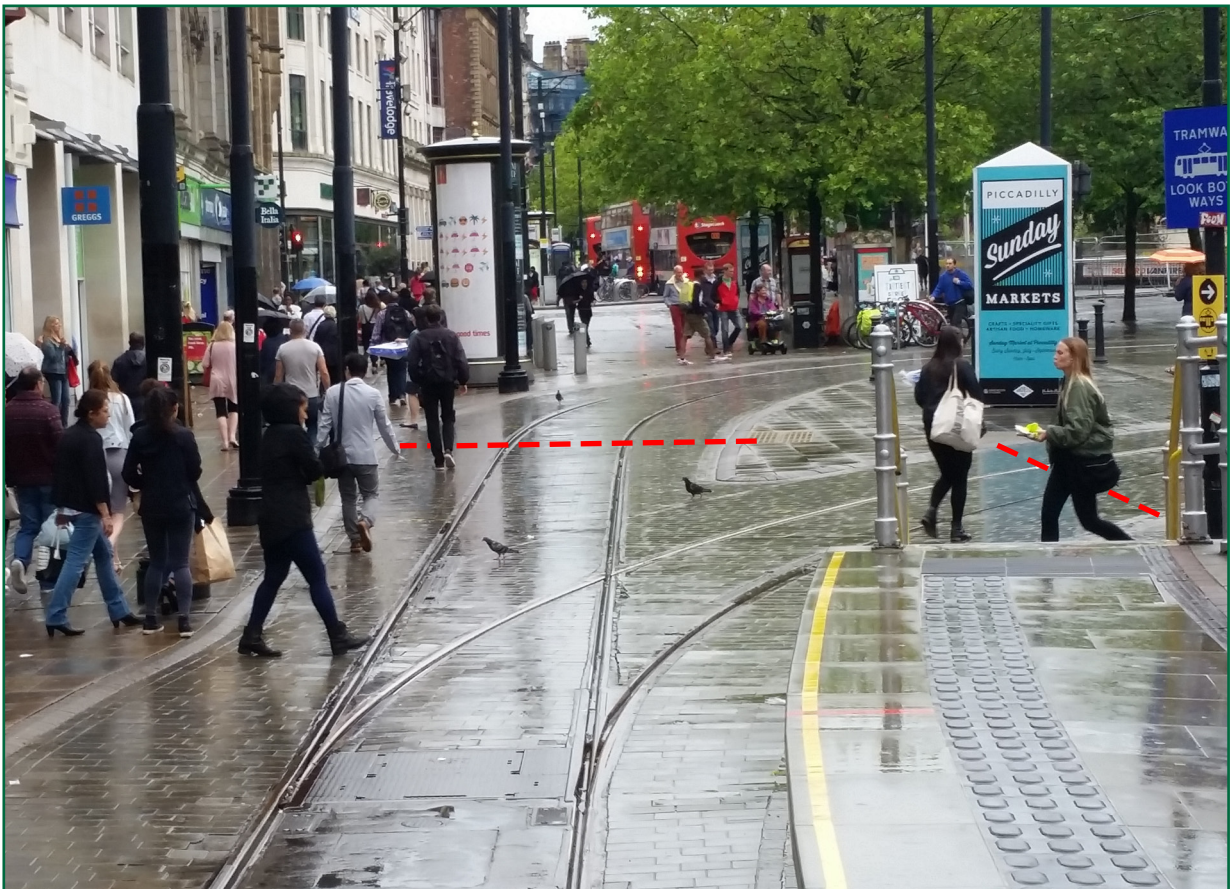
Figure 9: View from Market Street tram stop showing shortest routes between areas of tactile paving

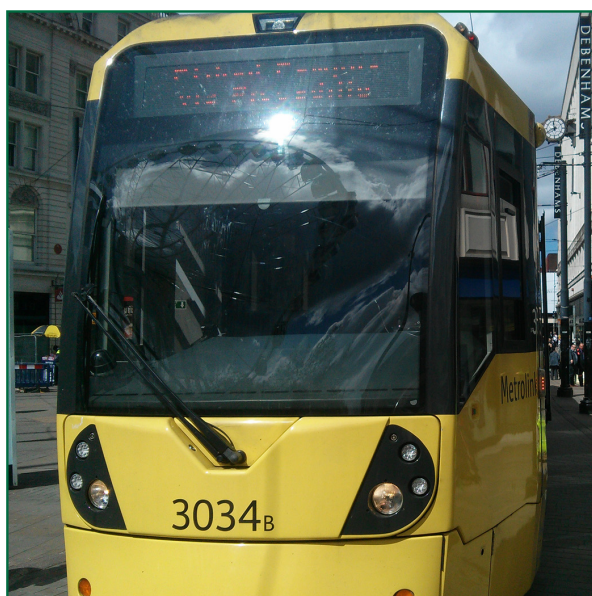
- 46 It is possible that the driver was distracted by something outside the cab, although no obvious distraction is evident in the forward facing CCTV footage. The sun was almost directly ahead of the tram (figure 6) and the driver stated that he might have had the sun in his eyes. However, the RAIB measured the effect of the sun angles relative to the geometry of the driving cab, and concluded that the cab roof would have shielded the driver's eyes from direct sunlight (the sun visor was also lowered at the time of the accident (figure 10)).

Figure 10: View of the tram's driving cab following the accident, showing position of the sun visor (courtesy MRDL)

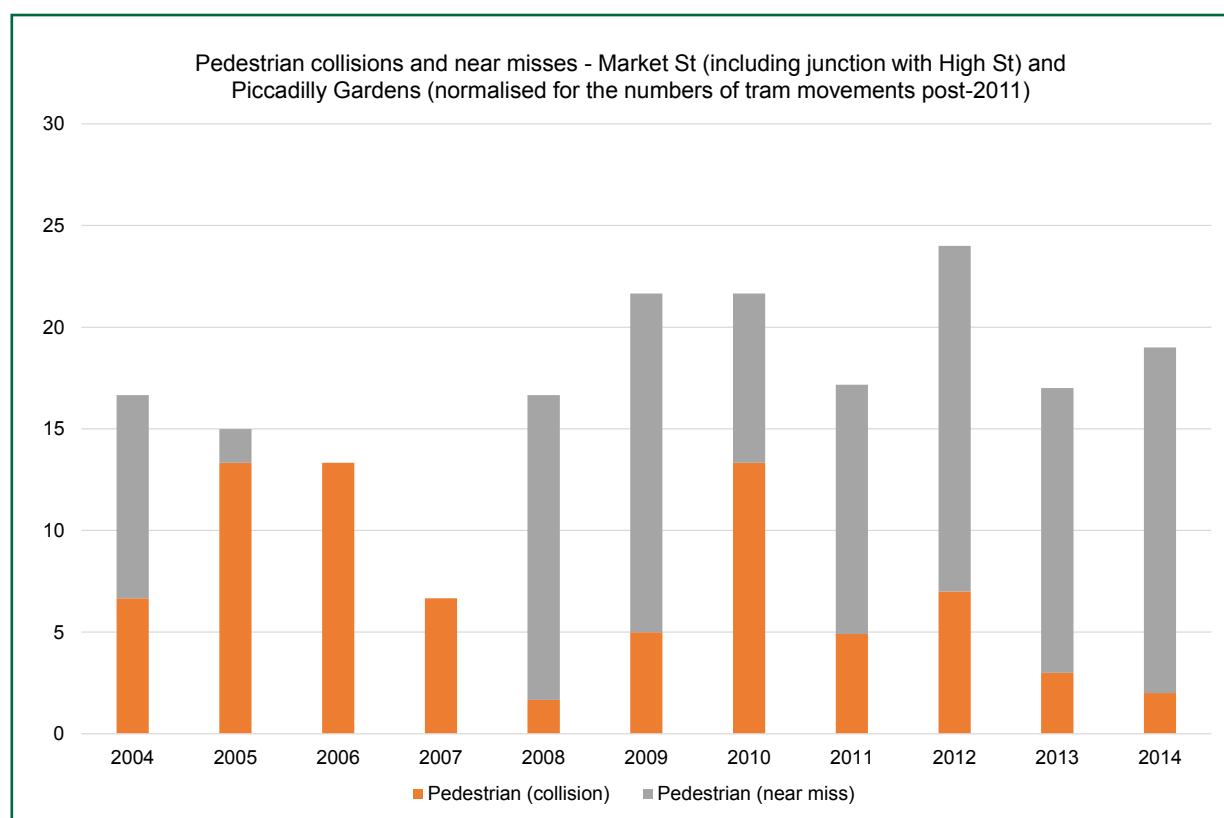
65 MRDL does not routinely aggregate statistics on pedestrian accidents occurring in pedestrianised areas, whether 'blameworthy' or not; this would be needed in order to understand the risk fully. The RAIB has reviewed data provided by MRDL for 2004-2014 and compiled a chart showing accidents and near misses between trams and pedestrians in the pedestrianised area near Piccadilly Gardens (figure 11)¹³. In absolute terms, the data records an average of five accidents and eight near misses per year over the eleven year period (it does not record the severity of any resulting injuries). Data supplied by TfGM indicates that the average footfall for Market Street and Piccadilly Gardens is approximately 20 million pedestrians per year.

Figure 11: Collisions and near misses in pedestrianised area
