# Rail Accident Investigation: Explanation of discontinuation

**Derailment of the jib runner of Crane  
ADRC96702 at Greenford East Curve  
20 November 2006**

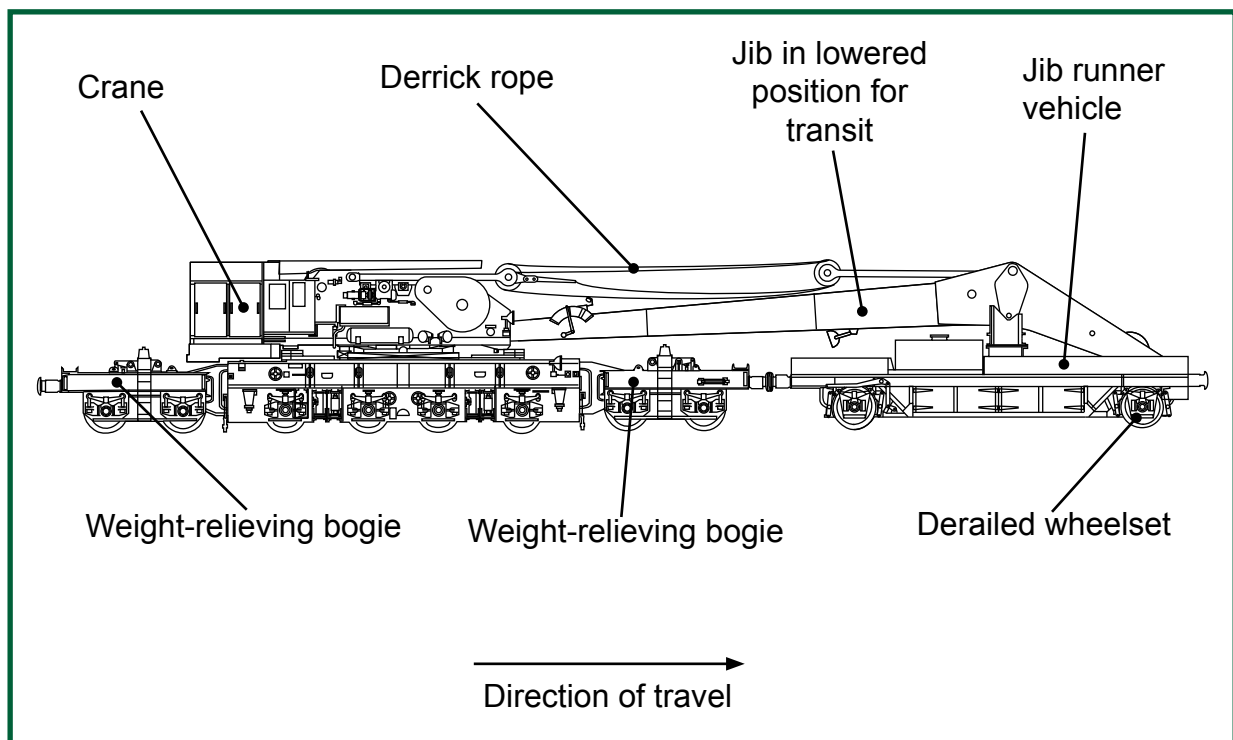
Figure 1: Crane ADRC96702 and jib runner vehicle

- 1 On 20 November 2006, breakdown train 2Z99 was travelling from Brighton to Old Oak Common depot in West London when the leading wheelset of the jib runner vehicle of crane ADRC96702 (Figure 1) derailed at 15:40 hrs on Greenford East Curve, near Greenford in West London. The derailment occurred at a speed of 13 mph (21 km/h).
- 2 The train, which was formed by the hauling Class 67 locomotive, three Mk1 coach type breakdown vans and rail crane ADRC96702, had left Brighton at 12:51 hrs, following a re-railing operation, and was on its return journey to Old Oak Common depot. Following the derailment, the train ran on for approximately 150 m before coming to rest, causing some damage to the jib runner vehicle and the track. There were no injuries.

- 10 CCTV images of train 2Z99 on its journey from Brighton were provided by Southern Railway to establish whether the derrick ropes (Figure 1), which are used to raise and lower the jib, had been correctly slackened prior to the journey.
