Rail Accident Investigation Branch

# Rail Accident Report

**Derailment of a freight train near Langworth,  
Lincolnshire  
30 June 2015**

Report 11/2016  
June 2016

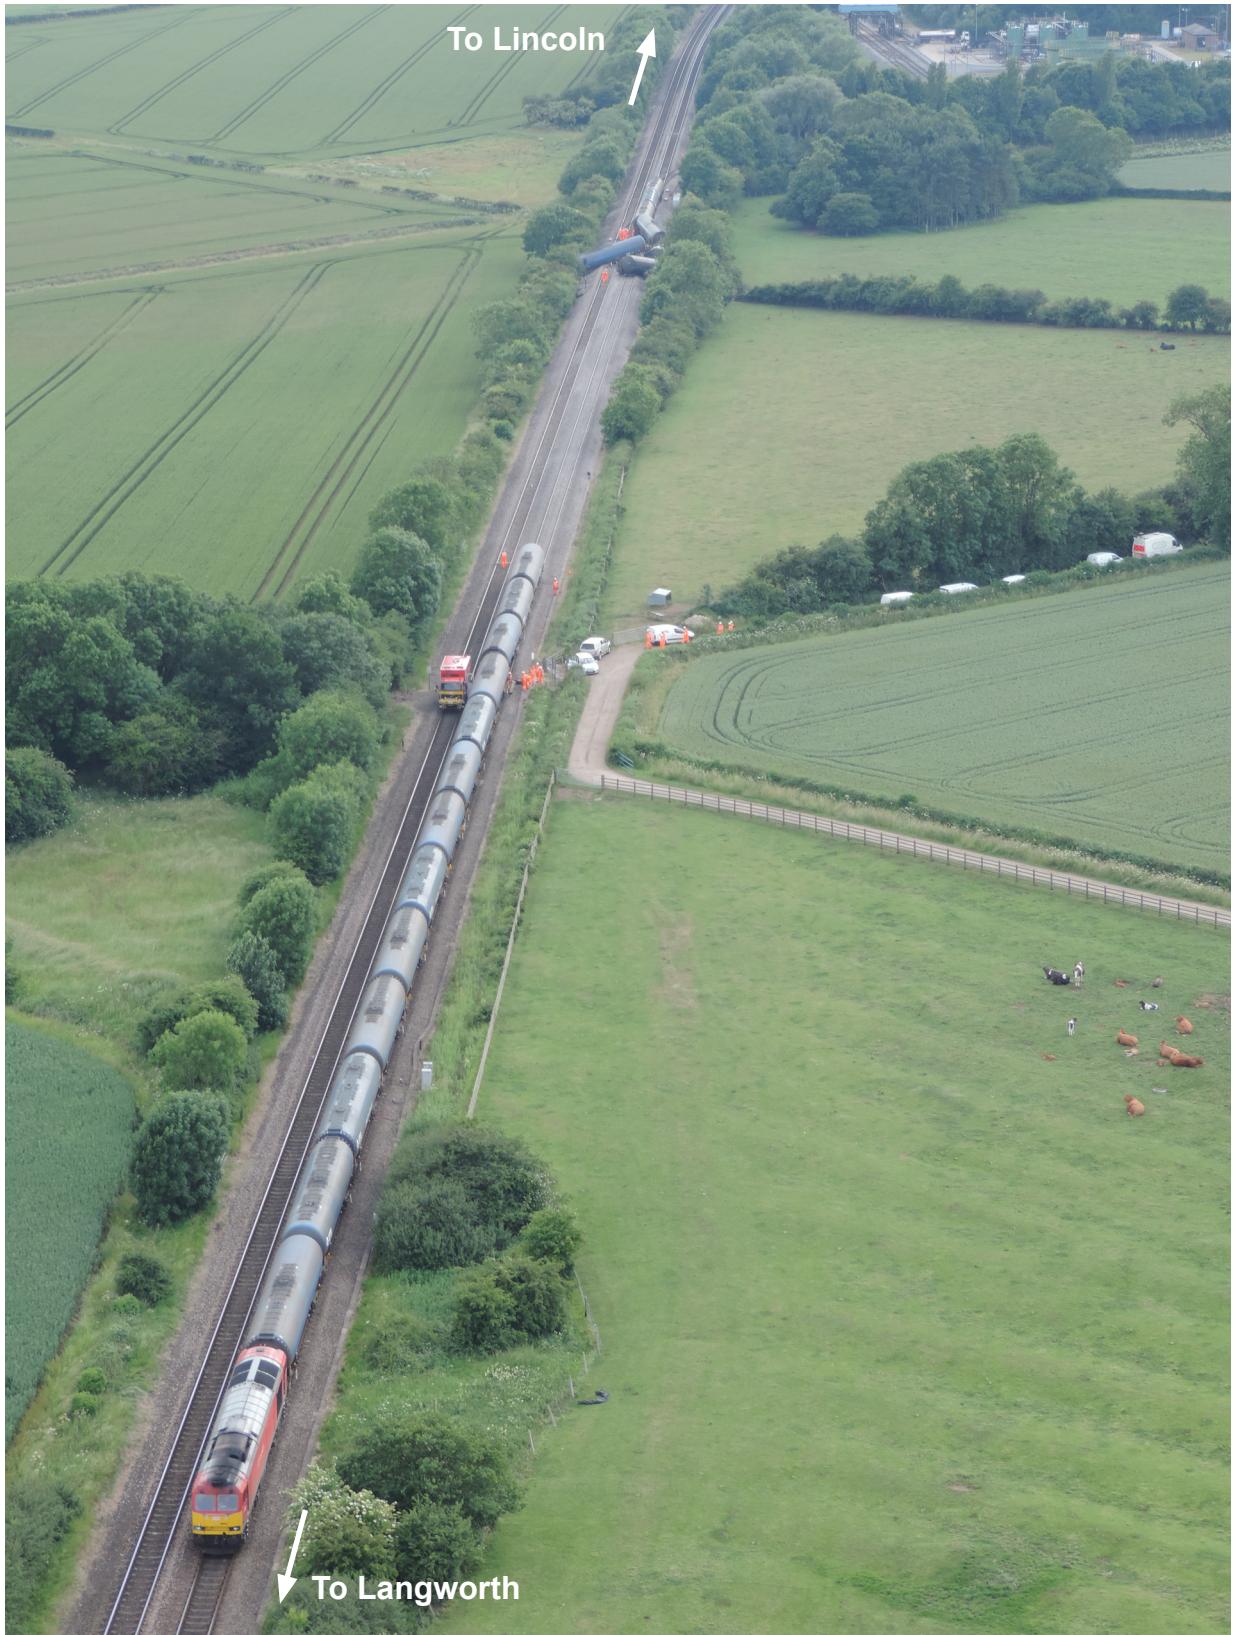
- 5 Wagons 11, 12 and 13 (from the leading end) derailed but remained upright. The train then separated between wagons 13 and 14, which caused the train's brakes to apply. The front part of the train came to rest about 250 metres from the rest of the train. Wagons 14 to 20 left the track with four wagons rolling over and one slewing across both tracks (figure 2). Wagons 21 and 22 did not derail.

Figure 2: Overview of the accident site (image courtesy of Network Rail)

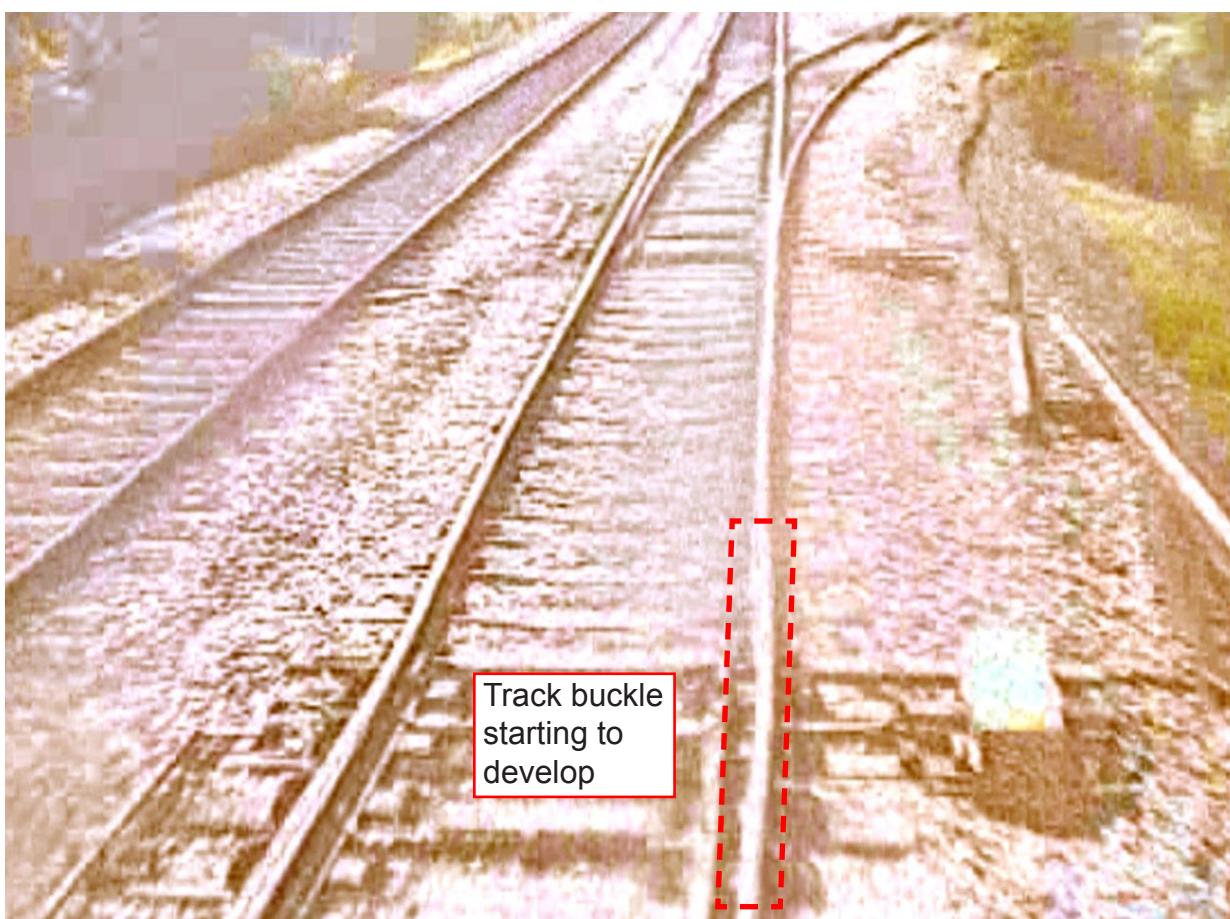
- 23 Train 6E54 discharged its load of diesel fuel at Kingsbury Oil Terminal and departed on its return journey to Humber Oil Refinery at 10:25 hrs. The driver reported an uneventful journey up to the derailment.
- 24 At 12:44 hrs an East Midlands Trains (EMT) passenger service from Lincoln to Grimsby, formed of a single vehicle, passed over the site. Although the driver reported that he did not see or feel anything amiss with the track, images from the forward and rearward facing CCTV cameras show there was a track buckle starting to develop around the toe of 101B points (figure 6). It is possible that the size of the buckle developed further under the train.

Figure 6: Image from rear facing CCTV camera on previous train at 12:44 hrs (image courtesy of East Midlands Trains)

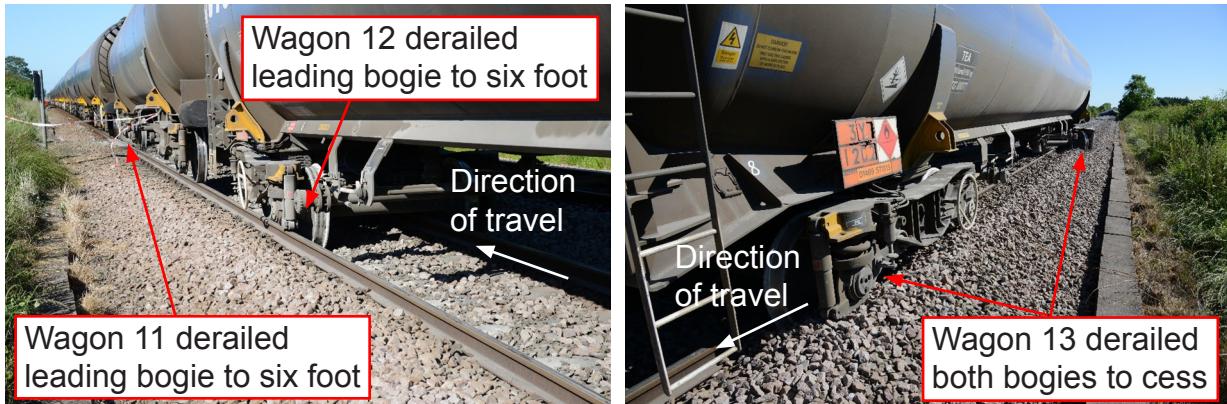
- 26 The locomotive and the first ten wagons had passed over the track buckle before the leading bogie of wagon 11 derailed to the *six-foot*, ie to the right, followed similarly by wagon 12. Wagon 13, however, derailed by both bogies to the *cess*, ie to the left (figure 7).

Figure 7: Wagons 11, 12 and 13

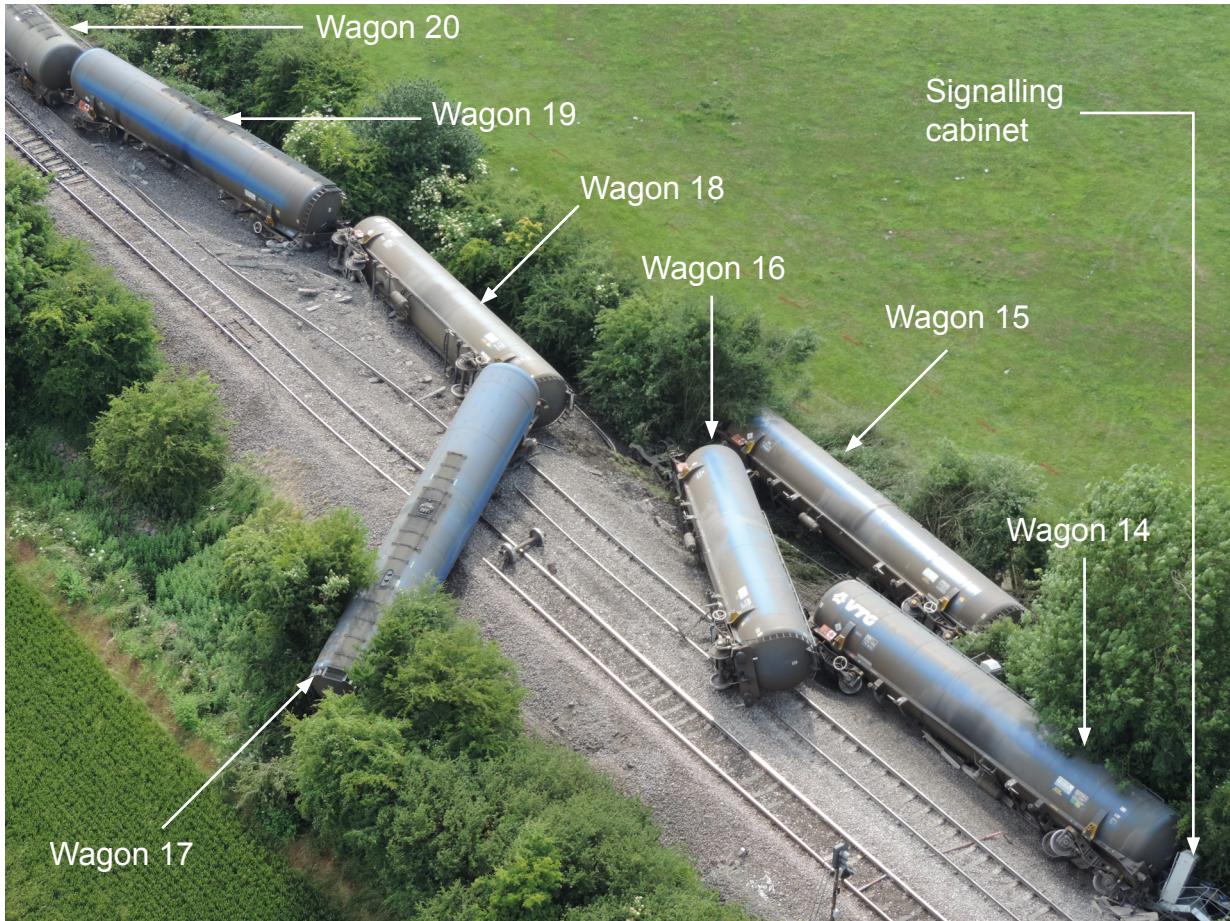
- 28 From the stopping position of wagon 13 there was a gap of approximately 250 metres to the rest of the train. The derailment marks suggest that wagons 14 and 15 (following the path of wagon 13) derailed to the *cess* and overturned, most likely when wagon 14 collided with a cabinet containing signalling equipment (figure 8). The leading bogie of wagon 16 also derailed to the *cess* but the trailing bogie moved towards the *six foot* with the result that wagons 16 and 17 jack-knifed and wagon 17 came to rest across both tracks. Wagons 18 to 20 derailed to the *cess* with wagon 18 overturning. Wagons 21 and 22 passed over the buckle without derailing, probably because of the slow train speed at this point, and came to rest with the rear of the train just beyond the toe of 101B points.

Figure 8: Wagons 14 to 20 (image courtesy of Network Rail)

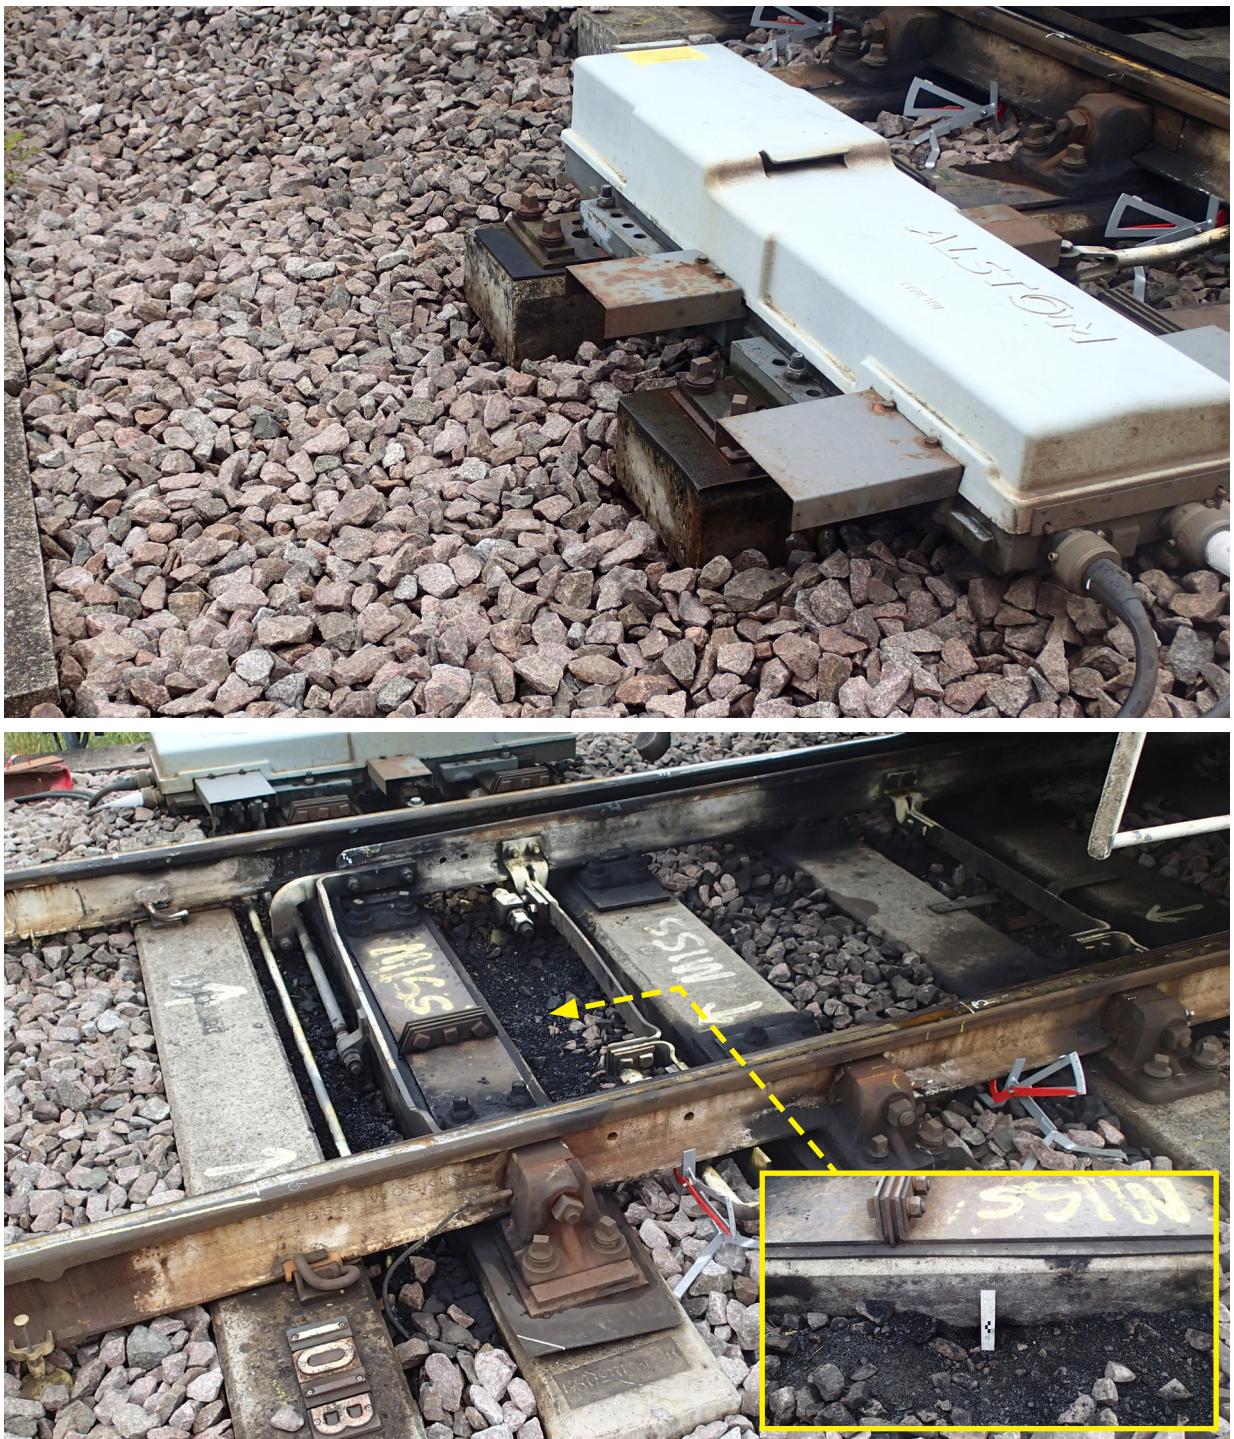
- 52 **There was insufficient ballast at the toe of 101B points to laterally restrain the track from buckling.**
- 53 After the accident the RAIB observed that there was an absence of ballast in the cess at the ends of the bearers for 101B points on which the point motor was mounted (figure 9). The bearers for 102A points were similarly exposed. There was also a minimal *ballast shoulder* on the cess-side ends of the sleepers between the closely abutting toes of 102A and 101B points (figure 10) and the ends of the sleepers adjacent to the toe of 101B points were above the level of the ballast (figure 11). However, the spaces between sleepers within the rails (known as ‘cribs’) were mainly full of ballast.

Figure 9: Ballast support at the ends of 101B point motor bearers and in the 'cribs' at the toe of the points

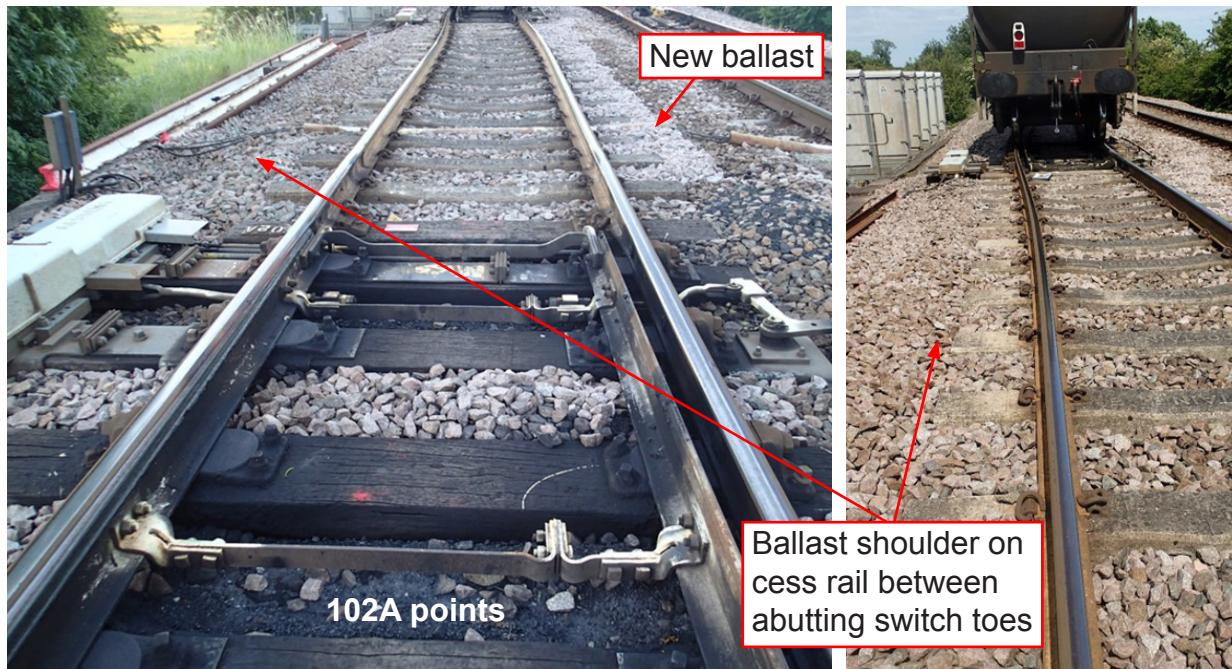
Figure 10: Ballast shoulder in plain line section between 102A and 101B points

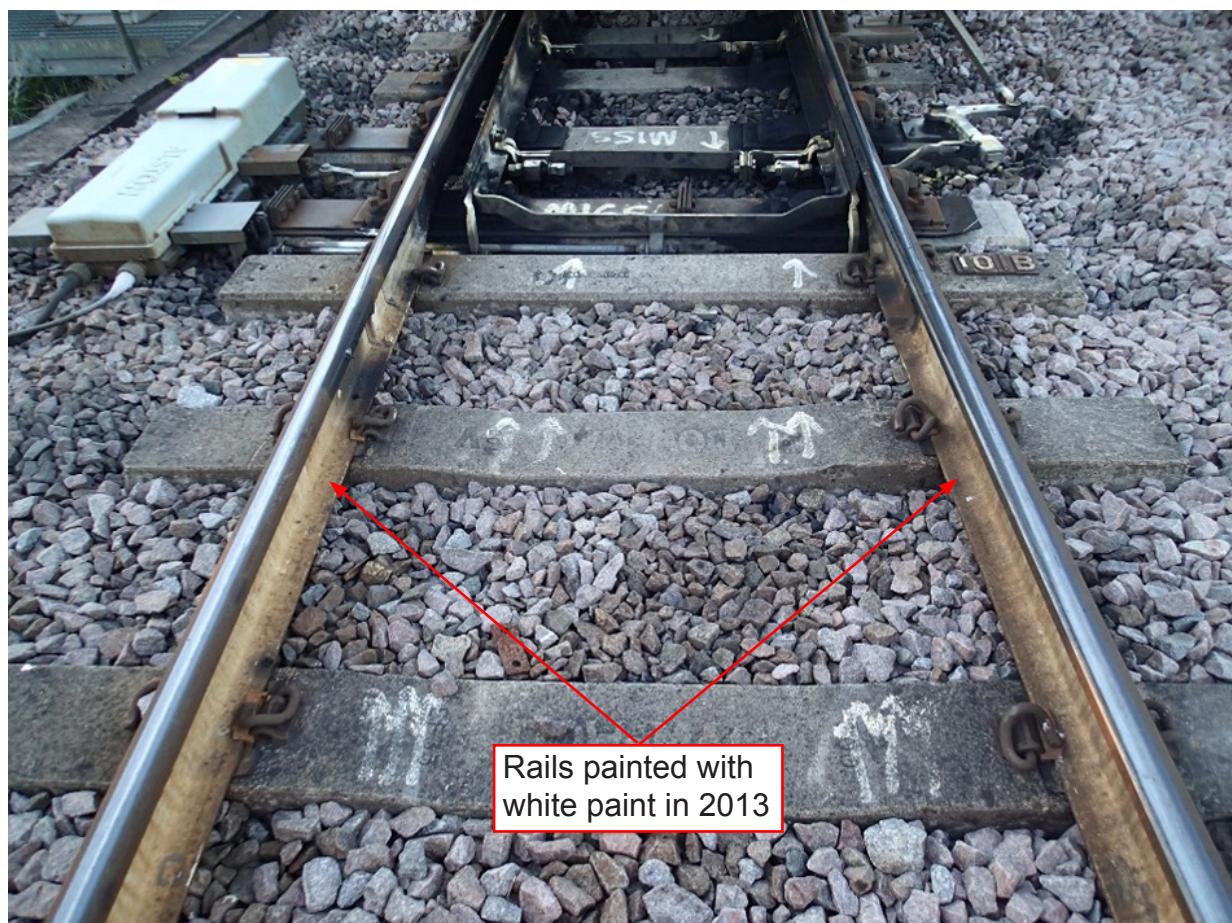
Figure 11: Sleeper tops above ballast at toe of 101B points

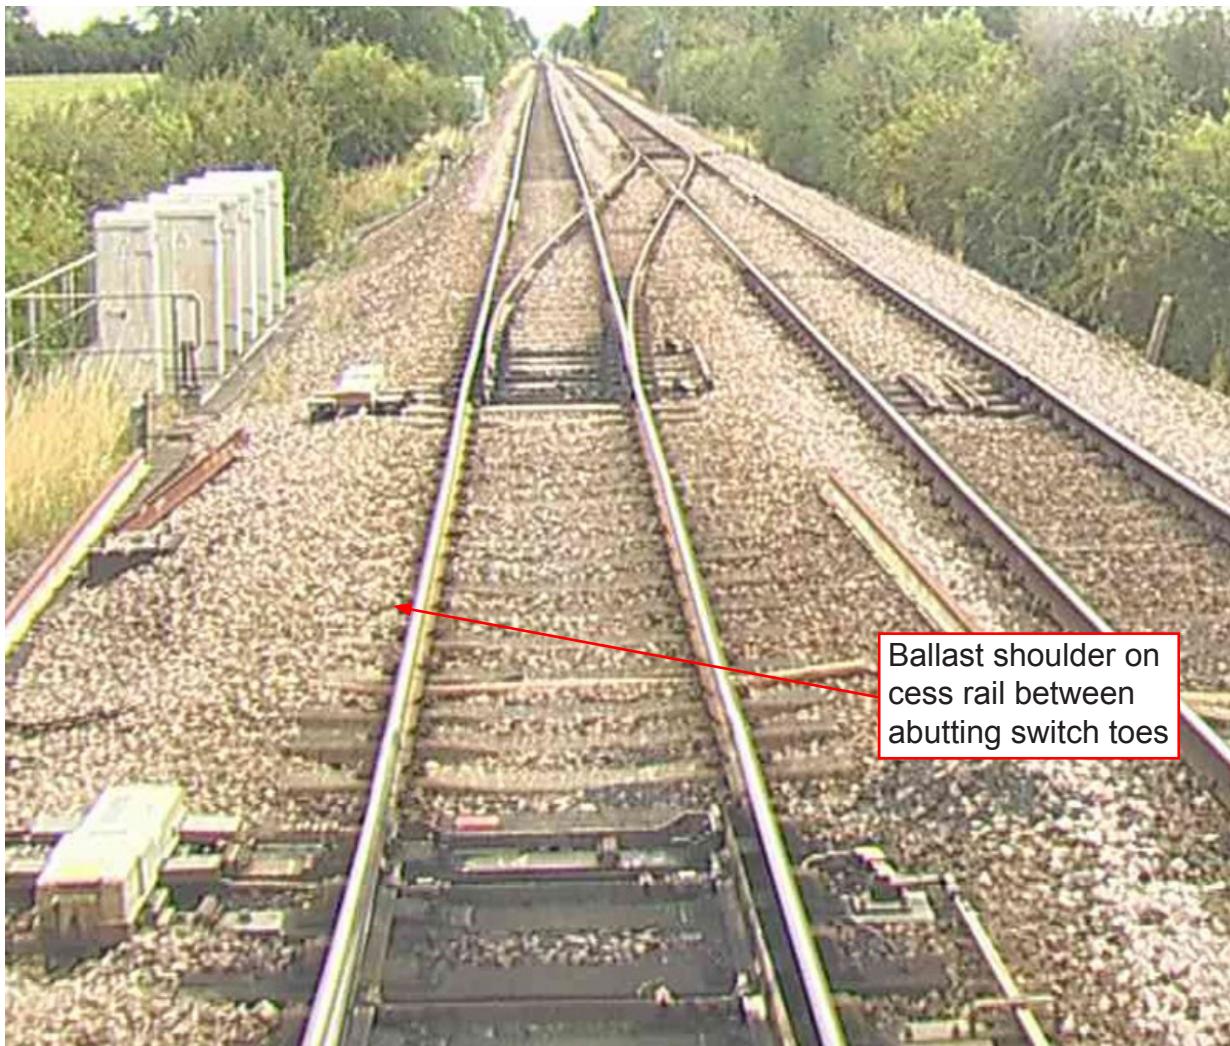
- 55 This ballast deficiency had existed for some time. A recording made by the forward facing CCTV on Network Rail’s track recording train (which measures track geometry) in August 2014 showed that the ballast profile on the cess-side of the track was very similar to that at the time of the derailment with little or no ballast shoulder, and some sleeper ends and sides exposed (figure 12).

Figure 12: Ballast shoulder in plain line section between 102A and 101B points, captured by the forward facing CCTV camera on Network Rail's track recording train, August 2014 (image courtesy of Network Rail)

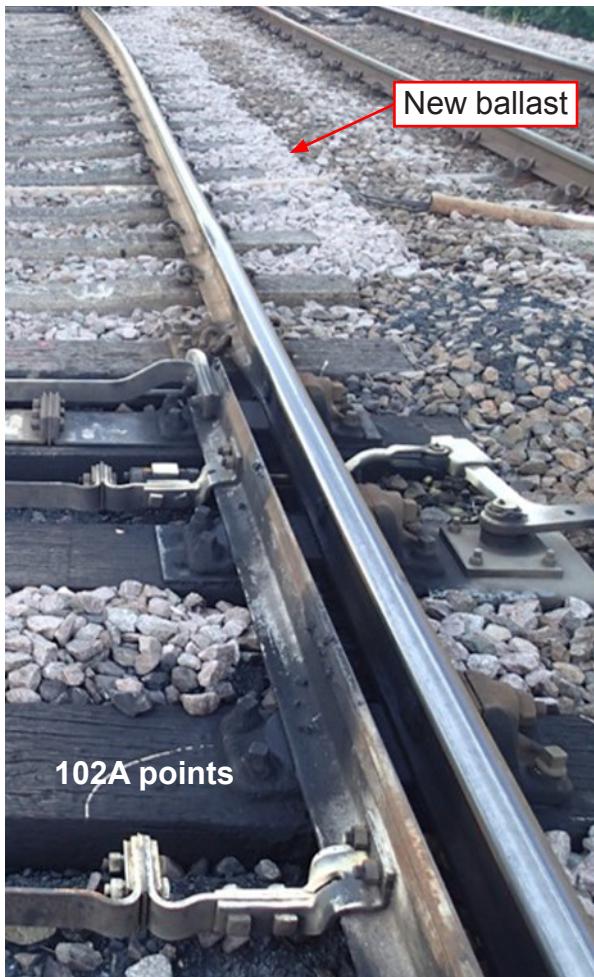
- 57 On 08 April 2015 the work order was cancelled by the SM(T). The SM(T) thought he might have cancelled it because he believed that new ballast had recently been dropped at the site. A comparison with the ballast profile recorded in August 2014 shows that there had been some dressing of the ballast on the six-foot (right-hand) shoulder on the approach to 101B points (figure 13).

Figure 13: Area of ballast dressing in the six-foot between 102A and 101B points

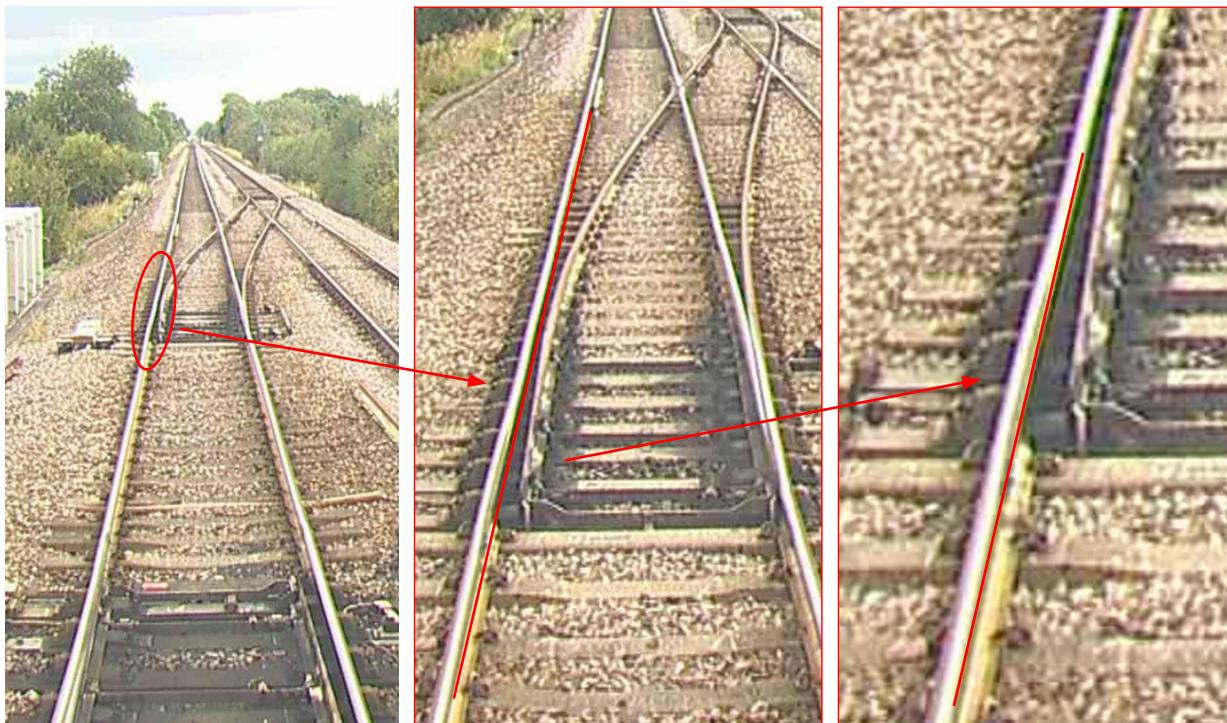
- 59 **There was a pre-existing lateral misalignment in the area of 101B points which promoted the formation of a track buckle.**
- 60 The track buckle that formed coincided with a lateral misalignment on the cess rail which was present in August 2014. Images from the forward facing camera on the track recording unit taken in August 2014 showed an apparent deviation in the rail at the toe of 101B points in the same place as the buckle occurred (figure 14).

Figure 14: Pre-existing misalignment on LH rail at 101B toes, captured by the forward facing CCTV camera on the Network Rail's track recording train, August 2014 (image courtesy of Network Rail)

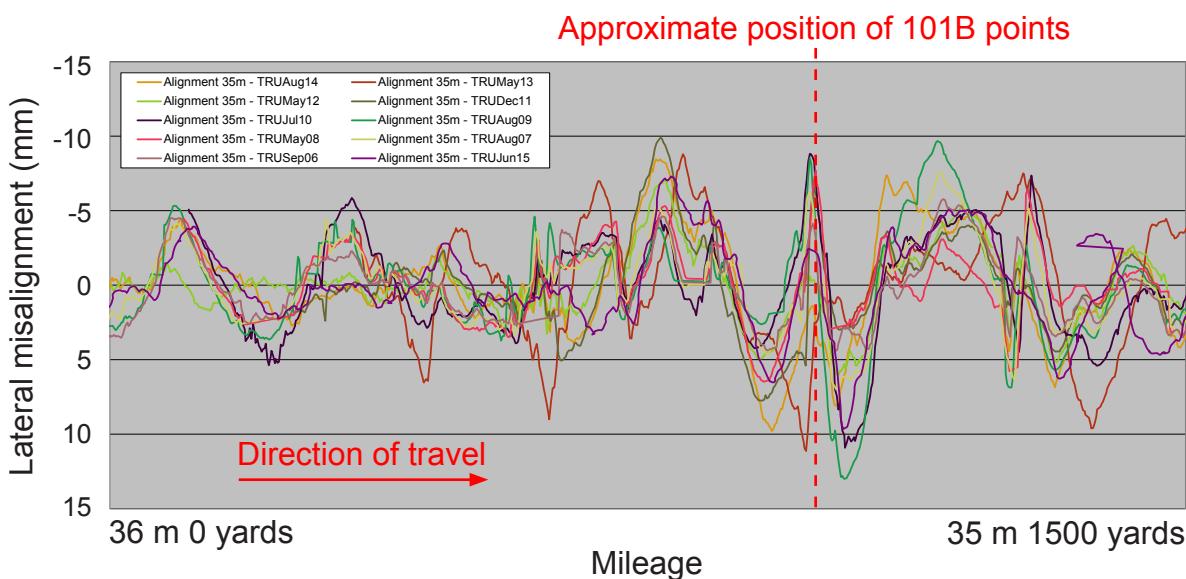
- 62 The switches and crossings at this location (Welton Oil Terminal) have had a history of problems with the horizontal and vertical alignment of the track, generally referred to as 'line' and 'top' respectively. Recordings of track geometry from Network Rail's track recording train going back to 2006 show that there were persistent problems with top in the area of the switches and crossings and, from about 2009 onwards, there were increasing issues with line (figure 15).

Figure 15: Traces of track alignment 2006 to 2014 for up line at 35 miles 1500 yards to 36 miles 0 yards
