## *St Apollo* (BA 359) Grounding and flooding in Inninmore Bay, Sound of Mull, Scotland 24 August 2015

### SUMMARY

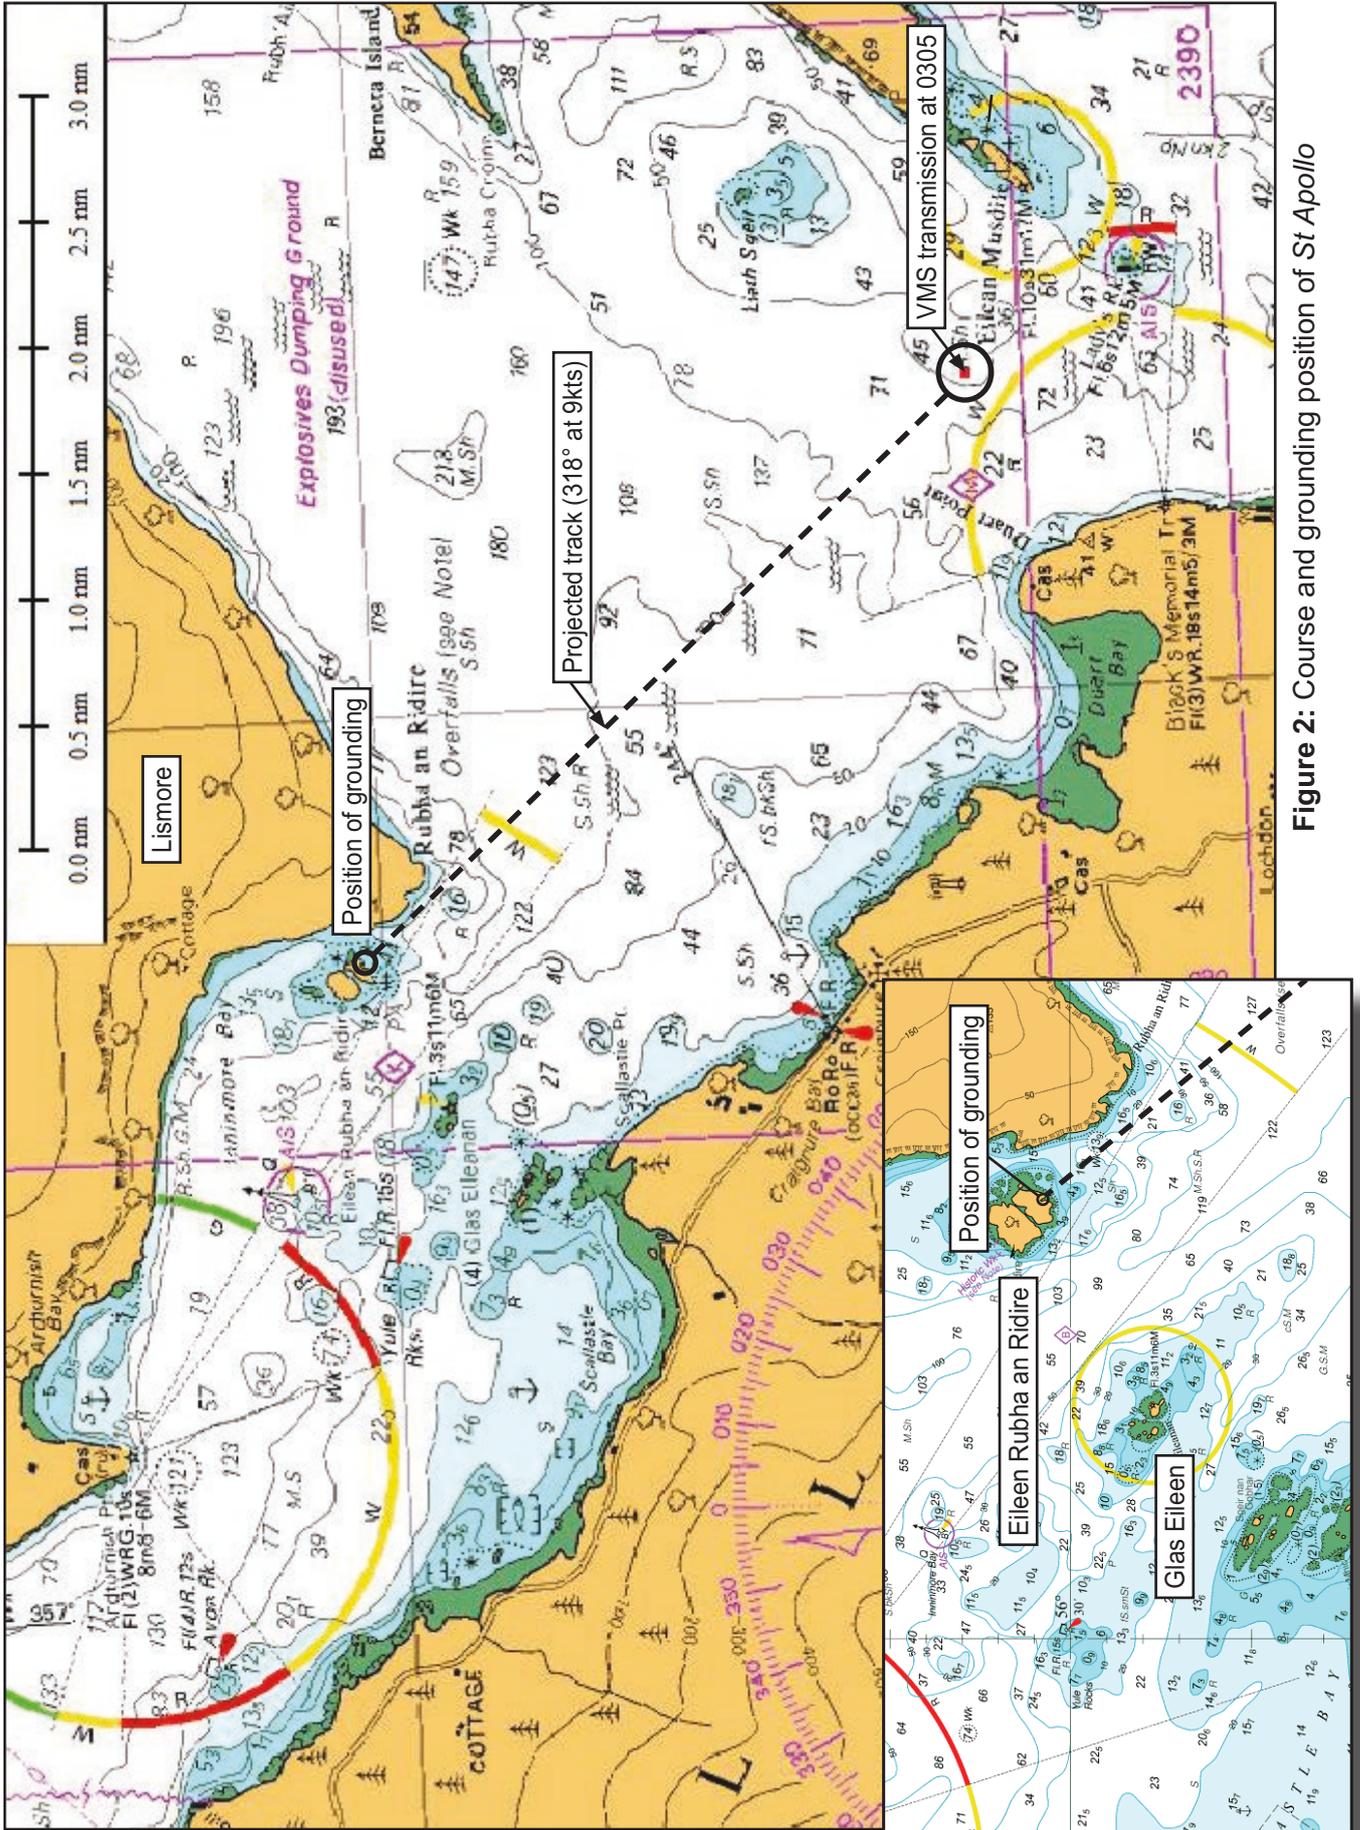
Figure 2: Course and grounding position of *St Apollo*

The skipper was woken by the watchkeeper's shouts. He got up, put on jogging bottoms and shoes and made his way to the wheelhouse. As he did so, *St Apollo* grounded on the south shore of Eilean Rubha an Ridire (**Figure 2**), a small island on the north side of the eastern end of the Sound of Mull.

If, as reported, *St Apollo*'s navigational track through the south-east end of the Sound of Mull, was equidistant from the dangers off Eilean Rubha an Ridire to the north-east and Glas Eileanan to the south-west (**Figure 2**), the vessel clearly grounded as a result of being to the north of the intended track. However, the absence of a record of the route in use, any positional data immediately before the grounding, or any material evidence of an electronic or mechanical failure, prevents a detailed and accurate analysis of the circumstances. Therefore, it is difficult to determine whether *St Apollo*'s grounding was due to navigational error, equipment malfunction, or a combination of both.

A projection of *St Apollo*'s course and speed made good (318° at 9kts) from the position transmitted by VMS at 0305 (**Figure 2**), runs directly to the grounding position at 0327 and possibly suggests that the vessel's heading was not altered during the intervening period. However, it is evident from the absence of the watch alarm sounding in the accommodation, and the watchkeeper's shout to the skipper before the grounding, that the watchkeeper had not fallen asleep.

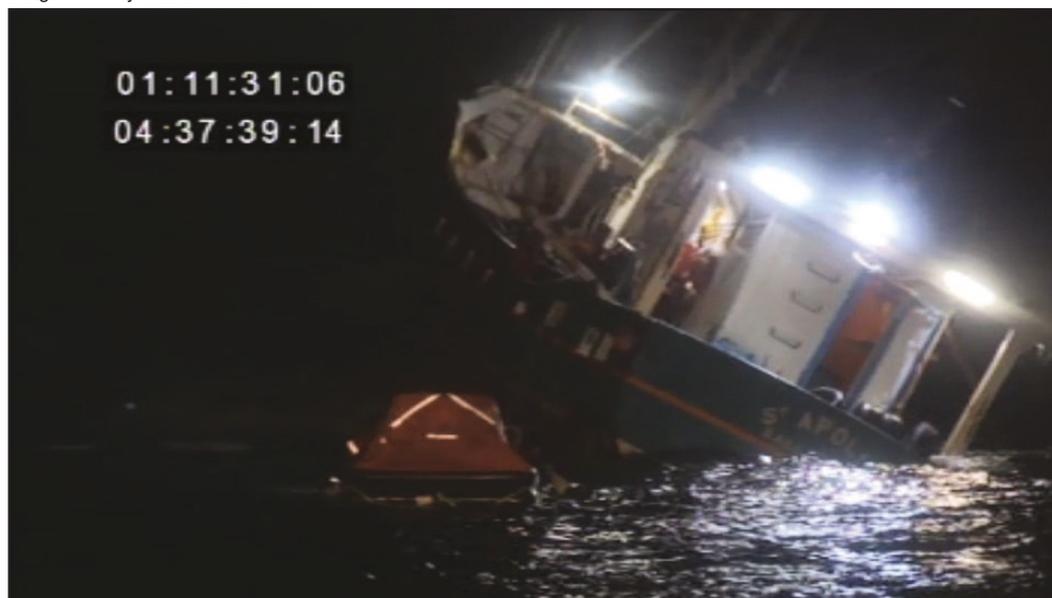
**Figure 3:** *St Apollo*'s crew abandoning the vessel

Stornoway Coastguard tasked the Oban all weather lifeboat (ALB) and rescue helicopter R177 to assist. The Oban ALB arrived on scene at 0426. By 0435, *St Apollo*'s starboard list had increased to approximately 35° and water had started to flood over the starboard bulwarks. The skipper and the crew abandoned into the liferaft (**Figure 3**), which they then paddled to the waiting ALB.

The skipper's actions following *St Apollo*'s grounding were generally well considered and timely. Despite being woken from sleep, he quickly arranged the assessment of the vessel's watertight integrity before attempting to re-float the vessel. His alerting of the coastguard was also timely and the abandonment was managed effectively and was well-judged. However, had more effort been made to close and secure all watertight doors, hatches and openings to prevent the ingress of water (**Figure 3**) the outcome for the vessel might have been less catastrophic.

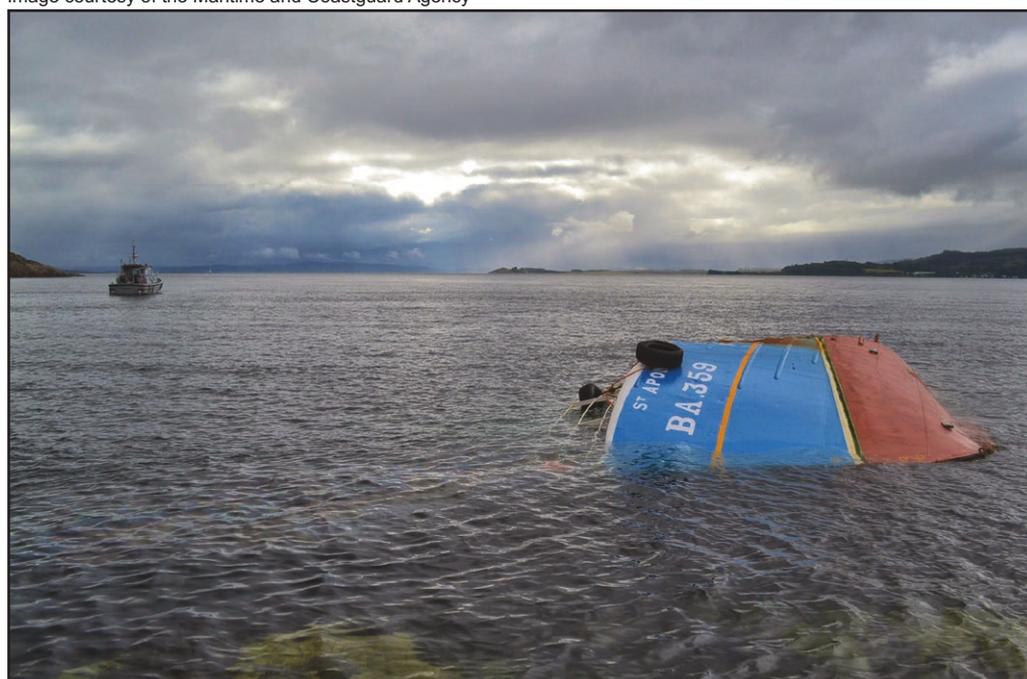
**Figure 4:** *St Apollo* partially submerged

At 0505, *St Apollo* toppled onto its starboard side and was partially submerged (**Figure 4**) in approximately 5m of water. The ALB returned to Oban with *St Apollo*'s crew. On arrival, the police breathalysed the skipper for alcohol and the test was clear. The crew were not breathalysed.

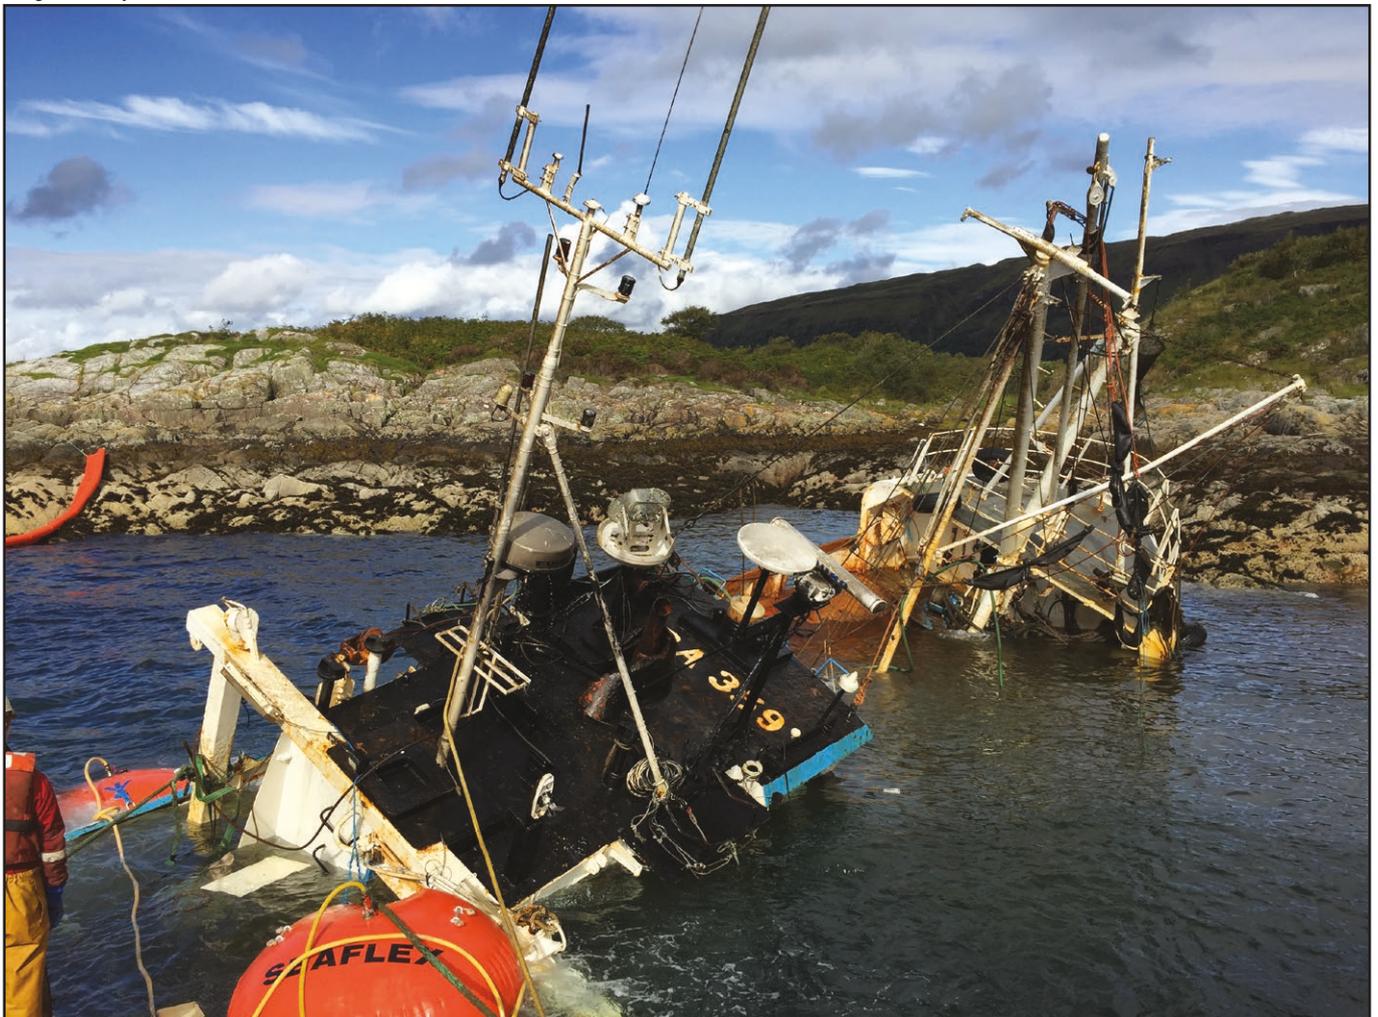
**Figure 5:** *St Apollo* being salvaged

On 15 September 2015, *St Apollo* was salvaged by North West Marine Ltd on behalf of the vessel's insurers. Flotation bags were used to bring the vessel upright (**Figure 5**) and entrained water was then pumped out. *St Apollo* had sustained little damage to its hull apart from slight distortion in way of the foot of the keel, forward. However, water ingress had damaged the vessel's engines and electrical systems. *St Apollo* was towed to Oban where it was determined to be beyond economical repair. The vessel was subsequently declared a constructive total loss.

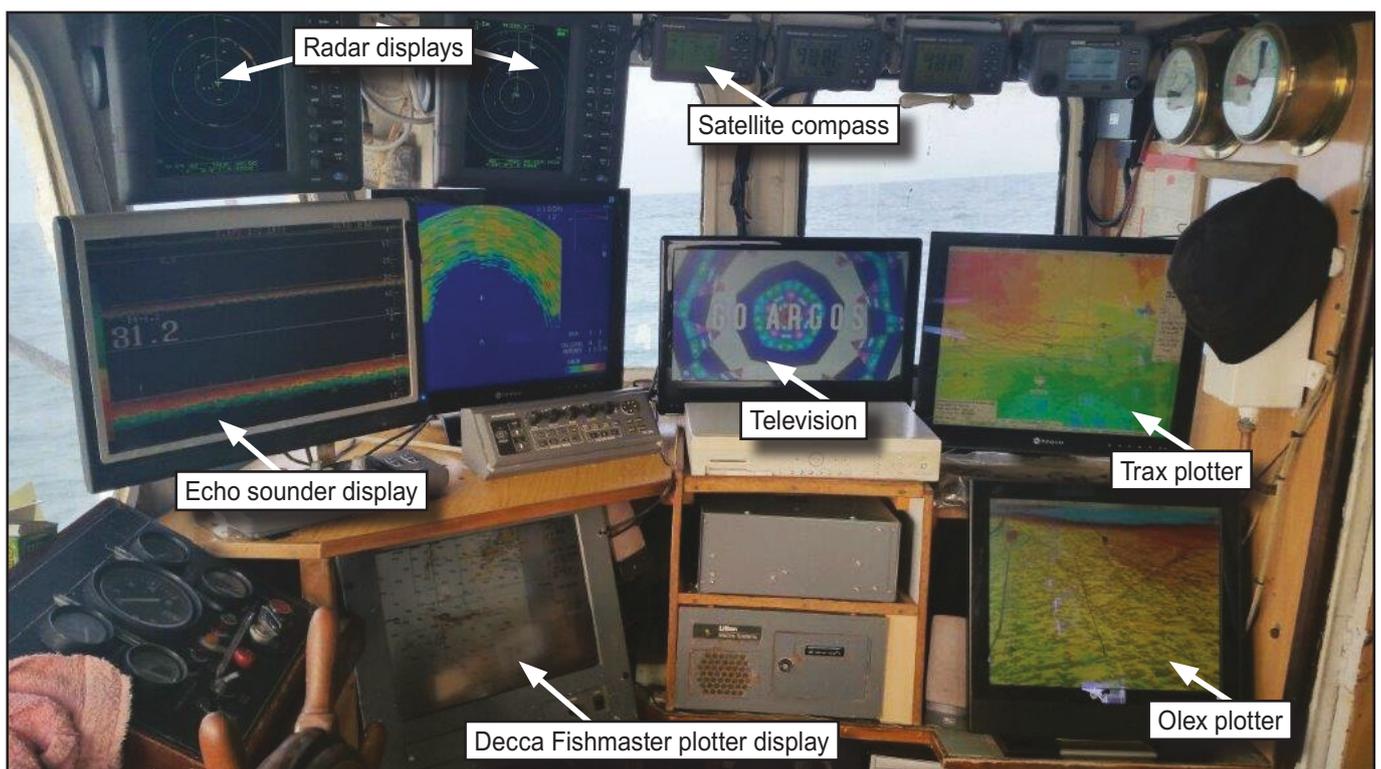
**Figure 6:** *St Apollo's* wheelhouse equipment (starboard side)

**Figure 6** shows the electronic equipment fitted on the starboard side of the wheelhouse.
