Rail Accident Investigation Branch

# Rail Accident Report

## Collision between a train and a piece of equipment at Barrow-upon-Soar, Leicestershire, 14 February 2016

Report 21/2016  
October 2016

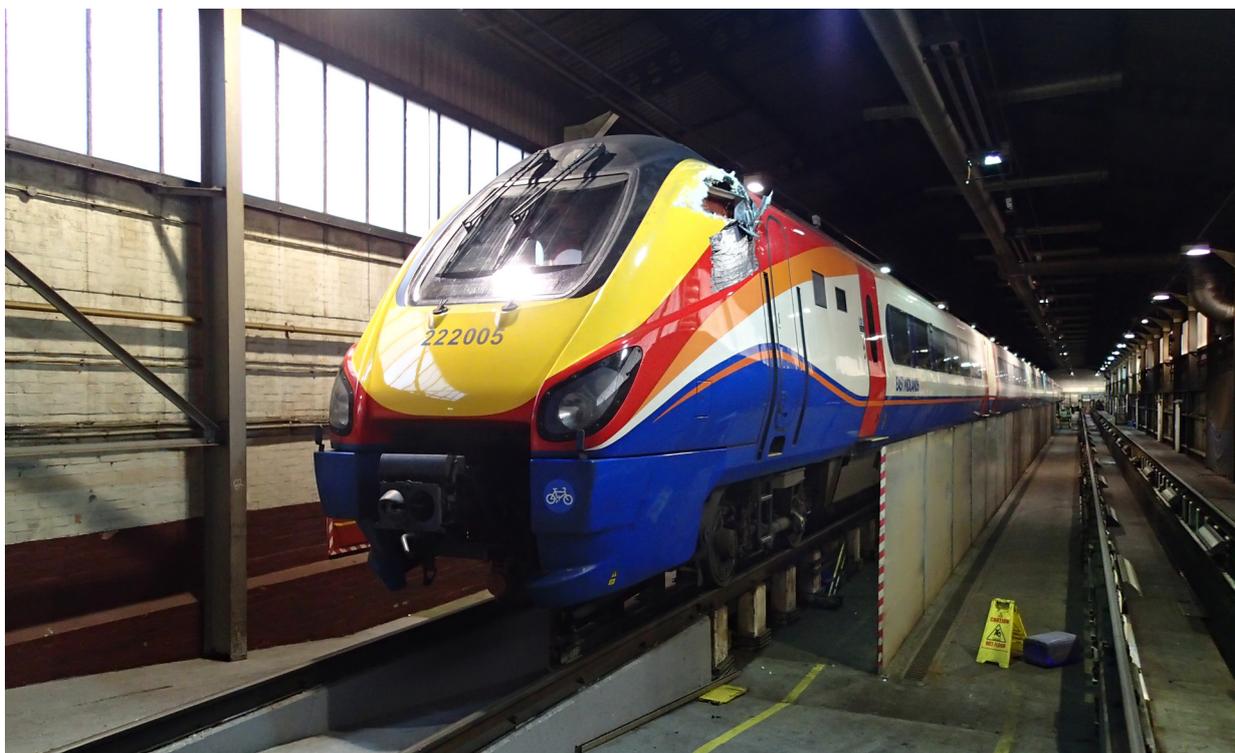
Figure 3: The damaged train

- 4 Two of the cars of the train were damaged by the impact, but did not derail (figure 3). The unloading wagon conveyor boom was also damaged.
- 5 A *fitter*, who had been working on the unloading wagon, was seriously injured and was taken to hospital by air ambulance. Nobody on the train was injured, but the driver was badly shaken.

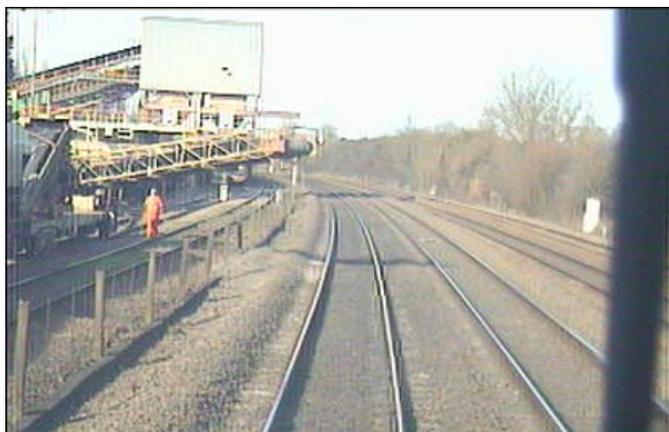
*Figure 7: View from train's FFCCTV just before the collision (image courtesy of East Midlands Trains)*

- 33 GS1 ran to the control room and used the dedicated line to the signaller at the EMCC to ask for trains to be stopped, but the train collided with the boom just as the call started at 10:26 hrs. Figure 7 shows the position of the boom, and fitter 1, just before the collision, as captured by the FFCCTV system on the train.

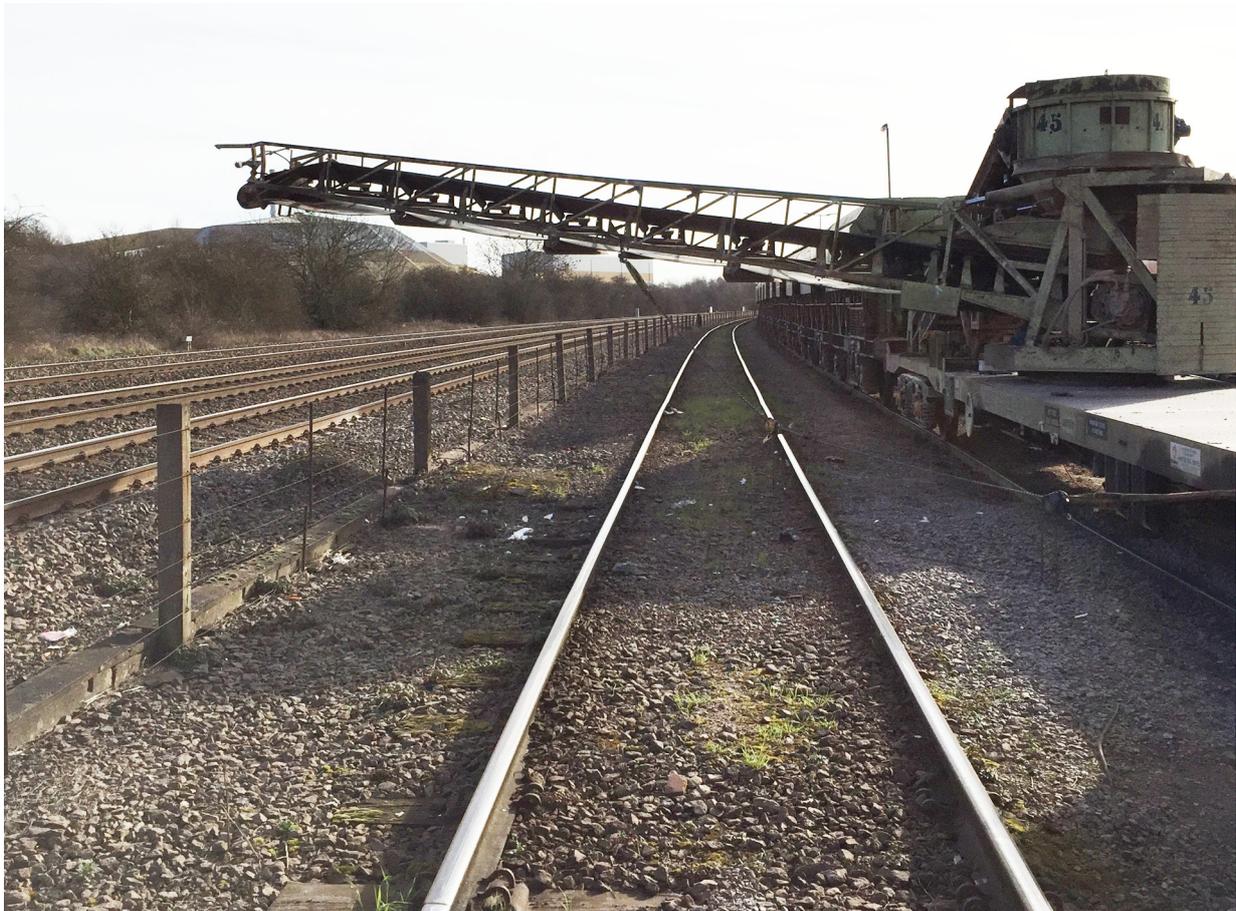
*Figure 8: Position of the conveyor boom shortly after the collision (and after a winch had been attached in preparation to move it) (image courtesy of Network Rail)*

- 40 The incident train was then taken to the EMT depot at Derby where the RAIB later examined it. The damage to the train is shown in figure 3. Figure 8 shows the wagon shortly after the collision, and after a winch had been attached to the boom ready to pull it back clear of the main line.

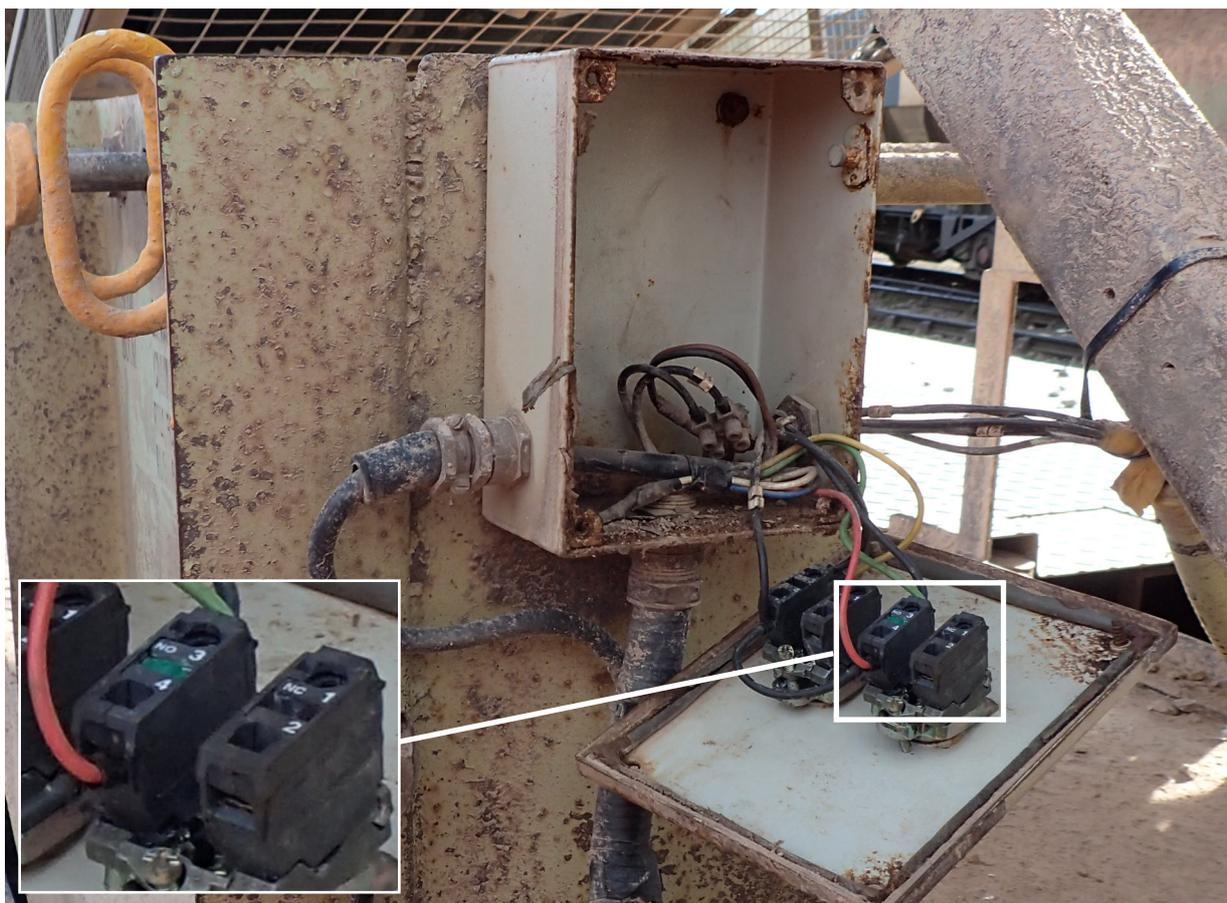
- 65 Fitter 1 pressed the main line side out button and released it, but the boom continued to slew. The button itself sprung back to its normal position (paragraph 49) but the switch behind it remained stuck in the on position. The switch contact block was still stuck in this position when photographed by the RAIB shortly after arrival at site (figure 10). The normally closed switch contact block on the same button had returned to its normal position, showing that the push button had moved back out and it was the normally open switch contact block that had stuck closed.

Figure 10: Control panel on mainline side of wagon after the incident

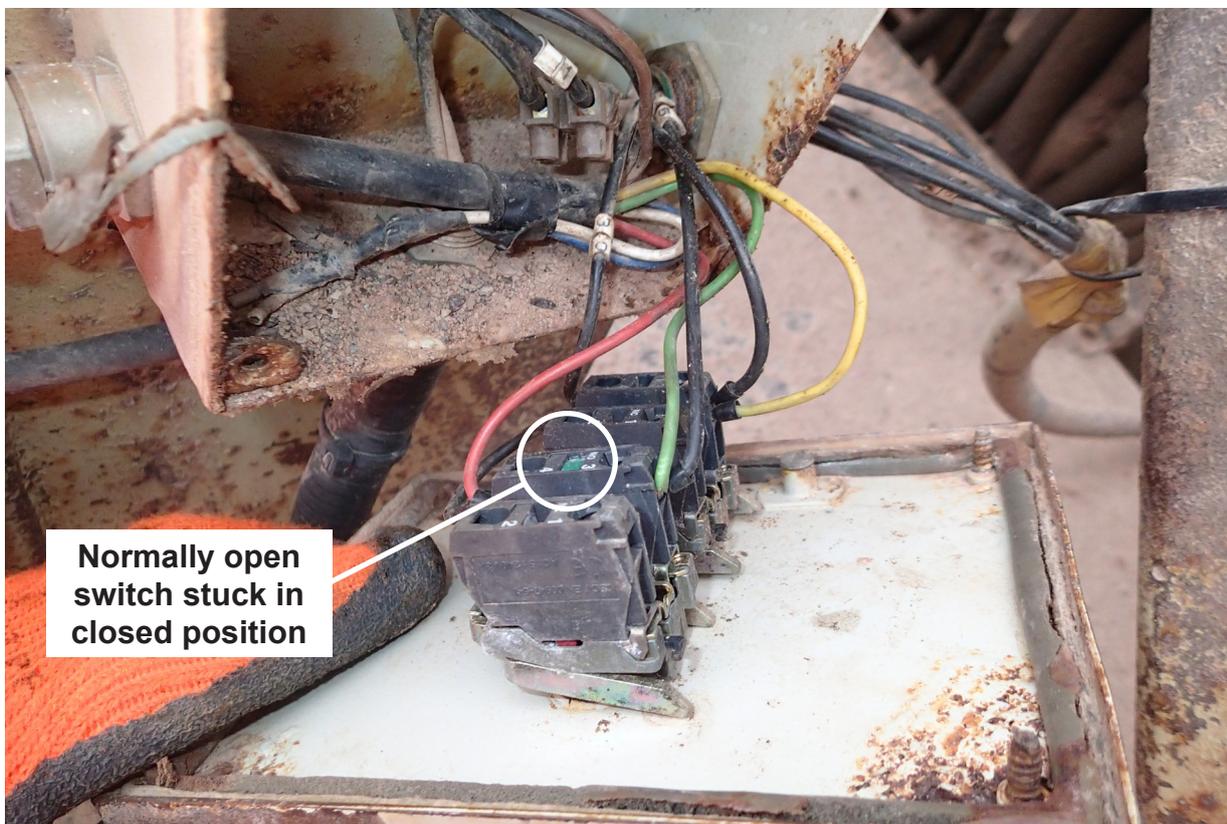
Figure 11: Normally open switch on 'out' button on main line side of wagon stuck in closed position during RAIB test of wagon on 8 March 2016

- 67 The solenoids were reconnected and the accident sequence recreated. The out button on the main line side was held in while the out button on the other side of the wagon was pressed. The test found that the movement of the boom continued in the outwards direction towards the main line when the button on the other side was pressed. This demonstrated that, during the accident with the out switch on the main line side stuck in the 'on' position, pressing the out button on the other side of the wagon would have had no effect on the boom.
- 68 It is probable that this switch stuck because:
- the moving part of the normally open switch contact block had become coated with corrosion product (paragraph 69);  
which in turn was most likely caused because;
  - the switch was used in environmental conditions that it was not rated to withstand (paragraph 76).

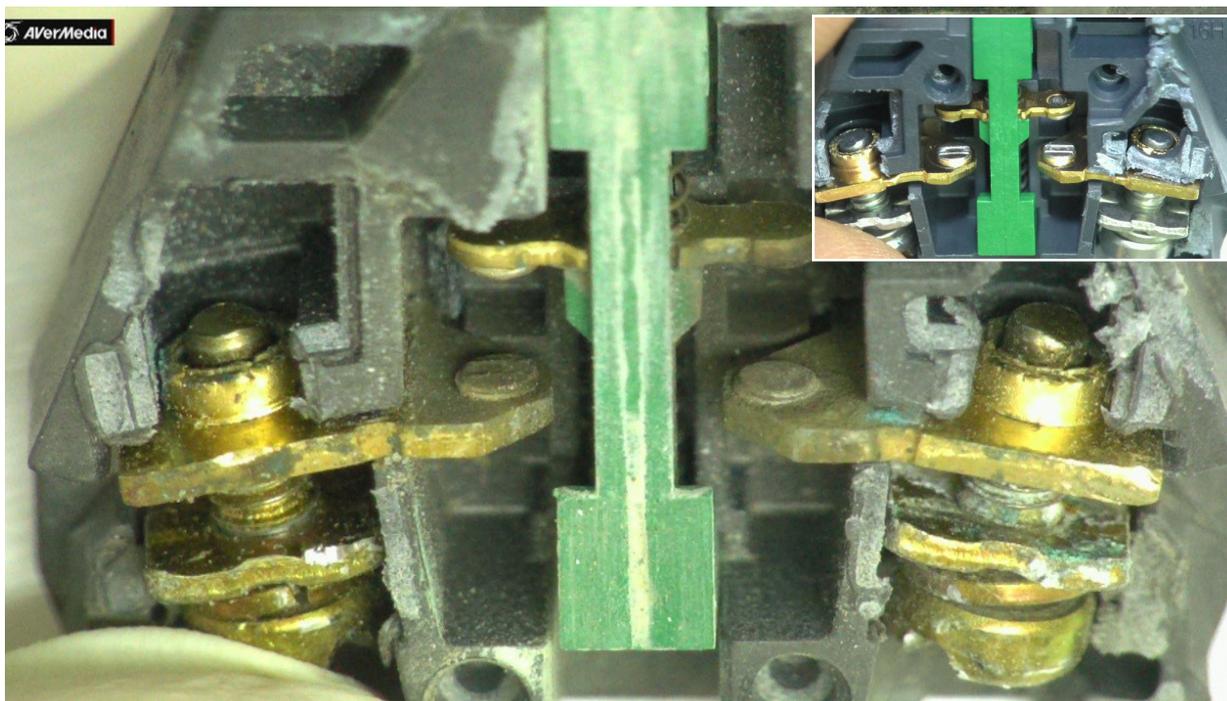
- 74 The switch contact block was then broken open (it is not designed to be taken apart). No foreign bodies or defects were found inside. There was evidence of some corrosion of the metal parts (figure 12), but not sufficient to have caused the switch to stick. There was some blackening of the contacts, as would be expected from a switch that was 15 years old, but no evidence of welding of the contacts.

Figure 12: Interior of normally open switch from 'out' button on main line side of wagon (inset shows corresponding view of new switch) (images courtesy of Schneider Electric)

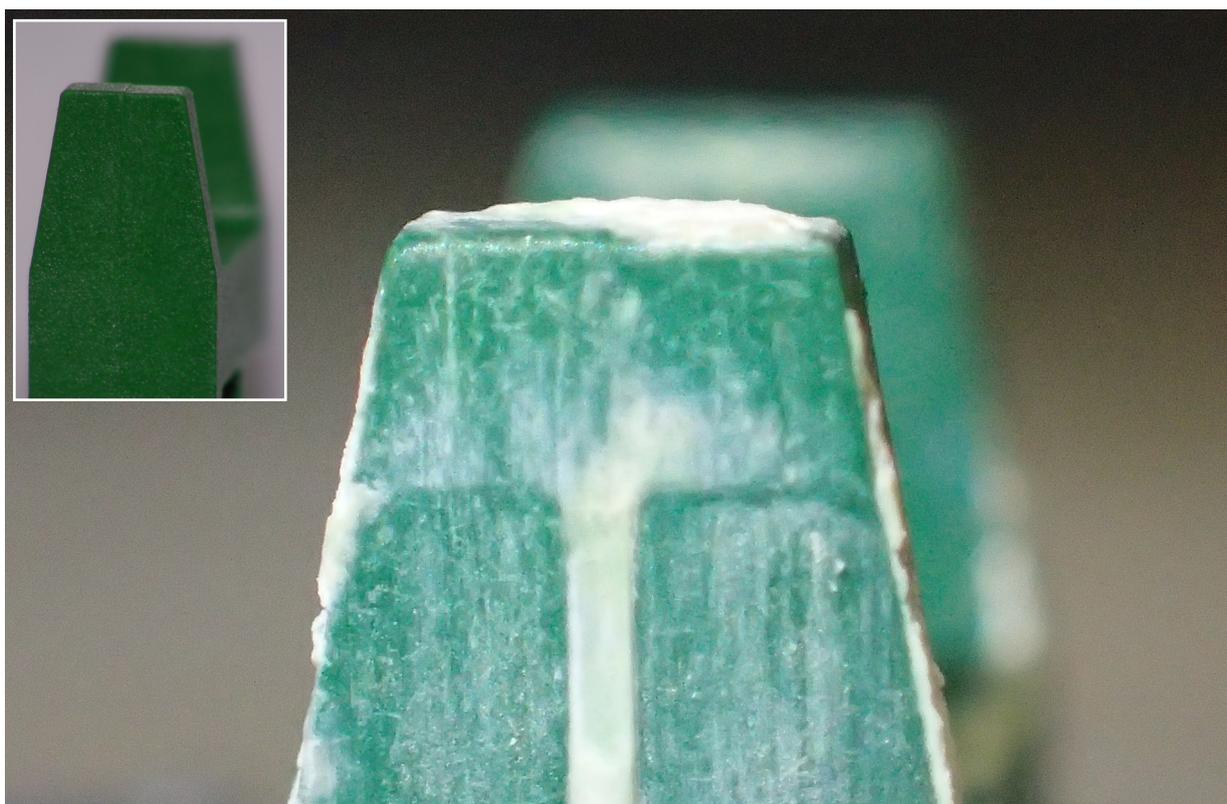
- 75 The plastic moving part of the switch contact block was coated with a hard white deposit (figure 13). Chemical analysis showed this to consist of oxides of zinc and aluminium. This was most likely to have come from corrosion of the zinc/aluminium alloy used for the casting on which the switches were mounted (figure 9). There were also traces of silicon, which is not present in any of the materials the switch is made from, but is a major component of granite. This corrosion deposit is probably the cause of the switch sticking. Figure 14 shows a close up view of the bracket on which the switch was mounted showing where the moving part of the switch had been rubbing against the corrosion deposit.

Figure 13: Close-up of moving part of switch from 'in' button on quarry side of wagon (inset shows corresponding view of new switch) (images courtesy of Schneider Electric)

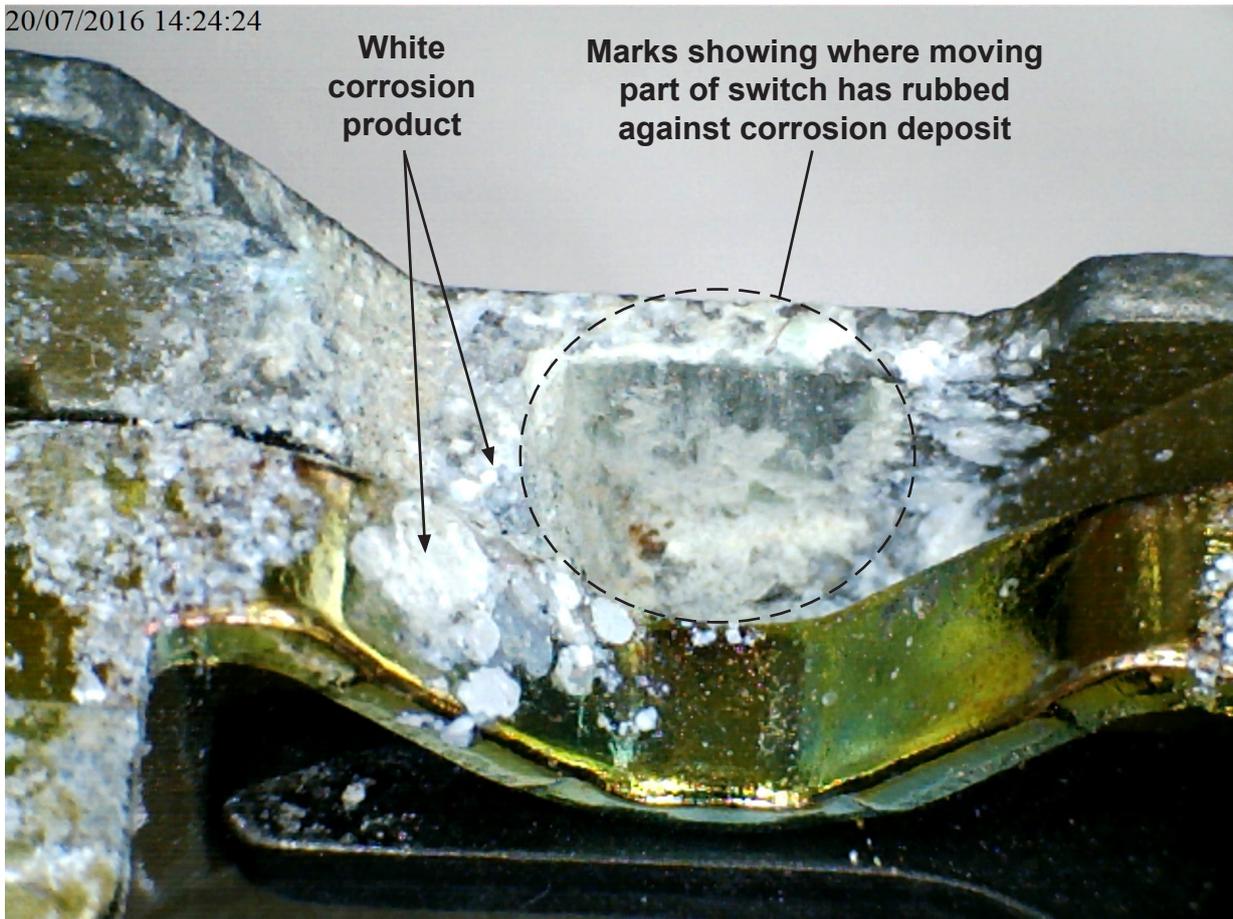
Figure 14: Close-up of diecast metal bracket (collar) from 'out' button on main line side of wagon

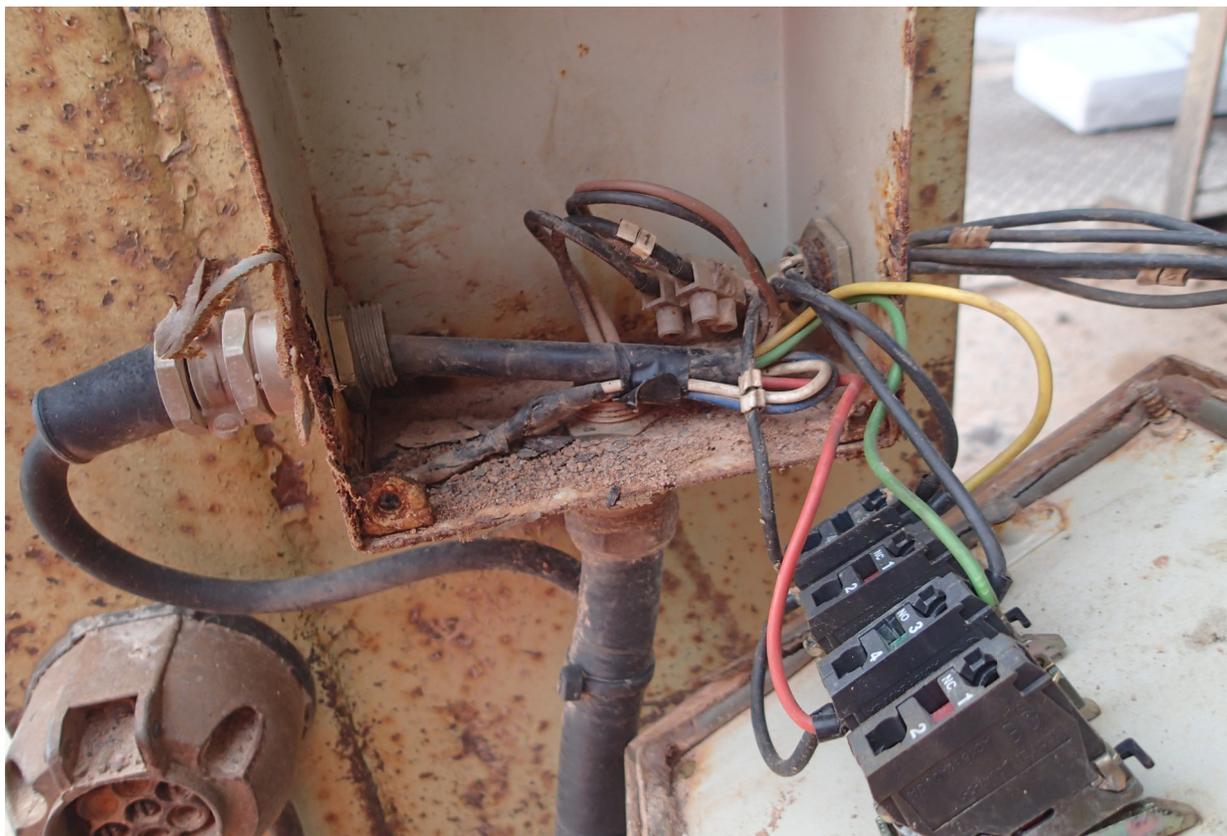
- 79 The switch contact block was designed to be mounted in an enclosure which would protect against moisture and dust to a degree suitable for the environment in which the equipment would be required to operate. The enclosure used on the SDT wagon was a steel box with a sealed lid and glands where the cables enter it. The boxes on both sides of the wagon had deteriorated to the extent that the lid seal was no longer effective and the cable entry points were no longer sealed (figure 15). The box was corroded inside and contained dust and debris. The corrosion indicated that moisture had penetrated the box. As there are no records of the electrical system on these wagons, the intended IP rating of the box is unknown.

Figure 15: Switch enclosure box on main line side of wagon

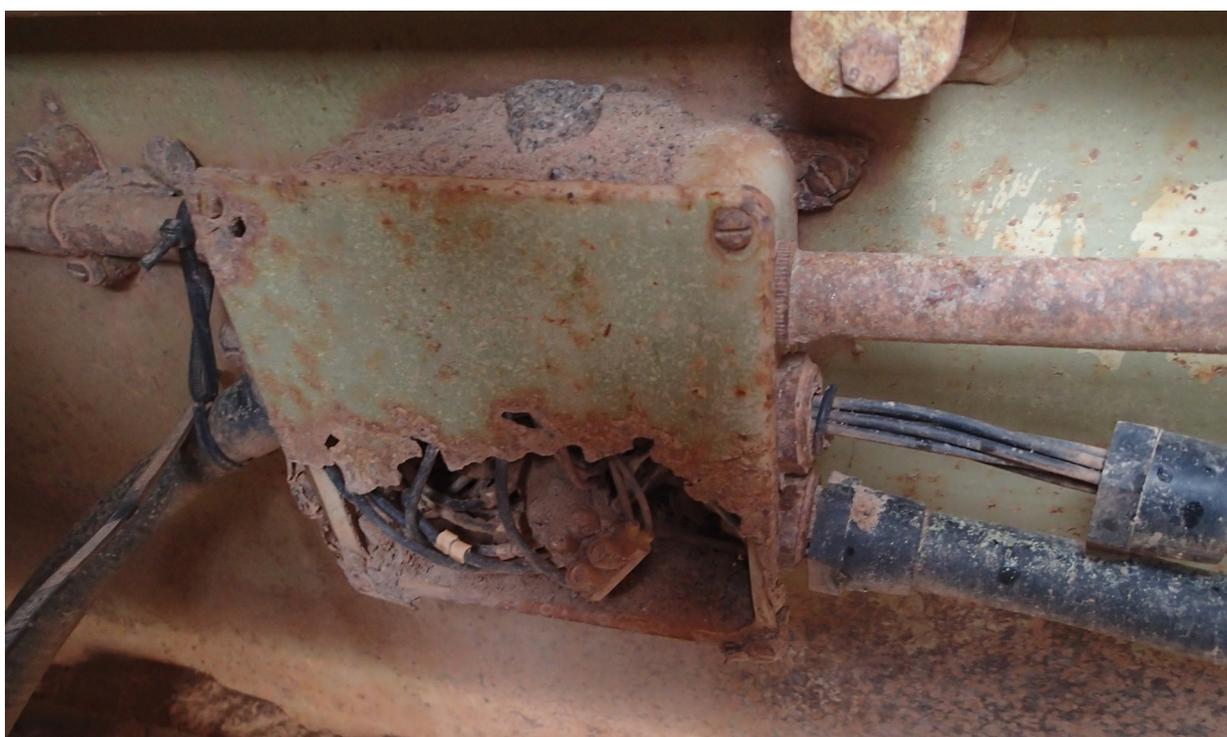
80 The RAIB examined other electrical junction boxes and panels on the wagon. These were also found to be badly deteriorated, with part of the lid completely corroded away in one case (figure 16 shows the junction box for the 'spider' switch cables).

Figure 16: Wiring junction box beneath 'spider' switch
