Post-incident reporting for reservoirs

Annual report 2015

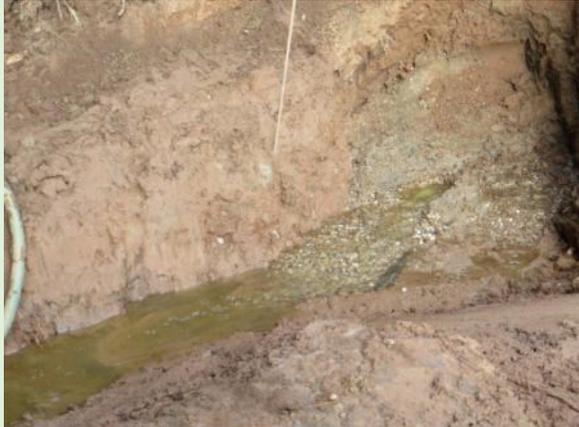
Incident 411	
Dam type	Earth embankment
Reservoir legal status	Statutory impounding reservoir
Dam height (m)	5
Incident type	Leak by pipe or culvert
Incident severity	2
<p>Description</p> <p>The outlet pipe through a 5m-high earth embankment dam required upgrading. Contractors were employed to line the existing timber culvert, fit a downstream valve and to remove the original intake structure and upstream control. Throughout the works, the water level in the reservoir was close to top water level.</p> <p>Removal of the intake structure resulted in leakage occurring along the outside of the new pipe through the dam. The works also resulted in local steepening of the downstream face and a tension crack appeared on the dam crest. There were concerns both for the stability of the embankment and the risk of failure through internal erosion.</p> <p>The supervising engineer was contacted and an inspecting engineer was called to the reservoir. Pumps were brought to the site to draw down the water level by 1.2 m over a period of three days. The reservoir was then emptied using the existing outlet.</p> <p>Investigations found that part of the original timber culvert roof was missing and fine material had been washed out from the overlying earthfill. The reservoir owner decided to abandon the outlet rather than attempting to improve its condition.</p> <p>Lessons learned</p> <p>Improvement works that affect the safety of a statutory reservoir should be carried out under the supervision of a suitably qualified engineer. Any works on existing dam structures should carefully consider the conditions that might be encountered to ensure contingency plans are in place if the conditions found differ from those anticipated.</p> <p>Reservoir improvement works of this nature should normally be carried out with a lowered reservoir level if possible.</p> <p>Photo shows seepage along the line of the culvert.</p>

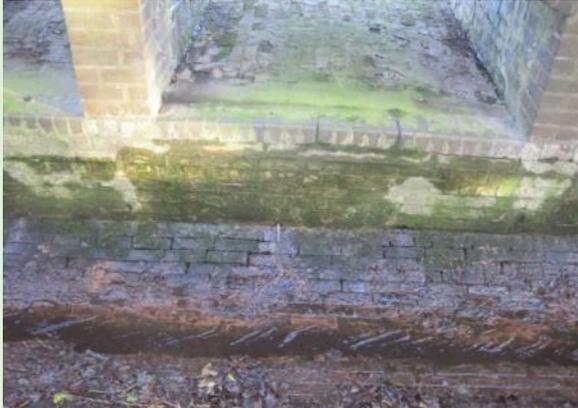
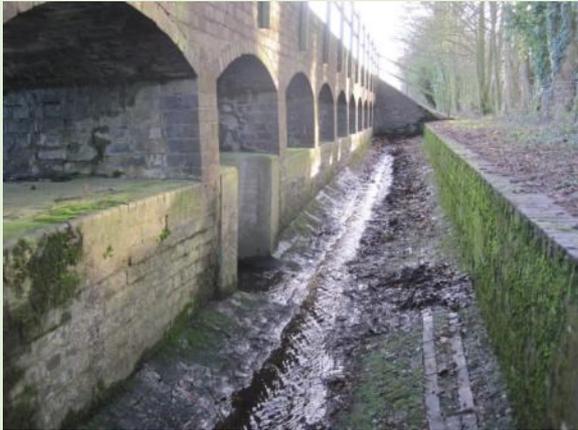
Incident 414	
Dam type	Earth embankment
Reservoir legal status	Statutory non-impounding reservoir
Dam height (m)	6
Incident type	Leakage - concrete/masonry
Incident severity	3
<p>Description</p> <p>During a routine surveillance inspection of a non-impounding reservoir, increased leakage was noted through the joints in the masonry spillway weir in two areas. Silty sand was observed being washed through the joints. The reservoir water level was reduced by 200 mm, which was sufficient to stop the leakage. Grouting works are planned to fill voids within the dam upstream of the weir.</p> <p>Lessons learned</p> <p>This incident illustrates the value of routine surveillance at reservoirs. In this case, the reservoir spillway was on a non-impounding reservoir which rarely overflowed and it was easy to notice the deterioration of the weir structure. In the case of impounding reservoirs that regularly have flows over the spillway, it is useful to inspect the downstream face of masonry weirs when the water is just below the sill level. Any leakage and loss of fine material over an extended period of time could potentially reduce the stability of the weir (see also incident 413 below).</p> <p>Photos, courtesy of the Canal and River Trust, shows seepage with deposition of fine material.</p>

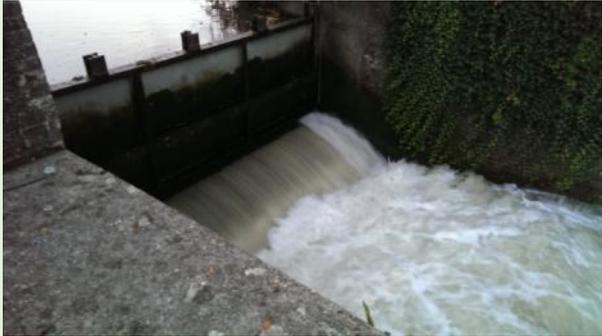
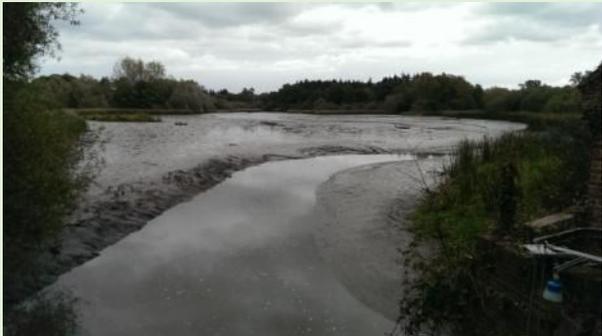
Incident 415	
Dam type	Earth embankment
Reservoir legal status	Statutory impounding reservoir
Dam height (m)	4
Incident type	Other
Incident severity	3
<p>Description</p> <p>An automated sluice gate was partially opened to reduce the reservoir water level at a site where construction works were being undertaken. The gate failed to close on request during the closing sequence. The reservoir substantially emptied through the gate over a period of two hours before the owner was able to close the gate manually. There was no downstream flooding as a result but there was some loss of fish and some silt was washed out from the reservoir.</p> <p>Investigations found that the failure to close the gate was the result of an electrical fault. Works on the electrical system had recently been carried out but had not been tested. There was also a delay in implementing the manual closure as staff on site had been provided with an incorrect procedure. There was no secondary gate or other means provided to stop the flow through the gate.</p> <p>Lessons learned</p> <p>This incident illustrates the importance of testing systems and procedures used for operating equipment. Where works are carried out on electrical or mechanical equipment it is essential that proper testing is carried out promptly. Gated waterway designs should consider the implications of gate failure and provide a secondary means of sealing waterways. Backup systems and procedures should be periodically reviewed and tested to ensure that they are effective when needed.</p> <p>Photos show gate and empty reservoir</p>
