# ***AAIB Bulletin***

***11/2016***

<b>Aircraft Type and Registration:</b>	Piper PA-46-350P Malibu Mirage, N186CB	
<b>No &amp; Type of Engines:</b>	1 Lycoming TIO-540-AE2A piston engine	
<b>Year of Manufacture:</b>	1990 (Serial no: 46-22085)	
<b>Date &amp; Time (UTC):</b>	14 November 2015 at 1134 hrs	
<b>Location:</b>	Buttles Farm, Churchinford, Somerset	
<b>Type of Flight:</b>	Private	
<b>Persons on Board:</b>	Crew - 1	Passengers - 3
<b>Injuries:</b>	Crew - 1 (Fatal)	Passengers - 3 (Fatal)
<b>Nature of Damage:</b>	Aircraft destroyed	
<b>Commander's Licence:</b>	Private Pilot's Licence	
<b>Commander's Age:</b>	56 years	
<b>Commander's Flying Experience:</b>	600 hours (of which 260 were on type) Last 90 days - 17 hours Last 28 days - 4 hours	
<b>Information Source:</b>	AAIB Field Investigation

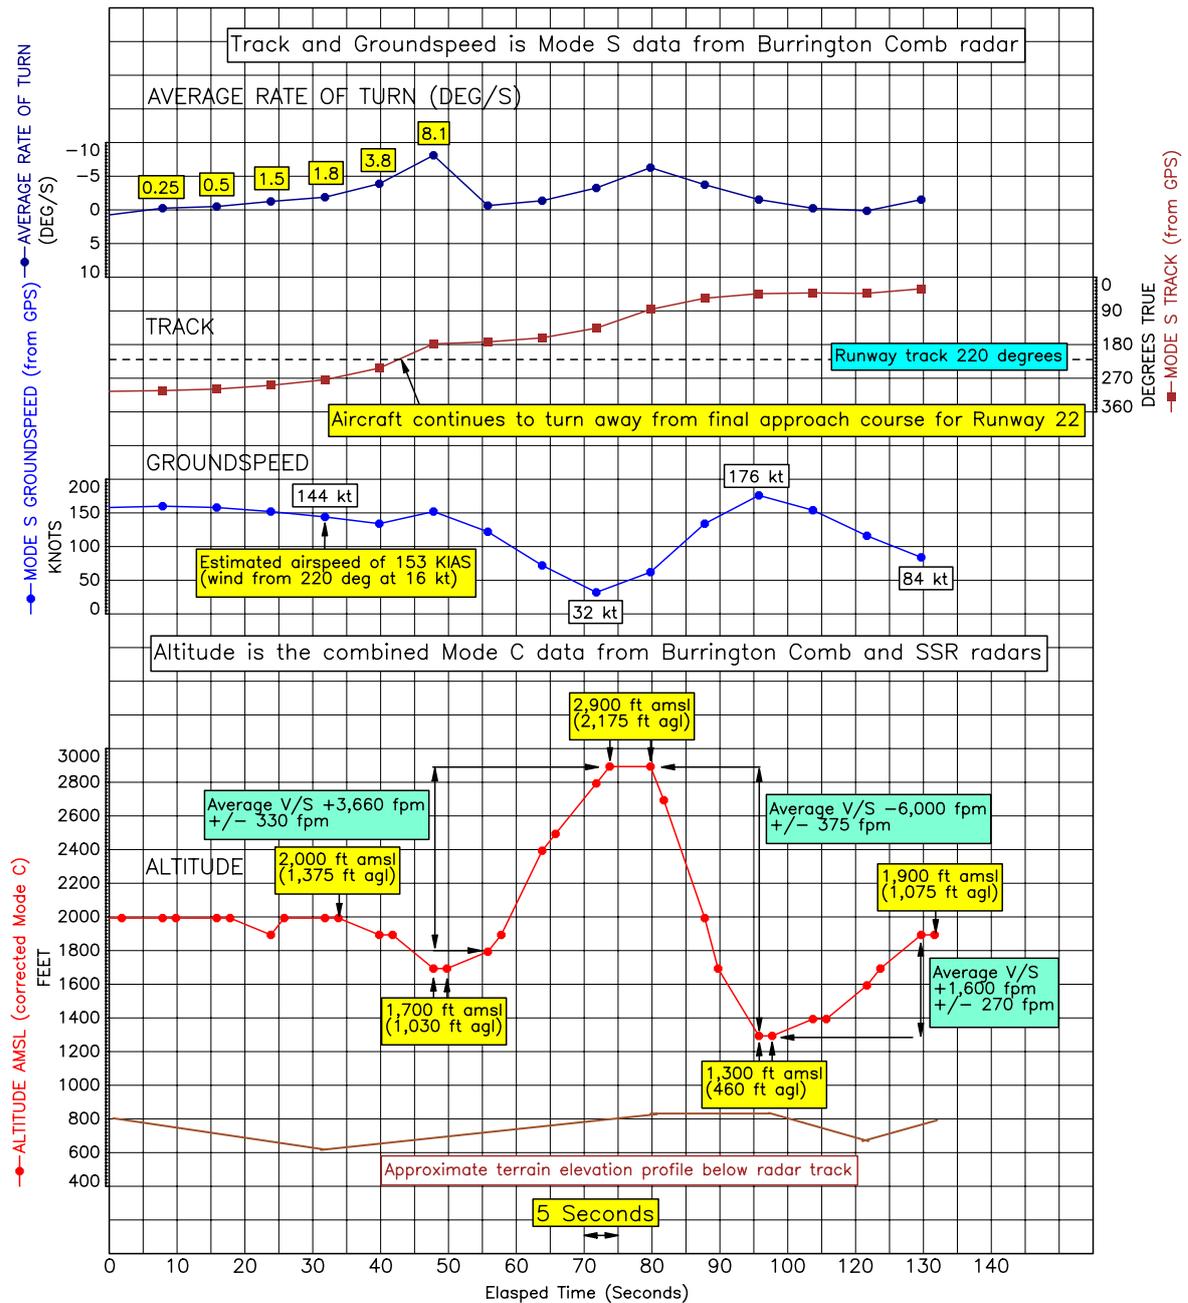
**Figure 3**  
Accident flight radar data from Burrington Comb and SSR radar heads

In the middle of the figure, under the altitude '2,900 ft amsl', the height should read '**2,175 ft agl**', not '1,175 ft agl' as originally stated. The supporting text, analysis and conclusions were unaffected by this error.

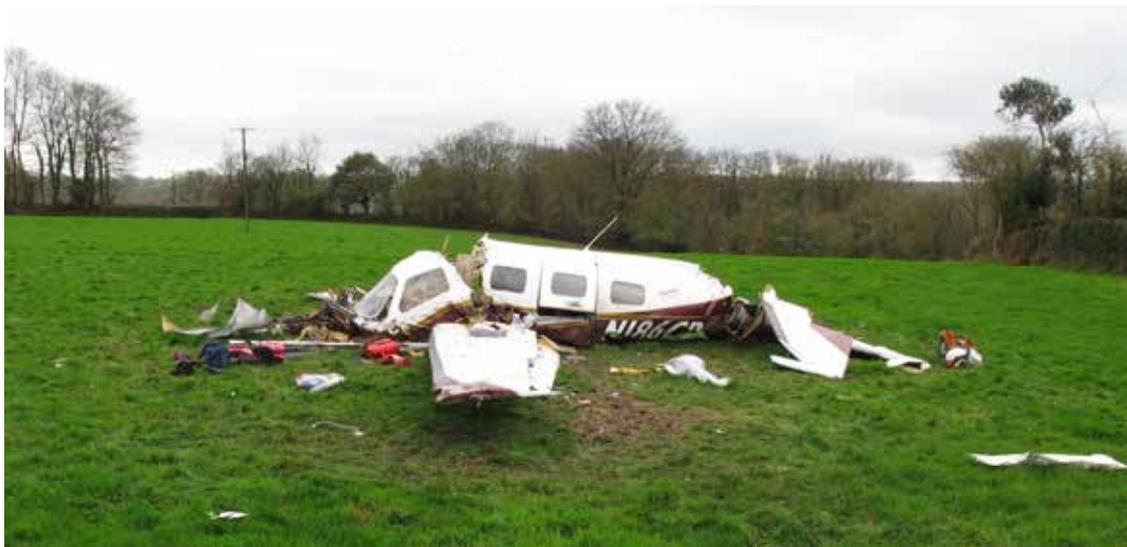
**Figure 9**  
Accident site

The aircraft wreckage was found in a field, 175 m north-east of the aircraft's last radar position. The aircraft had struck the ground at an elevation of 820 ft amsl, in a nose-down attitude, with a high rate of descent and at low forward speed (Figure 9). The orientation of the fuselage was in the direction 123°(M) and the fractured forward fuselage was resting at a nose-down attitude of about 25°. Damage to the undersides of the wing was consistent with the aircraft's flight path having been steeper than its nose-down attitude, suggesting that the wing was at a high-angle-of-attack, probably stalled, on impact. The aircraft had missed 6.5 m high power lines, which were 2.1 m aft of the aircraft's tail, and the left wing had travelled forward about 1 m from its initial impact point. The right wing had failed at the rear attachment and was angled forward. The tail section had failed in downward bending and the vertical tail had failed in forward and sideways bending. All external components of the aircraft were accounted for.

The propeller hub had fractured and its mounting flange had failed at the engine crankshaft attachment due to impact forces. One blade, which had detached from the failed hub, had suffered significant damage and was buried in the ground underneath the nose of the aircraft. The remaining blade, still attached to the hub, had suffered minimal damage with some chordwise scoring. The flaps and landing gear were in the retracted position.

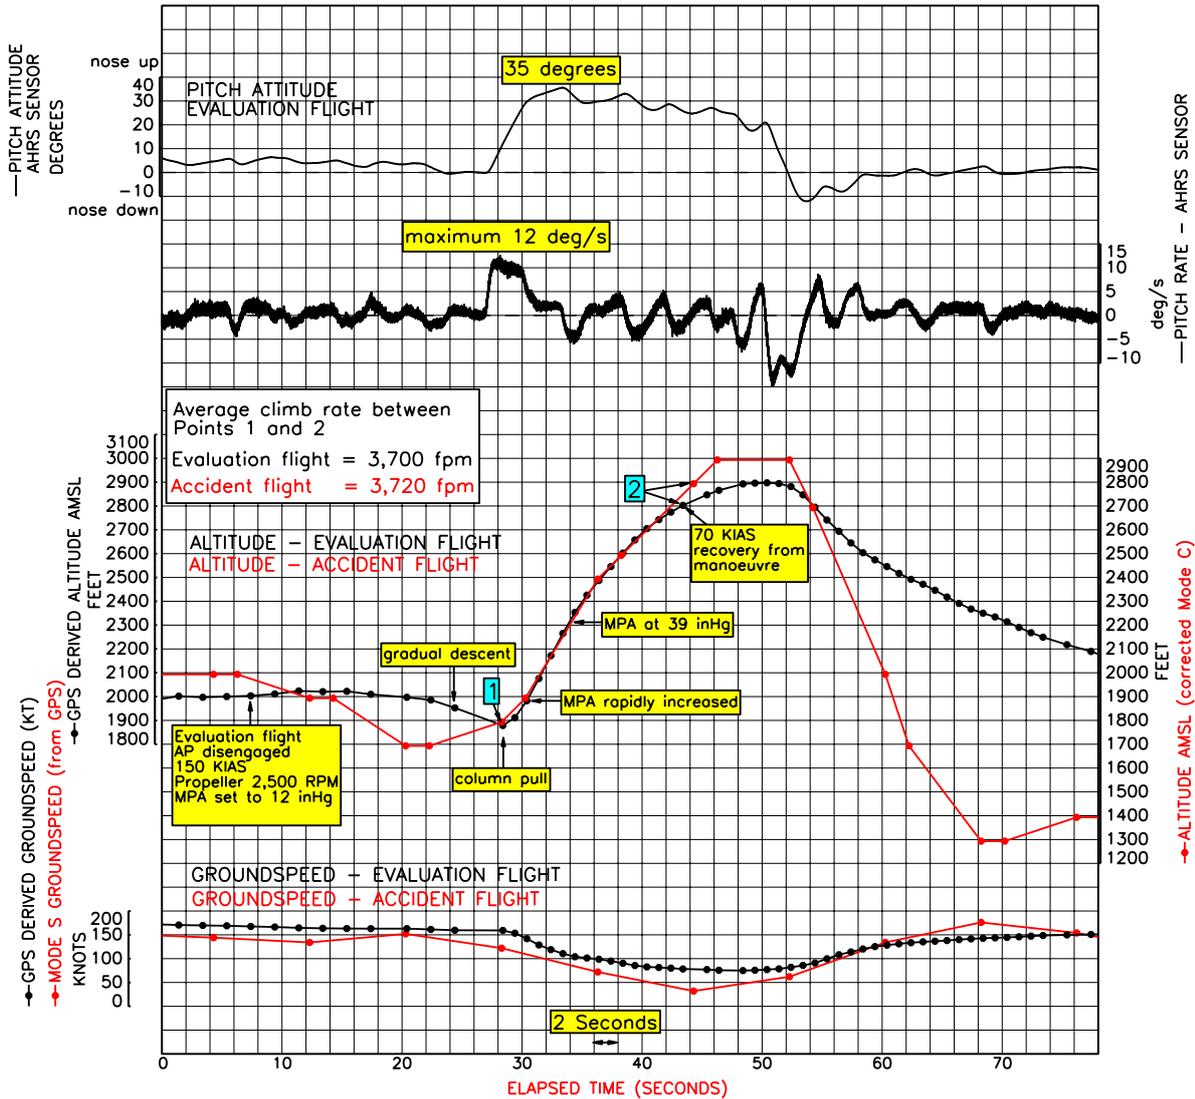
**Figure 11**  
 Comparison of accident and evaluation flight  
 (autopilot disengaged then climb at same rate as accident flight)

The test pilot considered that the high nose-up attitudes and pitch rates achieved during these manoeuvres would be extremely disorientating for a pilot, especially in IMC conditions. He also considered that the control column forces required to override the autopilot quickly became so large, that it was unlikely a pilot would continue to oppose them without re-trimming.

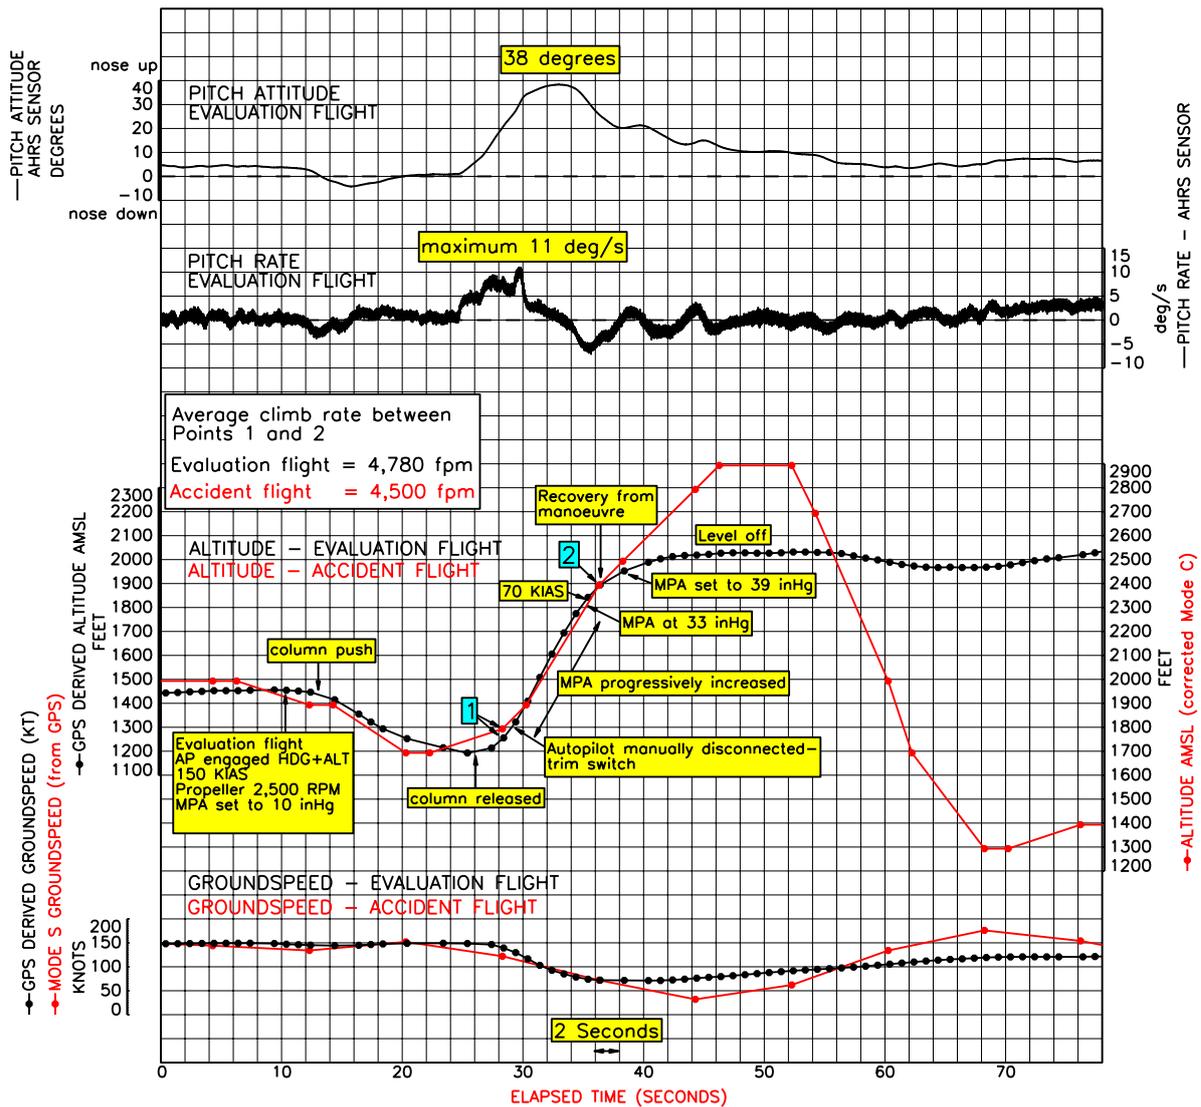
Figure 12

On subsequent tests, the test pilot pressed the pitch trim switches, disengaging the autopilot, when he considered the control column force was excessive. This occurred at approximately 300 ft below the set altitude. It was noted that the pitch trim had reached a setting of 3.5, which equated to a significant nose-up trim position for the weight and CG.

Comparison of accident and evaluation flight (autopilot engaged in heading and altitude hold, with control column pushed and then released)

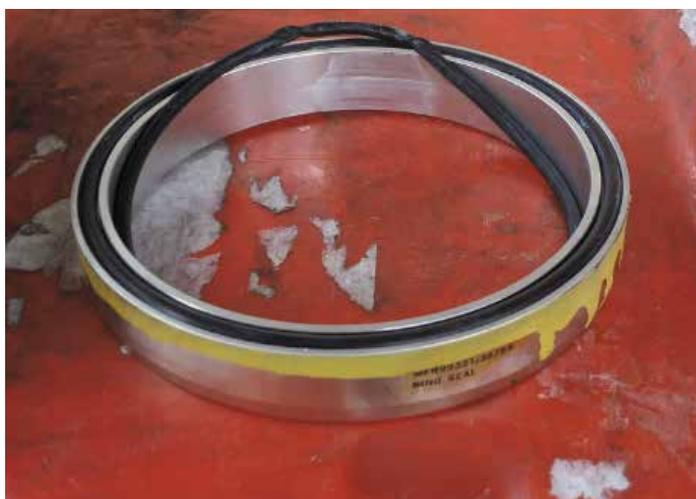
**Figure 1**

The following day, the aircraft departed Edinburgh on a ferry flight to Chicago. The same flight crew and flight attendants were assigned to the flight, but there were no passengers on board. During the climb-out from Edinburgh flight attendants again observed fuel streaming from the over-wing fuel filler cap on the right wing. The flight crew declared a MAYDAY and returned to Edinburgh. Fuel dumping was not necessary on this occasion as the aircraft was already below the maximum landing weight. The landing at Edinburgh was uneventful and following evaluation by the ARFFS, the aircraft was towed to a remote parking stand where further maintenance investigation revealed that an O-ring in the over-wing fuelling port was damaged (Figure 1).

Damaged O-ring from over-wing fuelling port

Maintenance engineers at Edinburgh replaced the over-wing fuel filler cap after which the fuel tank was fuelled to maximum capacity; no leaks were observed. The aircraft was then allowed to sit overnight in this condition and no further leaks were observed.

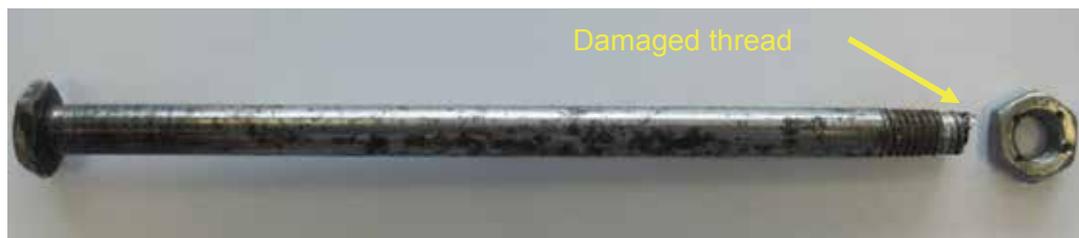
**Figure 1**

The pilot reported that the threads on the inboard forward attachment bolt appeared to have been stripped and the nut had been pulled off the end (Figure 1). In this condition the landing gear was not adequately restrained. This caused the lower attachment plate to bend, allowing the landing gear leg to twist outboard until it failed just above the lower attachment plate (Figure 2).

Failed landing gear attachment bolt

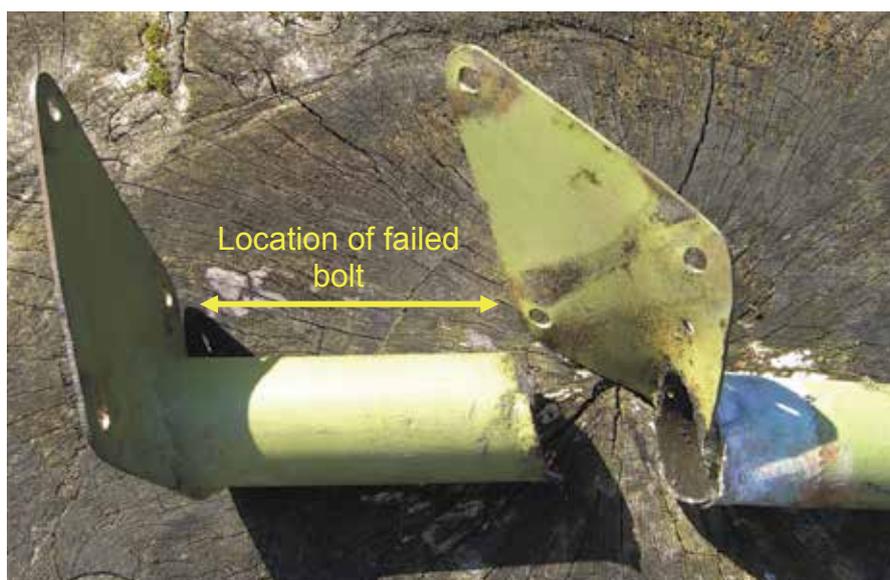
**Figure 2**

Damage to landing gear leg and attachment plates

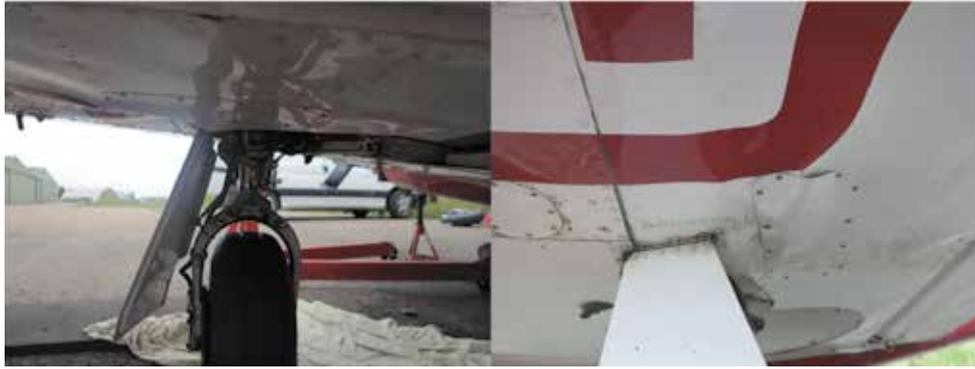
**Figure 1**

The creasing on the underside of the left wing (Figure 1) indicated that there was a higher-than-normal rate of descent on touchdown. The orientation of the nose landing gear drag brace (extended and slightly over-centre) (Figure 2) indicated that the nose landing gear was locked down during the approach. Figure 3 shows that the nose gear piston broke towards its top which suggested that it broke immediately on touchdown before the piston began to move into the nose gear cylinder under the weight of the aircraft's nose section.

Creasing on the underside of the left wing

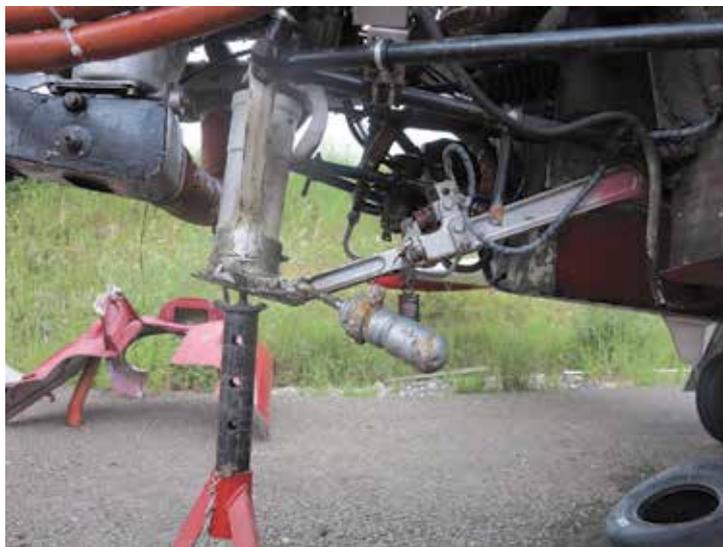
**Figure 2**

Nose landing gear drag brace

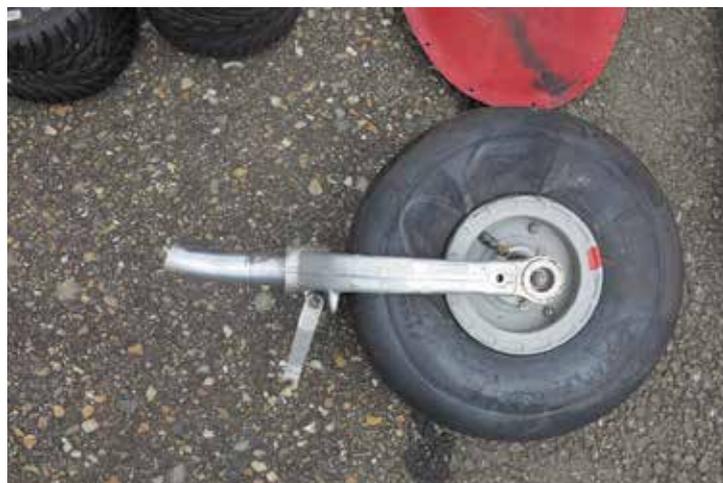
**Figure 3**

Break in the nose gear jack

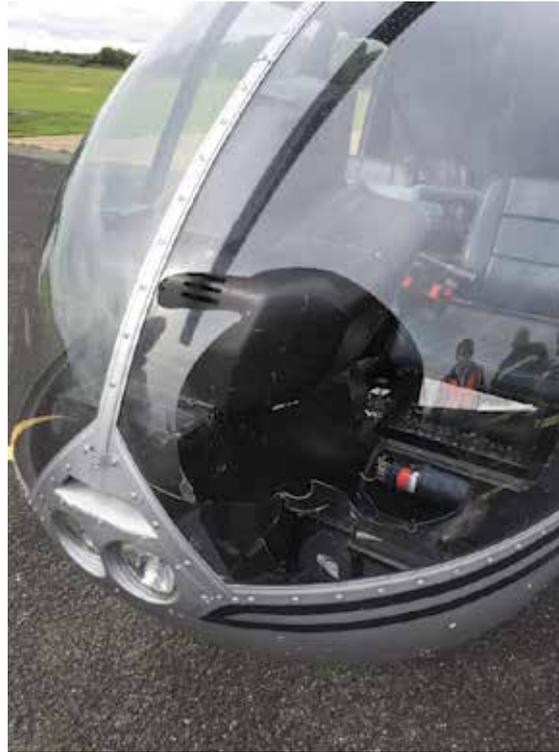
**Figure 1**

The commander had just taken control of the helicopter when a bird struck and broke through the left windscreen. The bird was killed on impact and entered the cockpit with its wings unfolded. The pilot in the right seat took control and the helicopter lost approximately 700 ft in altitude whilst the crew dealt with the incident. They declared a MAYDAY and returned to Barton for an uneventful landing (Figure 1). Neither crew were injured.

Damage to left windscreen of G-BZGO
