Rail Accident Investigation Branch

Rail Accident Report

Structural failure caused by scour at Lamington viaduct, South Lanarkshire 31 December 2015

Report 22/2016
November 2016

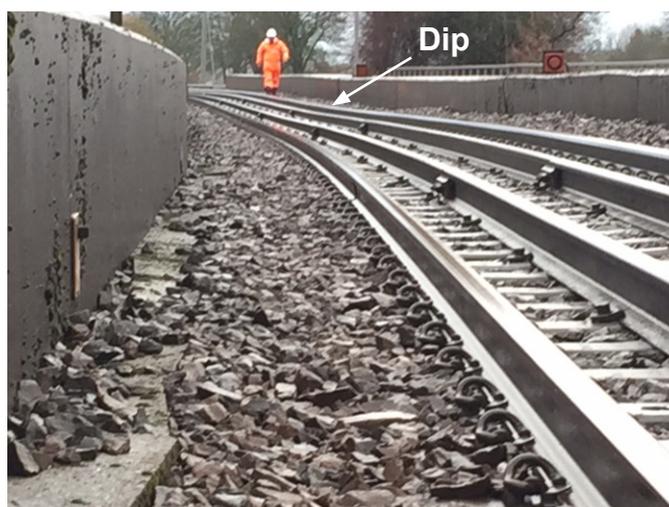
- 47 At the same time, another member of the track maintenance team informed control room staff that he had observed “great big sweeping dips in the track” (figure 8). He also reported that the *cant* of the track had deteriorated on both lines in the middle of the viaduct and that there may have been subsidence. He requested the attendance of a bridge examiner.

Figure 8: ‘Sweeping dip’ affecting down line on 31 December 2015 after closure. At this stage, the track had dropped by 70 mm (photograph courtesy of Network Rail)

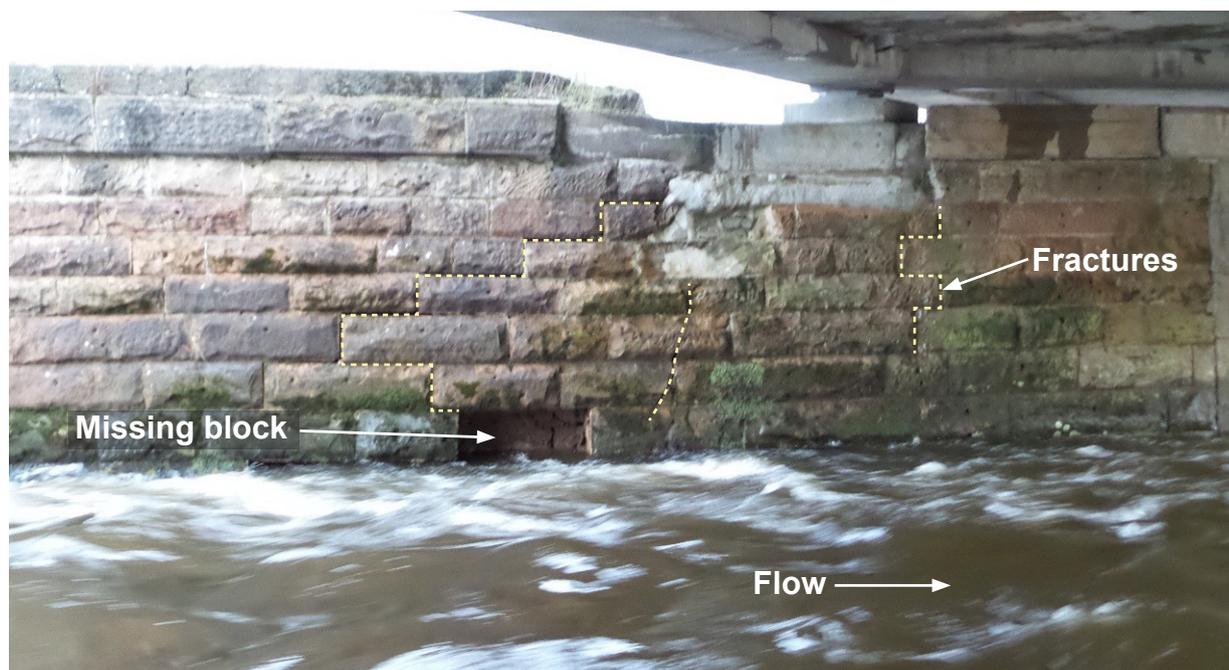
Figure 9: South face of pier 2 on 31 December 2015 showing missing block and fractures (photograph courtesy of Network Rail)

- 62 The missing block reported by the track maintenance staff at 08:52 hrs on 31 December (paragraph 49) was at the top of a pyramid-shaped void in the south face of pier 2, suggesting that significant damage had already occurred below water level. The void extended down by seven courses (2.8 metres) to the base of the structure. At its widest, the erosion extended 1.8 metres into the 2.1 metre wide solid masonry pier (figure 18), and beneath the concrete pier extension. The survey data shows that the total volume of masonry lost exceeded 20 m³, comprising 50 or more sandstone blocks, each weighing between 0.3 tonnes and 0.9 tonnes. It is likely that this damage occurred over a number of hours, gradually weakening the pier, although its north face remained intact providing residual support to the deck.

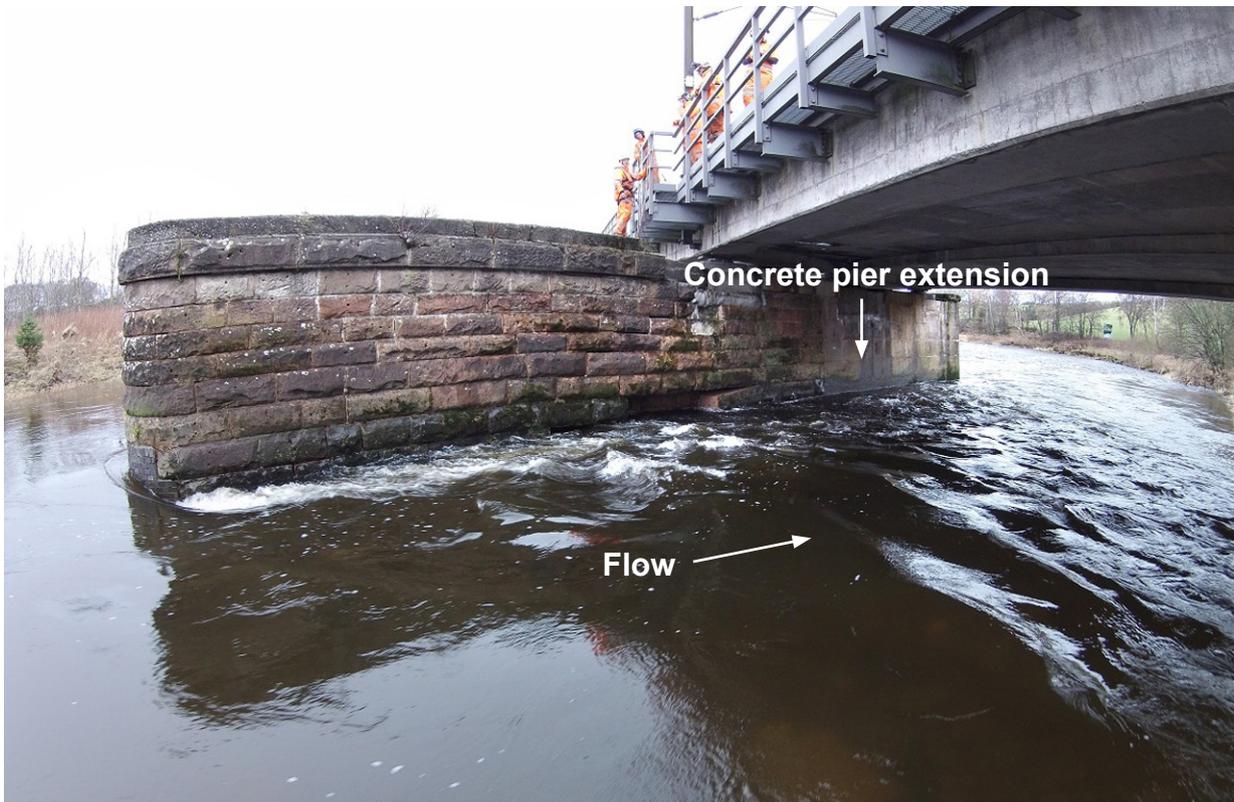
Figure 11: South face of pier 2 on 1 January 2016 prior to start of emergency stabilisation works. Note that the operative's safety harness is anchored to the adjacent overhead electrification mast (photograph courtesy of Network Rail Air Operations).

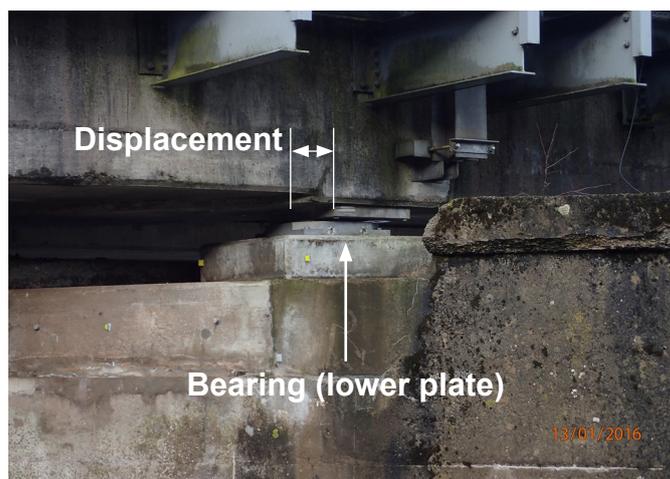
Figure 12: Bearing supporting outer main beam adjacent to the up line at the east end of pier 2. The bearing's lower plate is displaced to the left of its upper plate due to tilting of the pier

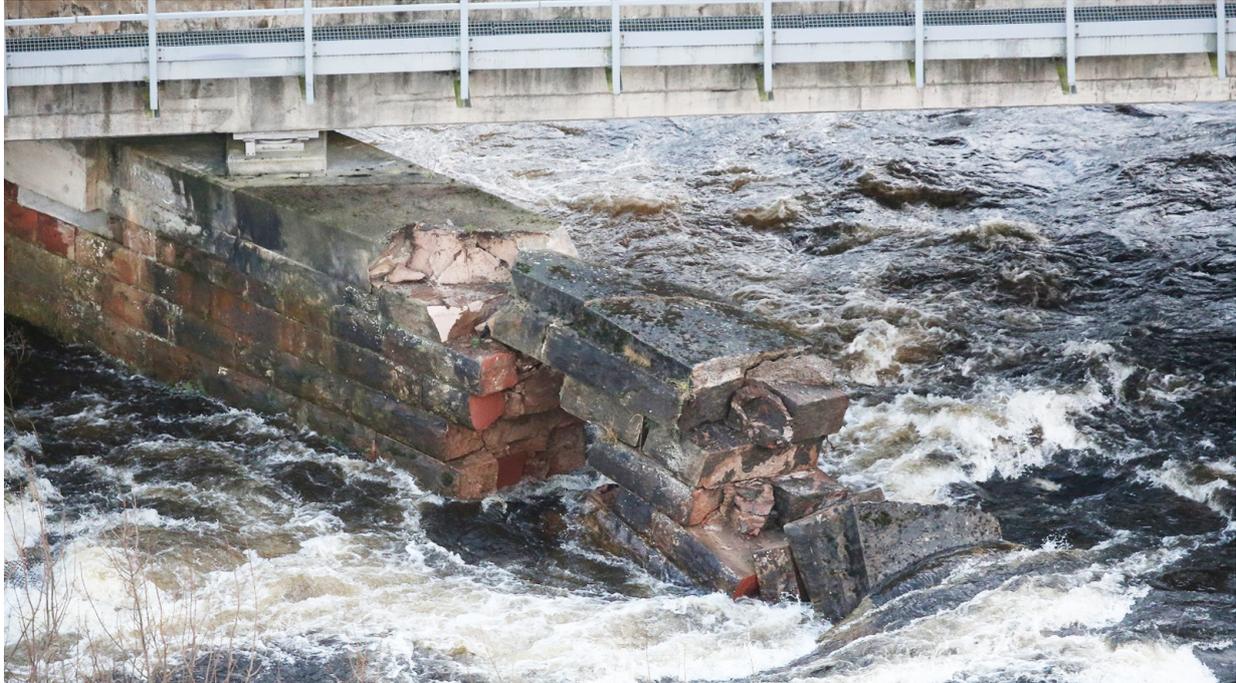
- 54 Subsequent periods of high river flow caused further scour damage. On 10 January, a 7 m redundant section of pier 3 collapsed (figure 14). On 27 January, a similar length of the north abutment and part of the approach embankment, including a disconnected overhead electrification mast, collapsed into the river (figure 15). On both occasions, the flow was significantly less than on 30 December 2015, but it was constricted by the stone causeway which would have increased the water velocity.

Figure 14: Scour damage to redundant section of pier 3 on 10 January 2016 (photograph courtesy of Network Rail Air Operations)

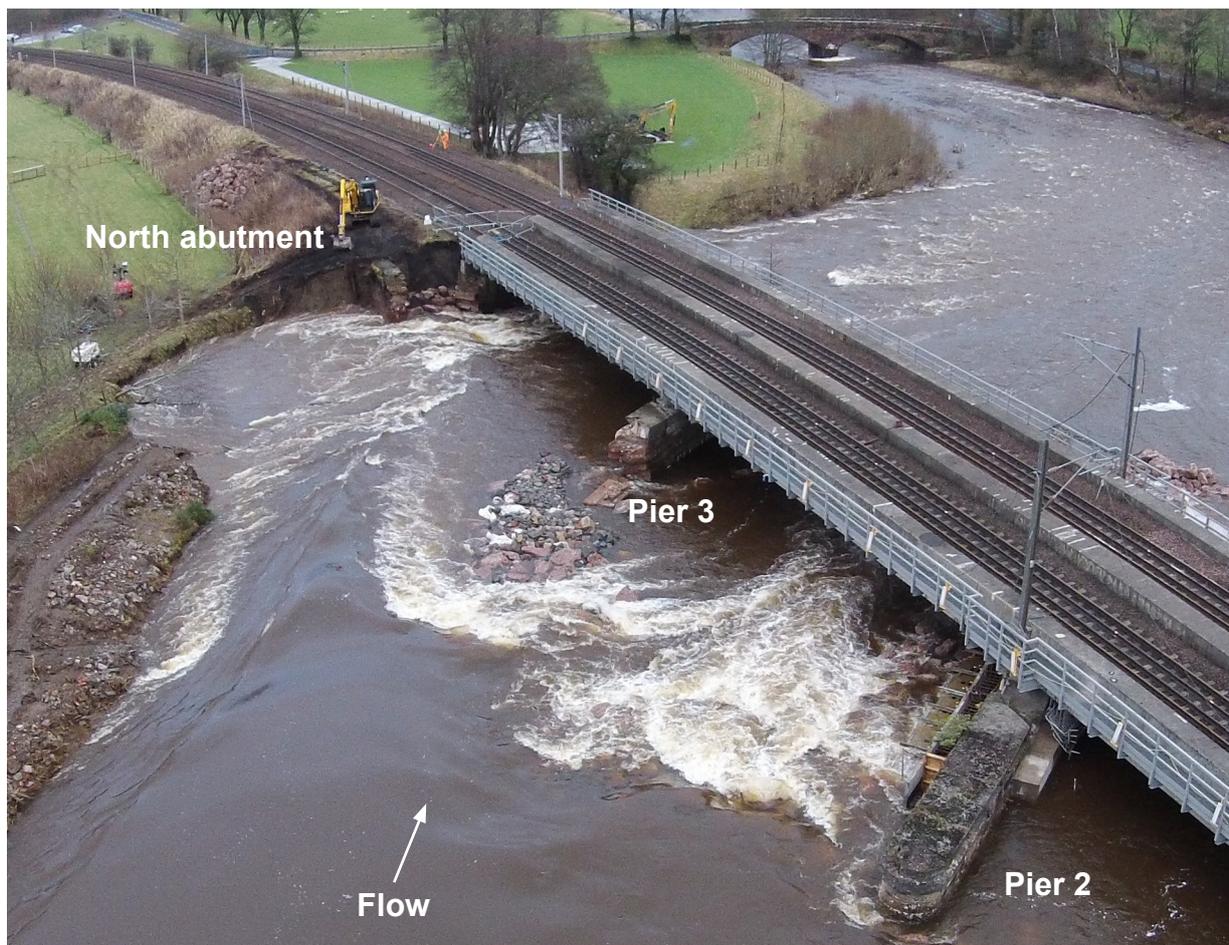
Figure 15: Scour damage to north abutment and embankment on 27 January (photograph courtesy of Network Rail Air Operations)

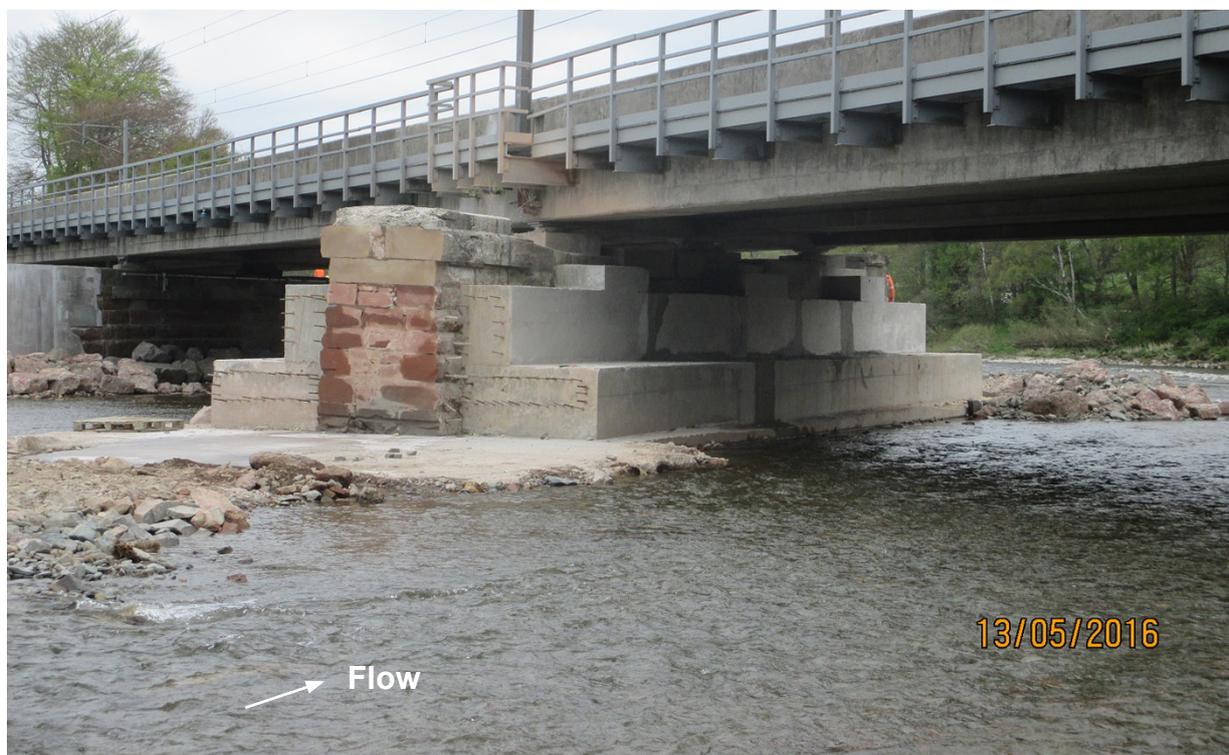
Figure 16: Pier 2 stabilisation works after removal of upstream end (photograph courtesy of Network Rail)

- 55 Pier 2 was stabilised in its final position by the construction of an additional reinforced concrete jacket on each side, attached with steel dowels to the original masonry and mass concrete pier, and anchored into the underlying ground. The steel bearings were replaced on modified concrete plinths, and the deck jacked back into its correct position to allow the line to reopen on 22 February 2016 (figure 16). Services were seriously disrupted while repairs were completed as trains were either diverted or replaced by road transport.

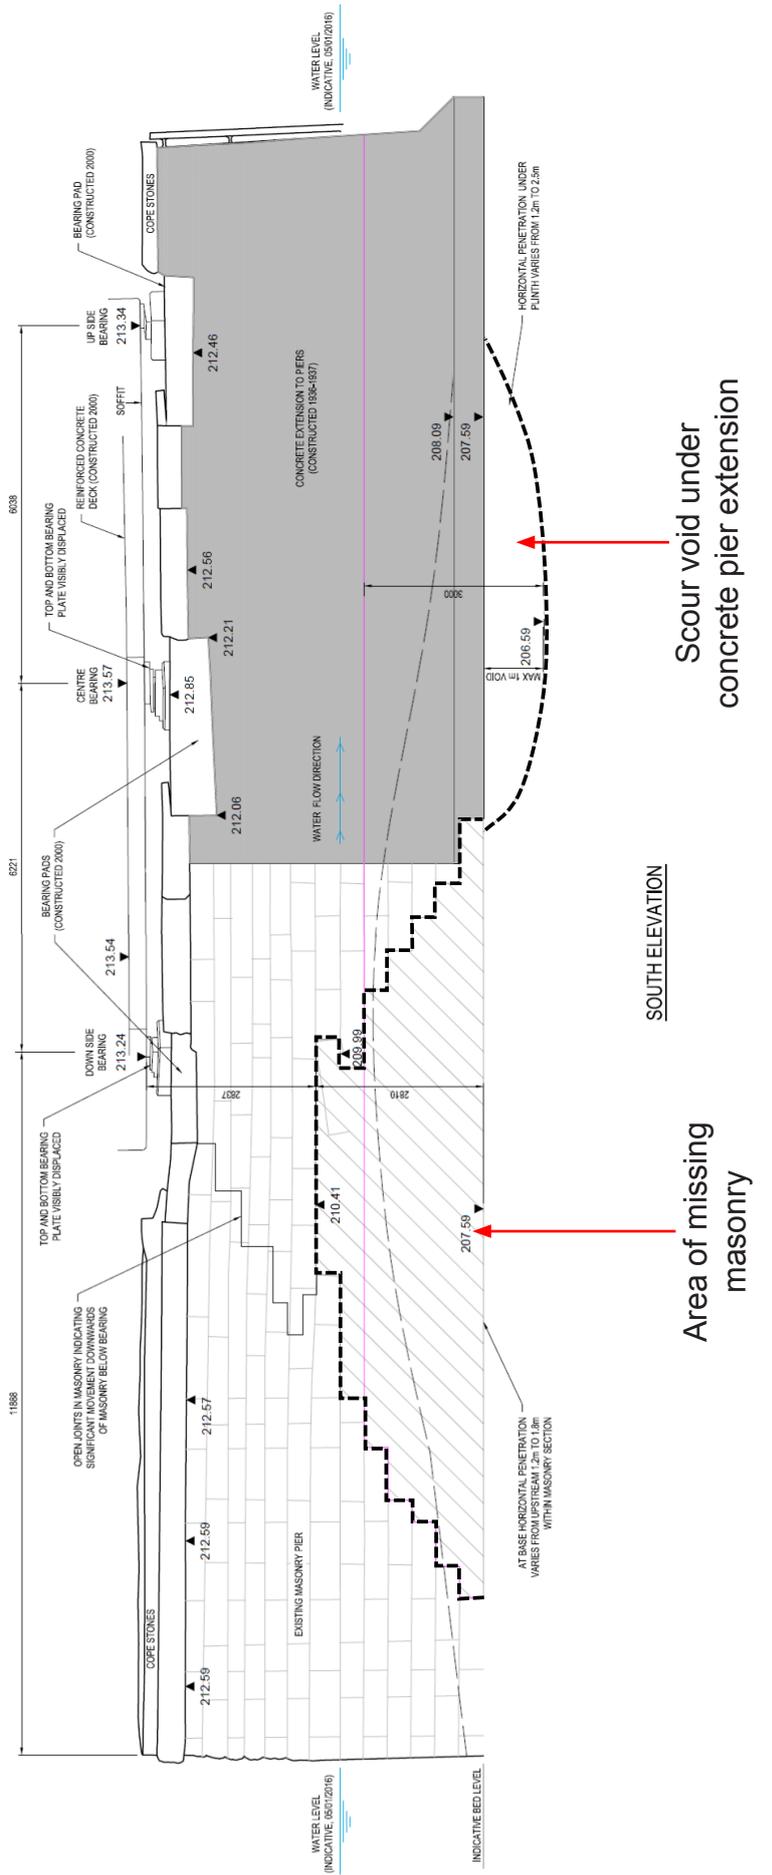
61 A diving survey on 2 January 2016 reported scour damage over a 21 metre length of the 28 metre long pier. The masonry section had partially collapsed and divers found a 1 metre deep scour hole underneath the concrete pier extension, with only its downstream end remaining supported (figure 17). It is probable that the masonry section also had its foundation undercut by scour with masonry falling into the resulting scour hole. Weak or missing mortar (refer to paragraphs 89 and 90), made it more likely that the water action would allow scour to displace the lowest level of blocks, with further blocks dropping downwards as each successive course was undermined.

Figure 17: South face of pier 2 showing scour damage recorded by divers on 2 January 2016 (courtesy of Network Rail)

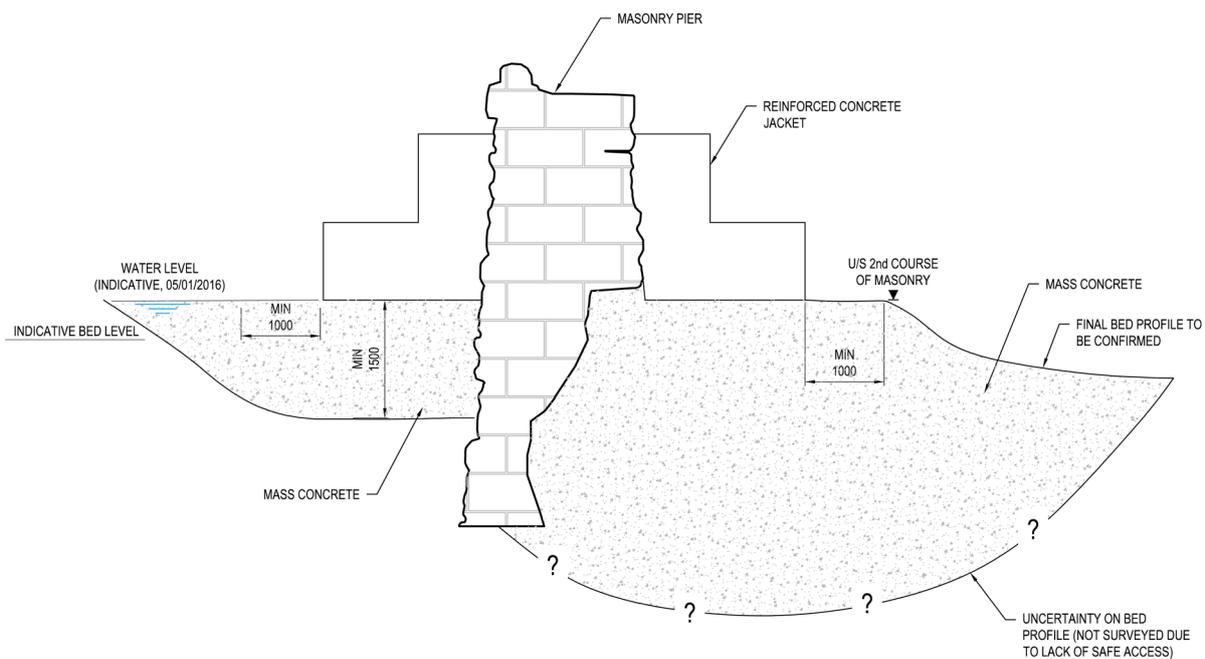
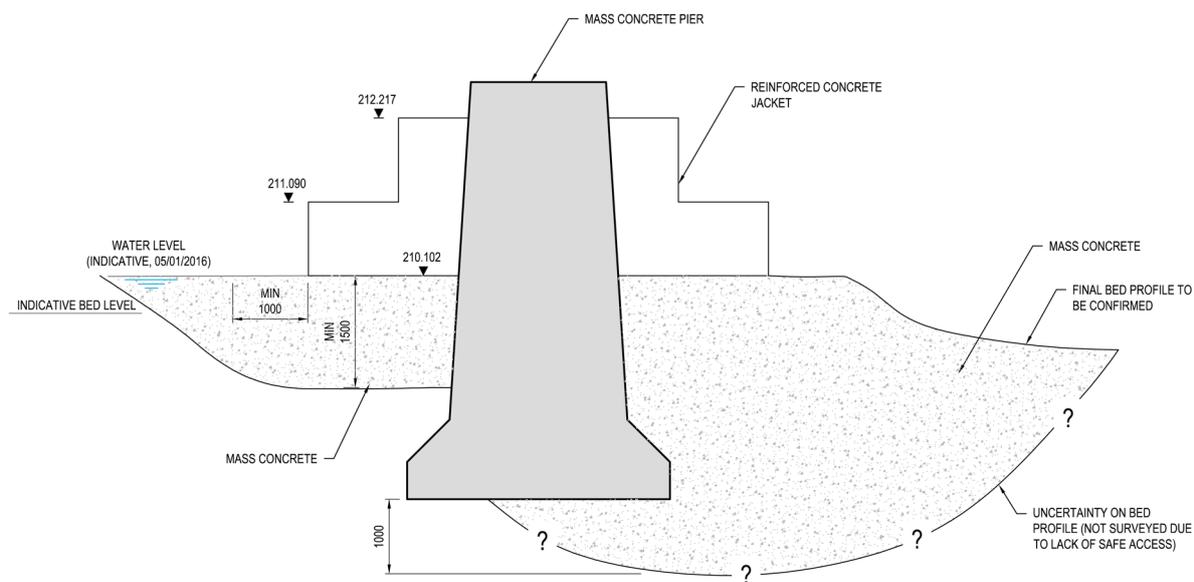
Figure 18: Cross-sections through pier 2's masonry section (upper) and concrete pier extension (lower) showing extent of scour damage recorded by divers on 2 January 2016. The reinforced concrete jackets installed to stabilise the pier are also shown (courtesy of Network Rail).

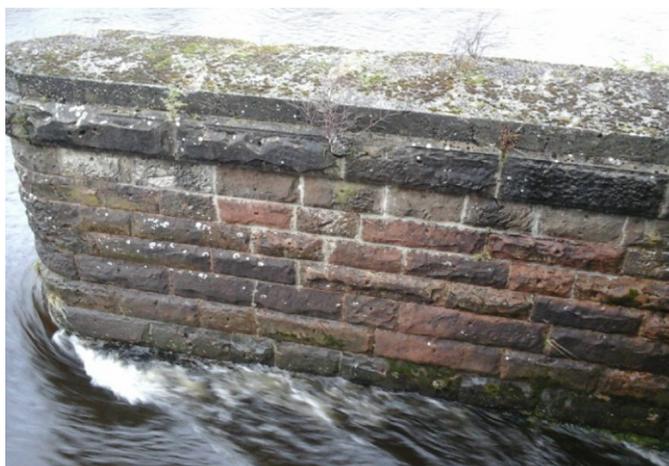
153 The upstream end of pier 2 had a long history of structural defects where voids had developed and masonry blocks had been displaced. Repairs were undertaken in 2008 and 2009, but these were limited in scope and did not address underlying structural issues. Despite these problems, the section of pier 2 that failed was downstream of the known voids and in an area with few recorded defects.

Figure 21: Upstream end of pier 2 on 9 December 2015, seen during a visual examination three weeks prior to the incident (photograph courtesy of Network Rail)

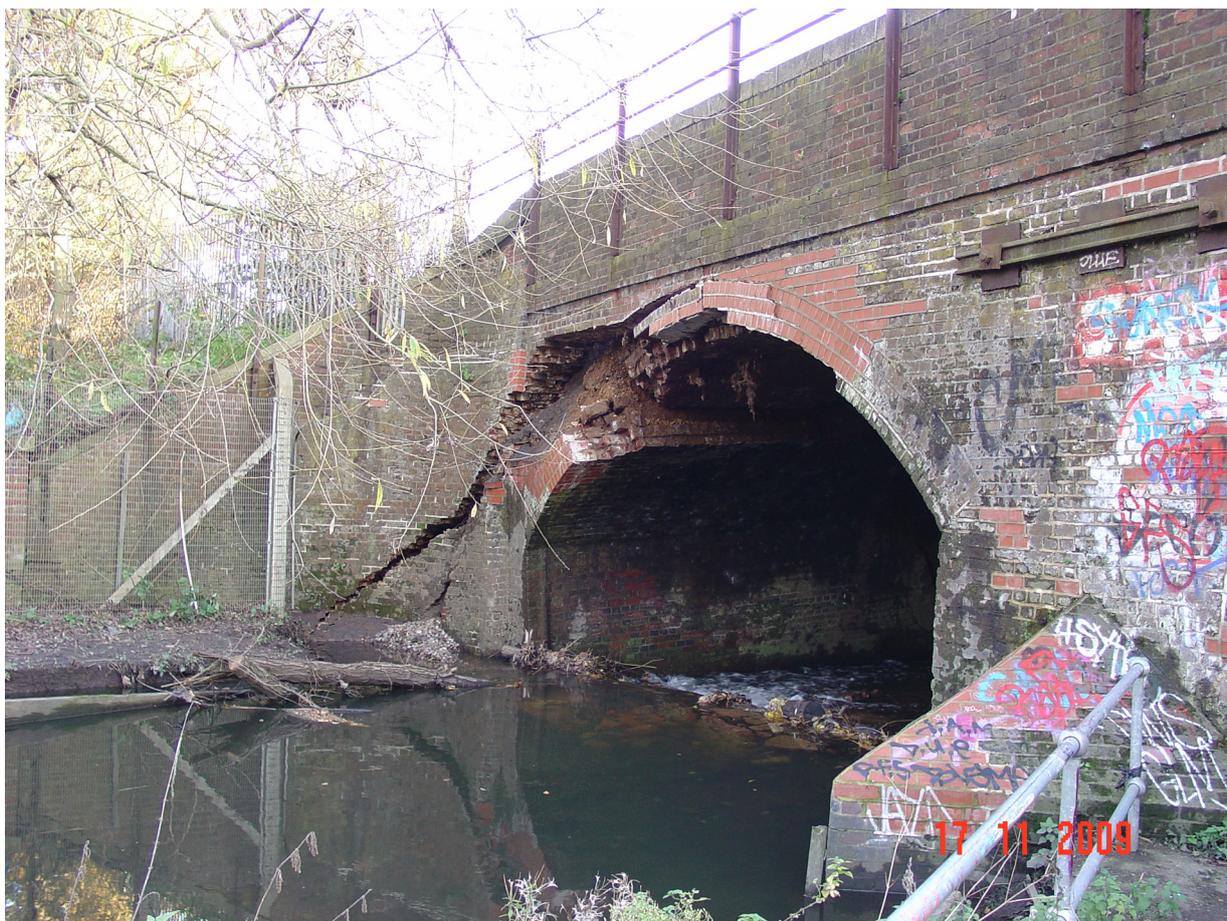
- 170 The most recent similar scour incident to affect Network Rail's infrastructure involved the failure of an arch bridge carrying the railway over the River Crane in Feltham, west London in November 2009 (figure 22). The bridge's foundations failed without warning after the river was partly blocked by debris, causing part of the bridge to subside ([RAIB report 17/2010](#)). The first indication of a problem was a track defect reported by a train driver. Track maintenance staff were called to the site and immediately blocked the line to all traffic when they became aware of a serious defect with the bridge. A total of 21 trains crossed the failing bridge between the first report and closure of the line. There was no derailment and no injuries occurred, but the bridge had to be demolished and rebuilt (refer to Recommendation 2).

Figure 22: Bridge RDG1 48, spanning the River Crane between Whitton and Feltham in west London. The arch failed after its abutment was undermined by scour erosion on 15 November 2009.

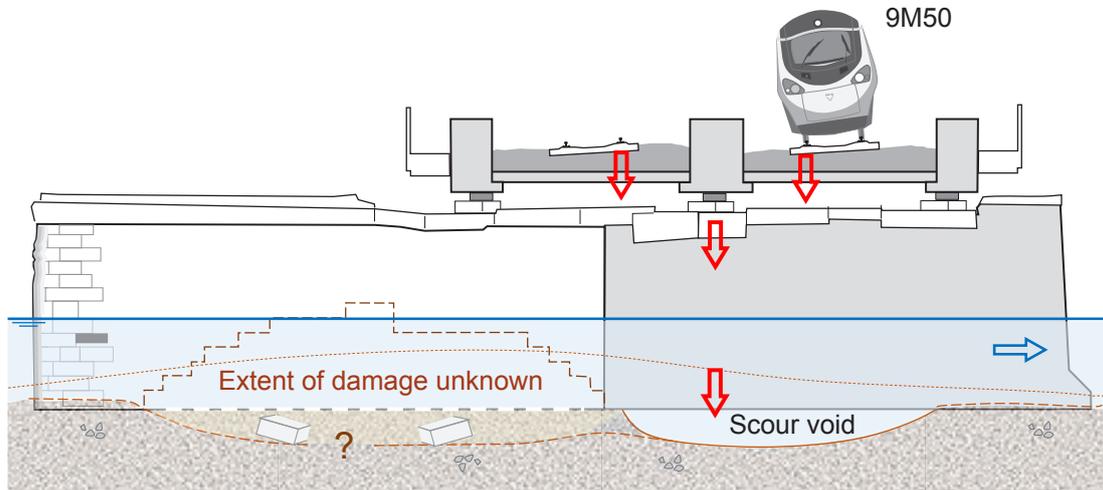
- 63 The relationship between scour damage and the dip felt at 07:28 hrs (paragraph 38) is illustrated in appendix D. The dipped rail on the up line was directly above a scour void beneath the concrete pier extension. It is likely that the loads imposed by train 1S34 passing over the viaduct at high speed at 08:40 hrs were the trigger for the large track movements seen after this train passed. It is likely that these loads fractured the already weakened masonry pier causing it to suddenly subside. Earlier trains would have imposed similar loads, but at a time when scour damage had not developed sufficiently for these loads to trigger a significant track movement.

D2: At 07:28 hrs on 31 December, the driver of 9M50 felt a dip in the track. This occurred because the supporting pier had been partially undermined by scour.

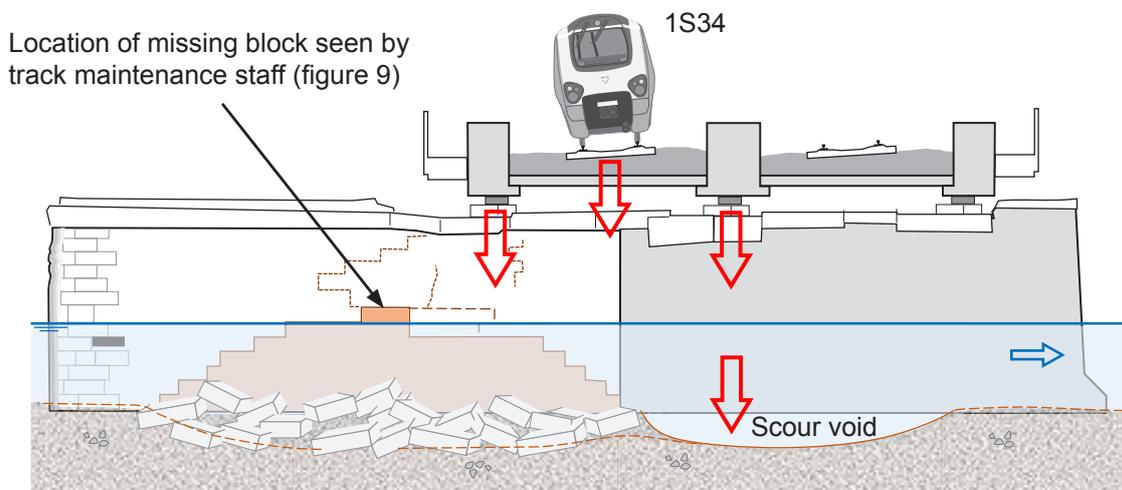
D3: At 08:40 hrs on 31 December, track distortion on down line revealed damage to the masonry section of the pier which had partially collapsed (refer to figure 16).
