SAFETY FLYER TO FISHING INDUSTRY

Fishing vessel *Our Sarah Jane* (NN710), fatal man overboard, 9 June 2016

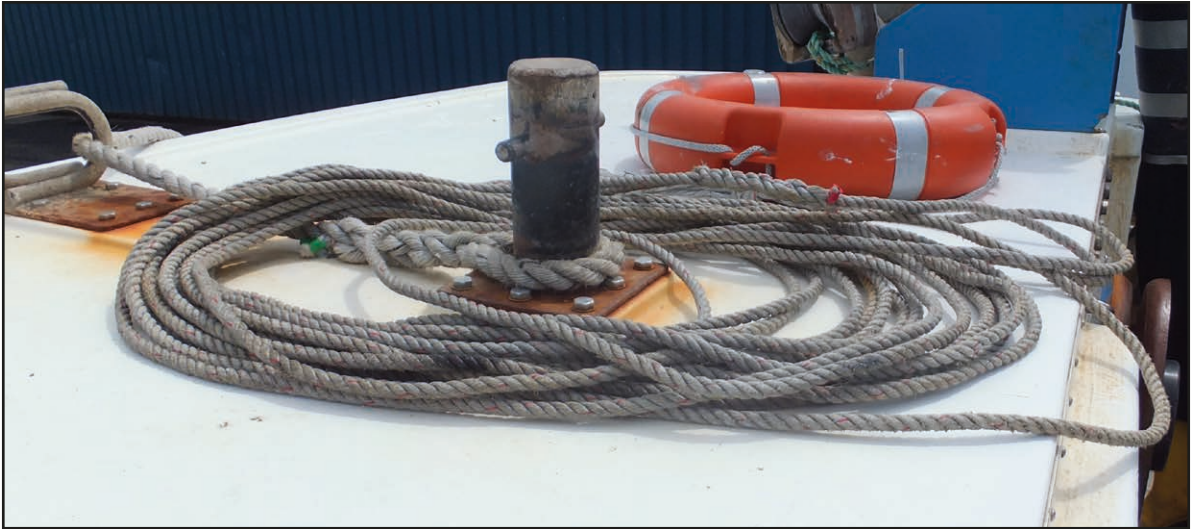
The skipper tied a polysteel mooring rope to a lifebuoy and threw it towards the man overboard, but it fell short. The skipper then parted the backline by putting both engines ahead at fast speed, but when the vessel was manoeuvred close to the man overboard he was face-down and motionless. The lifebuoy was again thrown, but the man overboard did not respond. The other deckhand jumped into the water to assist but he also quickly got into difficulty and started to lose his strength. He was not wearing a lifejacket and was being weighed down by the polysteel rope from the lifebuoy, which he had used as a lifeline. The skipper pulled the deckhand back on board but, by then, the man overboard was no longer in sight. Despite an extensive air and sea search he was not found.

The MAIB investigation identified that the man overboard had possibly been using recreational drugs, and had jumped into the water despite the skipper instructing him not to do so. He and the other deckhand almost certainly suffered from cold water shock following immersion. In addition, the assistance to the man overboard was initially impeded by the vessel's inability to manoeuvre, and valuable seconds were lost by not having at hand a lifebuoy with a lifeline already attached.

Lifebuoy and polysteel rope

3. It is essential that lifesaving equipment is available in an emergency situation. However, over time, such equipment is frequently damaged, misplaced, or goes 'out of date'. Owners and skippers should not rely on routine surveys to identify what is missing, but ensure they conduct regular checks to ensure the equipment will be available and effective if needed.

5. Lifebuoys are simple and effective devices that are intended to provide buoyancy to persons in the water to prevent them from drowning. Do not delay in throwing the nearest one available to optimise their chances of survival.
