# **Service Inquiry**

Watchkeeper 006

2 Nov 15

**SERVICE INQUIRY INTO AN ACCIDENT INVOLVING A WATCHKEEPER UNMANNED AIRCRAFT (UA) WK006 AT MoD BOSCOMBE DOWN (BDN), WILTSHIRE ON 2 NOV 15**

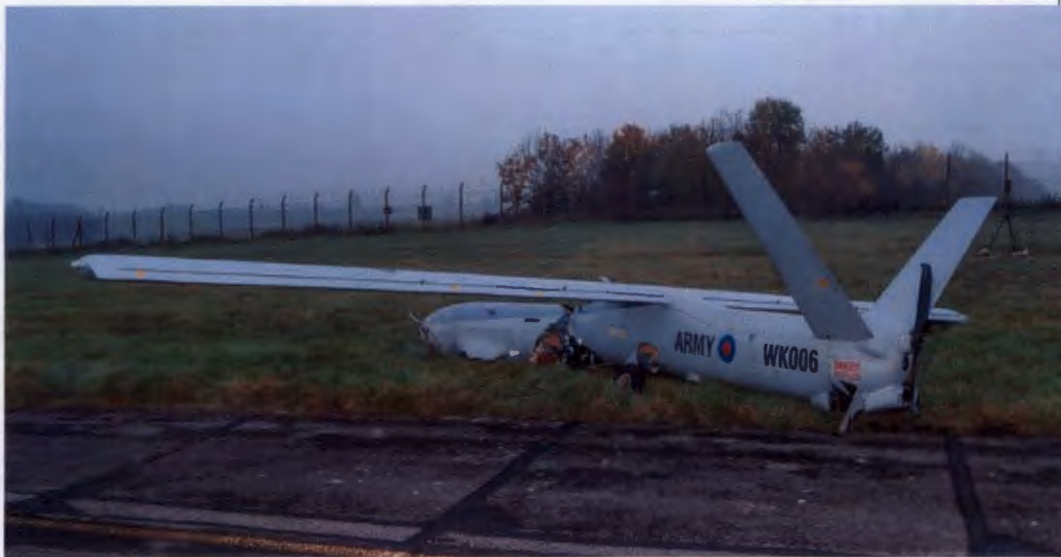
1.3.2. Following 2 aborted landing attempts, on the third attempt at 23ft Above Ground Level<sup>1</sup>(AGL), the UA pitched nose down, resulting in it impacting the ground at approximately 35-deg nose down, on the centreline, just over 100 metres short of the planned touchdown point. The UA nose and main undercarriage collapsed and the UA slid along the runway for approximately 120m before coming to rest just off the western side of the runway, as shown below in Figure 1. There was no post-crash fire or any injuries sustained to personnel.

Figure 1 – WK006 Wreckage

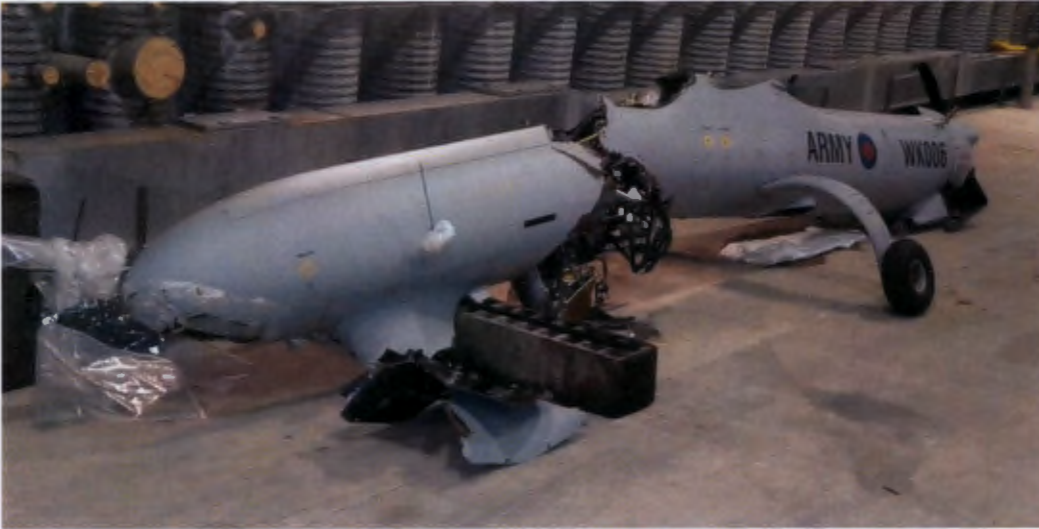
1.3.39. **Damage assessment.** The UA sustained significant damage as shown in Figure 9. Following an assessment and recommendation by 1710 NAS on 10 Feb 16 the damage to the UA was formally categorised as CAT 5 (beyond economical repair) by the DE&S Unmanned Air Systems Team (UAST).

**Figure 9 - Damage to UA (wing assembly removed).**

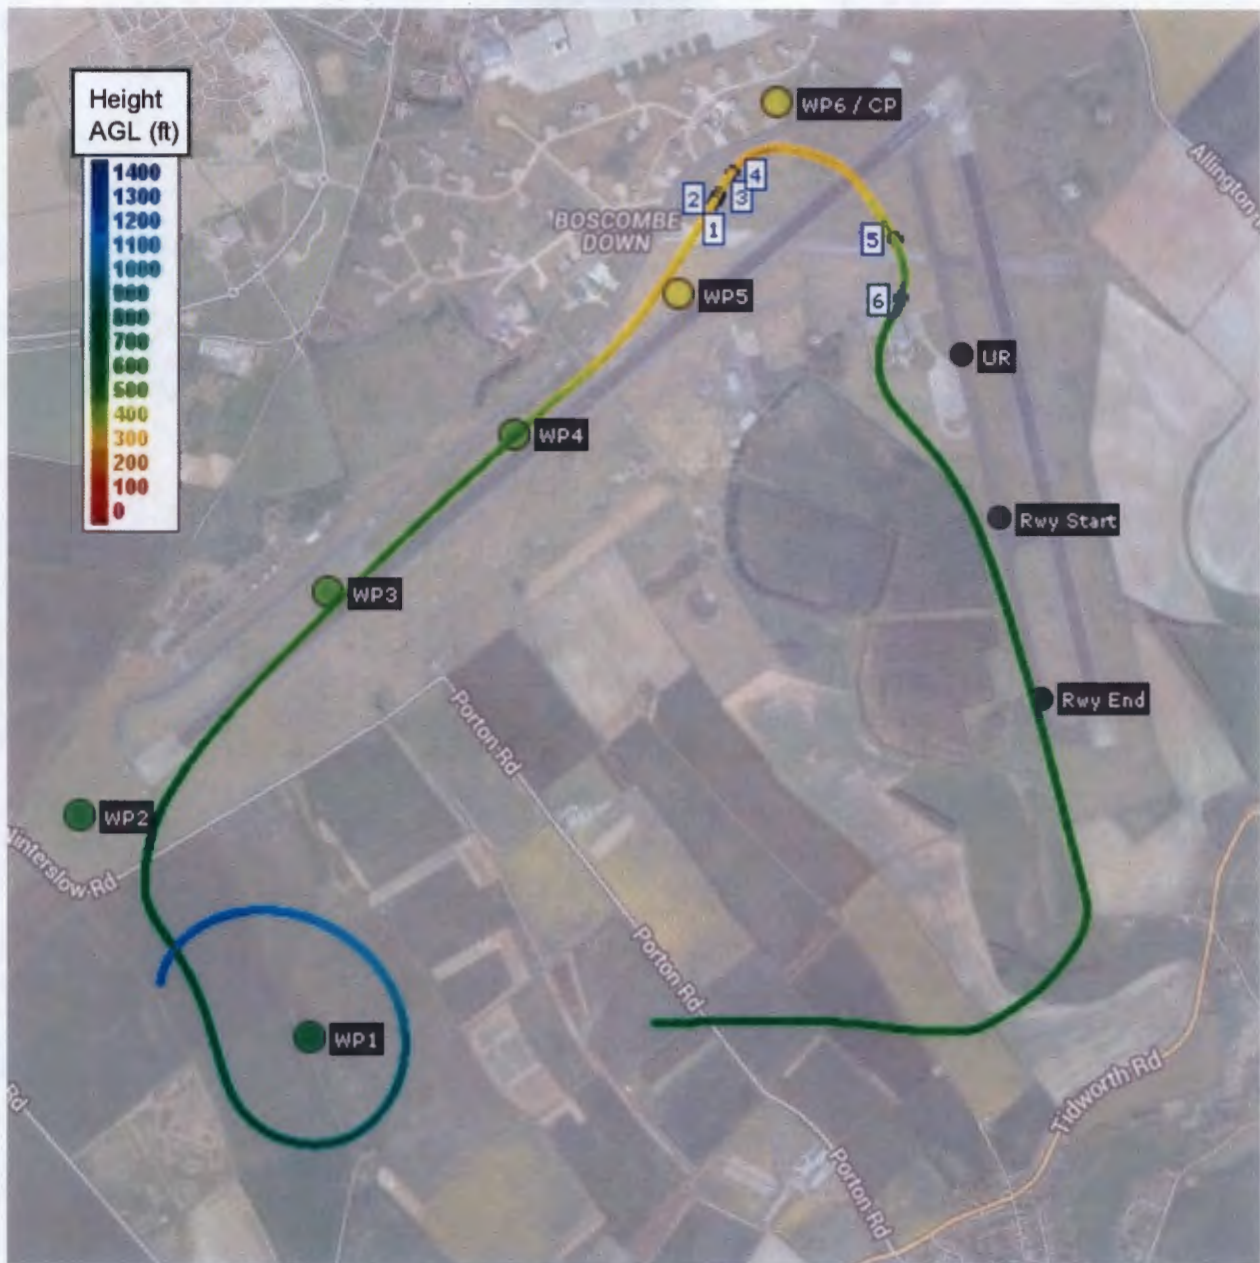
Figure 1 – First aborted approach and go-around.

Event Label	UTC	Description
1	1538:04.00	The ATOL mode recorded in the VMSC data changed from <i>Standby</i> (ATOL_STATE 11) to <i>Intercept</i> (ATOL_STATE 5), signifying that the UA had reached the CP.
	1538:04.05	The UA intercepted the glide slope. The ATOL mode changed from <i>Intercept</i> to <i>Approach</i> (ATOL_STATE 6)
2	1538:04.55	In the Master Fault List (MFL) <i>ATOL_MSG_67</i> was recorded, which means that no ATOLS data had

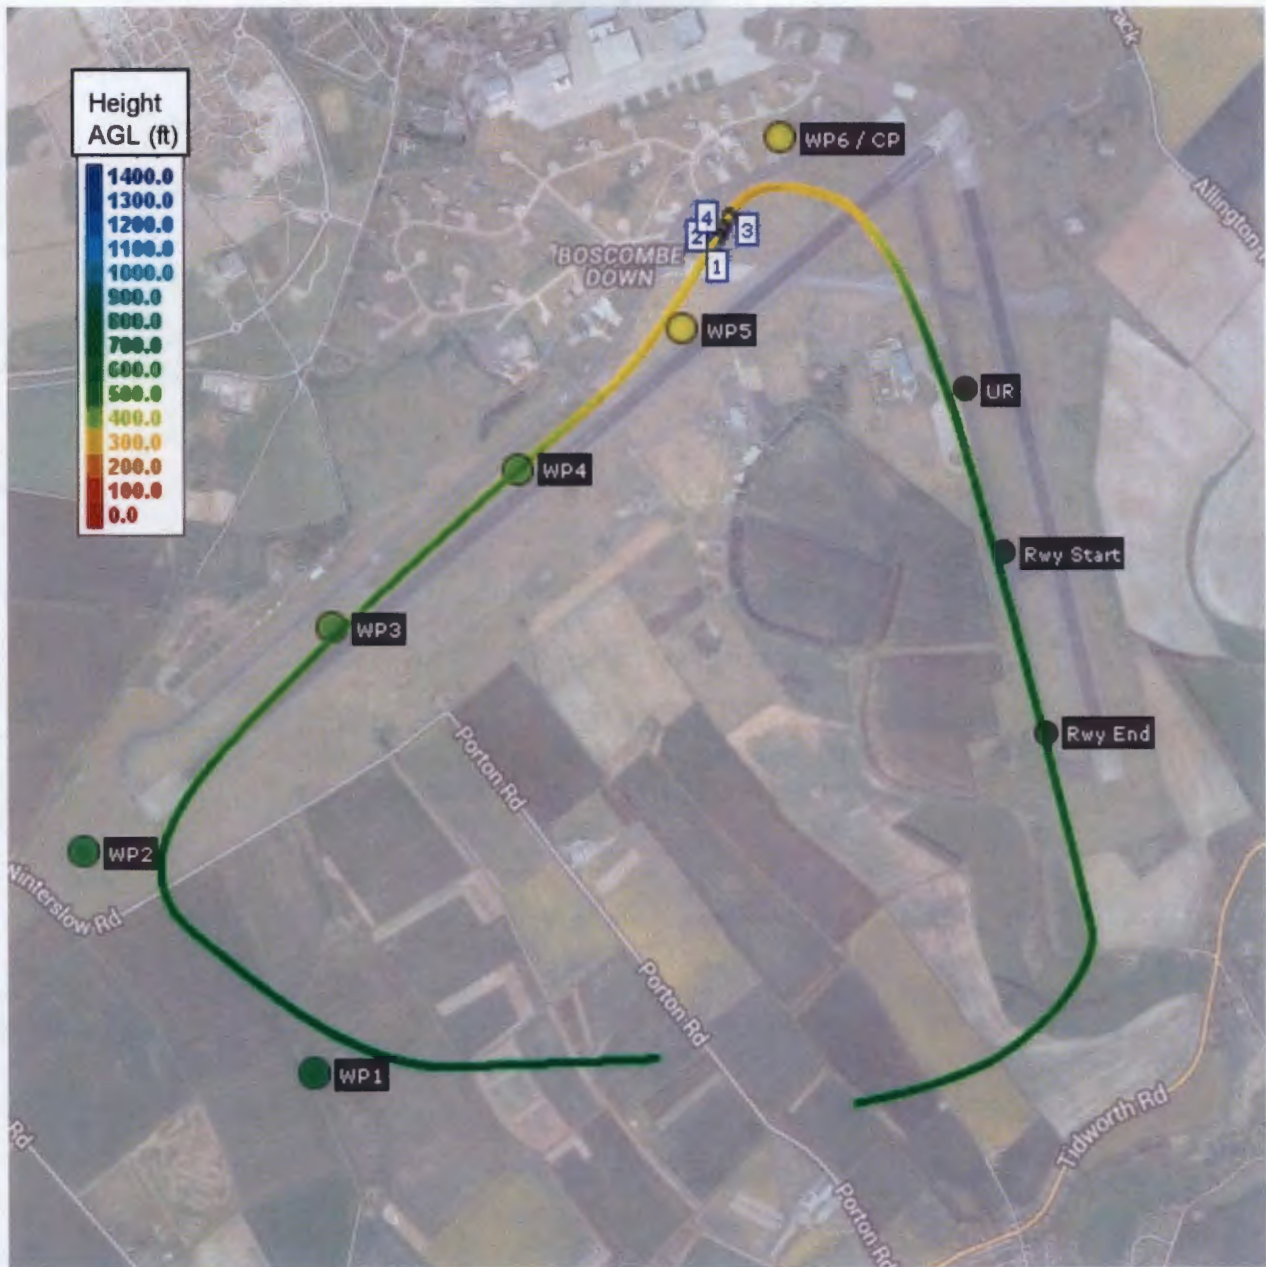
Figure 2 – Second aborted approach and go-around.

Event Label	UTC	Description
1	1542:54.00	The ATOL mode recorded in the VMSC data changed from <i>Standby</i> to <i>Approach</i> <sup>3</sup> showing that the UA had reached the CP and was within glide path limits. The laser altimeter readings were 0.25m and 0.78m, which opened a <i>Ground Touch identification window</i> .
2	1542:54.50	MFL – ATOL_MSG_67 was recorded indicating that the UA was not receiving ATOLS data.
3	1542:55.30	The Weight on Wheels (WOW)1 code changed from <i>In-air</i> (WOW1 code 0) to <i>Air-to-ground</i> (WOW1 code 4) showing that the UA had sensed a <i>Ground Touch</i> .
	1542:55.35	The WOW1 code changed to <i>Ground-to-air</i> (WOW1 code 64) showing that the VMSC had sensed that the UA had 'bounced'. The ATOL mode changed from <i>Approach</i> to <i>Air Jump</i> (ATOL_STATE 15) as a result.
4	1542:56.80	MFL – ATOL_LANDING_TIMEOUT was recorded indicating that the <i>Ground Touch identification window</i> had again timed-out. The landing was automatically aborted.

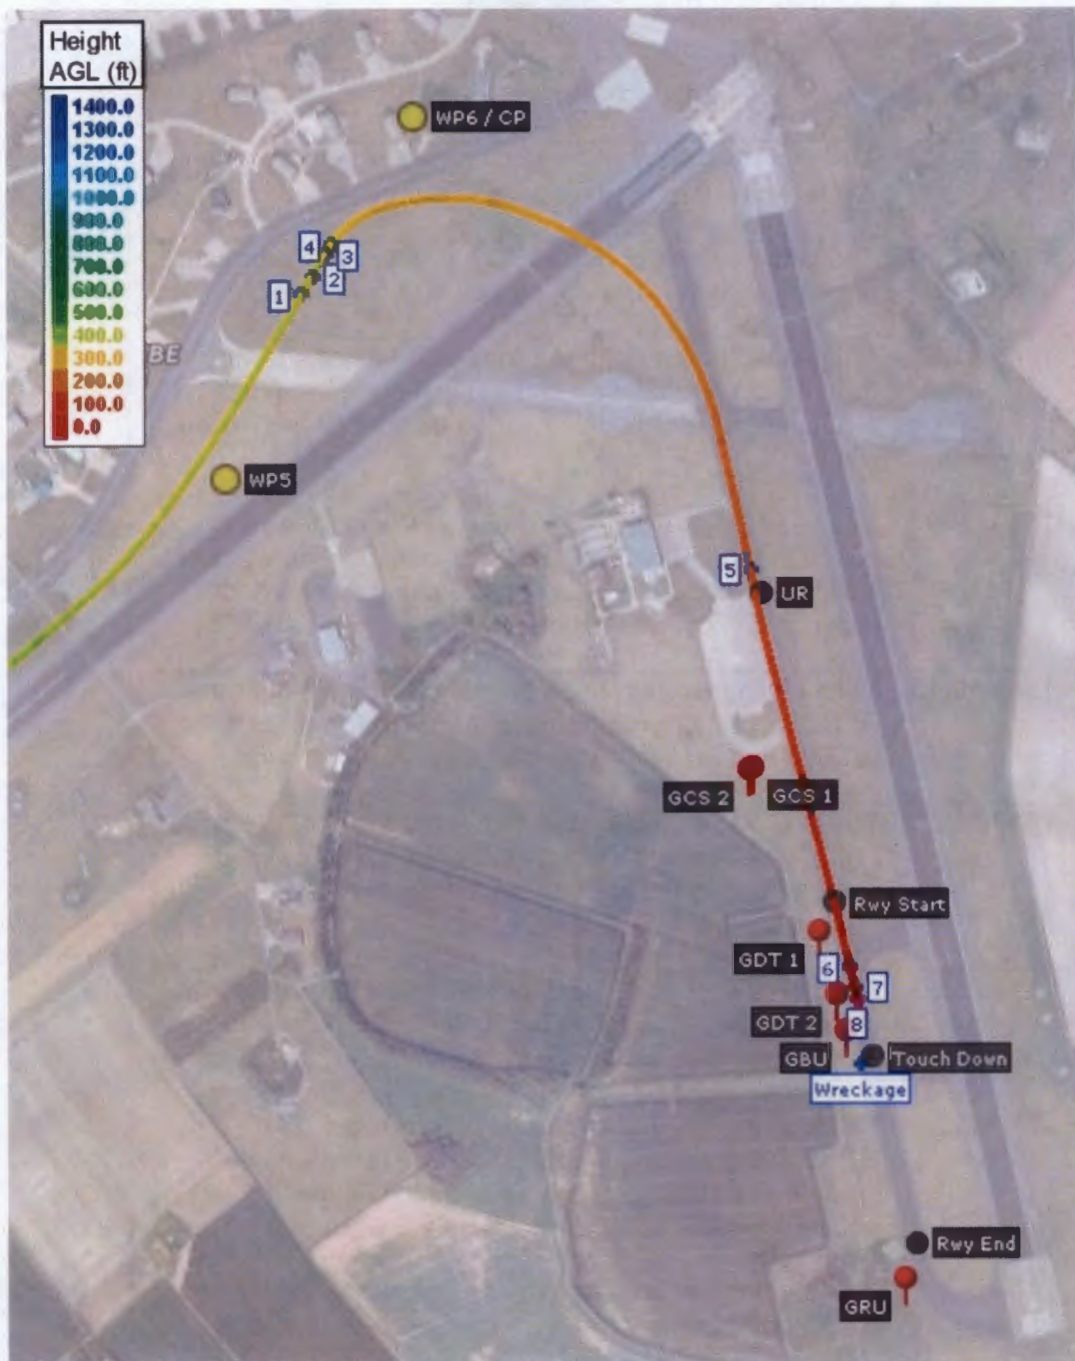
Figure 3 – Final approach and crash landing on the runway

Event Label	UTC	Description
1	1549:46.00	The ATOL mode changed from <i>Standby</i> to <i>Intercept</i> denoting that the UA declared that it had reached the CP.  The laser altimeters gave readings of 0.34m and

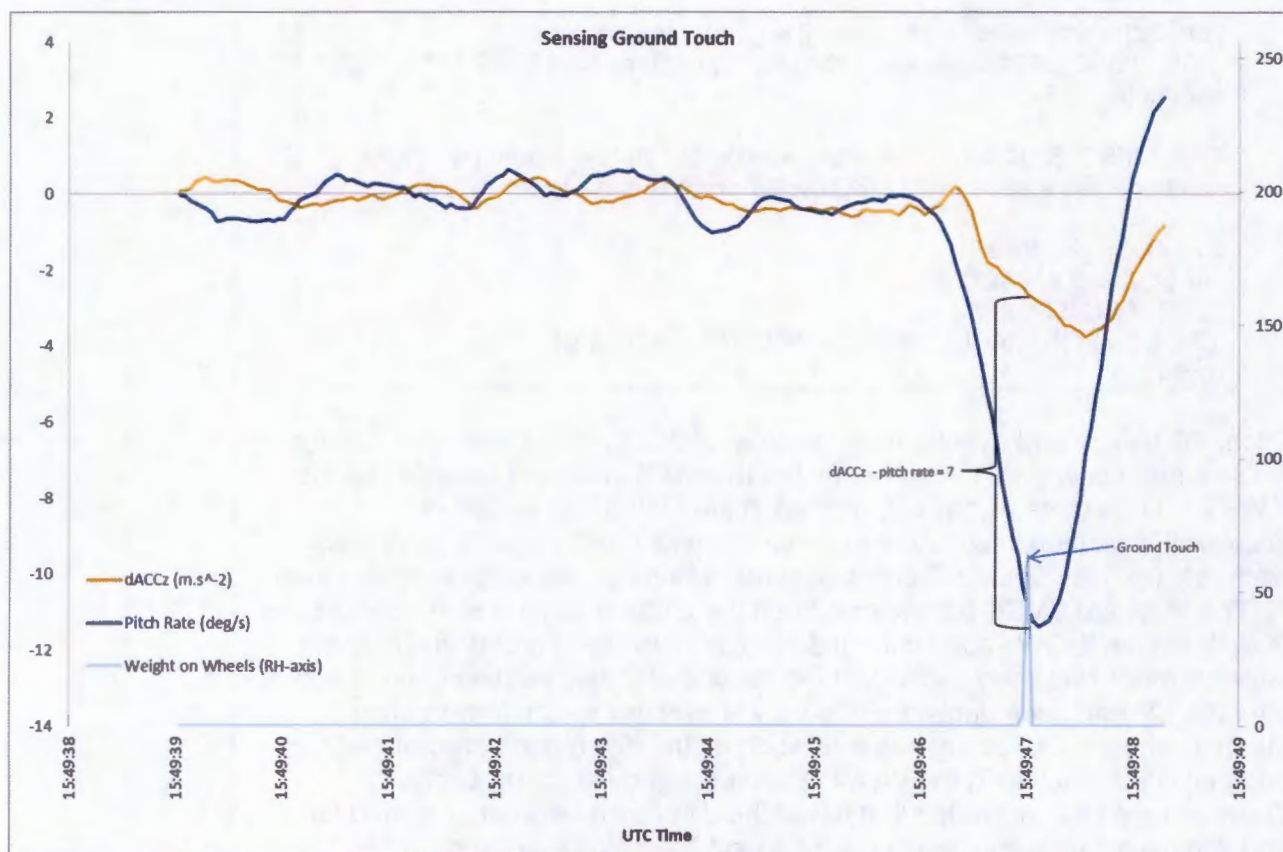
Pitch, Pitch Rate and Acceleration (given as  $ACC\ X$ ,  $ACC\ Y$  and  $ACC\ Z$  in the FRS extract above) are measured by the INS/GPS units and recorded by the VMSC. The parameter  $dACCZ$ , defined in the FRS as a function of acceleration, is then used to determine a *Ground Touch value* by subtracting *pitch rate* from it. *Ground Touch* is declared when this value goes greater than 7. The recorded VMSC data showed that the *Ground Touch value* went greater than 7 and the WOW1 code changed from *In-air* to *Air-to-ground* indicating a *Ground Touch* had been sensed on the second and third landing attempt shortly after the CP had been declared. Figure 4 shows this on the final landing attempt, where it can be seen that as soon as the difference between  $dACCZ$  and *pitch rate* reached 7, the WOW1 state changed indicating *Ground Touch*. The panel concluded that it was the difference between the *pitch rate* and vertical acceleration that caused *Ground Touch* to be sensed.

Figure 4 – Sensing Ground Touch whilst airborne on the final circuit

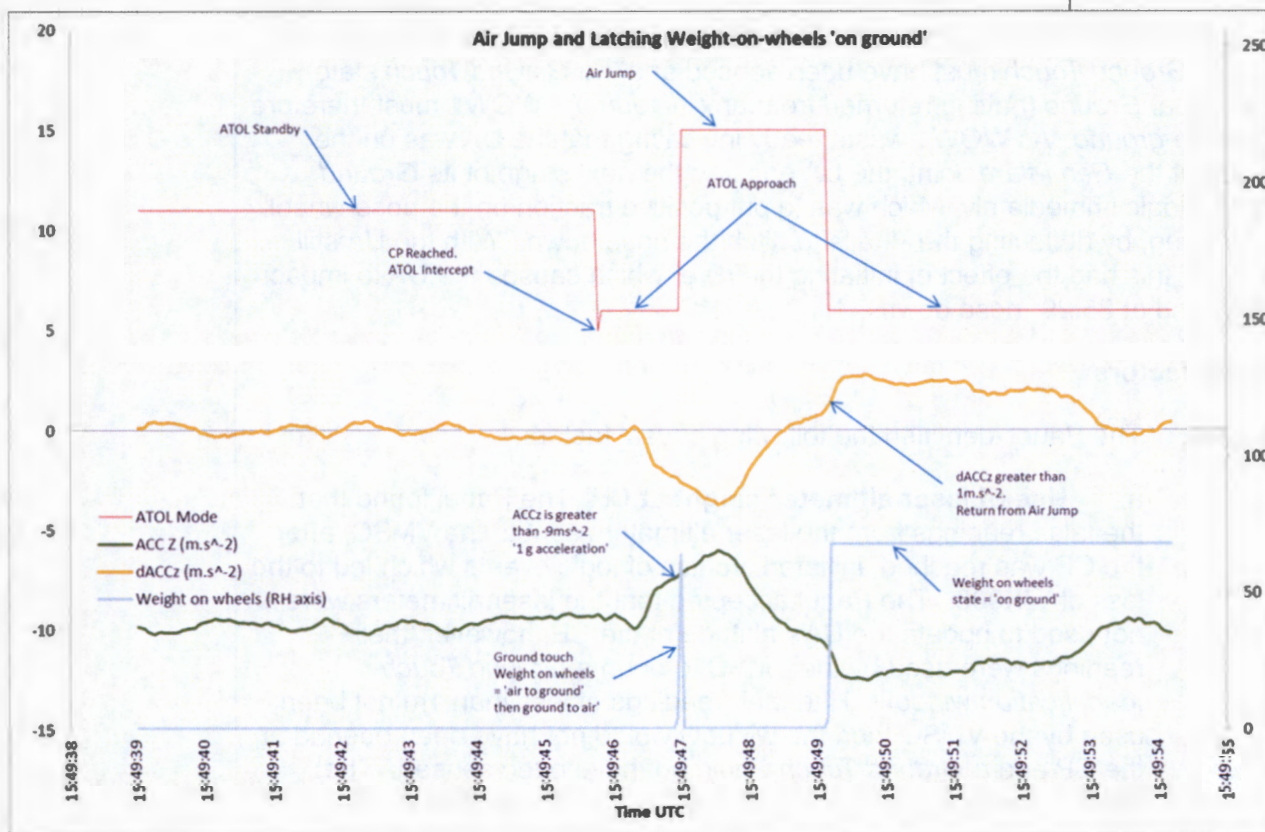
Therefore, it can be seen that *Air Jump* should end when dACCz has a value of greater than  $1\text{ms}^{-2}$  for more than 0.1 seconds. Analysis of the VMSC data showed that on the final approach *Air Jump* ended when these parameters were met, with a corresponding change in the WOW1 state to *On-ground*. Figure 5 shows that vertical acceleration (labelled as ACC Z) was greater than  $-9\text{ms}^{-2}$  at the first *Ground Touch* and that the ATOL State changed to *Air Jump*, only returning to *Approach* when dACCz reached a value of  $1\text{ms}^{-2}$ , at which point WOW1 latched to *On-ground*.

Figure 5 – Air Jump and Latching Weight-on-Wheels

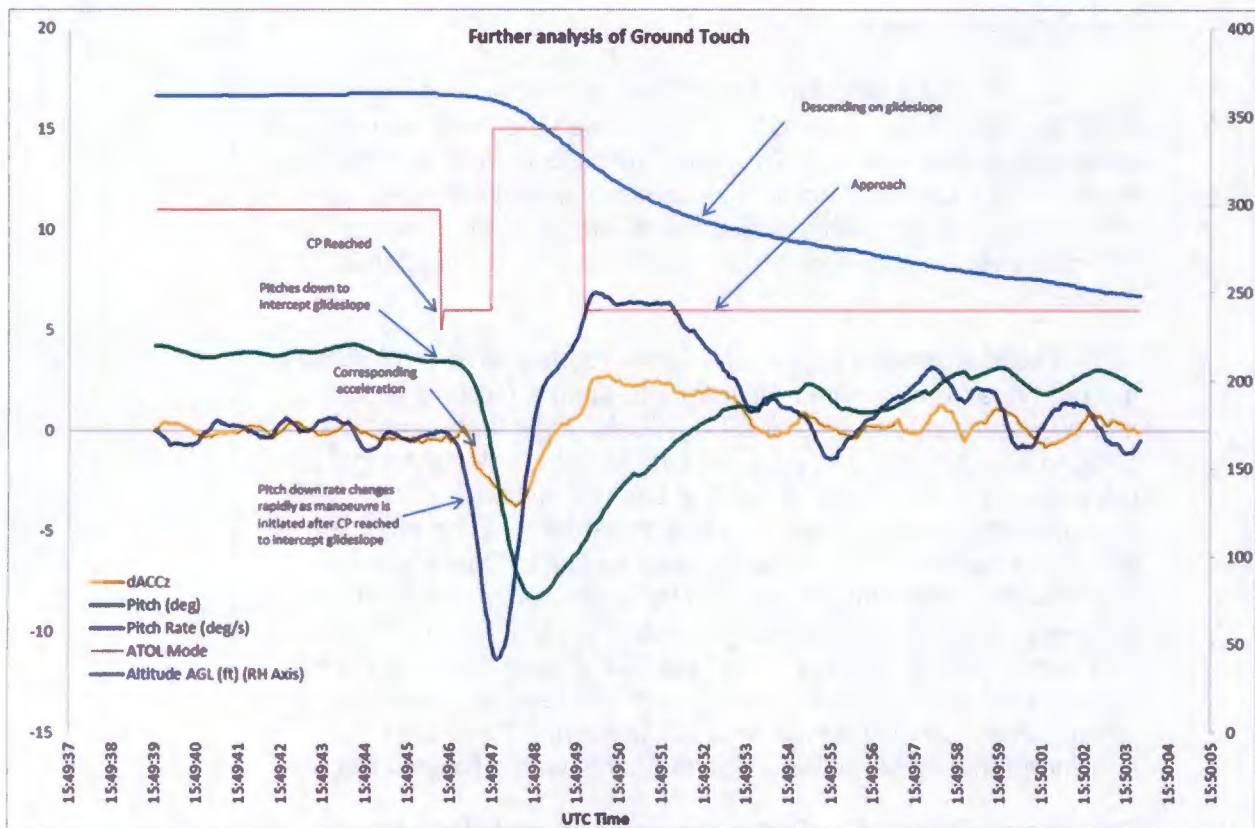
1.4.1.36. **Cause of Ground Touch at the CP.** The Panel investigated what caused the difference between the pitch rate and vertical acceleration, which triggered *Ground Touch* shortly after the CP was declared on the final 2 approaches. The VMSC data plotted in Figure 6 shows that on declaring the CP, the UA pitched nose-down to a maximum of  $-8^{\circ}$ . The rate of change in pitch (pitch rate) associated with this reached a maximum rate of  $-12^{\circ}\text{s}^{-1}$ . This manoeuvre also induced an upwards vertical acceleration (negative g-force), shown by the negative dACCZ values at the start of the manoeuvre. Despite dACCZ and pitch rate both moving in the same direction (becoming increasingly negative), the pitch rate changed more rapidly and a sufficient difference between the two parameters developed resulting in a *Ground Touch* being declared (as previously shown in Figure 4). The Panel, therefore, concluded that it was the rapid pitch down manoeuvre immediately after the CP was declared that caused *Ground Touch* to be sensed on the second and third approach.

Figure 6 – Further analysis of Ground Touch

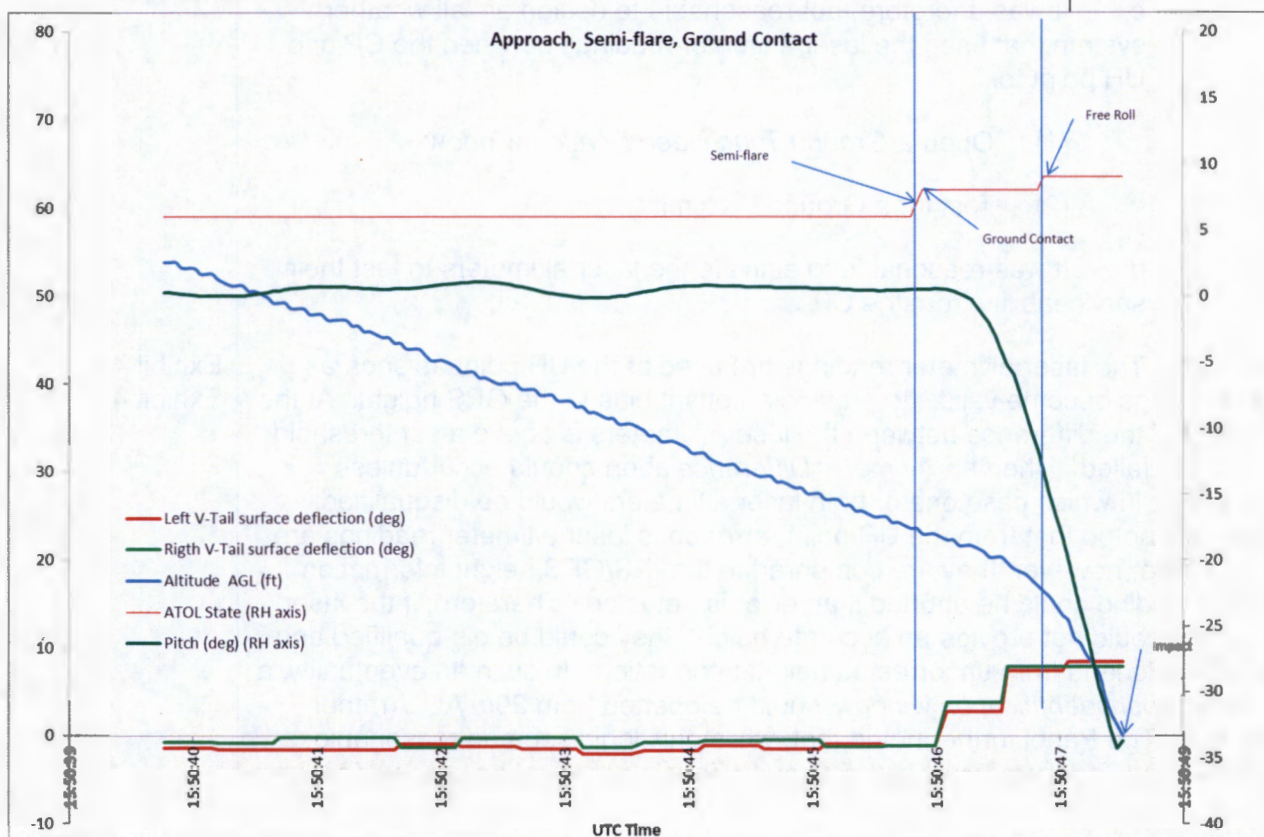
- The UA was descending on a constant glide path up to the Semi-flare point.
- On reaching the Semi-flare point, the ATOL state immediately changed to Ground Contact.
- Both V-tails deflected down (note a positive value denotes a downward deflection) inducing a pitch down manoeuvre.
- Free-roll was declared one second after *Ground Contact* was declared, by which time the UA was already pitching down.

The Panel concluded that the UA commanded post landing actions after *Ground Contact* was declared and that *Free-Roll* had no effect on the pitch of the aircraft, which continued to increase until it hit the ground. *Free-Roll* was therefore **not a factor**.

Figure 7 – Approach, Semi-flare, Ground Contact, Free-roll
