## SECTION 1.4.5 – LEVELS OF PLANNING AND PREPARATION

1. Watchkeeper number 006 (WK006) was the second Watchkeeper (WK) air vehicle to crash in just over 12 months, the first being WK031 at West Wales Airport in Oct 14. Both crashes were as a result of the Vehicle Management System Computer (VMSC) commanding post landing actions (V-tail deflection) whilst the vehicles were still airborne. In both cases, the VMSC sensed and latched a false Ground Touch, although the hazard entry condition in each case was different, WK031 being a gust of wind and WK006 a pitching manoeuvre (to capture the glideslope) both of which produced negative accelerations to the point of the VMSC registering Ground Touch. In both accidents the laser altimeters were reading erroneously during periods of the approach either due to fog below the air vehicle or a wet runway causing reflections. These conditions set the scene for the vehicle to believe it was on the ground during the semi-flare when it was in fact still airborne. It is of concern that further unforeseen technical hazard entry conditions existed which meant that mitigation of known system issues was insufficient to prevent reoccurrence. Accordingl

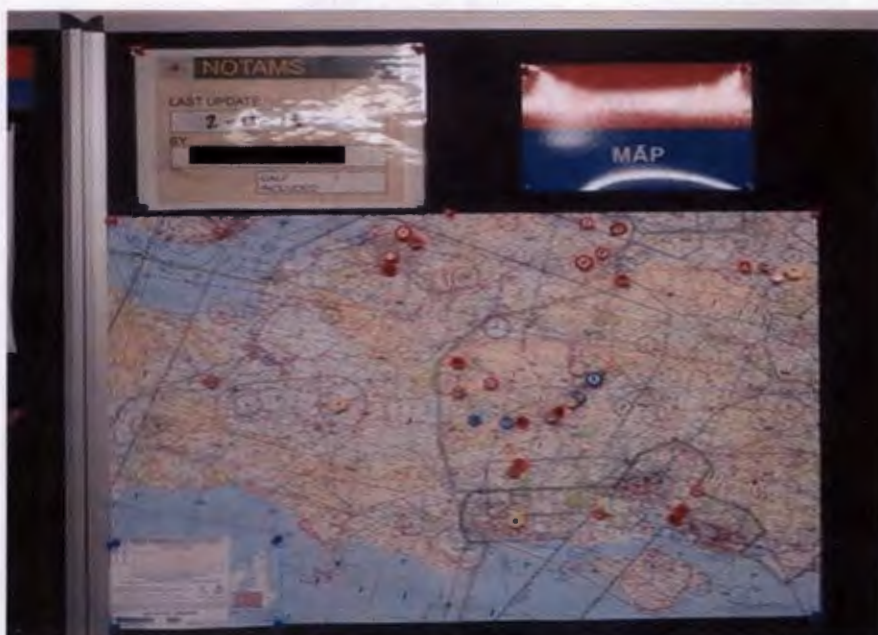
Figure 25 - NOTAM display in Bty Planning/Briefing Room

b. **Panel Analysis.** The CALF<sup>64</sup> document displayed in the Bty was over 4 months out of date on 2 Nov 15. Additionally, the Panel established that the NOTAM LFC<sup>65</sup> Map in the Planning and Briefing Room showed no record of CALFs being included (Figure 25). Whilst the Panel identified that the limited availability of Ops SQEP was in the process of being addressed by JHC and mitigations had been put in place, such as Army personnel being seconded to BDN Main Ops, the Panel **observed** that WK Ops personnel were not sufficiently SQEP, with potential implications on the safe operation of WK.

1.4.5.24. **Recommendation.** The Panel recommends that the Delivery Duty Holder should:

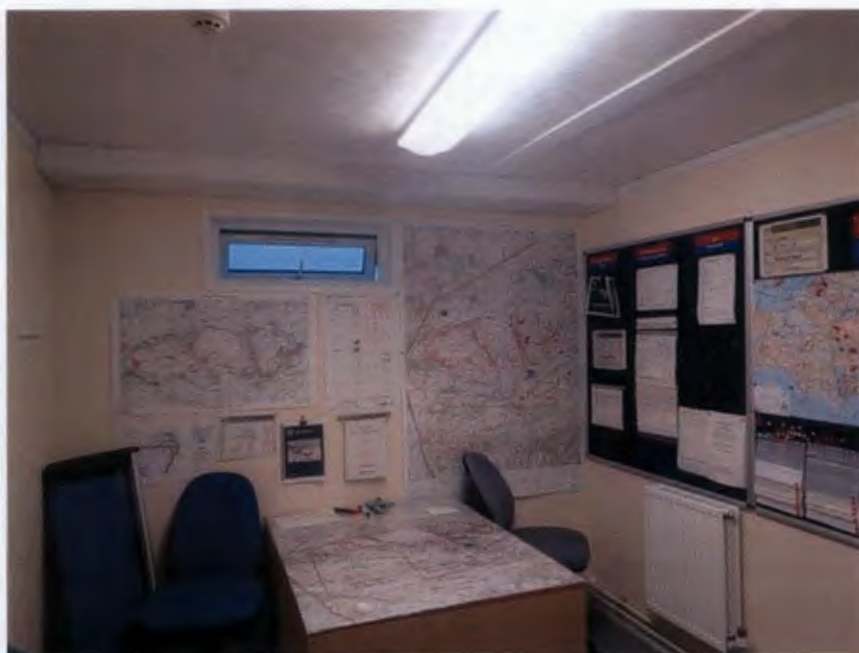
Figure 26 - Planning and Briefing Facility for WK at BDN

b. **Observed** that the planning and briefing facilities were inadequate. The room available to plan and brief (Figure 26) was extremely limited in size considering the number of crew involved. Additionally, the Bty Ops set up did not follow recognised best practice by providing a dedicated flight authorisation area.

1.4.5.27. **Recommendation.** The Panel recommends that the Head of Capability Combat Support should ensure that:
