# Rail Accident Report

## Collision at Plymouth station 3 April 2016

Report 02/2017  
February 2017

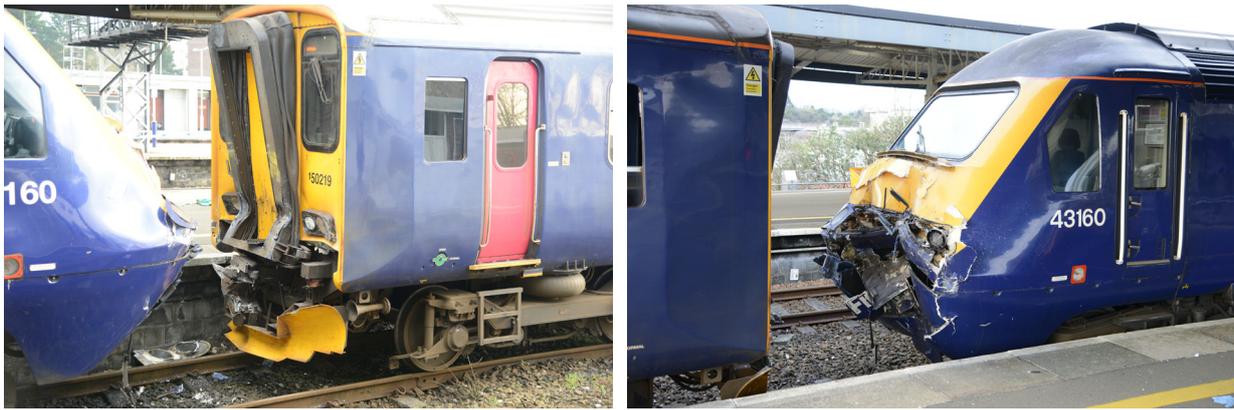
Figure 2: Damage to train 2E68 (left image) and train 1A91 (right image)

- 29 Many people who were standing up waiting to get off train 2E68 were thrown into each other, into the train's fixtures, and onto the floor. The collision resulted in injuries to 42 passengers and 4 members of staff on train 2E68, including one passenger who was seriously injured<sup>3</sup>. Two members of GWR staff on train 1A91 were also injured during the collision. Both trains were damaged.

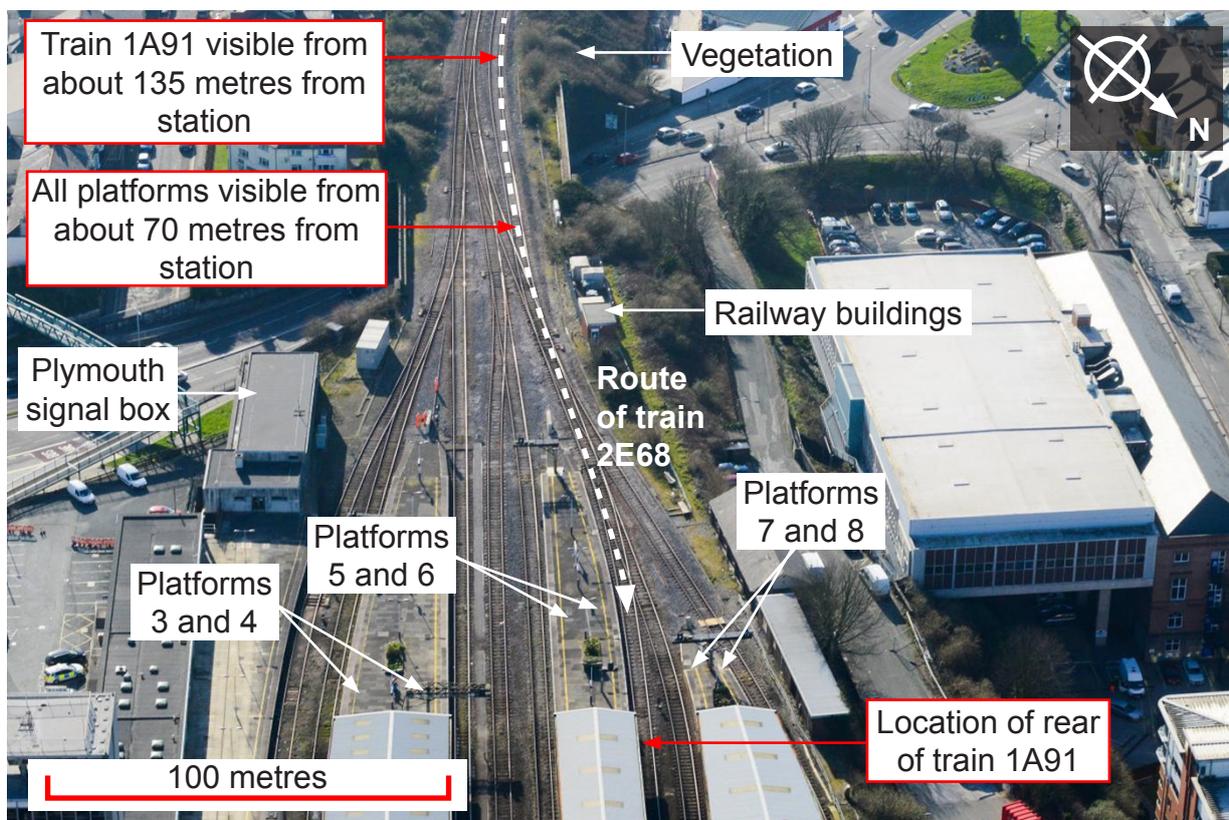
Figure 4: Features obscuring an approaching driver's view of platforms 6, 7 and 8 (image courtesy of Network Rail)

- 70 The presence of track curvature, vegetation and railway buildings (figures 3, 4 and 12) meant that the driver of 2E68 could not see platforms 7 and 8, and so could not establish the location of platform 6 by counting across from platform 8, until about 13 seconds (125 metres) before the collision. Counting at this stage would have revealed that train 1A91 was in platform 6 and would have given the driver sufficient time to stop his train safely. He did not count platforms at this stage because he had concluded that there was insufficient room for his train to share the platform occupied by train 1A91, and so had discounted the possibility of his train being routed into this platform. Although the driver of train 2E68 was competent to drive the route to Plymouth, he was still gaining practical experience driving it. It is possible that a more experienced driver would have recognised that train 1A91 was occupying platform 6 in time to prevent a collision (paragraphs 66 and 67).

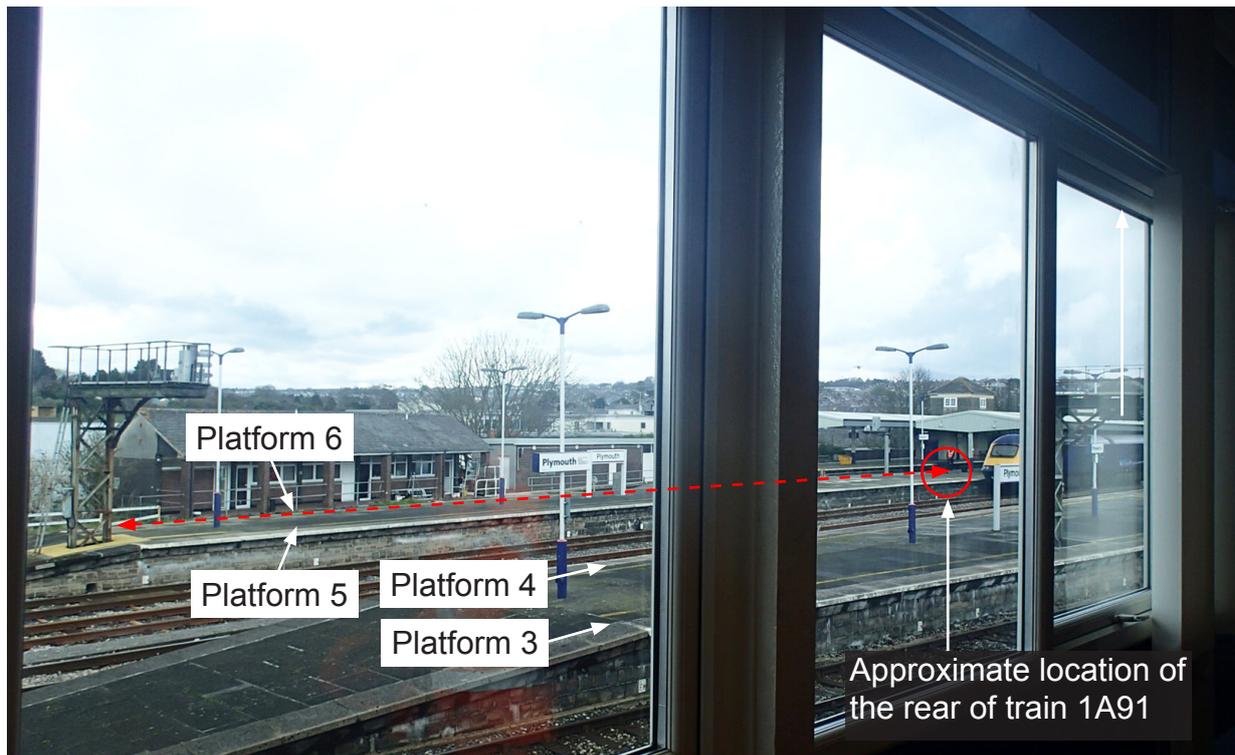
- 45 When considering whether he could put train 2E68 into platform 6, the signaller looked through the signal box window and judged that there was enough room for train 2E68, which he knew to be four vehicles long, to fit between the rear of train 1A91 and the end of the platform (figure 9). This would require a permissive movement by train 2E68 (paragraph 32).

Figure 9: View of platform 6 through the signal box window

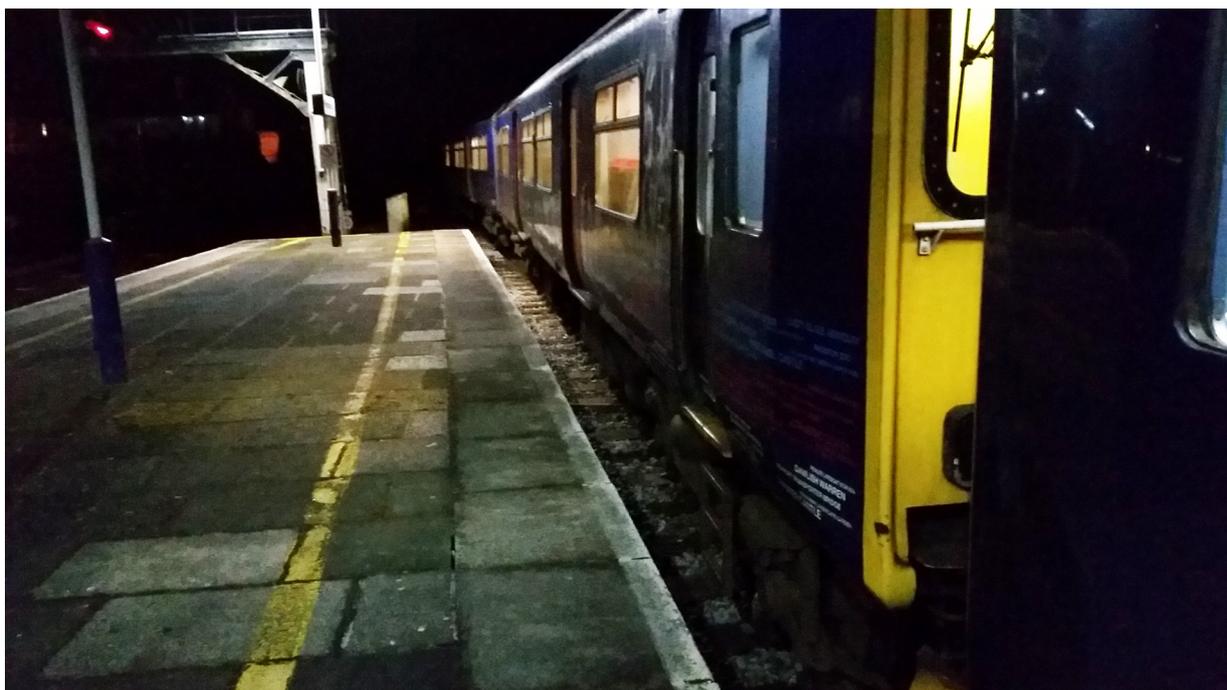
- 49 The actual length of platform available to accommodate train 2E68 was about 61 metres, around 20 metres less than needed. GWR considered that part of this 61 metres was unsuitable for boarding and alighting passengers (paragraph 53).

Figure 10: Gap between the third vehicle of train 2E68 and the platform edge

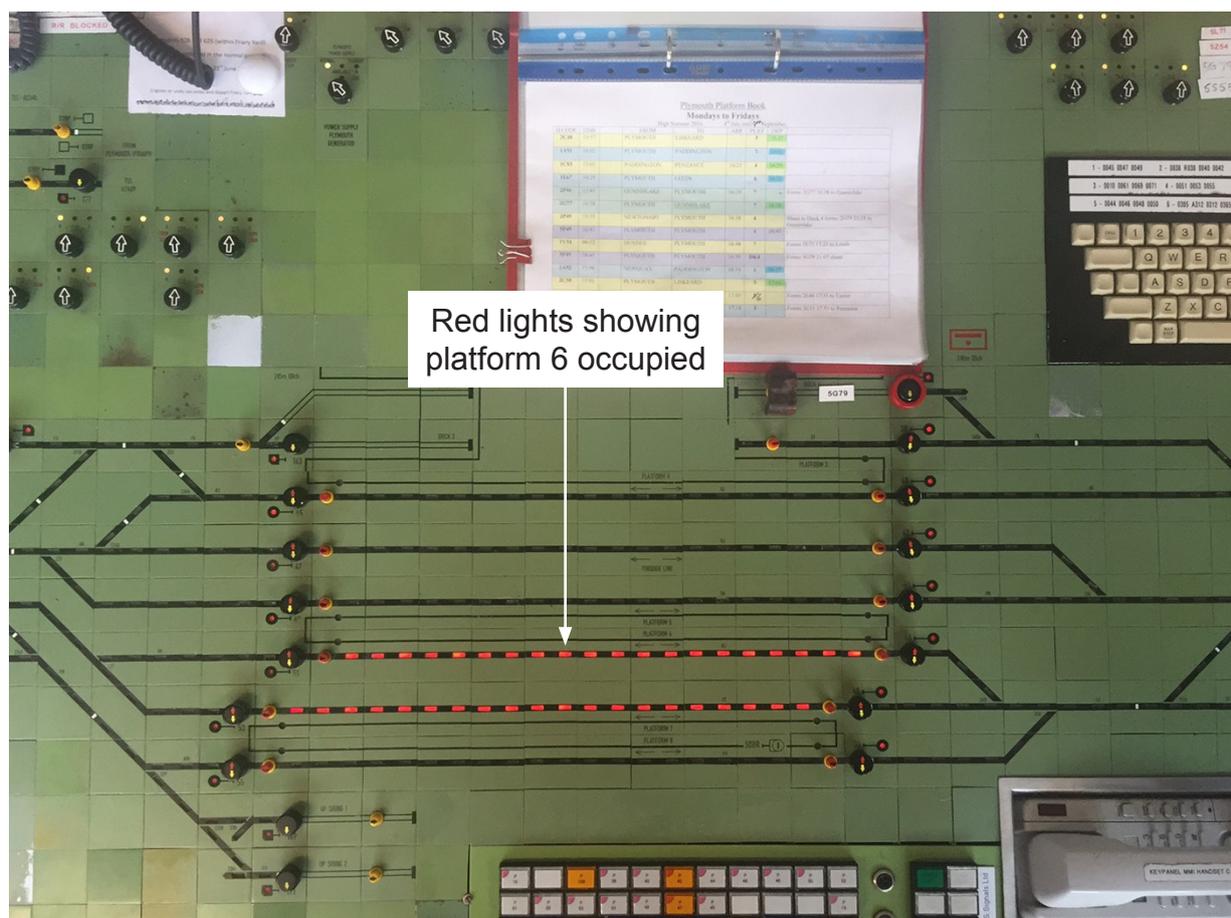
- 52 Network Rail had not formally provided the signallers at Plymouth with information about the combinations of trains that could be safely accommodated in each platform. However, the signallers had produced their own document, based on information from the Western Route Sectional Appendix that showed the length of each platform and the length of typical trains that use the station. This document showed that platform 6 had a useable length of 260 metres, and that the combined length of trains 1A91 and 2E68 was 301 metres. Use of this document was not mandated and it was little used by the Plymouth signallers. On the day of the accident the signaller had not referred to the document because he had relied on his visualisation of the length of train 2E68, and his judgement of the available length of platform 6 (paragraph 45).

Figure 11: The signaller's panel display at Plymouth signal box

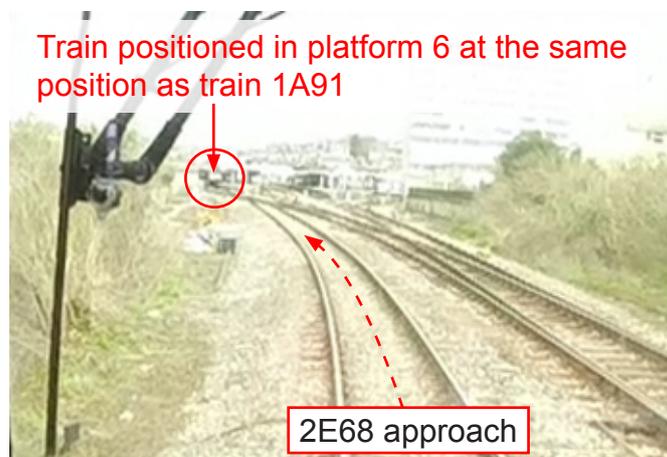
- 66 The driver further stated that as his train rounded the curve on the approach to Plymouth station, he saw train 1A91 in a platform ahead. He immediately thought that his train would not be going into the same platform because train 1A91 looked as though it was occupying nearly the whole length of platform and there was no room for his train to fit behind it. At this time platforms 7 and 8 were not visible to the driver because of track curvature and the position of nearby railway buildings (figure 12). This meant that he did not realise that train 1A91 was actually standing in platform 6, the same platform that his train was to use.

Figure 12: Platforms 3, 4, 5 and 6 become visible from about 135 metres from the station (image courtesy of GWR)

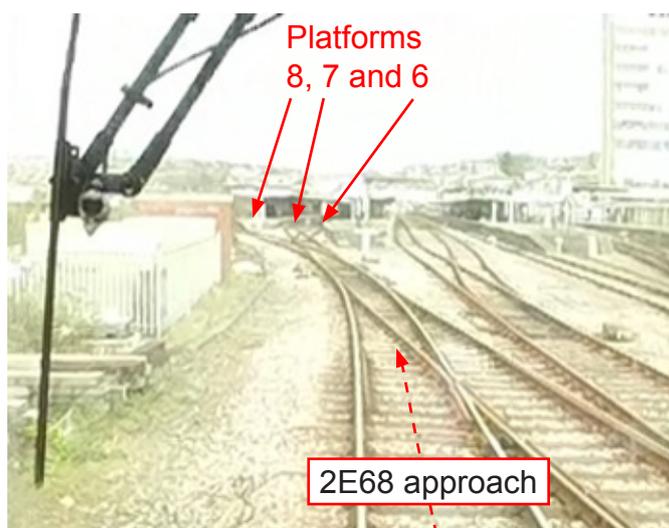
- 67 Train 2E68 continued towards Plymouth station with the driver's attention divided between looking forward, looking at the train's speedometer in the driving cab, and adjusting the power settings as the train negotiated the inclined and curved approach. When platforms 8 and 7 came into view to the left of train 1A91, the driver of train 2E68 continued to discount the possibility that his train was proceeding towards the same platform that train 1A91 was occupying because he firmly believed he was proceeding into one of the platforms to the left of train 1A91. His view along these platforms was partly obscured by train 1A91 and station buildings and so he could not see that there were no trains standing further along these platforms (paragraph 64, figure 13) where he would have expected a shorter train to be.

Figure 13: All platforms visible from about 70 metres from the station (image courtesy of GWR)

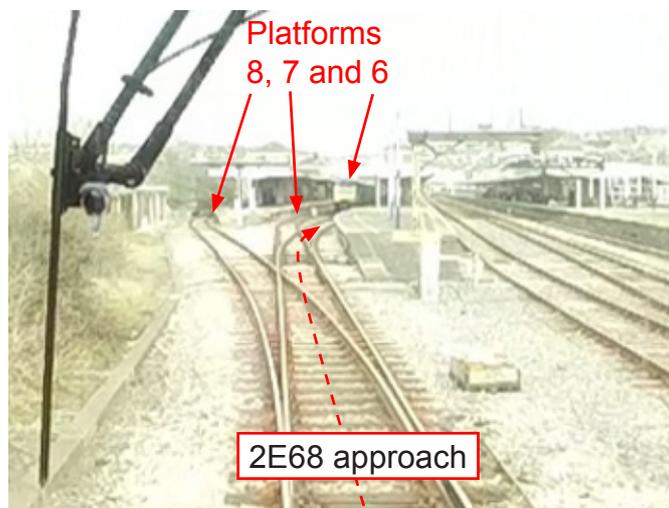
- 68 About 10 seconds (91 metres) before the collision, train 2E68 approached the points giving access to platform 8 (figures 6 and 14). The driver stated he looked at the points and saw that they were set for the straight ahead route, and continued to believe that his train was not going into the platform occupied by train 1A91.

Figure 14: Approaching the points giving access to platform 8 about 91 metres from where train 1A91 was standing in platform 6 (image courtesy of GWR)

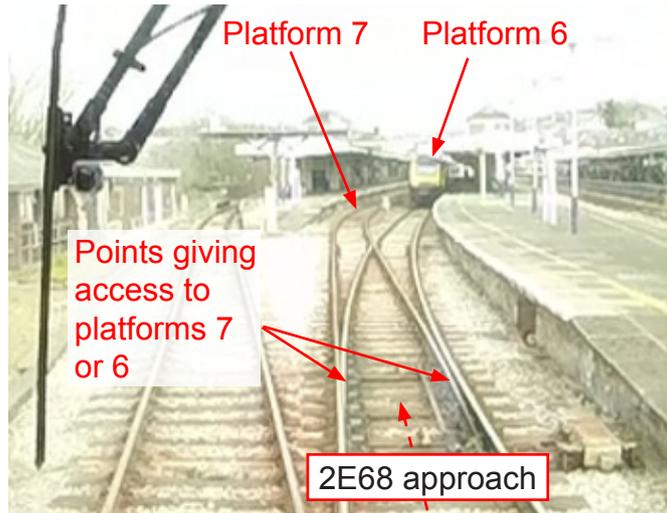
- 69 About 7 seconds (62 metres) before the collision, the train approached the start of platform 6 and the driver shut off power in preparation to stop in the station. At about the same time the driver looked at the final set of points which are located at the start of platform 6. This set of points permits a straight ahead movement into platform 7, or a route to the right into platform 6 (figure 15). On the final approach to this set of points the driver saw they were set towards train 1A91. The driver stated that, in disbelief, he counted the platforms across from 8 to 6, and on realising train 1A91 was in platform 6, he made an emergency brake application. The OTDR shows that the emergency brake was applied about 4 seconds (31 metres) before the collision.

Figure 15: The points giving access to platforms 7 or 6 located near the start of platform 6 (image courtesy of GWR)

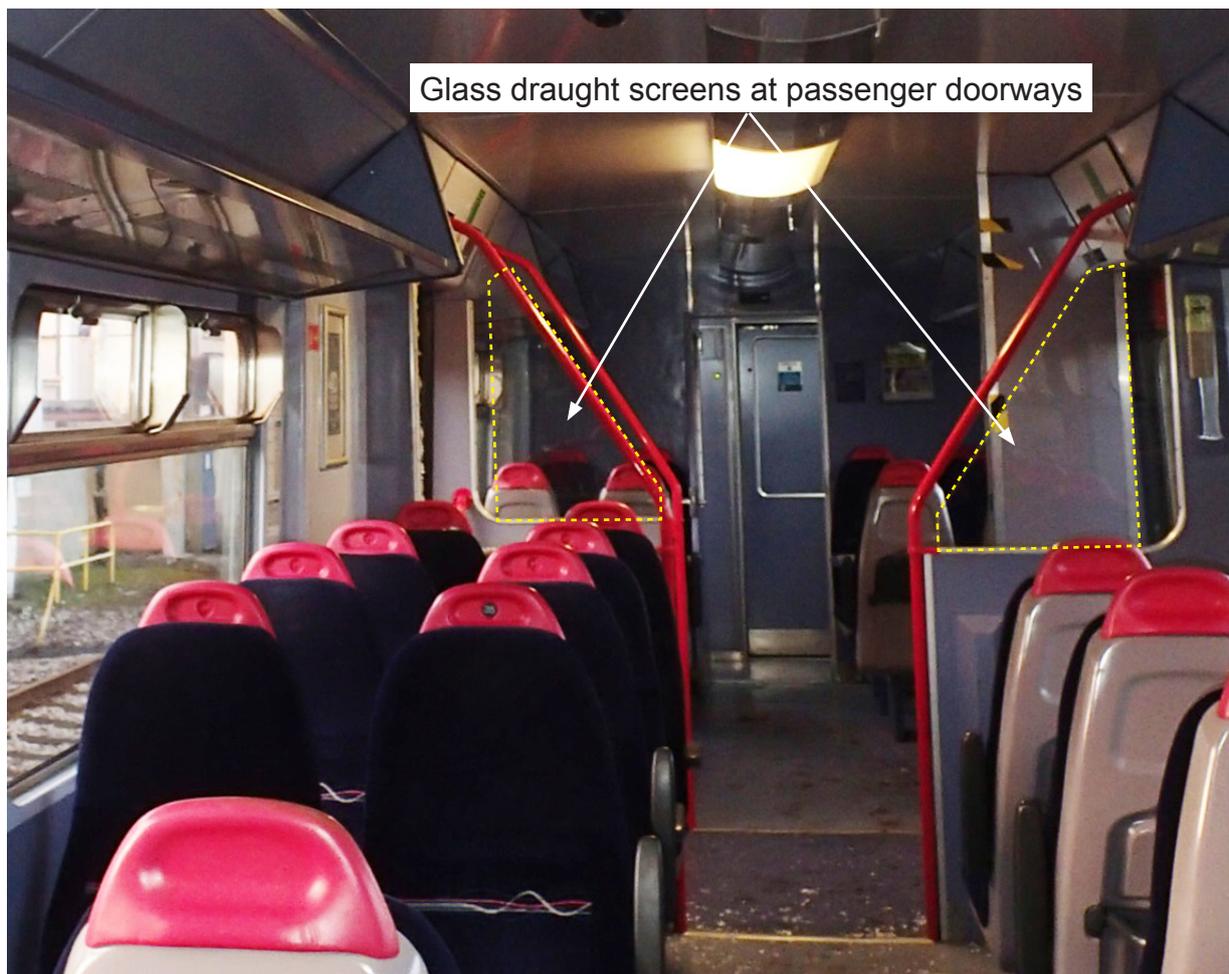
- 103 Some passengers were injured when they made contact with the glass draught screens (figure 16). One passenger was injured when the draught screen broke because their head struck it. Other passengers were injured when they struck their heads against the screens, but the screens did not break. The draught screens on train 2E68 were made of toughened glass as their installation predates the requirement in the current Railway Group standard<sup>7</sup> to fit laminated glass. This accident does not provide sufficient evidence to justify a recommendation for retro-fitting laminated glass to class 150 trains.

Figure 16: Glass draught screens

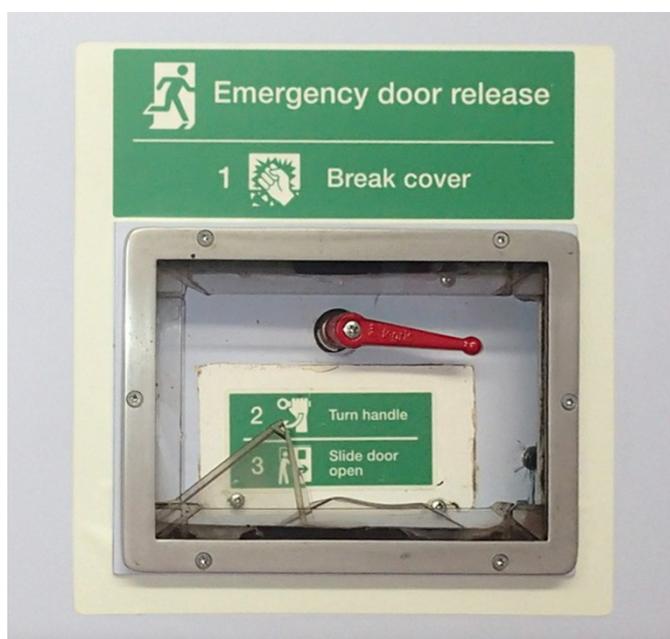
- 107 **One passenger and a member of GWR staff were injured when they broke the protective covers in order to operate the emergency door release handles. Other passengers said they were afraid to break the covers in case they injured themselves.**
- 108 An emergency door release device is provided adjacent to each passenger doorway on trains where the door locks are operated remotely by train crew. Operating this device allows the adjacent train door to be opened in an emergency situation. On class 150 trains the emergency release device is operated by a lever which cannot be used until a protective cover is broken. The cover is intended to prevent misuse of the lever. The sign next to each emergency door release lever says 'break cover' and shows an image of a closed fist (figure 17).

Figure 17: Emergency door release

- 109 One passenger and one member of GWR staff reported cutting themselves when breaking the covers while attempting to open the doors to enable evacuation of the train following the accident. Some passengers told RAIB they were afraid to break the covers because they thought the cover was glass and would cause them injury. Figure 17 shows that, even though they are not made of glass, the hard plastic cover can leave sharp edges when broken.
