Passenger train collision with buffer stop at Preston station, 1 April 2017

2. Summary of the accident

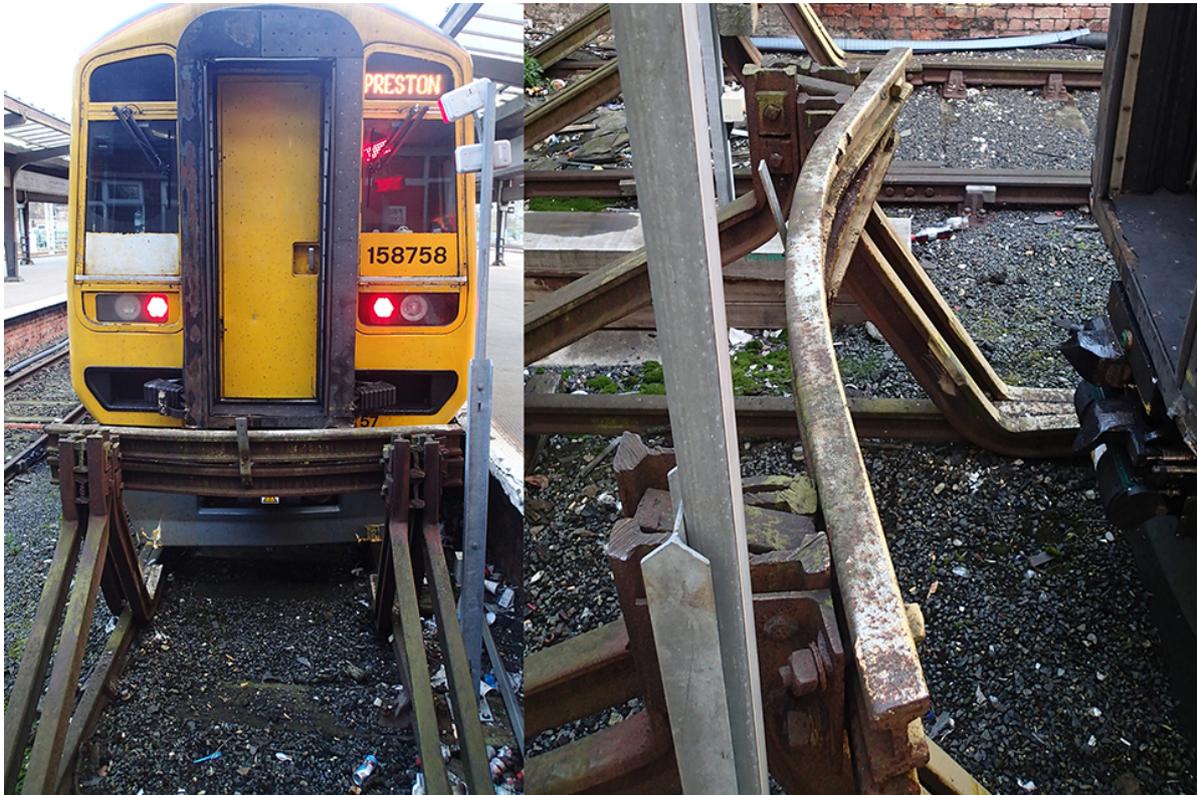
(Left) View of front of train with driving cab to the right of gangway; and (right) view of deformation in buffer stop beam after the collision

The impact bent the buffer stop beam and caused damage to the front of the train. Two locked internal doors came open in the collision: a passenger fell through the door between the front car saloon and the driving cab, and the door to a locker containing a disabled access boarding ramp opened and the ramp fell out. No-one was injured by the falling ramp but the RAIB understands that the ramp fell next to an occupied pushchair. The RAIB subsequently issued an Urgent Safety Advice (appendix A) regarding the security of the boarding ramp to operators of class 158 (and the similar class 159) trains and other relevant parties. On 15 June 2017, RSSB issued a National Incident Report (NIR 3348) related to this issue.

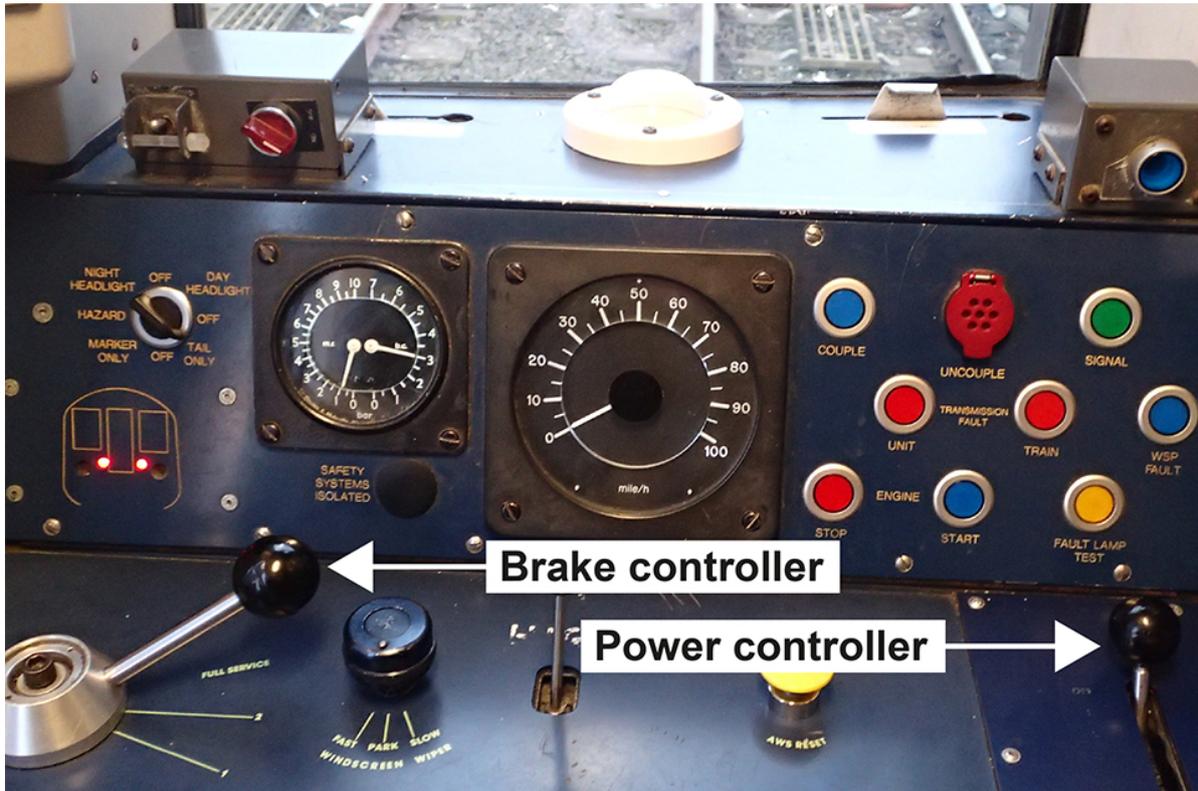
When approximately 16 metres from the buffer stop, the OTDR shows that the trainee driver operated the power controller (which is to the right-hand side of the driver's desk), selecting power notch 2, instead of the brake controller (which is on the left-hand side). The driver mentor realised the trainee had applied power instead of braking and instructed him to brake. The trainee driver also became aware of his error when the train did not slow. He applied the emergency brake around four seconds after applying power. However, by then it was too late to stop the train before it collided with the buffer stop.

View of class 158 driver's desk showing power and brake controllers

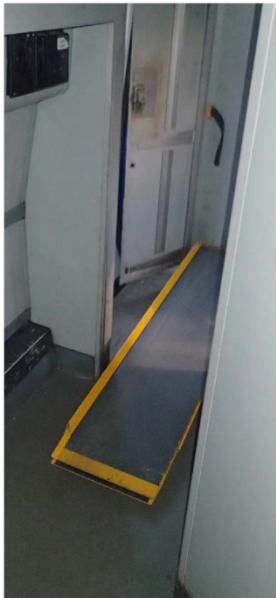
Fig 1

SUPPORTING REFERENCES	<p>Figure 1: Ramp cupboard door open and ramp on floor of vestibule.</p> <p>Figure 2: Hook and loop strapping used to secure ramp to back wall of cupboard.</p> <p>Figure 3: Lock keep on the door jamb of the cupboard door.</p> <p>Figure 4: Broken lower bracket mounted on the cupboard door jamb.</p> <p>Figure 5: Strip of self-adhesive hook and loop tape applied in place of the original door magnet.</p> <p>Figure 6 Strip of self-adhesive hook and loop tape applied in place of the original bracket.</p>

2. URGENT SAFETY ADVICE	
USA DATE:	25/04/2017
TITLE:	Securing of refreshment trolley/disabled access ramp
SYSTEM / EQUIPMENT:	Class 158/159 rolling stock
SAFETY ISSUE DESCRIPTION:	The refreshment trolley/disabled access ramp was not adequately secure.
CIRCUMSTANCES:	<p>The refreshment trolley/disabled access ramp was stowed in a cupboard in the vestibule of the rear vehicle. The cupboard door has a budget lock which requires a 'T' key to open. It closes on to the keep shown in figure 3. On the inside of the door, there were originally two magnets at the top and bottom which closed on to mating brackets mounted on the door jamb. The ramp was held upright in the cupboard by two strips of hook and loop strapping fixed to the rear wall of the cupboard (figure 2).</p> <p>At some point in the past, the upper door magnet and bracket had been replaced with self-adhesive hook and loop tape (figures 5 and 6).</p> <p>The deceleration of the train during the impact with the buffer stop overcame the internal fixings and caused the locked door to spring open. The ramp pulled through the hook and loop strapping and fell out of the cupboard onto the floor of the vestibule (figure 1). The lower door bracket had also been pulled out of the door jamb.</p>

SAFETY ADVICE:	<p>Operators and maintainers of class 158 and class 159 rolling stock should check compliance of the fixtures and fittings used to stow the refreshment trolley/disabled access ramp against the design standard for body mounted equipment, and address any deficiencies found. The design standard deceleration in the longitudinal direction has remain unchanged at $\pm 3g$. The RAIB estimates that the deceleration in the rear vehicle during the impact was significantly less than this.</p> <p>This advice may be applicable to other rolling stock with similar methods of securing trolley/disabled access ramps.</p> <p>The RAIB has observed that it is good practice for rolling stock operators and maintainers to carry out regular checks on the condition of fixtures and fittings used to secure heavy items of internal equipment, such as trolley/disabled access ramps, fire extinguishers etc.</p>
