Rail Accident Investigation Branch

# Rail Accident Report

## **Derailment due to a landslide, and subsequent collision, Watford 16 September 2016**

Report 11/2017  
August 2017

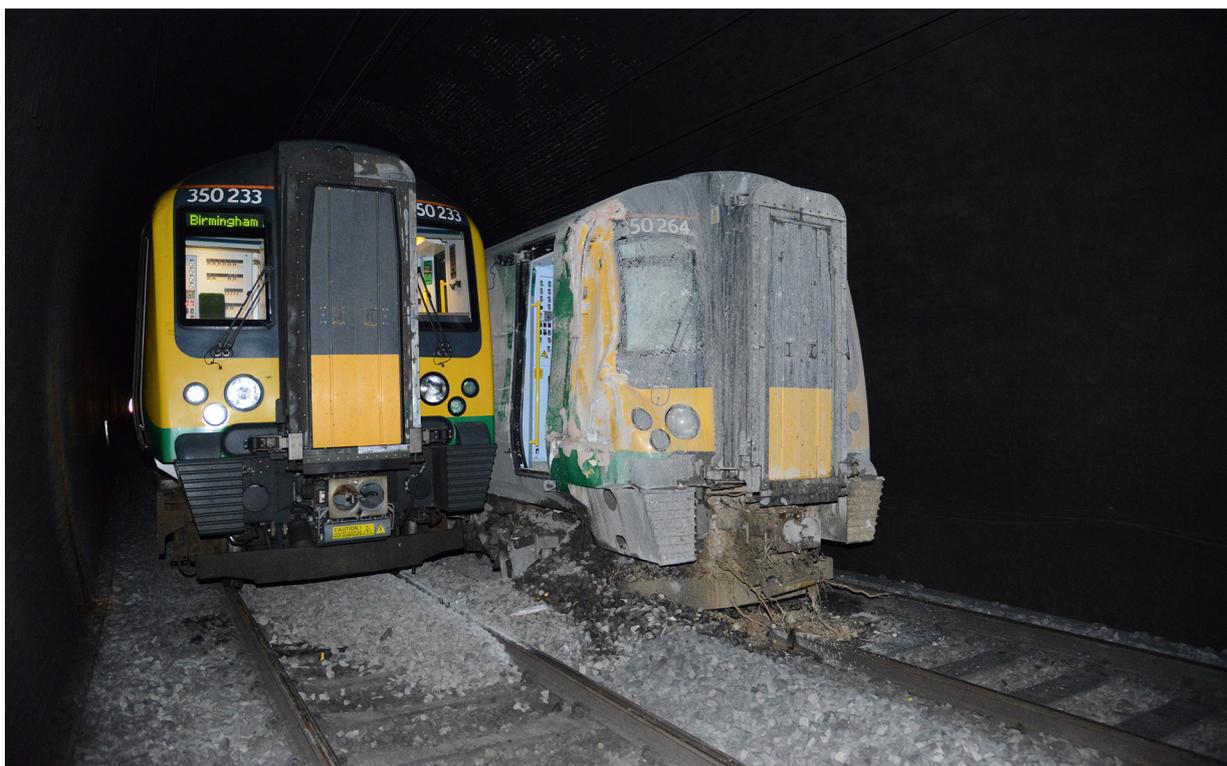
- 5 Train 2Y59, the 06:34 hrs London Midland service from Euston to Birmingham was already in Watford slow lines tunnel and approaching on the down slow line at 79 mph (127 km/h) when its driver received an emergency stop message triggered by the driver of train 2K04. The driver of train 2Y59 applied the brakes which reduced the speed of the train to about 34 mph (55 km/h) by the time the collision occurred. Train 2Y59 did not derail and stopped alongside the derailed train (figure 2).

- 6 The right-hand cab doors of both trains were torn off during the collision and the leading vehicles of both trains were damaged. The driver of train 2K04 and two passengers on this train were slightly injured. There were no injuries on train 2Y59.

Figure 2: Rear of train 2Y59 (left) stopped inside the tunnel adjacent to derailed train 2K04 (photograph courtesy of British Transport Police)

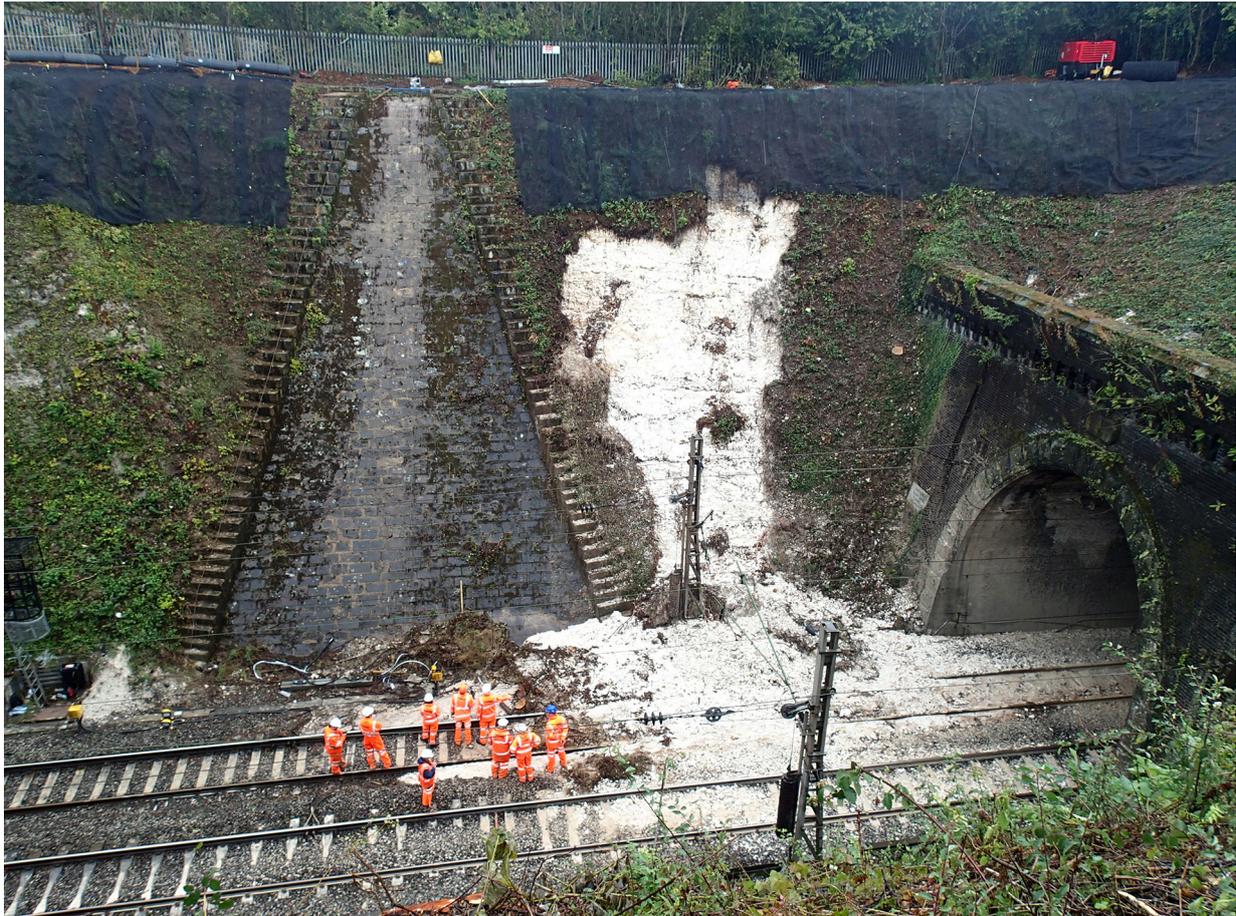
53 At 07:32 hrs, track maintenance staff arrived on site and reported that debris was still falling onto the up slow line, that the down slow line was also affected, and that flood water was up to rail height in the cutting (figure 5).

Figure 5: View of landslide and debris on track. The adjacent masonry structure is a face wall (refer to paragraph 90).

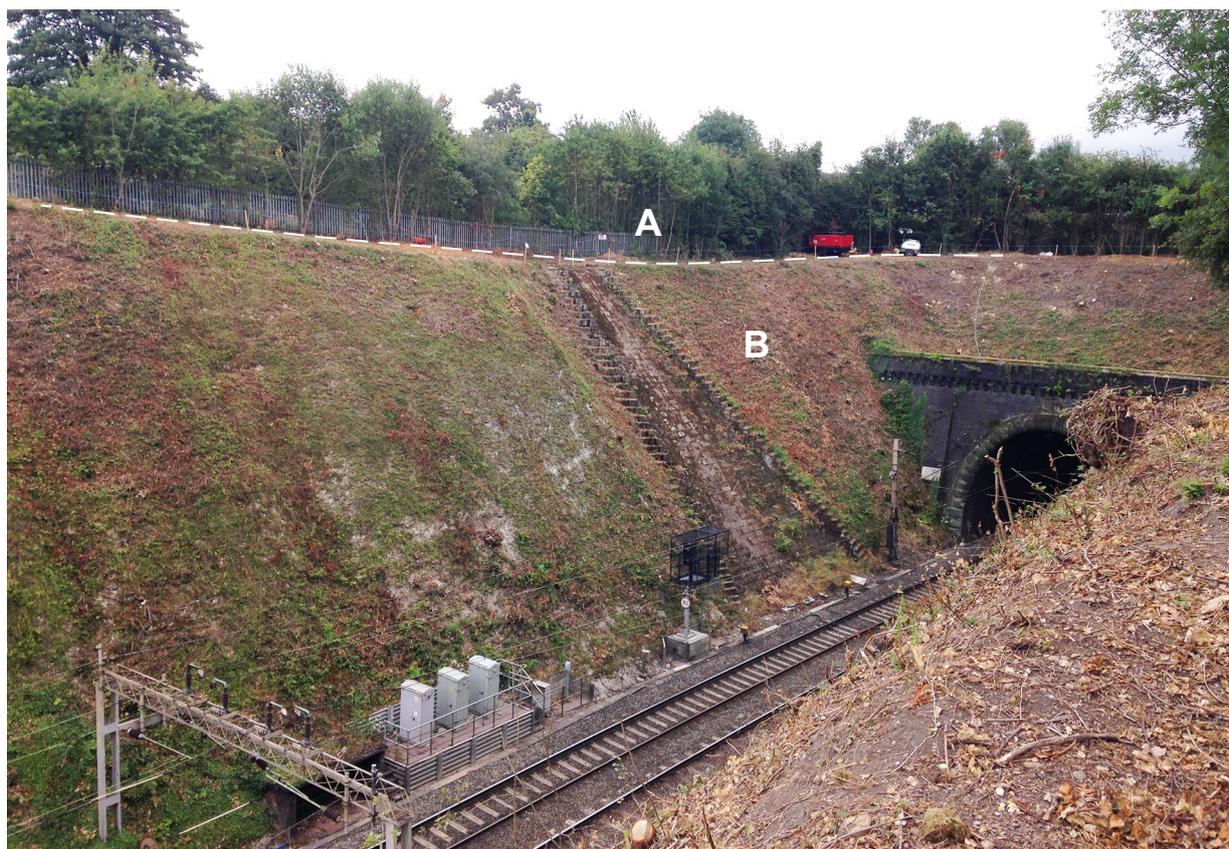
Figure 6: Photograph of cutting taken in July 2016 following vegetation clearance looking east (courtesy of Network Rail). The white dashed line indicates the profile of the cutting crest with the low point marked 'A'. The location of the future landslip is marked 'B'.

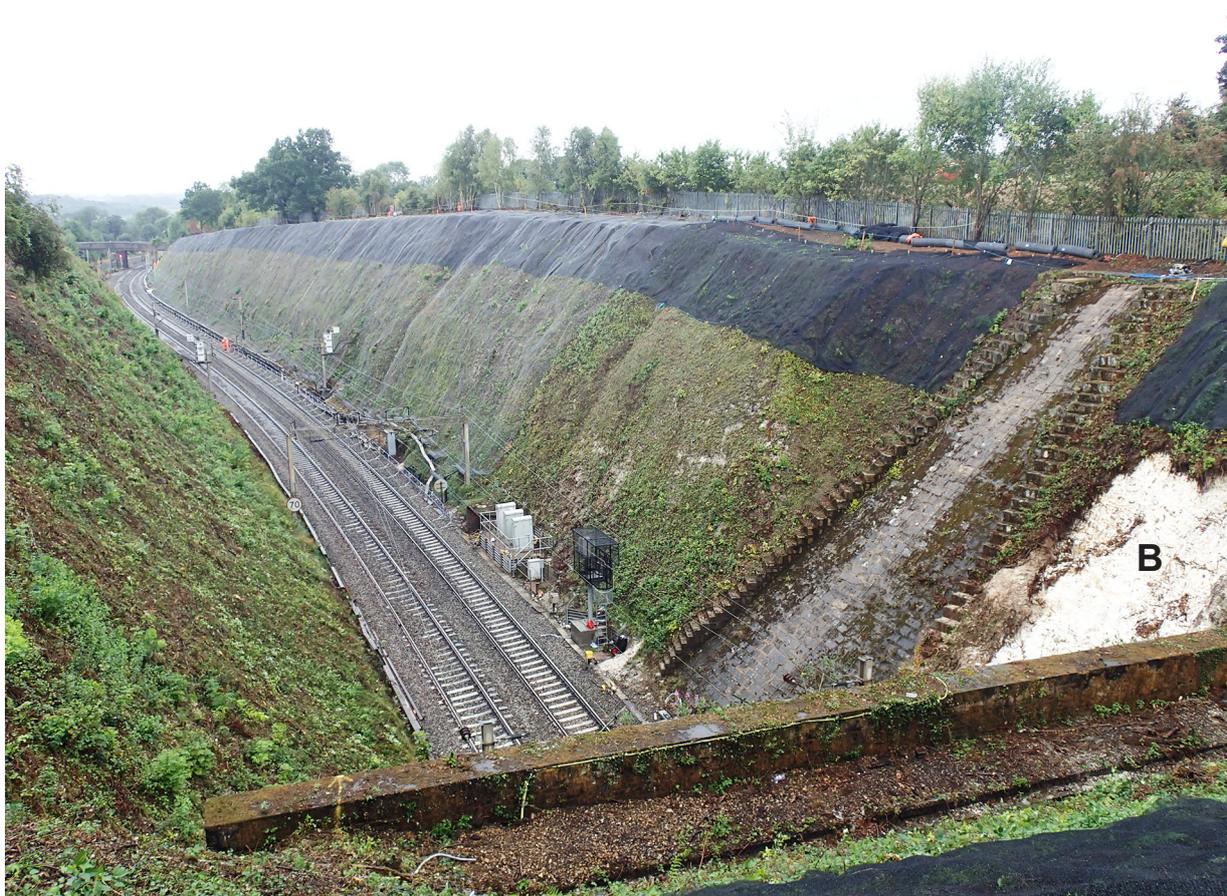
- 75 An evaluation of surface water run off was made by the design consultant in their Geotechnical Assessment Report which led to the conclusion that drainage for surface water run off was not required (paragraphs 95 to 98 and figure 7).

Figure 7: View of slow lines cutting from above tunnel portal, looking north-west towards Gypsy Lane bridge on 16 September 2016. The partly completed slope protection works are visible. The landslip is marked 'B'.

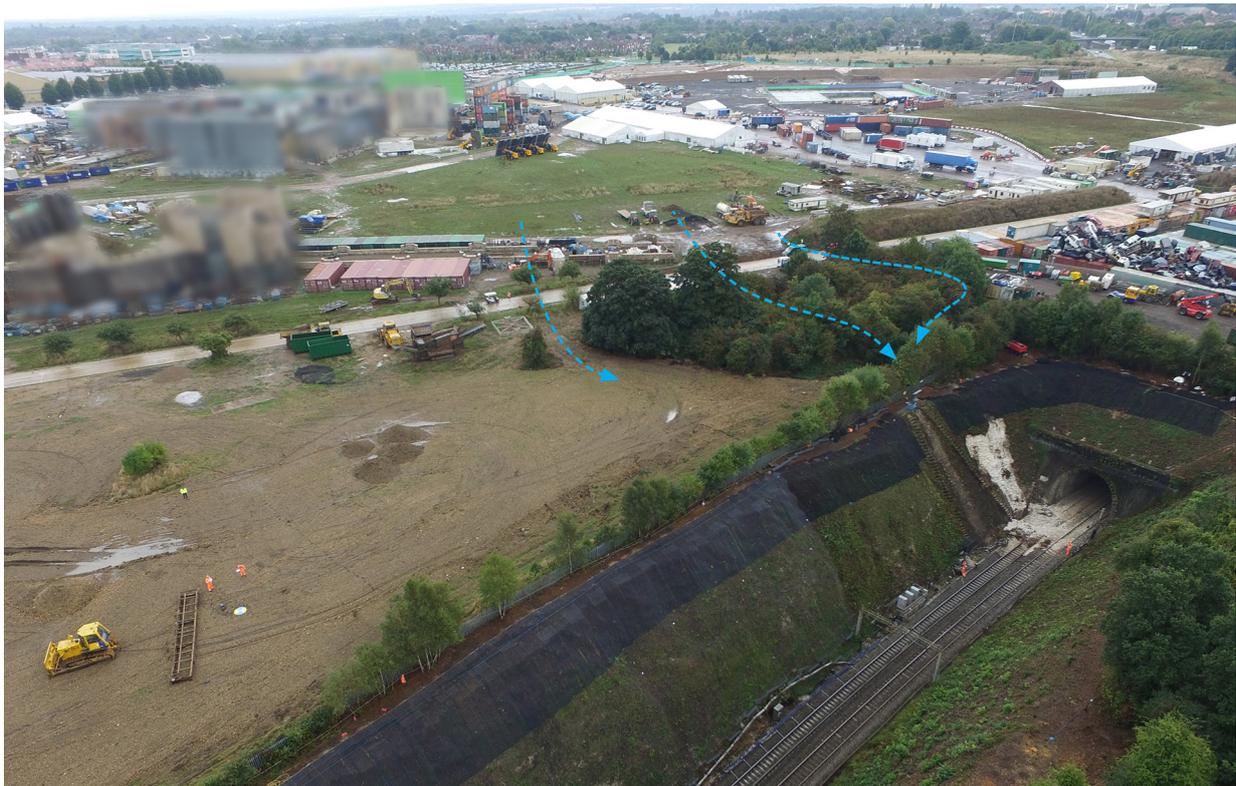
79 The *catchment area* to the east of the slow lines cutting comprises a flat-topped hill within the studio complex. Following the accident, the RAM (drainage) made an initial estimate suggesting that a catchment area of around 30 hectares (300,000 m<sup>2</sup>) could exist east of the cutting, leading to a low point above the landslip location (figure 6). An area of this size would have accumulated over 15,000m<sup>3</sup> of water (equivalent to six Olympic-size swimming pools) over the four hour period from 03:00 hrs on 16 September. The unsurfaced ground was dry and hardened following a period of hot weather, so initially, there was limited opportunity for rainfall to percolate into the ground. An inspection of the site by the RAIB and representatives of the studio complex on 16 September 2016 found evidence that a significant volume of water had flowed towards one location above the cutting (figure 8). The local topography created a water concentration feature, and the resulting flow over the edge of the cutting, possibly in combination with sub-surface flows (paragraph 83), caused a washout failure of the cutting slope (figure 9).

Figure 8: Aerial photograph of catchment area on 16 September 2016 showing water paths. Part of this image has been deliberately blurred.

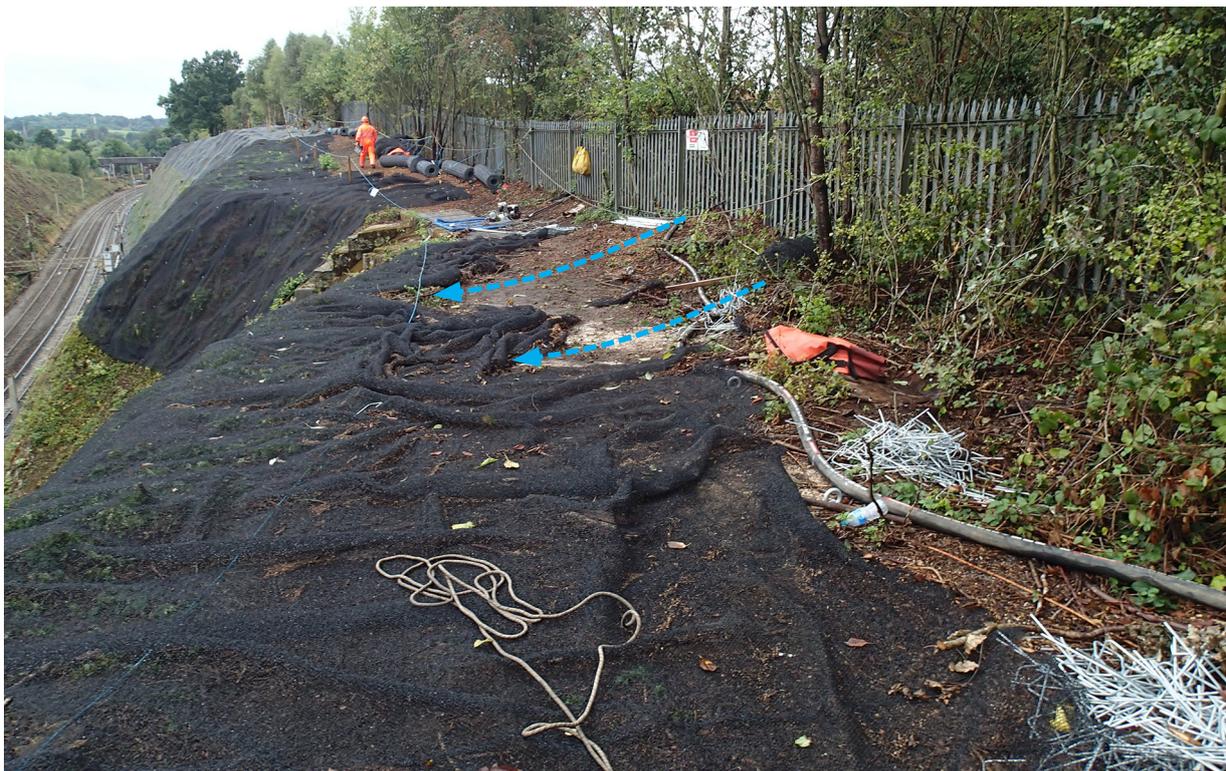
78 There was no *crest drainage* or sub-surface drainage at this location which meant intense rainfall led to a *washout failure* on the cutting slope.

Figure 9: Crest of cutting above landslide showing erosion matting displaced by surface water flow

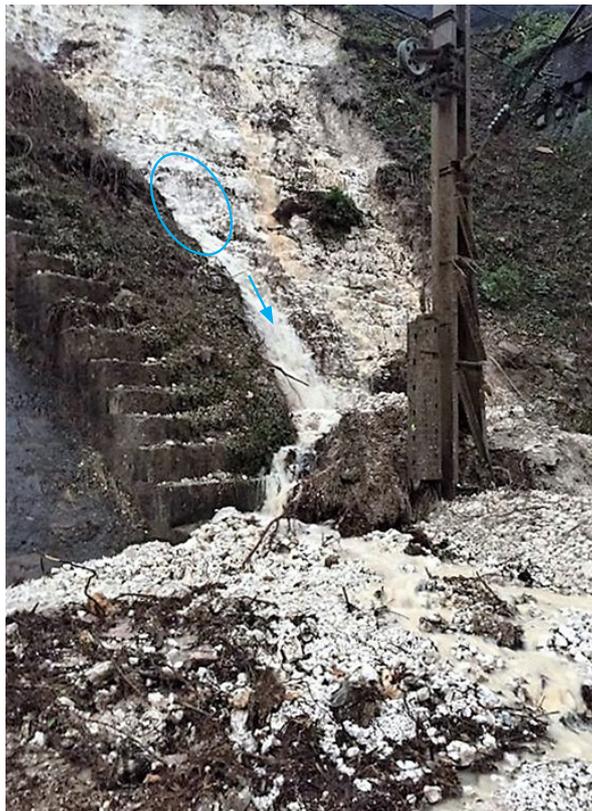
- 83 There is evidence that some water flowed through ground to emerge at the cutting face. Photographs and a video taken from track level by one of the first members of Network Rail staff to arrive on site on 16 September, show a large volume of water appearing to emanate from a point about half-way up the slope (figure 10). This location was adjacent to the south side of an existing masonry structure built to support the cutting face and known as a face wall (refer to paragraph 90).

Figure 10: Image showing water emanating from part-way down the cutting slope (courtesy of Network Rail)

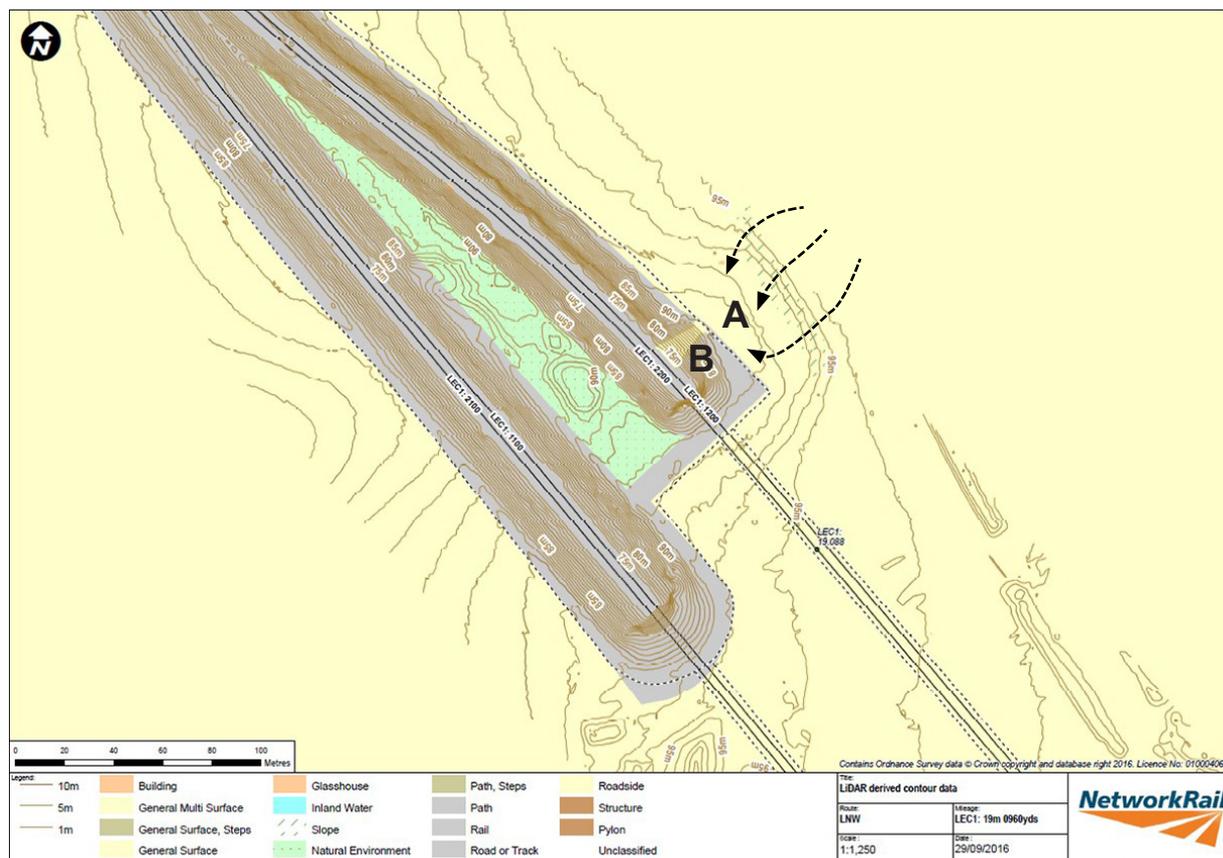
Figure 11: Network Rail LIDAR survey drawing showing contours adjacent to the tunnel portals. The low point is marked 'A' and the position of the landslip is marked 'B'. The approximate surface water flow paths are also shown.

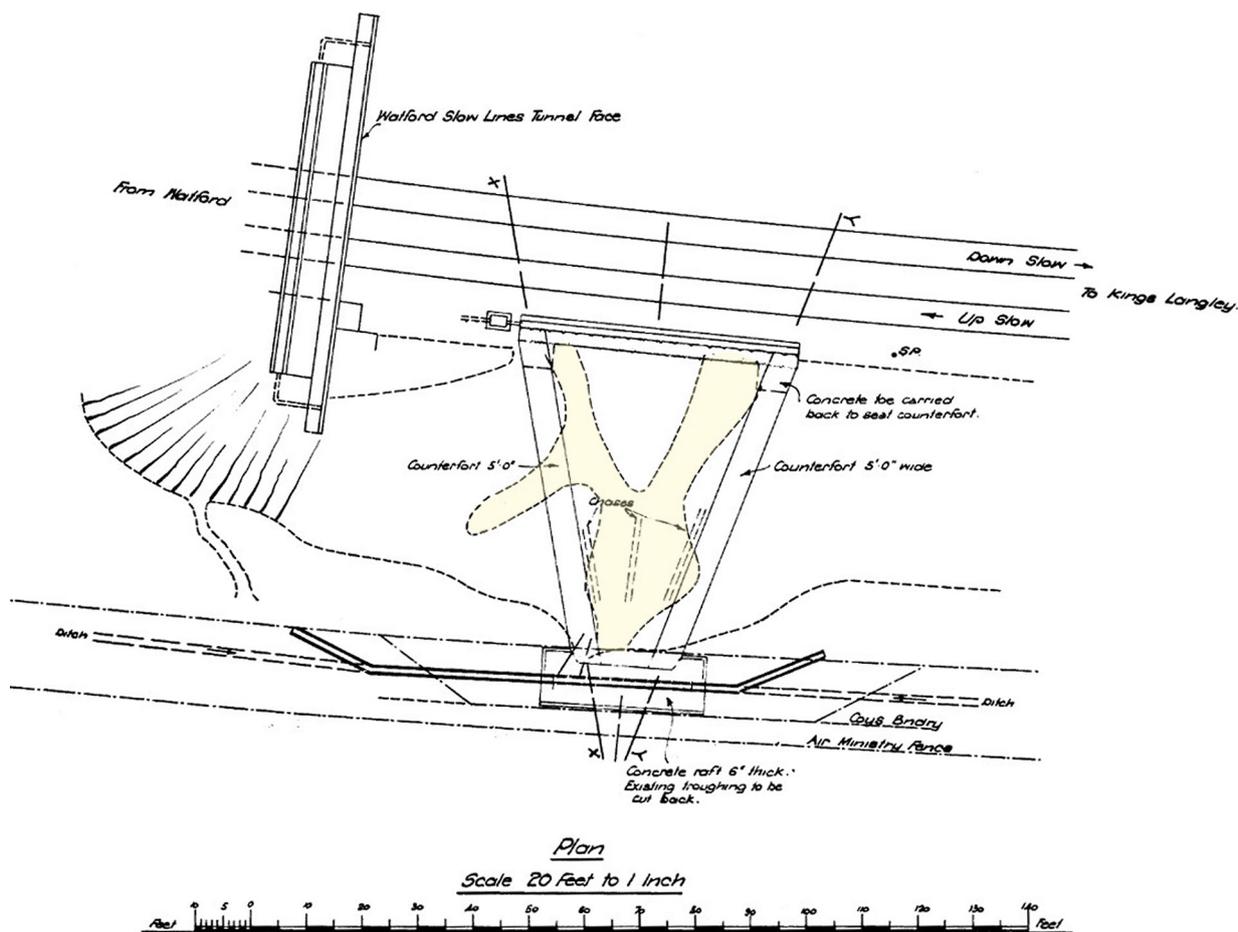
Figure 12: Extract from a historical drawing of the face wall dated April 1943. The position of rubble filled cavities behind the masonry is indicated by shading.

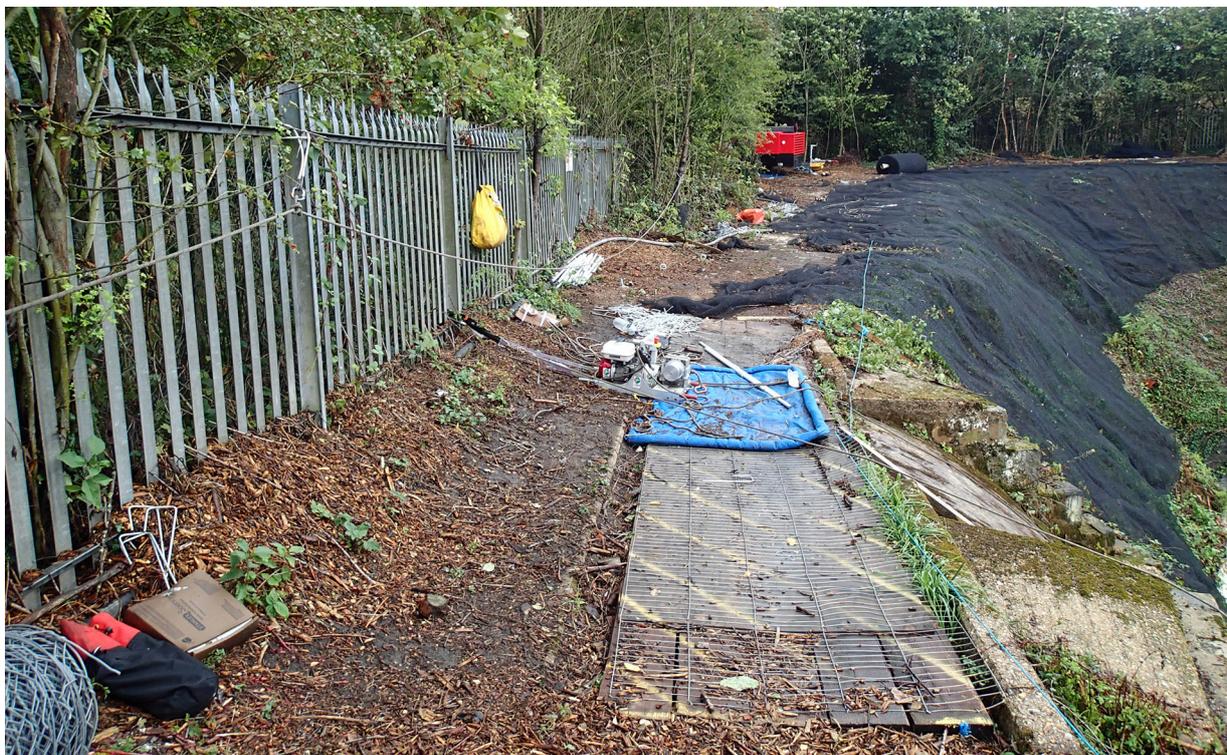
Figure 13: Concrete raft above face wall. Scaffolding boards had been placed inside the raft to remove a tripping hazard during the slope protection works.

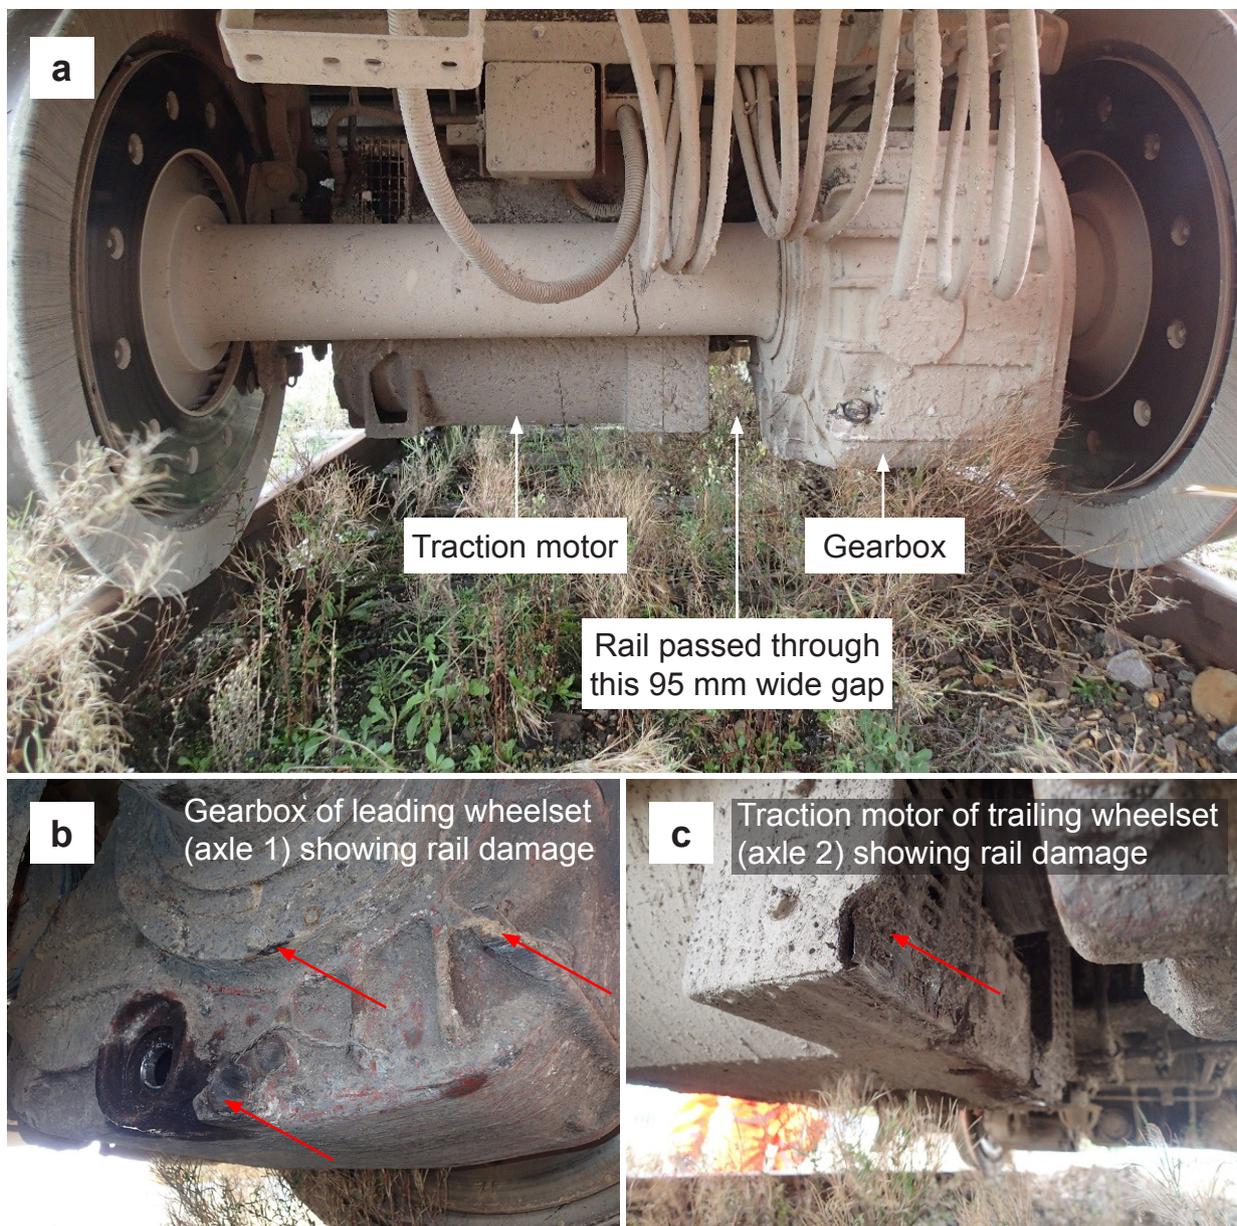
105 A post-accident examination of the leading vehicle of train 2K04 by the RAIB and Siemens found damage that was consistent with the right-hand (six foot) rail engaging with a gap between a gearbox and a traction motor (figures 14 and figure 15) on three of its four axles. This prevented the vehicle moving a large distance from the track centreline, and it is likely that this reduced the extent to which the derailed train obstructed the adjacent track. As the derailed train slowed, the leading bogie became embedded in the ballast, causing the front of the leading vehicle to drop by about 300 mm and lean slightly towards the front of the leading track.

Figures 14a, b and c: Images showing examples of damage caused by interaction between traction equipment and rail during derailment beneath the leading bogie of train 2K04

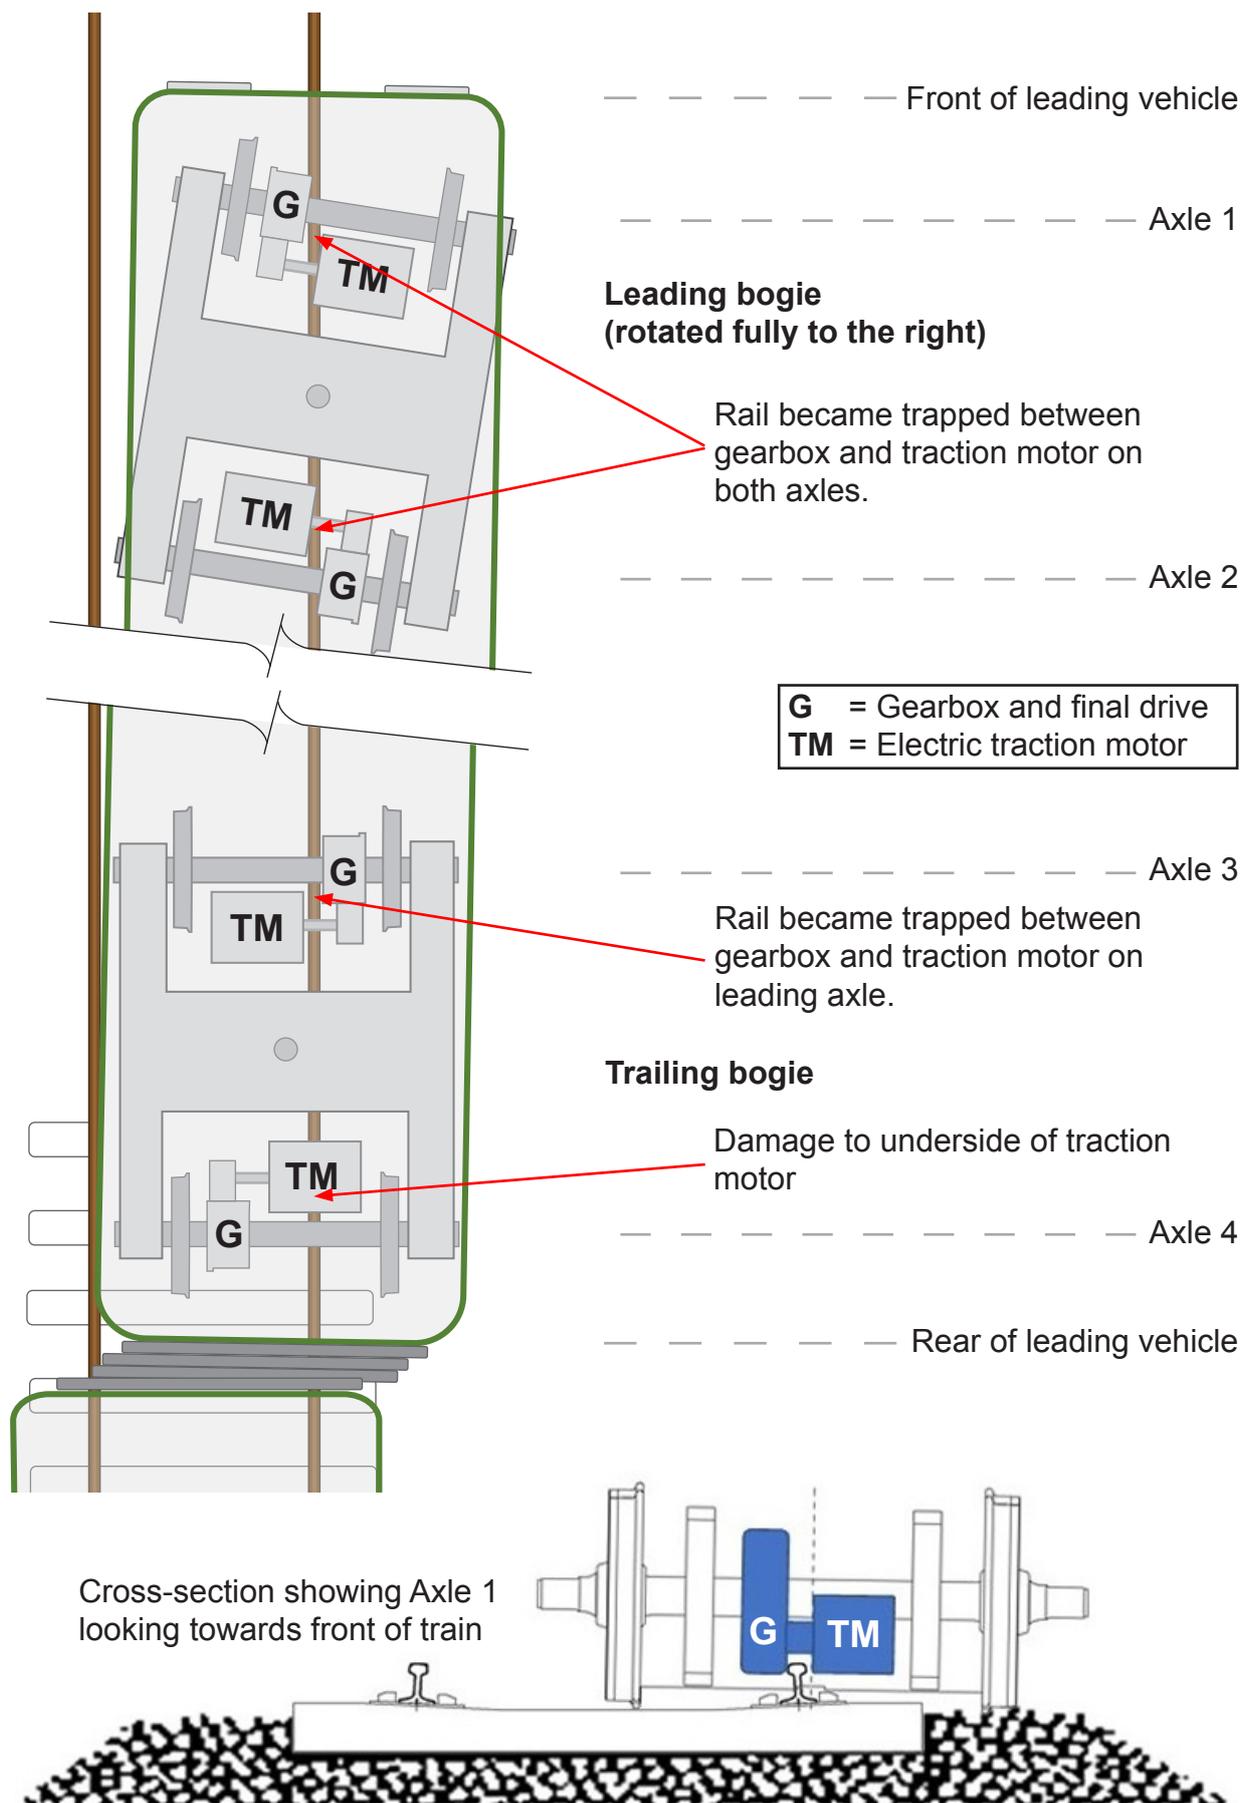
Figures 15a and b: Diagrams showing the leading vehicle of train 2K04 and interaction between traction equipment and right-hand rail during derailment. Figure 15b courtesy of RSSB.

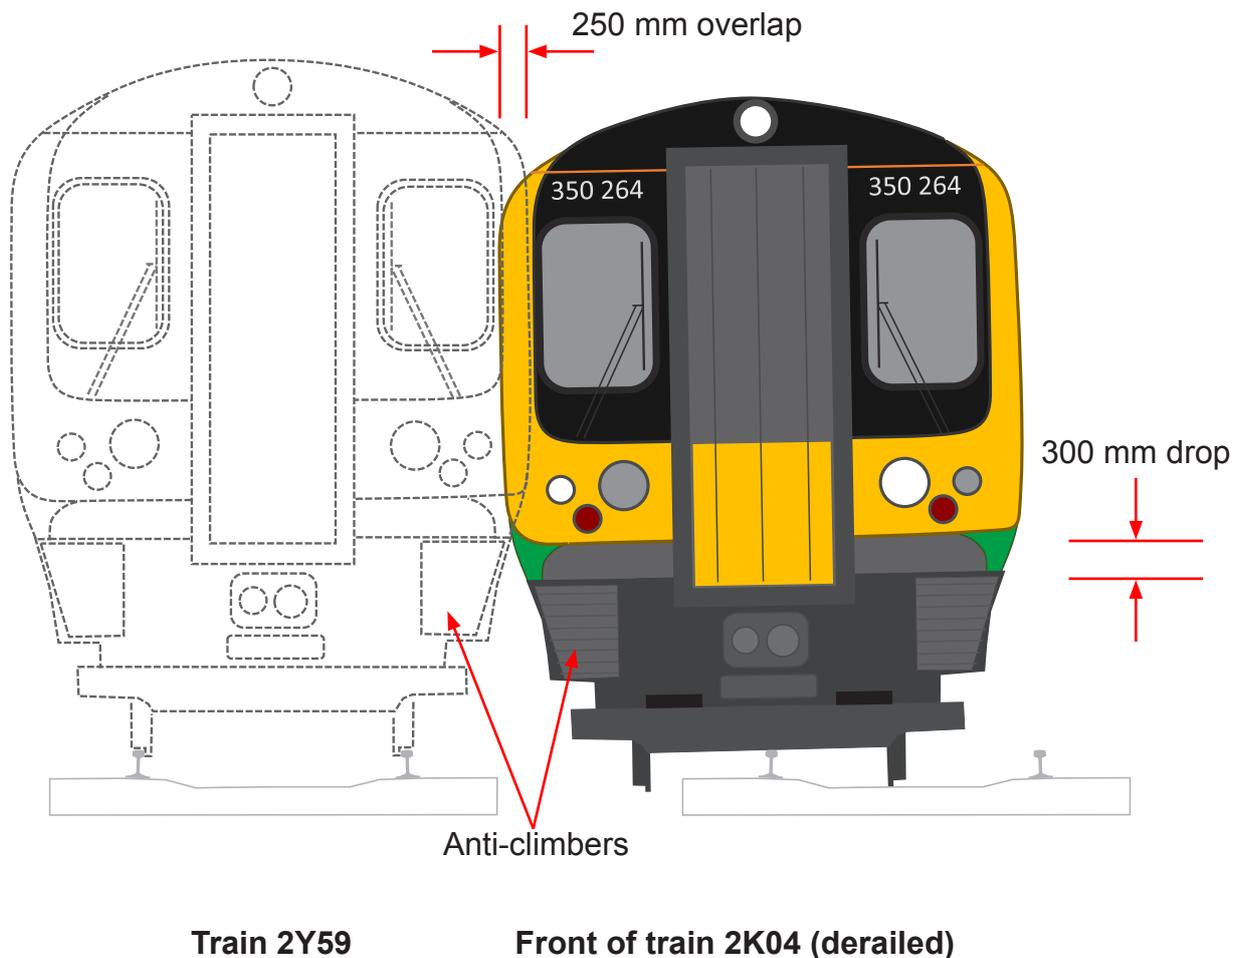
106 The relative position of the cabs of the two trains at the time of collision (figure 16) meant that contact was made by relatively easily deformable bodywork, rather than by stronger and less deformable structural elements. The leading cab of train 2Y59 (figure 17a) was guided so that it ran alongside train 2K04 by the corner pillar of the leading cab of train 2K04 (figure 17b). The rounded corner pillar absorbed some energy in the collision by deformation, a consequence of its shape and the relatively small overlap between the two cabs at the time of the collision. Had the leading vehicle of train 2K04 encroached slightly further towards the down slow line, or contact been made between the *anti-climbers* (buffers) attached to the underframe (chassis) at the front of each unit, the resulting collision would almost certainly have been significantly more serious.

Figure 16: Diagram showing overlap between trains at moment of collision

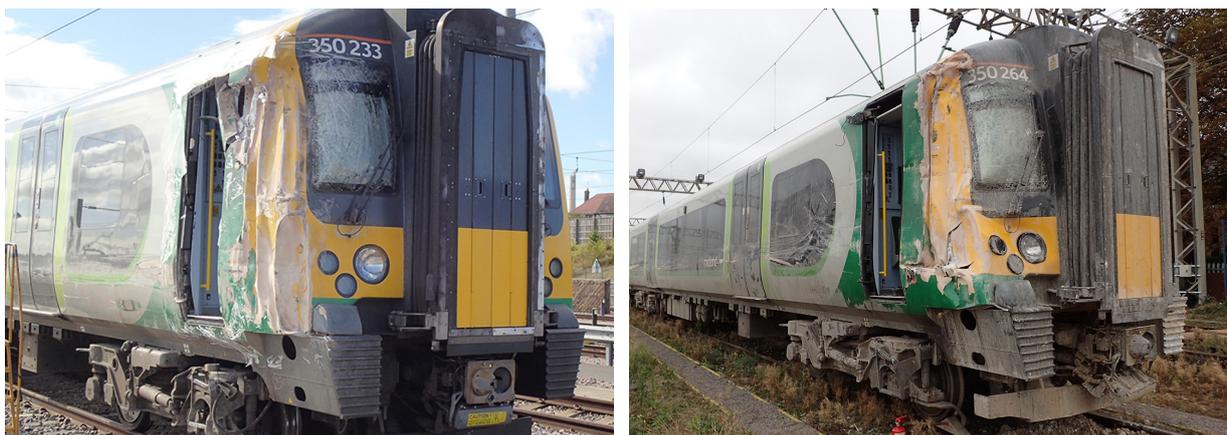
Figure 17a and b: Front view of train 2Y59 (unit 350233) and train 2K04 (unit 350264) following recovery from the tunnel

107 Although the leading vehicles of both units were seriously damaged, and there was damage to the outer skin of all vehicles of train 2Y59, there was no penetration of the vehicles' inner skins.

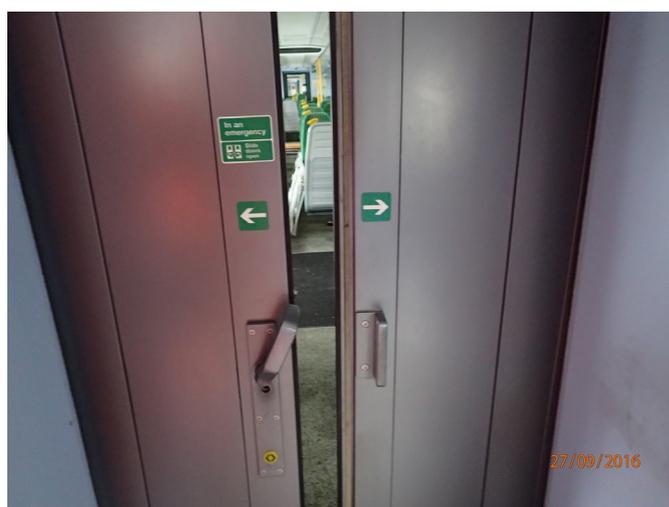
**108 The cab-saloon doors on train 2K04 became jammed in the part-open position as a result of the accident. This prevented the driver from leaving the cab other than by climbing down onto the track.**

109 The double-leaf sliding doors became jammed in the part-open position (figure 18). This occurred because small stones and screws collected in the lower guide rail during the accident and became trapped under one of the door leaves. Siemens has confirmed that the doors and frame were undamaged. The RAIB observes that debris collecting in this area may be an unavoidable consequence of a collision, and that similar debris could affect a single leaf door in the same way.

Figure 18: Maximum width that the sliding cab-saloon doors could be opened following the accident

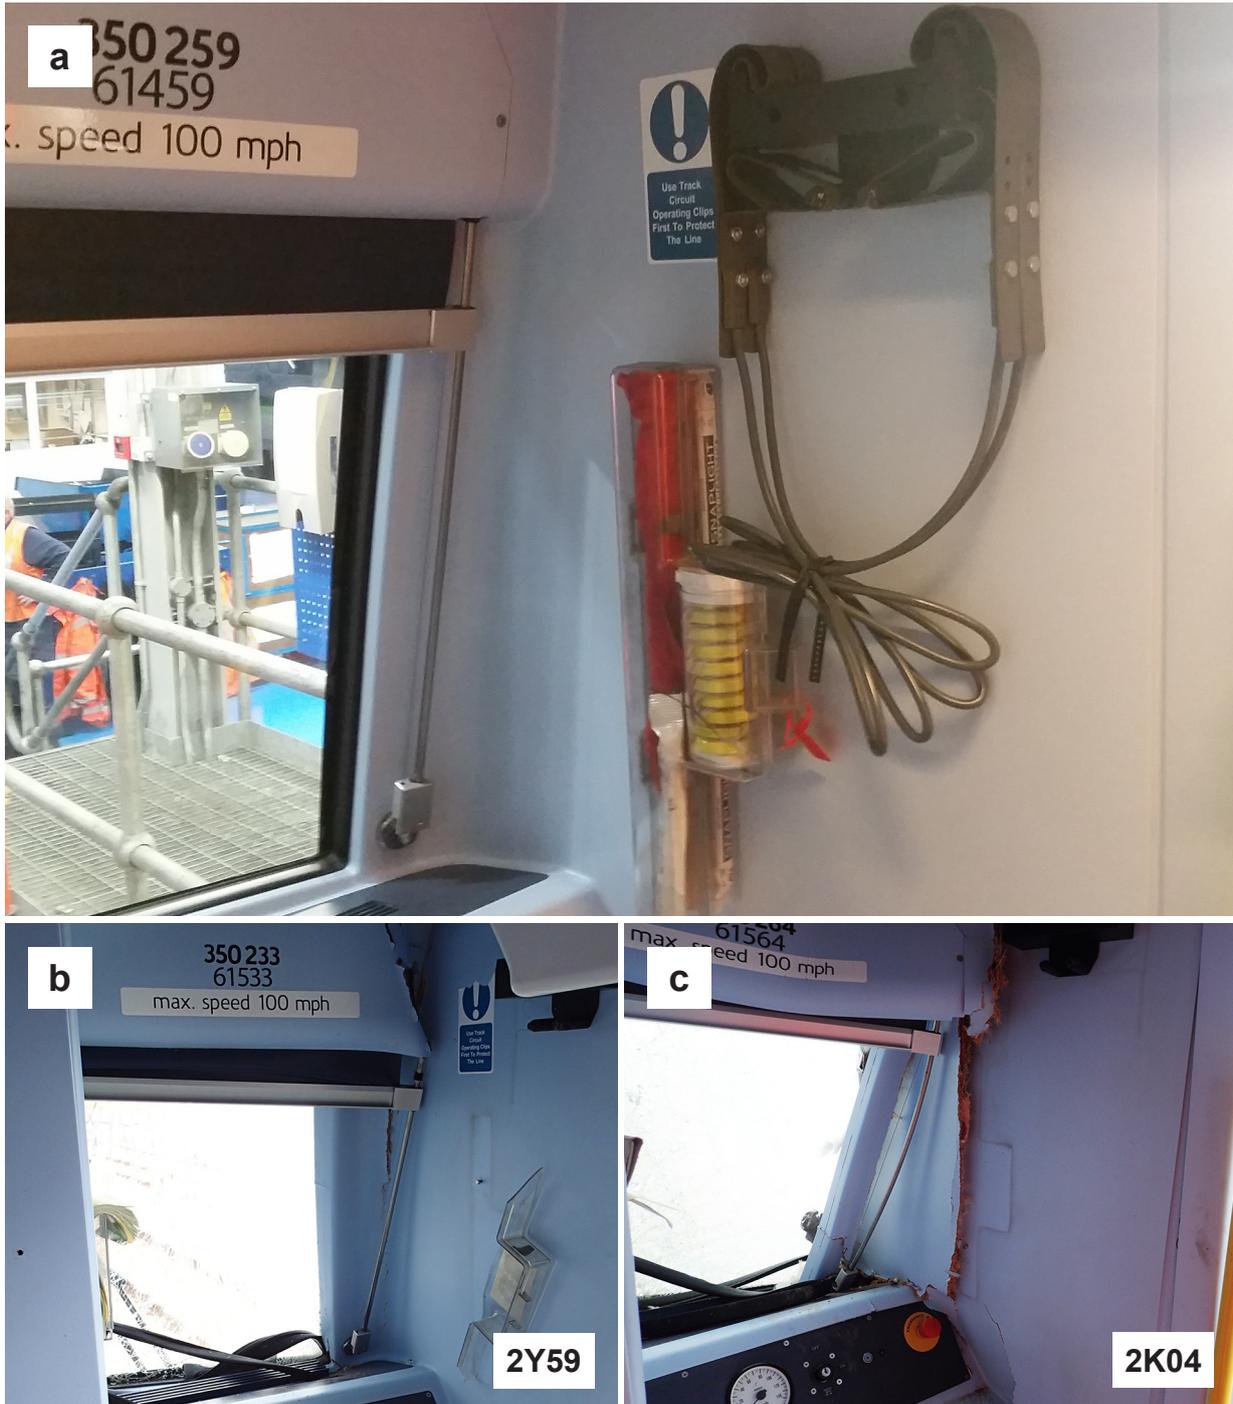
## 110 Emergency equipment in both driving cabs was displaced by the collision.

111 Class 350, and other classes of Desiro unit, have a set of emergency equipment attached to the right-hand side wall of the cab. This includes track-circuit operating clips and a clear plastic case containing detonators and flags (figure 19a). Equipment came loose in the cab of train 2Y59 when the case itself broke (figure 19b), and in the cab of train 2K04 when the case broke off the wall (figure 19c). Fortunately this did not cause injury to either driver, but the risk of injury was illustrated in train 2K04 where the equipment hit the back wall of the cab.

Figure 19a, b and c: Photographs showing the location of cab emergency equipment in an unaffected train, and damage to the leading cabs of trains 2Y59 and 2K04

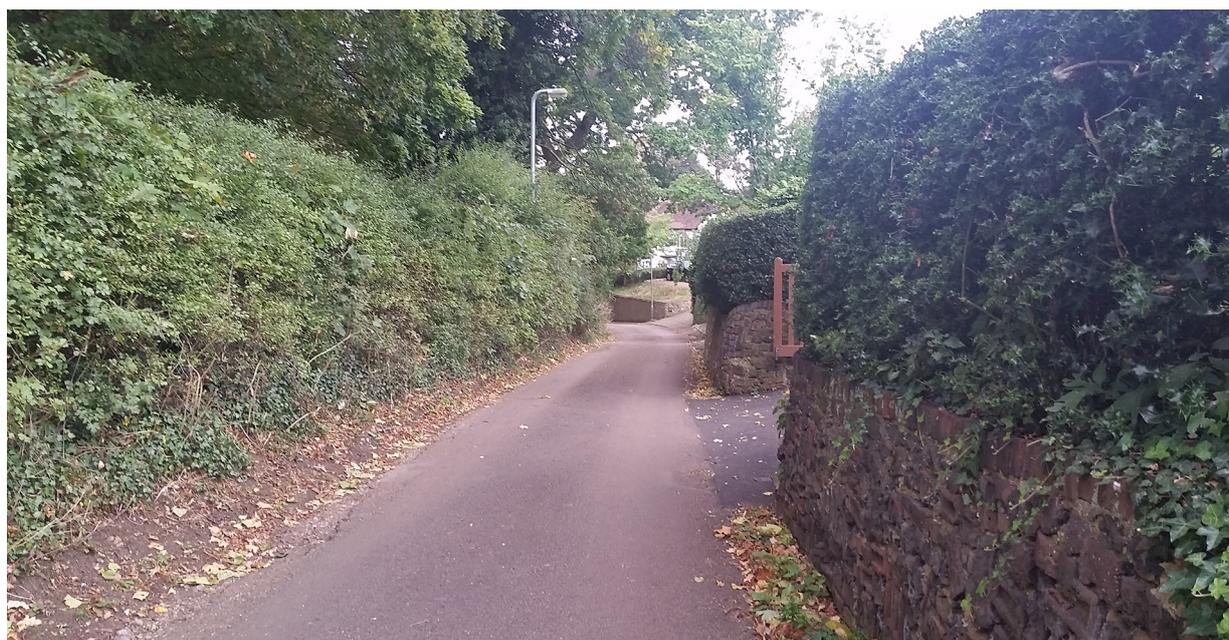
122 The emergency plan does not consider the suitability of the road approach to the Gypsy Lane access point. Gypsy Lane is a single track residential road with limited parking and no opportunity for easy turning of road vehicles. These limitations would have a material impact on the emergency services' ability to respond effectively. At an accident scene, vehicle marshalling is the responsibility of the Fire & Rescue Service under the 'Joint Emergency Services Interoperability Programme' (JESIP) principles for joint working by the emergency services. Hertfordshire FRS undertake an annual inspection of emergency access points as required by section 7 of the Fire Services Act, and was aware of the restricted access via Gypsy Lane (figure 20). It does not undertake formal joint access inspections with Network Rail, to address issues such as gate access, foliage management and turning space.

*Figure 20: Gypsy Lane, Kings Langley, looking towards the railway access point*
