## SAFETY BULLETIN 10 - COSMO MED and Type Approved Fire Doors – Faulty A60, A0 and B15 Fire doors

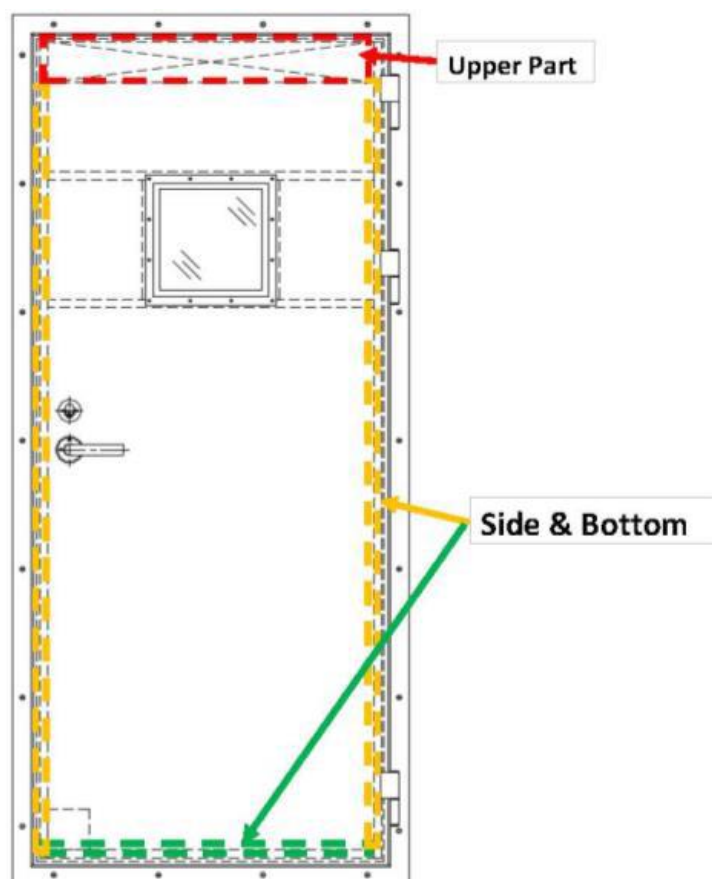
**Figure 1: Affected areas of COSMO fire doors**

It has come to light that the insulation in these doors is missing from the upper part, sides and bottom of the doors as can be seen in Figure 1. This is likely to have occurred during a change of work process when new equipment was introduced in November 2013.

The fire doors affected have been found to fail on the insulation performance criteria requirement of the IMO FTP Code Part 3.

COSMO with support from DNV GL is now working towards a solution to the problem that will be informed to affected parties. If evidence of these faulty doors is discovered then contact should be made to [marinetechnology@mcga.gov.uk](mailto:marinetechnology@mcga.gov.uk) (or the relevant Flag state) and your Classification Society.

Owners and operators of affected UK vessels should take temporary mitigating measures in the form of regular fire watch/ fire patrols, added precautions in case of hot work, attention to good housekeeping and to arrange fire hoses to be ready near the affected doors in the interim period considering the small increase in risk to the safety of the vessel.

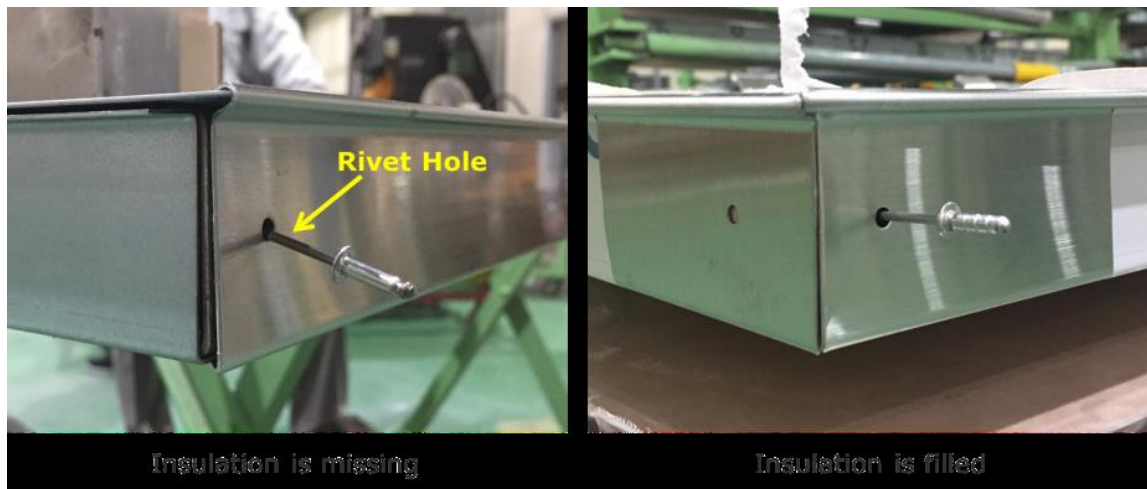
**Figure 2: How to check COSMO fire doors to identify if insulation is missing (left) or if insulation present (right)**

1. Remove a rivet or hinge bolt from the side of the door.
2. Insert a metal pin through this rivet/bolt hole, and check for missing insulation.
3. If a door is found to be missing insulation, please inform COSMO at: COSMO CO., LTD. 20, Myeongnyesandan 2-ro, Jangan-eup, Gijang-gun, Busan, Korea Tel: +82 51 519 9900, Fax: +82 51 519 9900 [www.bn-cosmo.com](http://www.bn-cosmo.com)
