Rail Accident Report

Dangerous train door incident at Bank station on the Docklands Light Railway 6 February 2017

Report 12/2017
September 2017

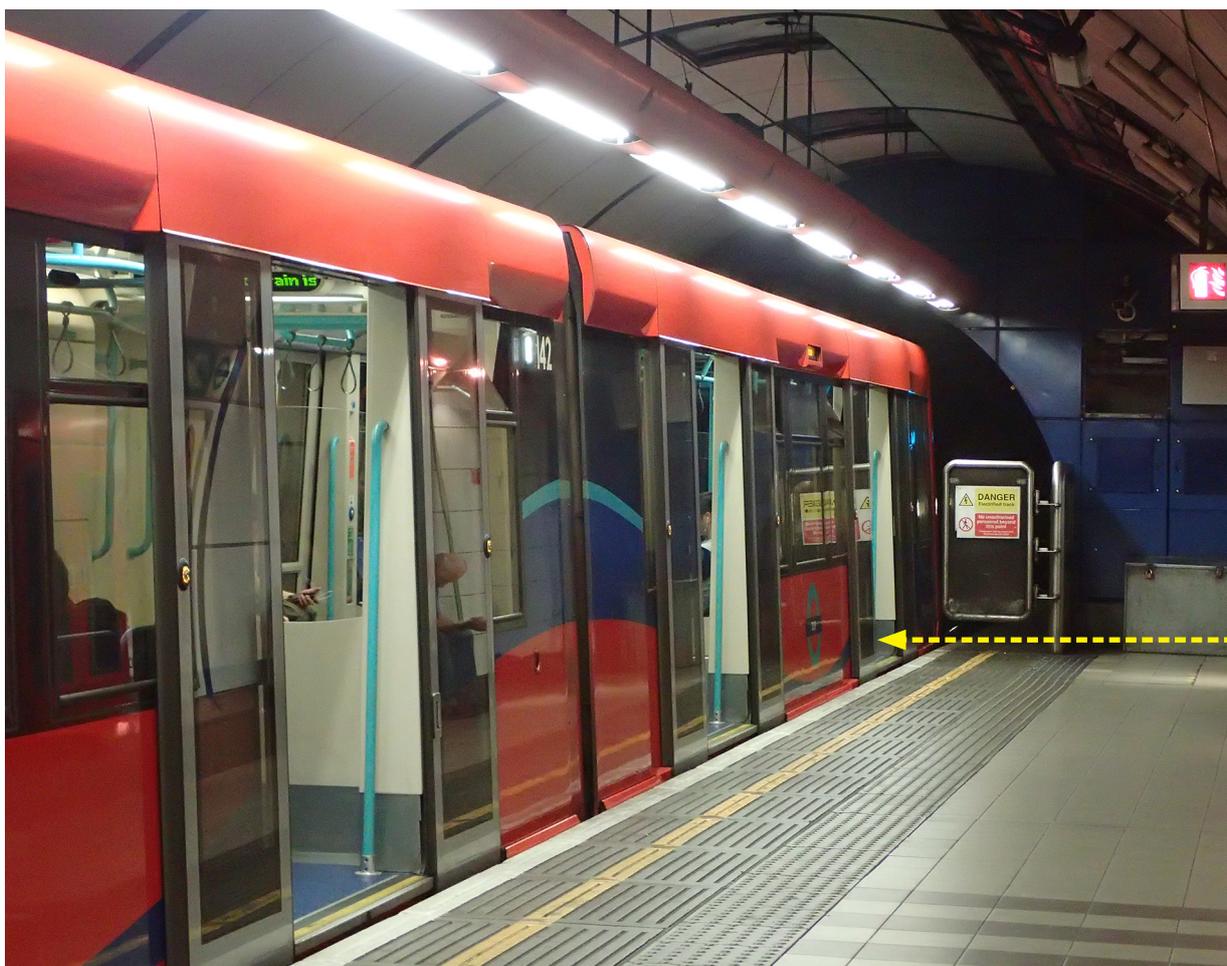
Figure 4: The area of platform 9 at Bank station where the incident took place – view looking east. Arrow indicates path of the passenger.

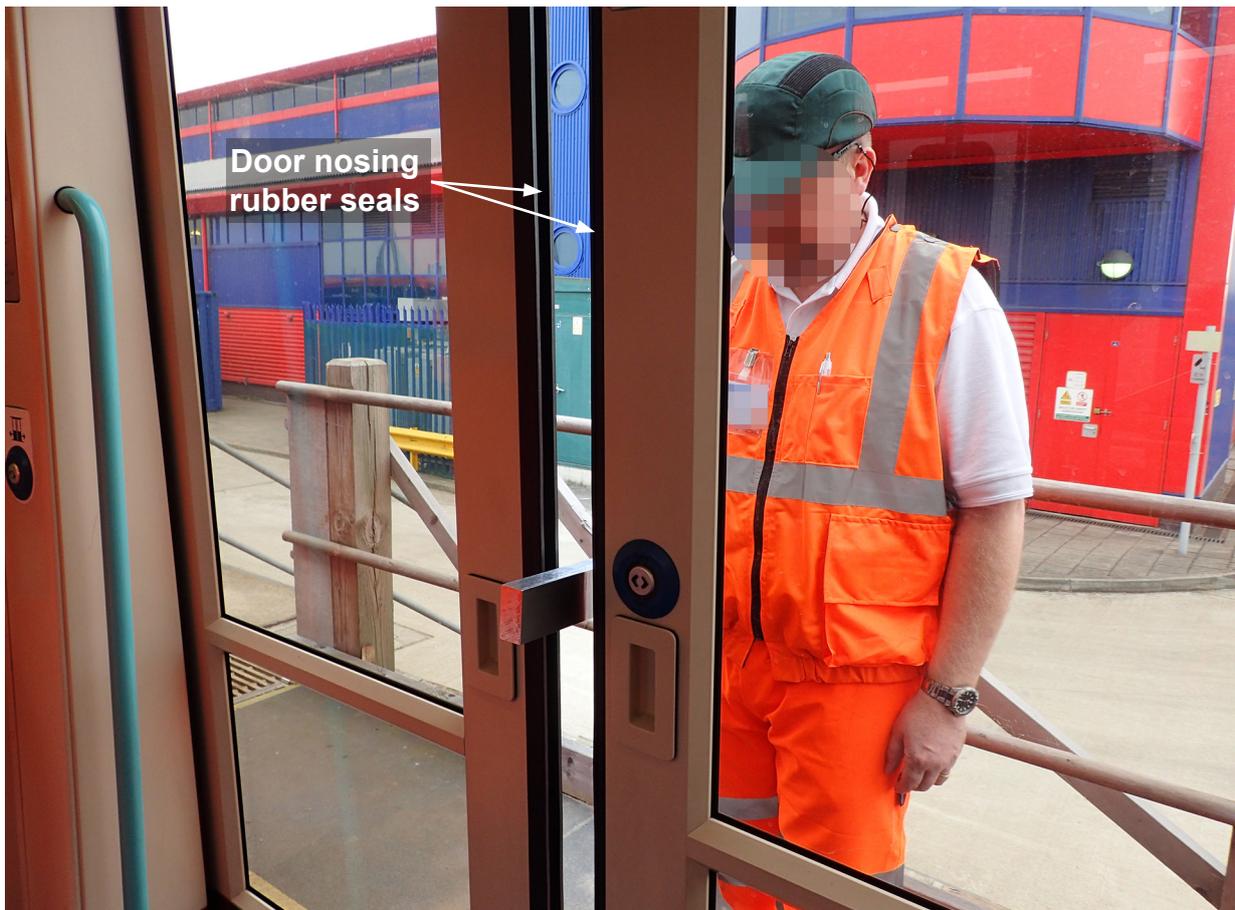
Figure 8: Testing of the door system

- 46 Testing carried out by the RAIB (figure 8) demonstrated that the door system was able to detect a rigid object significantly smaller than the 30 mm x 60 mm standard test block. Provided that the object was rigid, the door system was able to detect objects as small as 1 mm wide (such as a steel ruler).

- 47 However, the RAIB found that objects which were thin and flexible, such as a coat drawstring or fabric, were deflected around the door *nosing rubbers* (paragraph 64) and were not detected by the door system.

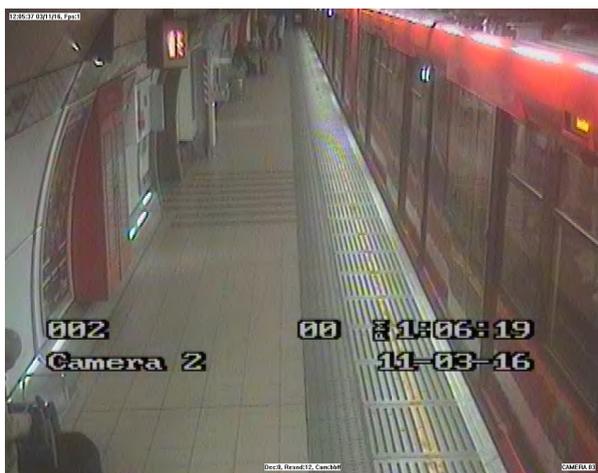
- 54 To allow observation of the platform and doors of a three-car train at platform 9 at Bank station, two CCTV monitor screens are provided for the use of PSAs located at the EDP. The monitors are located at the entrance to the tunnel at the eastern end of the station. One screen shows an image of the eastern end of the platform and the train. The second screen shows a similar image from the western end of the platform.
- 55 The camera showing the image from the eastern end was incorrectly angled. The effect of this defect was that the image shown on the CCTV monitor did not show the leading door (figure 9). As a result, this door and the adjacent platform area could not be observed by a PSA when located at the EDP.

Figure 9: Platform CCTV image at the time of the incident (image courtesy of Keolis Amey Docklands)

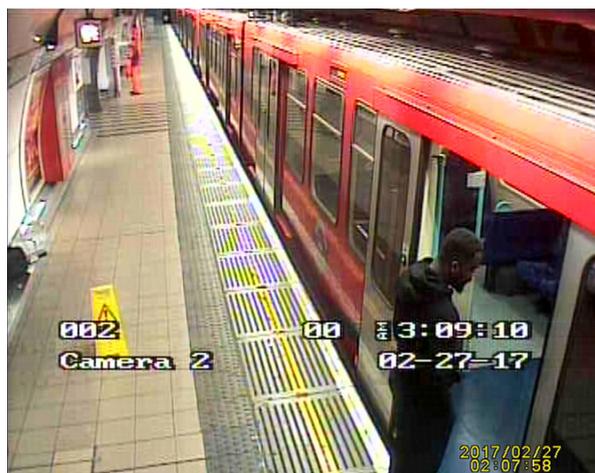
Figure 10: Platform CCTV view after camera adjustment following the incident (image courtesy of Keolis Amey Docklands)

- 56 The RAIB has been unable to establish what caused the camera to be incorrectly angled or when it became so. Following the incident, the camera was angled to show the leading door (figure 10). The management of the CCTV system defect at platform 9 is discussed further at paragraph 68.

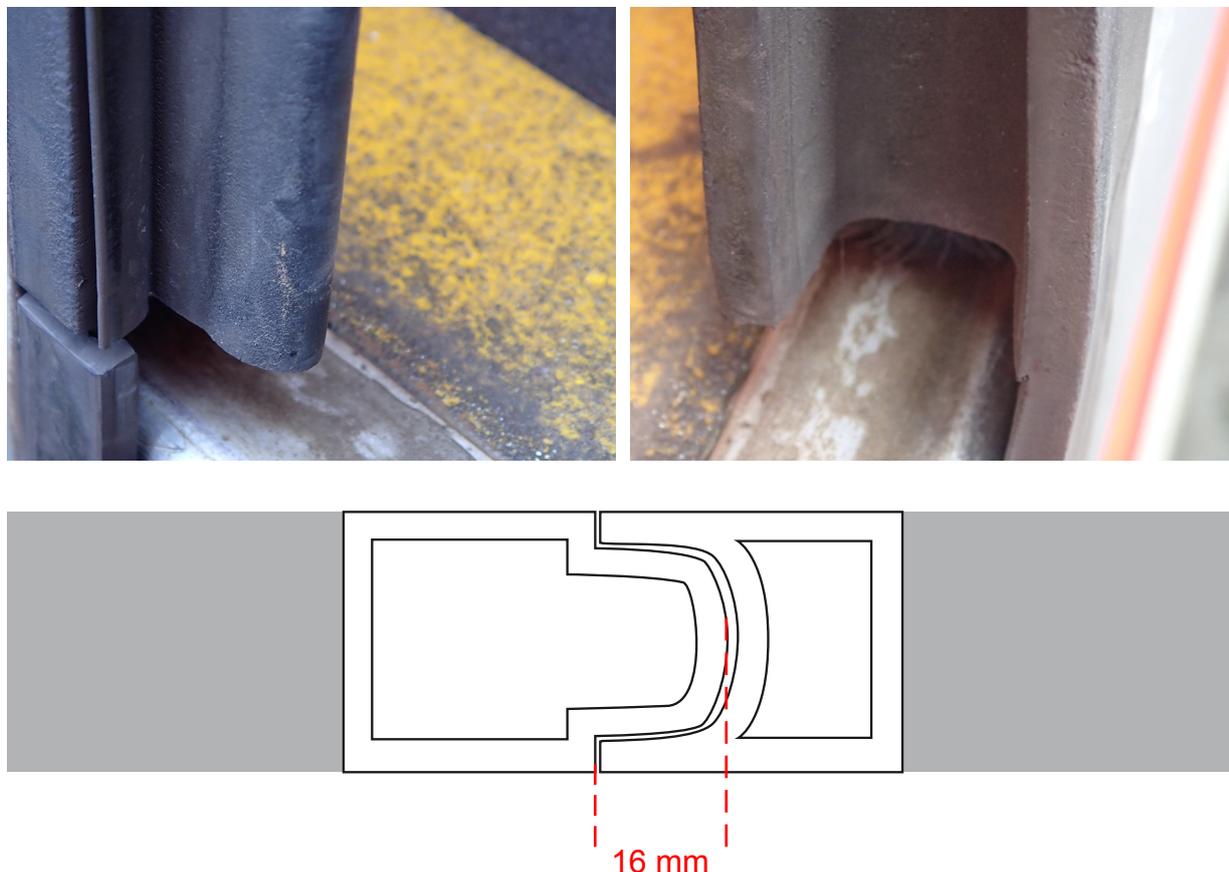
Figure 11: Nosing rubber element used on DLR cars

- 64 The doors on DLR cars have seals called ‘nosing rubbers’, along the vertical edges of the door leaves (figure 8). One door leaf seal has a convex cross-section. This engages with a concave cross-section (figure 11) on the opposing door leaf. The seals reduce draughts, water ingress and noise.

- 65 The nosing rubbers are able to compress around small objects when the doors close, but are intended to have sufficient flexibility, when combined with a *pushback mechanism*, to allow trapped objects to be withdrawn. The shape, flexibility and friction characteristics of the nosing rubbers affects the ease with which trapped objects can be pulled from the doors. The interlocking between the two halves of the nosing rubbers on the DLR cars is around 16 mm. It is greater than that on LUL vehicles² (figure 12), which is around 3 mm. Although the RAIB has not carried out any comparative tests, it is evident that the more convoluted the path that a flexible object, such as a piece of trapped clothing, has to take to be extracted the greater the extraction forces are likely to be, for a given type of nosing rubber design.

- 66 The RAIB also carried out testing using a piece of clothing trapped in the doors of DLR cars and found that forces in excess of 200 N were required to withdraw a fabric test piece. By comparison, the maximum force criteria used by LUL in its tests using a fabric test piece is 90 N.

- a) measure the forces required to pull out thin flexible objects trapped by train doors in its current fleet to determine the range of forces, and assess the risk of trap and drag incidents;
 - b) investigate changing the design of the door nosing rubbers on its current fleet to reduce the forces required to pull out trapped objects so that they are in line with good industry practice; and
 - c) where practicable, change the door nosing rubbers on its trains to reduce the pull-out force to the target level identified in (b).
- 2 *The intent of this recommendation is that safety learning from this investigation about minimising extraction forces for objects accidentally trapped in doors, is addressed when new trains for the Docklands Light Railway are specified.*
