# Rail Accident Report

## **Fatal collision between a tram and pedestrian at Woodbourn Road, Sheffield 22 December 2016**

Report 13/2017  
September 2017

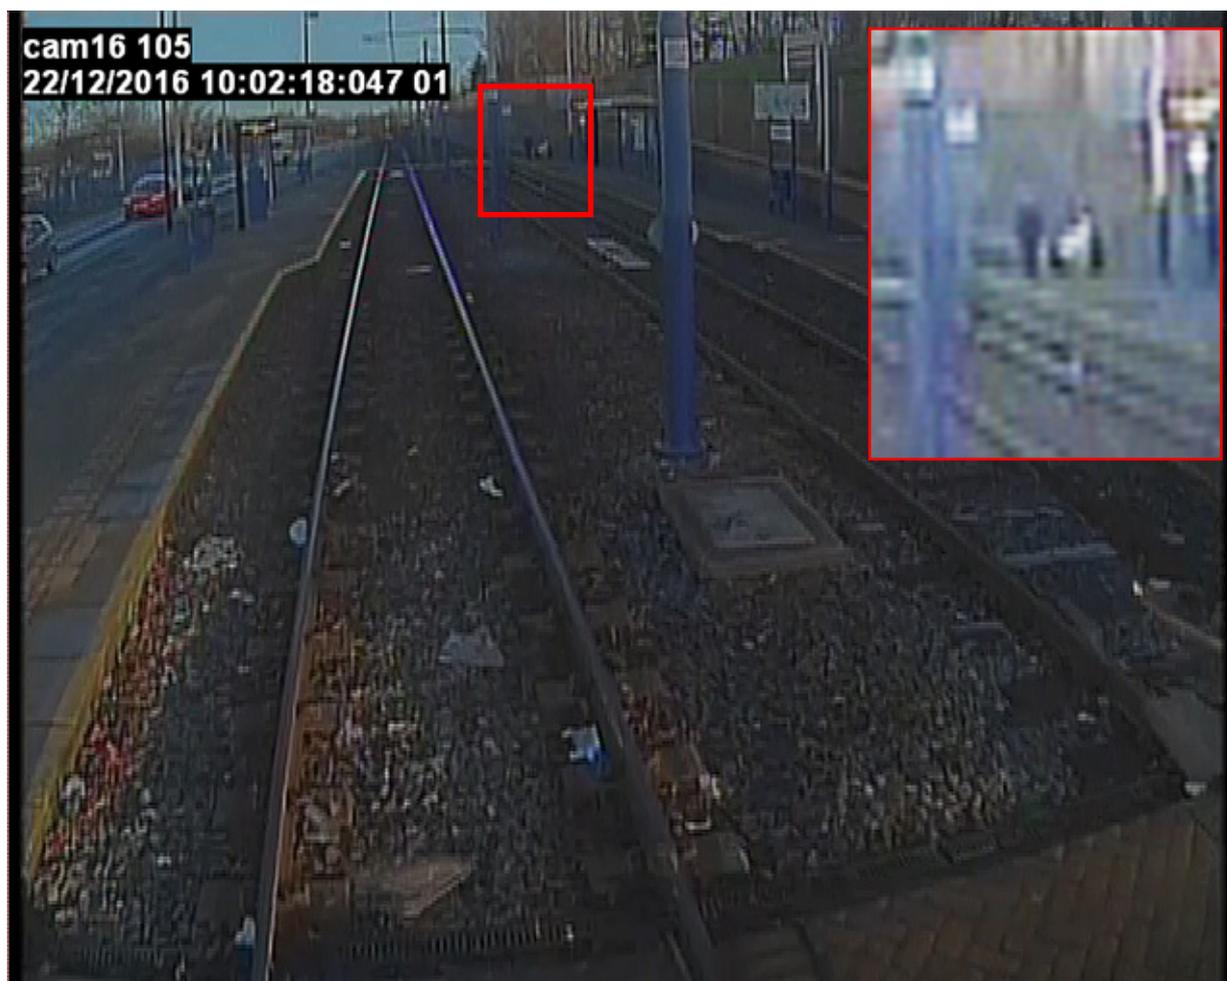
Figure 6: Forward facing CCTV footage from tram 105 as it was entering the tram stop (courtesy of Stagecoach Supertram)

- 21 At 10:02:23 hrs, the front of tram 105 was at about the middle of the outbound platform and 24 metres from the point of collision. By now, the pedestrian had begun to cross the tramway and was walking over the inbound track. Figure 7 shows the sequence of events from 10:02:24.2 hrs, when the tram was about 17.5 metres from the point of collision, through to when the collision happened.

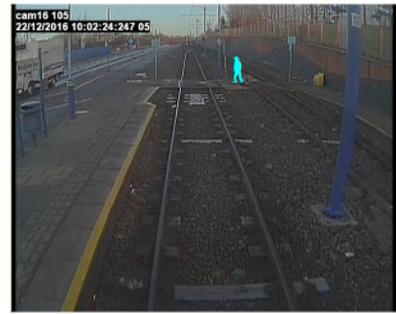
**Time: 10:02:25.0 - Tram distance to collision: 13.5 metres**

The tram is now straight in the tram stop and it is braking. Its speed is between 13 and 11 mph (21 and 18 km/h).

The pedestrian is nearing the halfway point of the crossing.

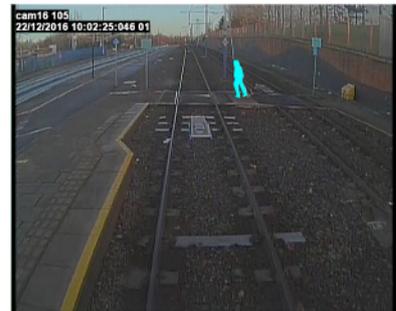
**Time: 10:02:26.0 - Tram distance to collision: 9.0 metres**

The tram stops braking and traction power is applied. Its speed is 11 mph (18 km/h).

The pedestrian is halfway across, in the centre of the crossing.

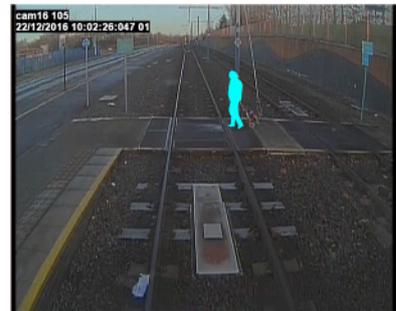
**Time: 10:02:27.2 - Tram distance to collision: 2.0 metres**

The tram is nearing the front edge of the crossing with traction power applied. Its speed is between 11 and 13 mph (18 and 21 km/h).

The pedestrian is moving onto the outbound track.

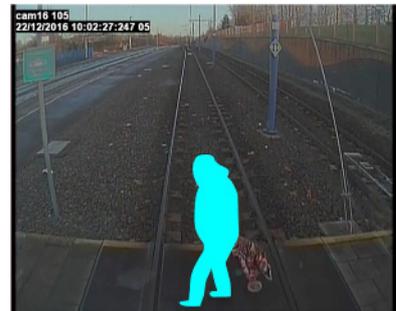
**Time: 10:02:27.6 - Tram distance to collision: 0.0 metres**

The tram reaches the front edge of the crossing with traction power applied. Its speed is between 11 and 13 mph (18 and 21 km/h).

The pedestrian is in the centre of the outbound track.

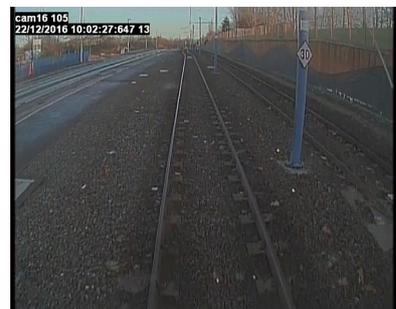
Figure 7: The sequence of the events during the accident (images courtesy of Stagecoach Supertram)

The tram collides with the pedestrian. Traction power is removed and braking is applied. Its speed is 13 mph (21 km/h).

The pedestrian is knocked to the ground in front of the tram.

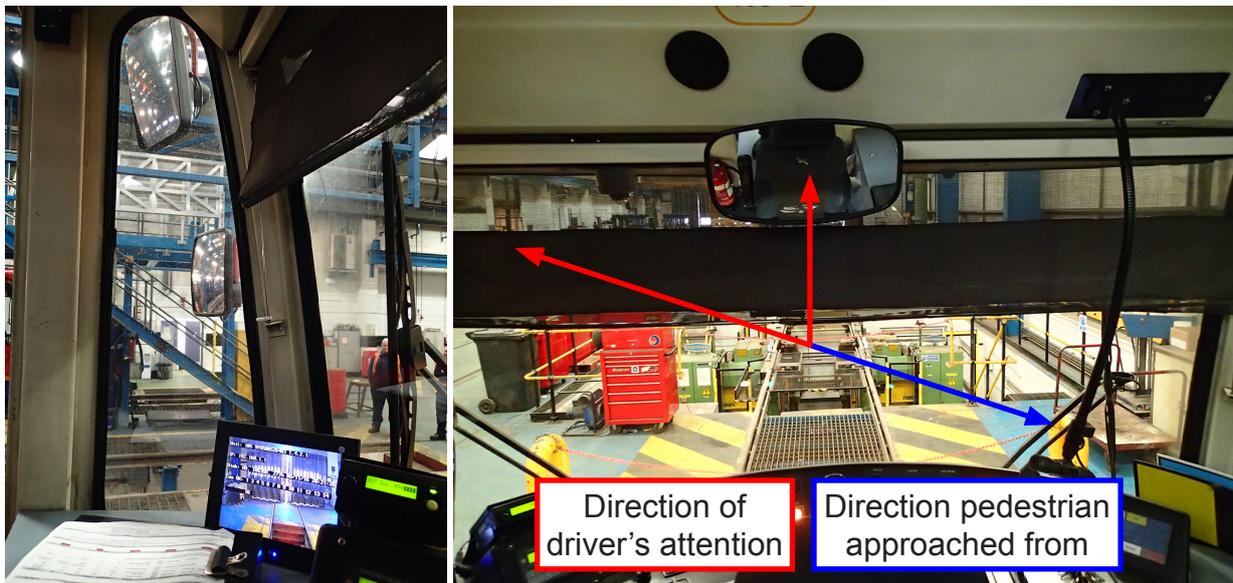
Figure 8: The location of the tram's mirrors

- 36 As the tram passed non-stop through the tram stop, and prior to seeing the pedestrian, the driver's attention was focused on the tram's mirrors. Stagecoach Supertram's *operational standards* define the rules that its tram drivers are required to follow and include a requirement for drivers to operate trams on line of sight. This means the 'driver must ensure that the tram can be stopped within the range of vision' and at all times drivers must 'control the tram so as to be able to stop short of any vehicle, pedestrian, or other potential hazard ahead'. However, instead of looking ahead, the driver reported that she was monitoring the external left-hand side mirror and the internal rear view mirror (figure 8).

- 37 The position of both these mirrors takes the driver's attention away from looking ahead, particularly the internal rear view mirror which is almost directly above the driver's head. Consequently, if using these mirrors the driver would not have seen the pedestrian in her peripheral vision as he crossed from the bottom right-hand corner of her view.

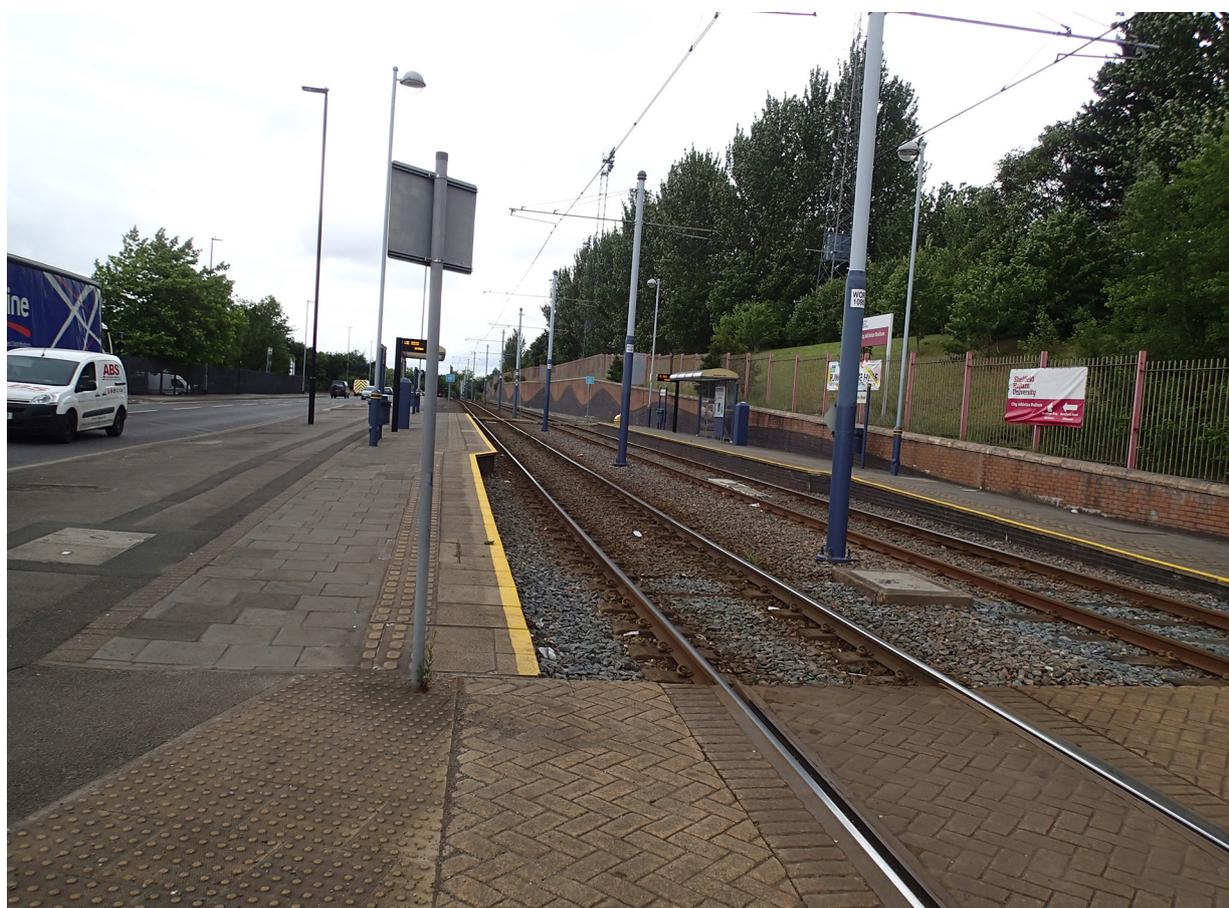
Figure 9: The position of the posts between the tracks through the tram stop

- 44 When the front of the tram entered the tram stop, the pedestrian was about 52 metres away and walking down the inbound platform ramp at the far end of the tram stop (figure 6). Posts that support the tramway's overhead electrification wiring are located between the tracks through the length of the tram stop and are likely to have interrupted the driver's view of the pedestrian (figure 9).

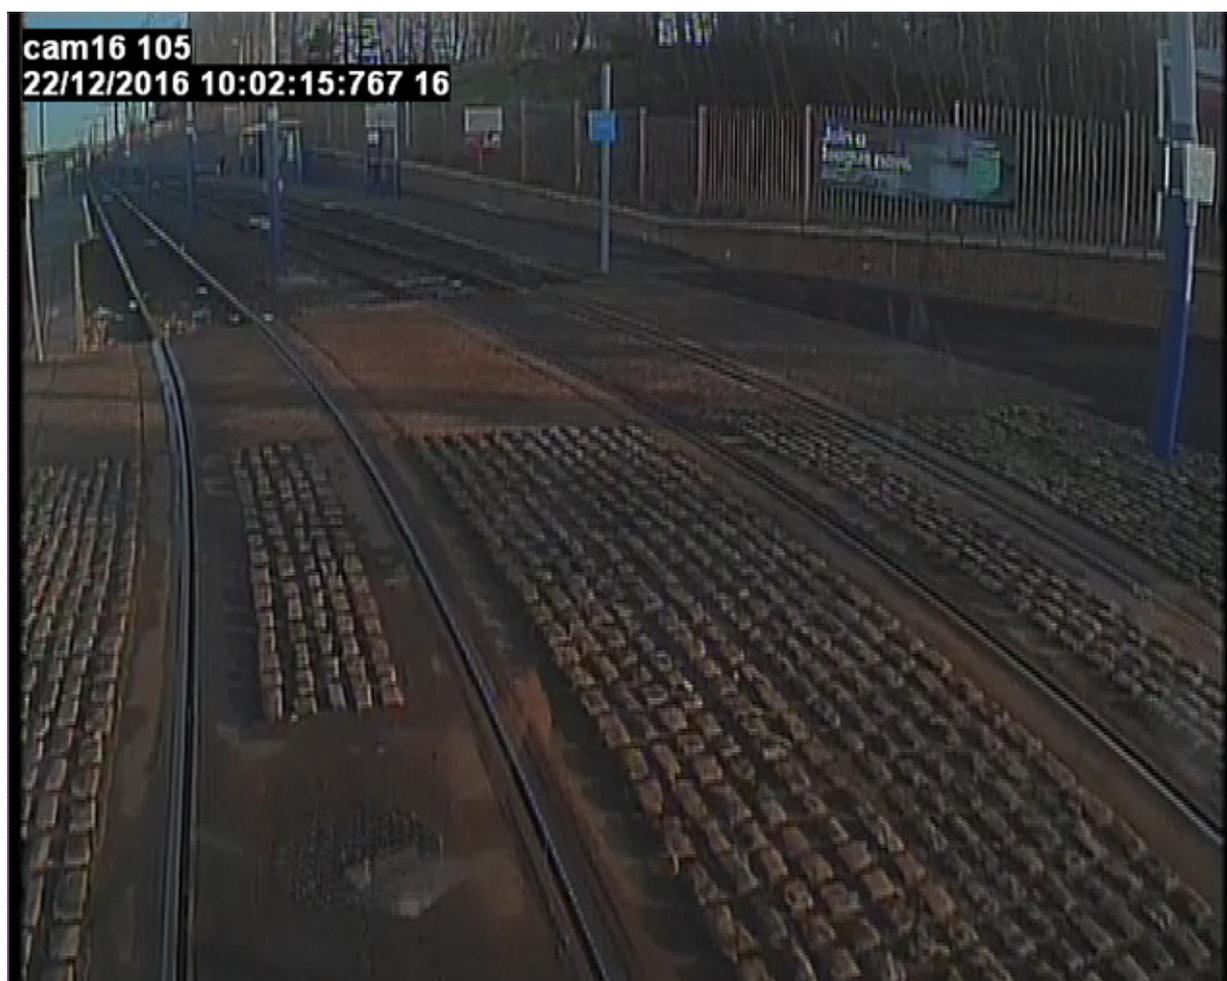
Figure 10: Forward facing CCTV images showing the approach to the tram stop in sunlight and parts of the tram stop in shade (courtesy of Stagecoach Supertram)

- 47 The low winter sun was casting long shadows that morning (paragraph 14). This meant the tram travelled through areas which were sunlit and others that were shaded and the driver's eyes would have needed time to adjust to the changes in light conditions. When the tram approached Woodbourn Road tram stop, the driver was in a sunlit area (figure 10). As she entered the tram stop, this changed to a shaded area which included the whole of the inbound platform, with the pedestrian at the far end of it (figure 6). The colour of the pedestrian's clothes did not stand out against the background of the tram stop and the wall behind it, which made him less easy to spot when in shade.

- 48 The driver was wearing sunglasses that morning to combat glare from sunlight reflecting off the rails and other surfaces. However, wearing them made it less likely that driver would see the pedestrian against a dark background in a shaded area when entering the tram stop. The driver was wearing prescription sunglasses, which she reported had a 70% or 75% tint (allowing either 30% or 25% of the light through to the eye). The Highway Code does not define what level of tint is acceptable for glasses or lenses that are worn when driving. However, guidance on sunglasses issued by The AA<sup>5</sup> classifies the driver's sunglasses as having category 2 lenses, which transmit between 18% and 43% of light, and which are recommended for daytime driving.

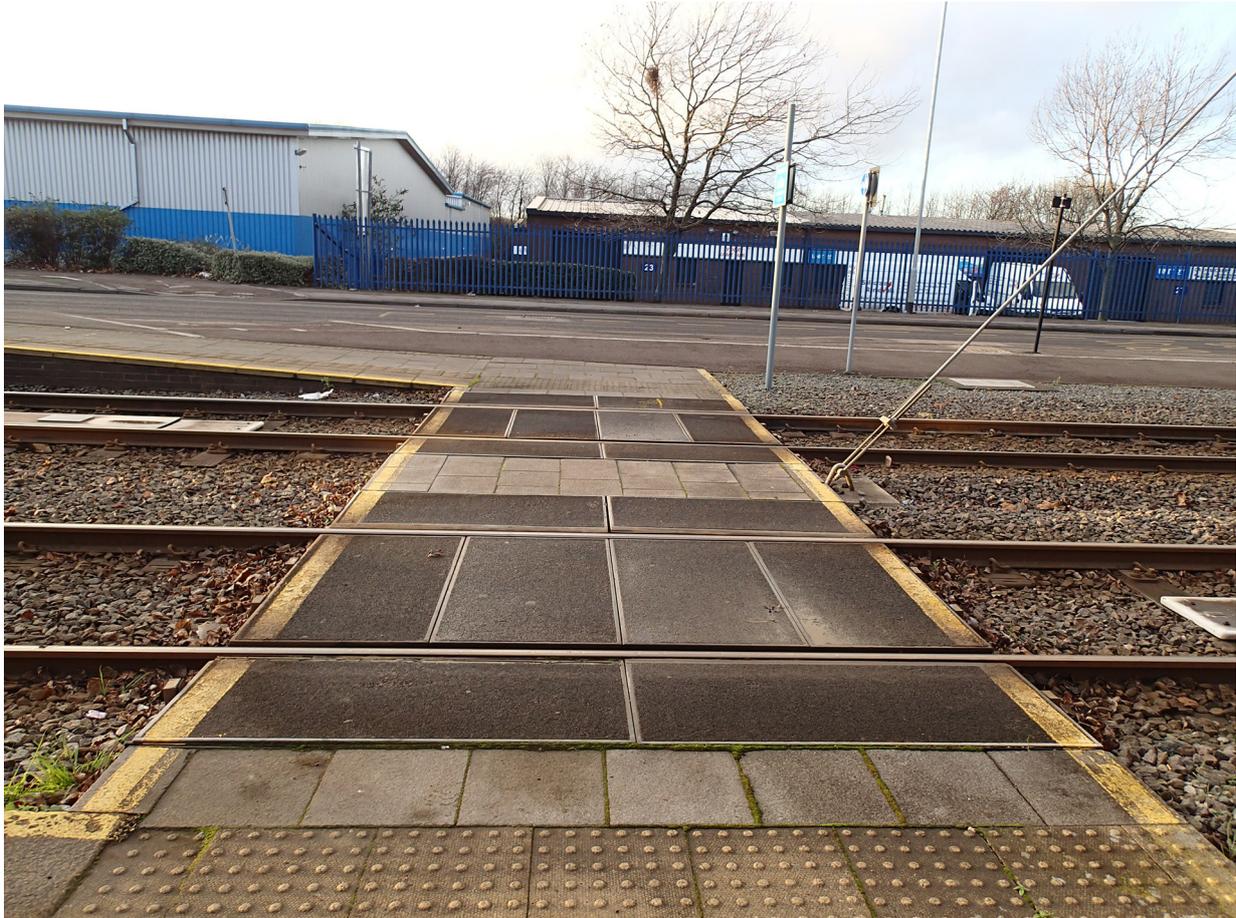
Figure 11: Photograph showing the surface over the crossing

- 85 The condition of the crossing, including its surface, was not a factor. Stagecoach Supertram's records show the tram stop was last inspected on 30 November 2016. The only defect noted during this inspection was graffiti on some of the signs which was removed that day. The crossing surface was reported in the inspection as 'ok' and no issues could be seen with it during a visual inspection after the accident. It was level throughout its length, at the same height as the head of the rail, and tactile paving strips were present at the outer edges, denoting the start and end of the crossing (figure 11).

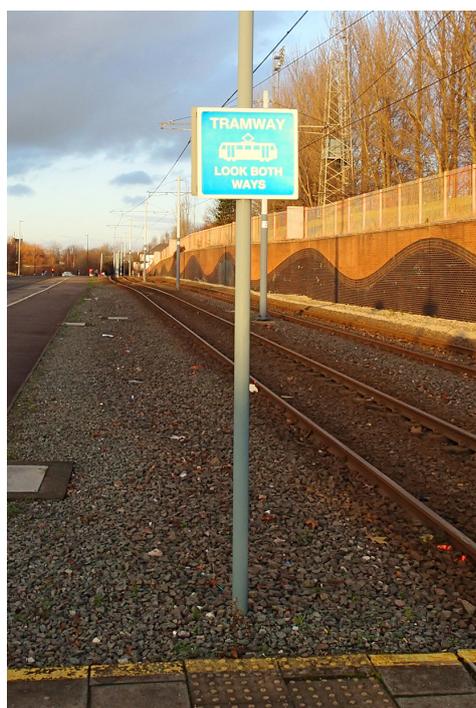
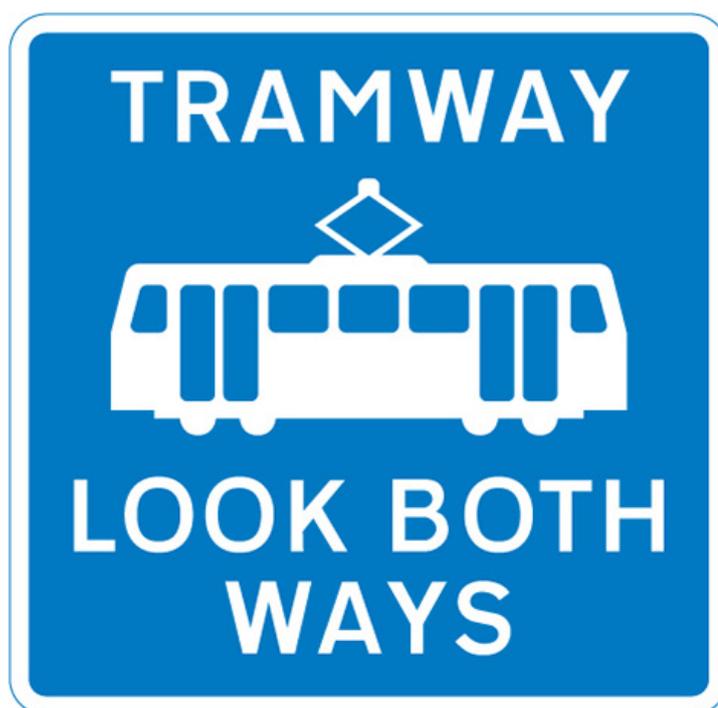
Figure 12: Example of the signage for crossing users

- 84 It is unlikely that the signage provided at the crossing was a factor. Four 'Tramway Look Both Ways' signs were in place on the northern crossing for its users (figure 12). These signs were the same as the 'Tramway Look Both Ways' sign shown in the Highway Code. When the pedestrian approached the crossing, one of these signs, located on the inbound side of the crossing, was in the pedestrian's line of sight. Stagecoach Supertram has since placed another of these signs on the outbound side of the crossing, which faces users crossing from the inbound side (paragraph 103 and figure 13). Guidance on tramways<sup>10</sup> issued by the ORR mentions that these signs should be provided at pedestrian crossings but it does not state whereabouts on the crossing. It is unlikely that the presence of a second sign would have altered the way in which the pedestrian used the crossing because he had just got off a tram and had just walked past such a sign.
