BRE Global Client Report

BS 8414-1:2015 + A1:2017 test referred to as DCLG test 3.

Prepared for: DCLG
Date: 3rd August 2017 (Issue 1.0)
12th September 2017 (Issue 1.2)
Report Number: B137611-1037 (DCLG test 3) **Issue: 1.2**

Prepared for:
Department for Communities and Local
Government
2 Marsham Street
London
SW1P 4DF

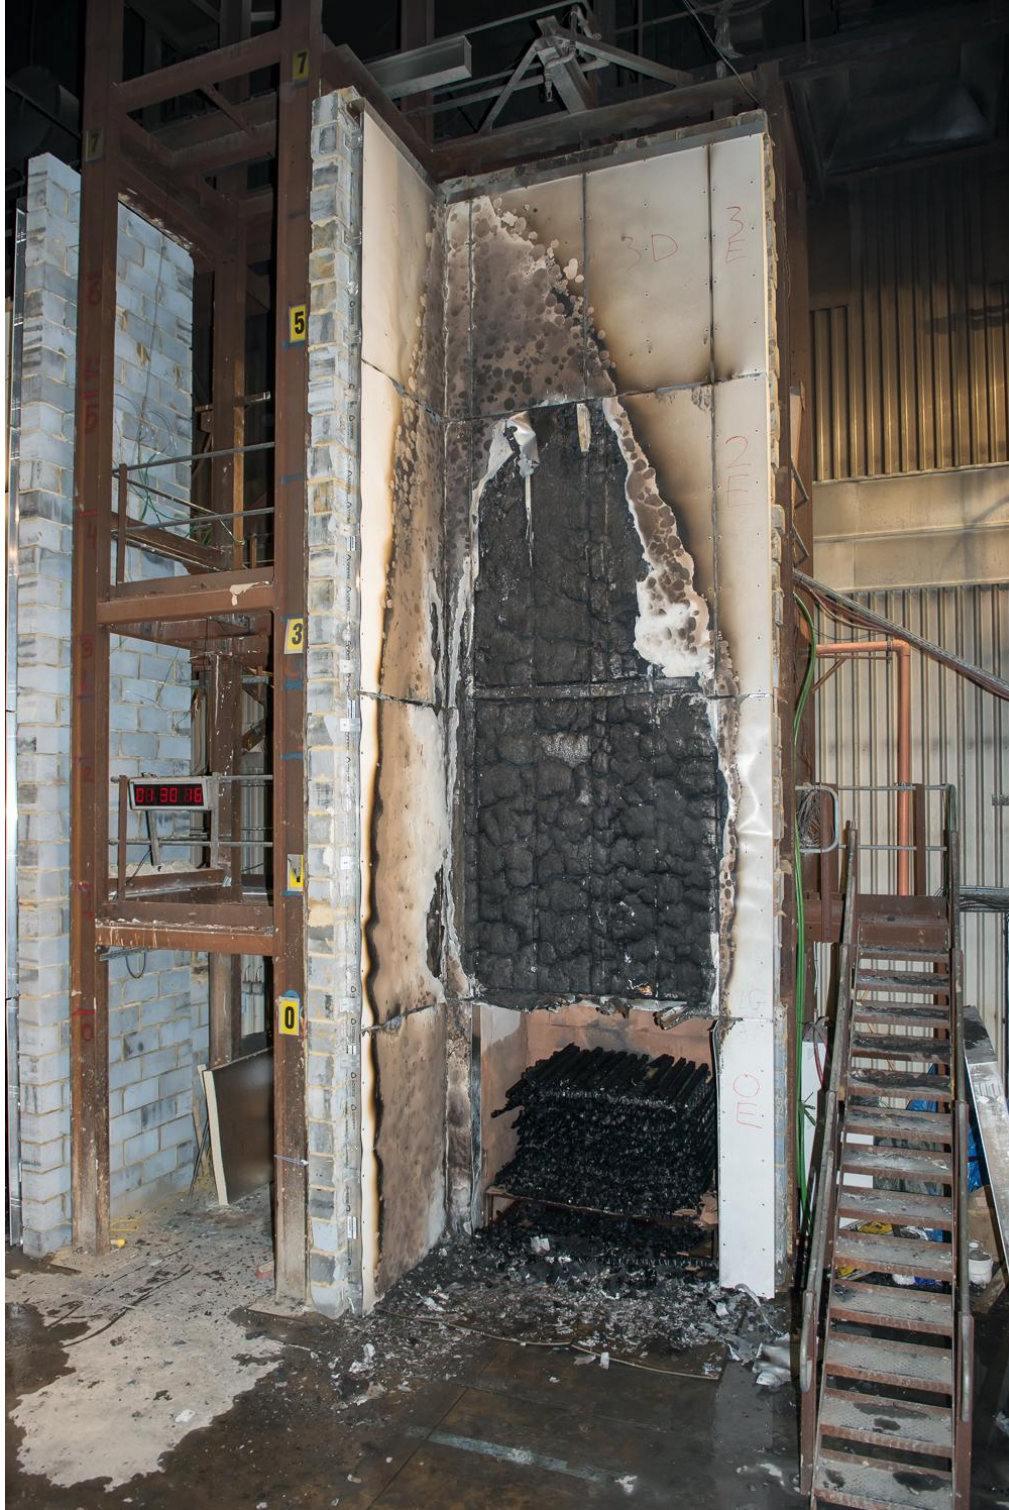
Significant discolouration and distortion was sustained by panels: 3B (100%), 3C (75% - top right corner furthest from wing wall remained relatively undamaged) and 2D (25% - immediately adjacent to the area of panel consumption a damaged strip with an area approximately 0.6m² was present) – see Figures 24, 26 & 27.

Significant discolouration and distortion was sustained by panels: 0A (90%), 1A (90%), 2A (60%) and 3A (25%) – see Figure 24-27. The damaged area tapered, in the direction of the main wall, from the outer edge of the wing wall (approximately 1.5m above the height of the combustion chamber) to the wing-main wall junction at the top of the cladding system.

Figure 24. Full height photograph of system after test termination – general.

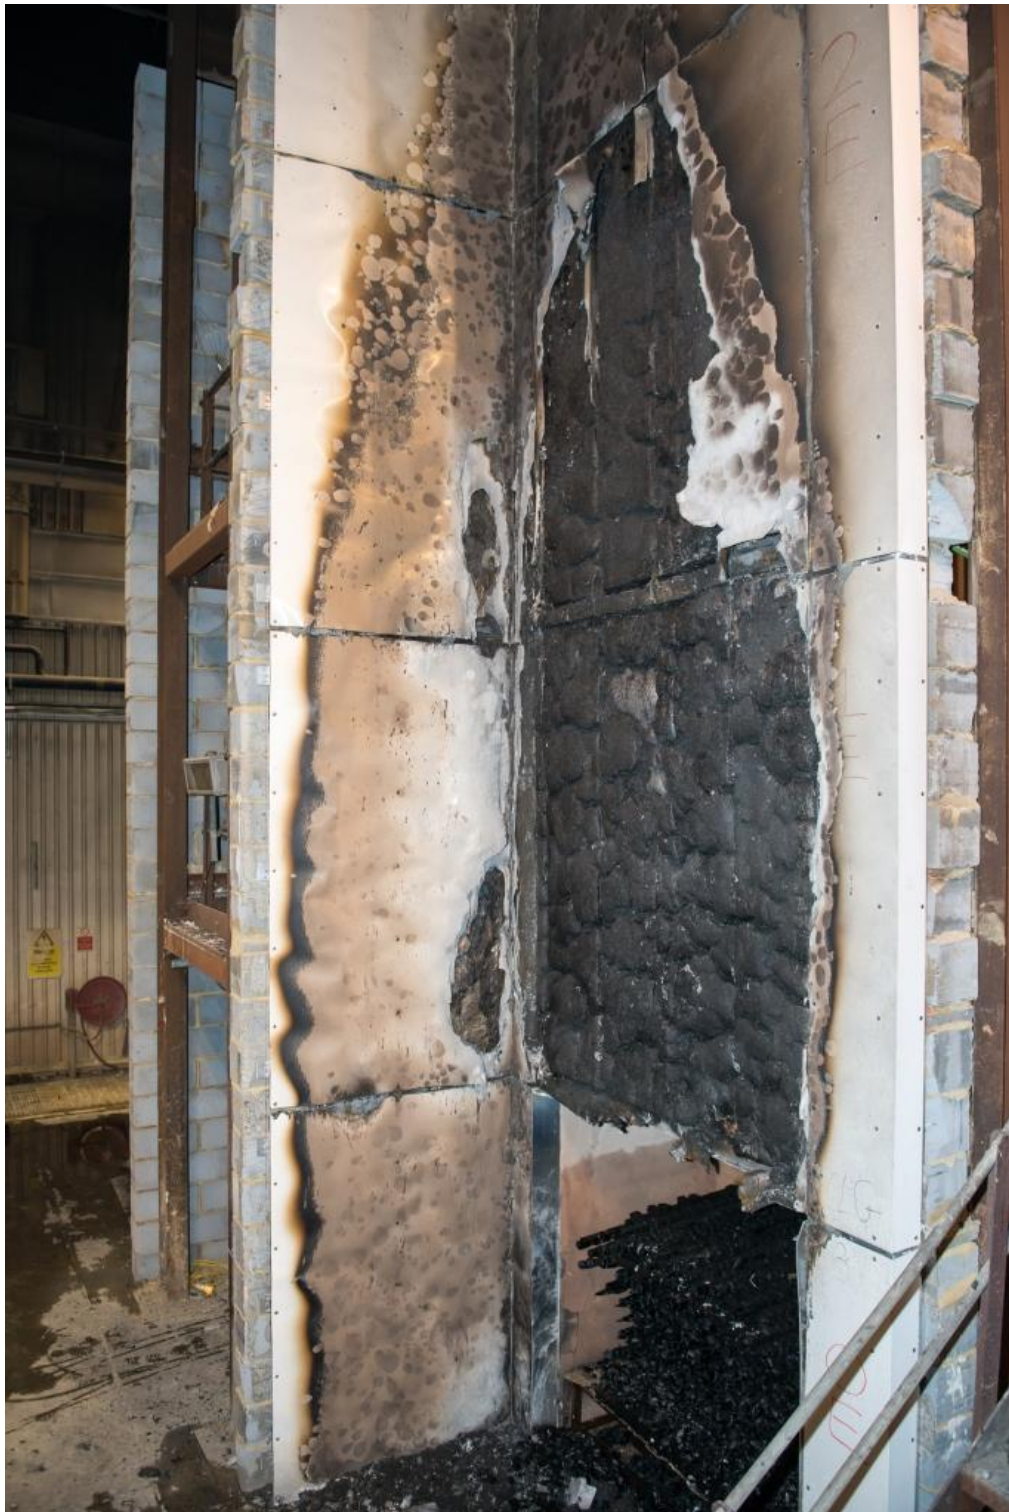
Figure 25. Full height photograph of system after test termination – wing wall.

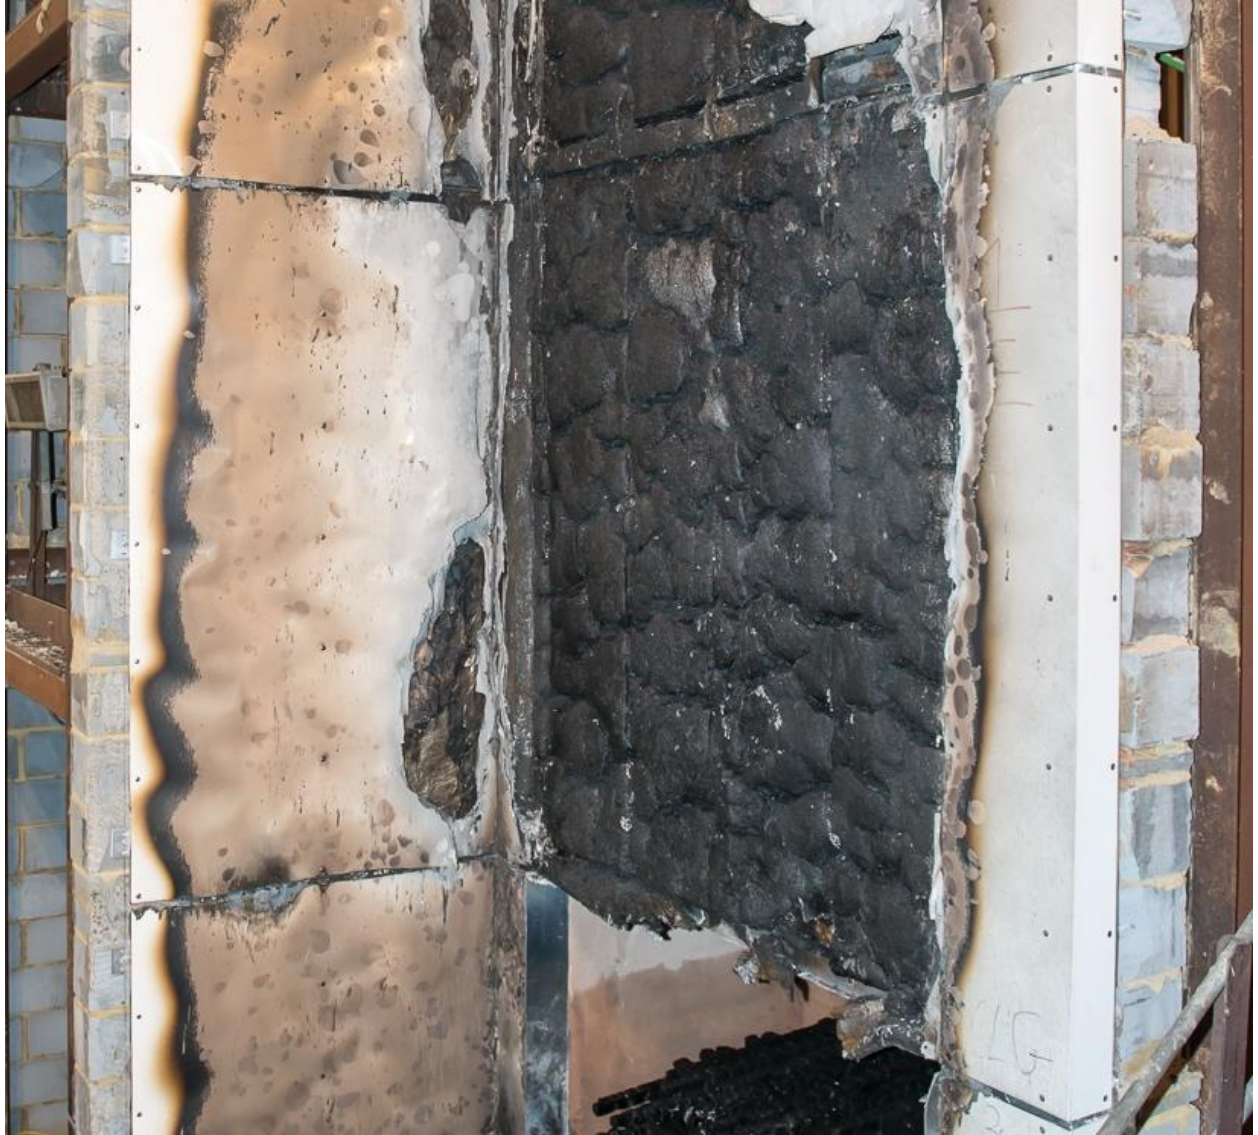
Figure 26. First row ACM panels (directly above combustion chamber).

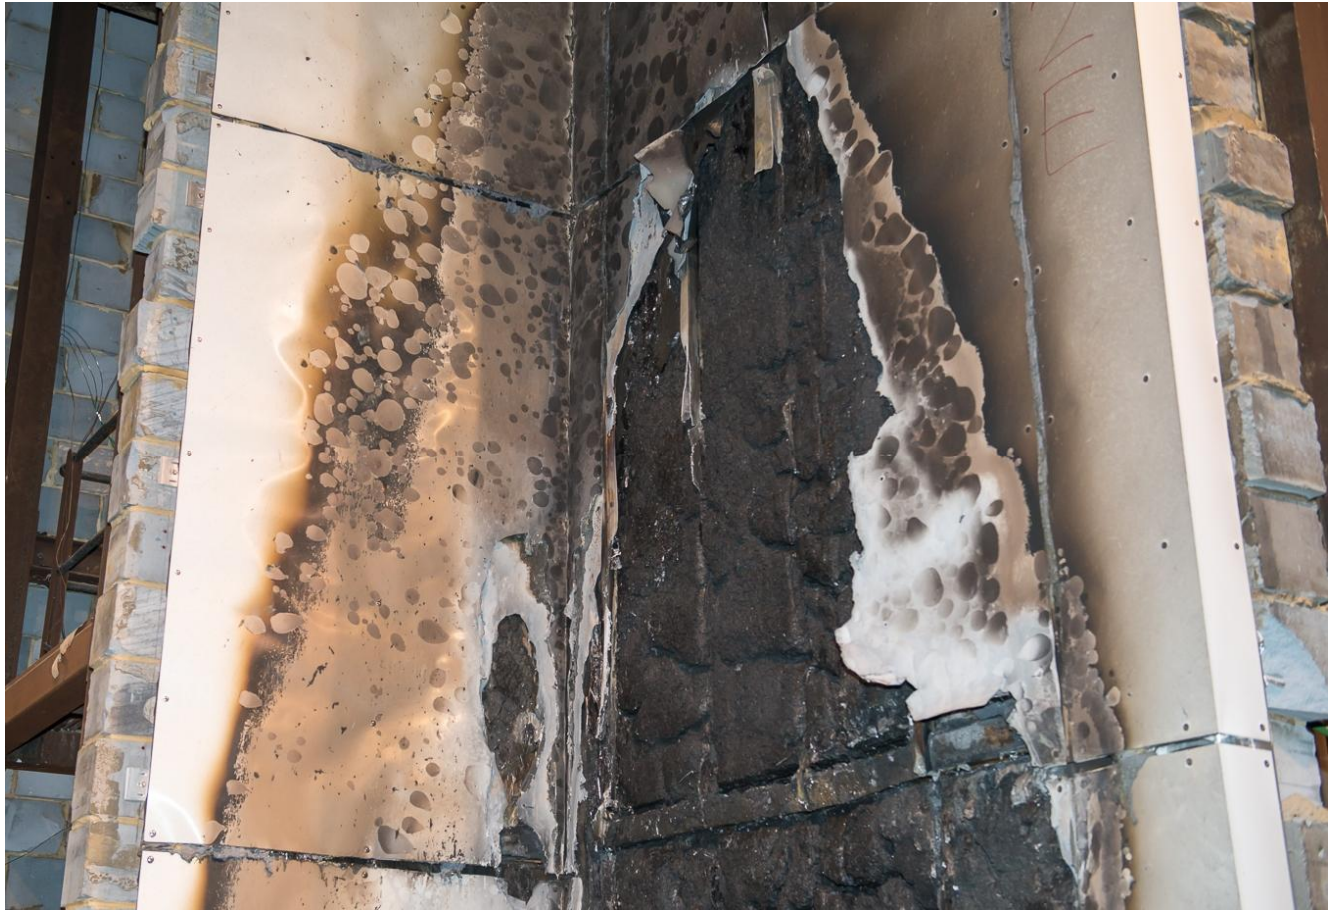
Figure 27. Second row ACM panels (approximately 2300mm-4600mm above combustion chamber).

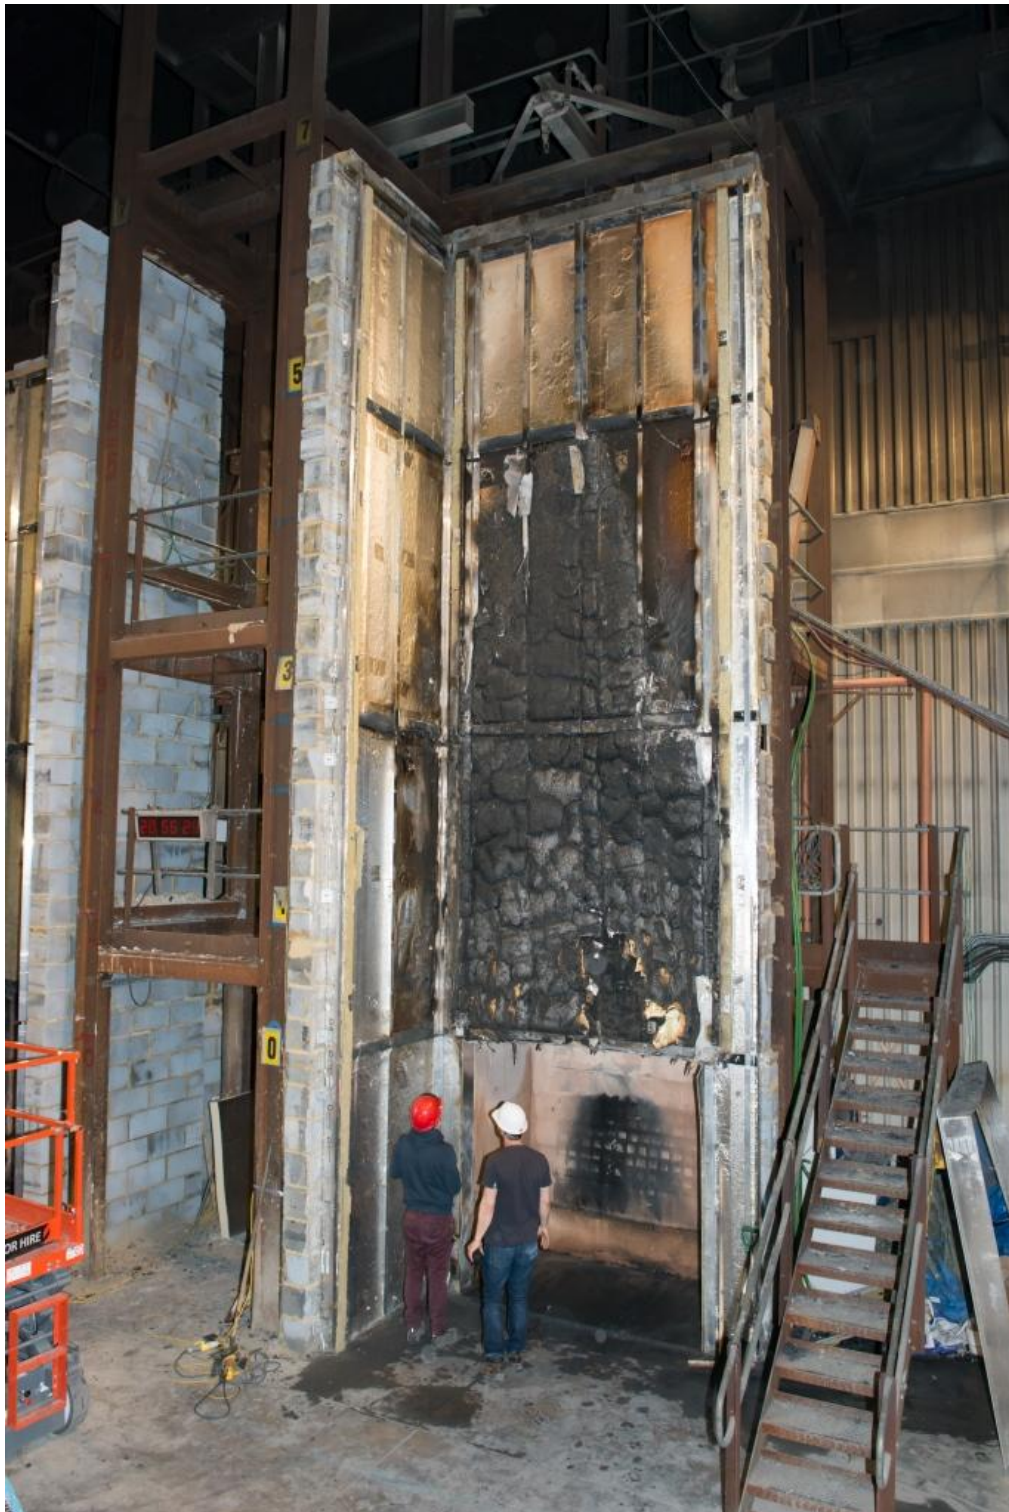
Damage to the rail substructure was most severe on the main wall with the five sections spaced evenly across the combustion chamber opening sustaining significant consumption – see Figures 28, 29 and 31. At 500mm intervals from the edge of the combustion chamber adjacent to the wing wall the following damage occurred:

The fire damage to the cladding system on the main wall was contained within the bounds of the vertical cavity barriers across the combustion chamber opening – see *Figure 28*. The cavity barriers remained intact despite significant charring and discolouration along the inside edges running parallel to the vertical edges of the combustion chamber.

Figure 28. Full height photograph of system following removal of ACM panels.

Note: 500mm-wide×800mm-high section of absent insulation, located immediately above the combustion chamber, removed post-test.

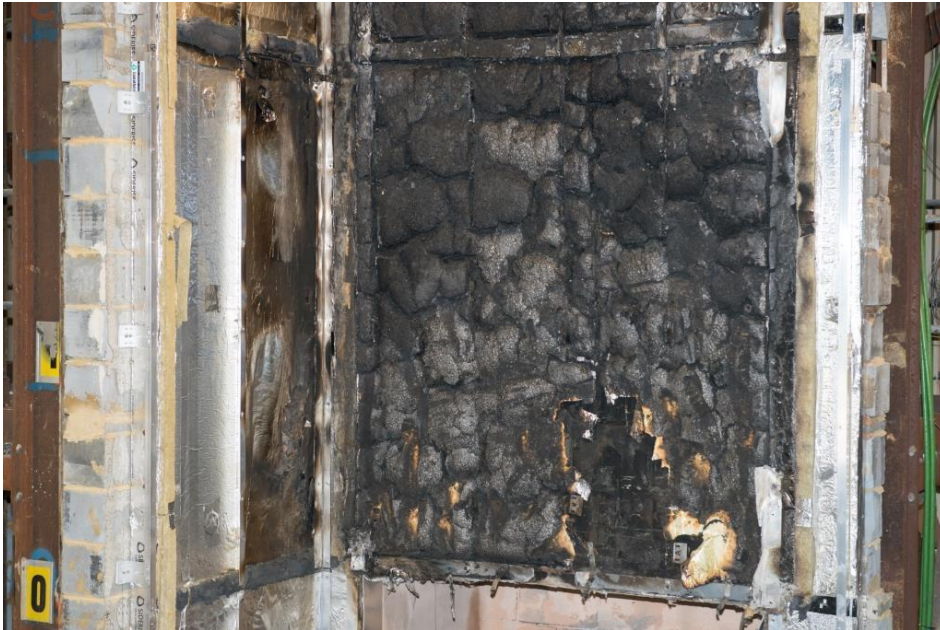
The second row horizontal cavity barrier shows evidence of activation but by test termination all expanded material directly in line with the combustion chamber opening had been consumed – see *Figures 29 & 31*. The section of cavity barrier at the outside edge, beneath panel 2E, is undamaged and has not activated. On the wing wall, full width activation of the cavity barrier is evident: to the outside of the centrally supporting 'L'-rail the intumescent material fills the void, towards the main wall the intumescent material has started to detach and deteriorate – see *Figure 32*.

Figure 29. Damage to cladding system beneath ACM panels directly above the combustion chamber.

Note: 500mm-wide×800mm-high section of absent insulation, located immediately above the combustion chamber, removed post-test.

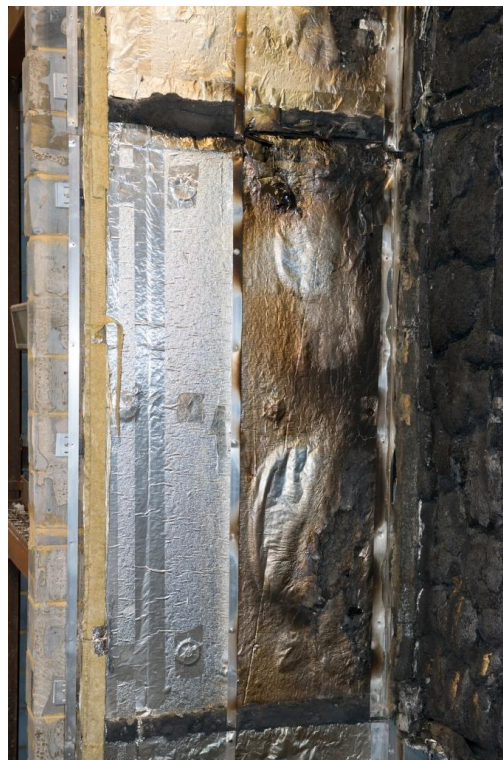
Damage to the rail substructure on the wing wall was far less severe – see *Figures 28, 30, 32 & 34*. Between the first and the second cavity barrier, the 'L'-rail adjacent to the main wall was charred and distorted – see *Figure 30*. The 'L'-rail at the centre of panel 1A sustained isolated areas of dark discolouration. Between the second and the third cavity barrier, isolated areas of lighter discolouration were observed on the lower 1m of the 'L'-rails at the centre and main wall edge of panel 2A – see *Figures 32*. The rail substructure above this, and at the outside edge (full-height) of the vertical cavity barrier was undamaged *Figures 28, 30, 32 & 34*.

Figure 30. Damage to cladding system beneath ACM panels on wing wall between the first and second horizontal cavity barrier (approximately 0-2400mm above the height of the combustion chamber).

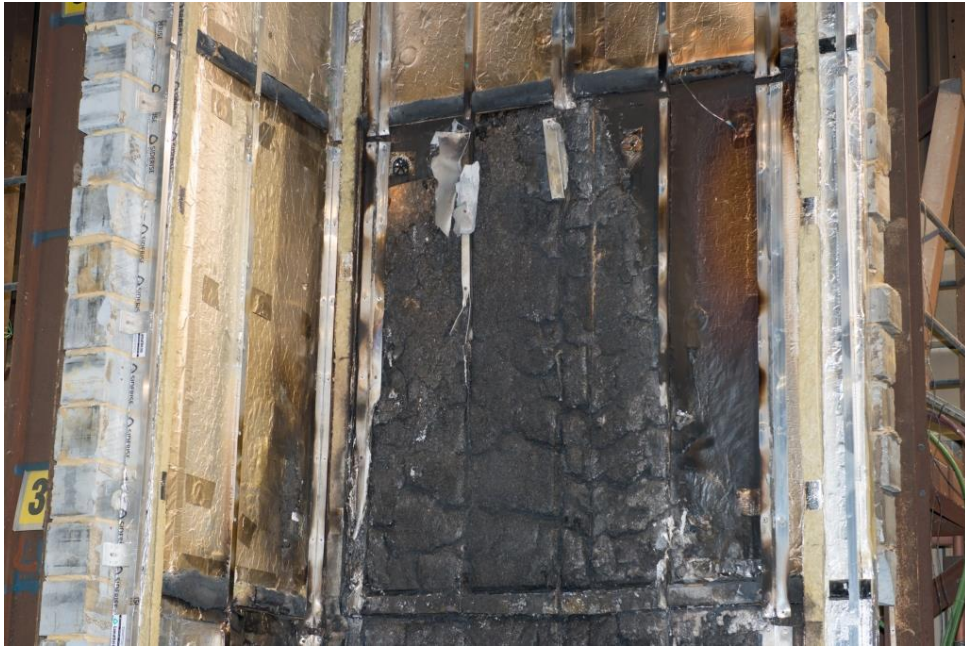
Figure 31. Damage to cladding system beneath ACM panels between the second and third horizontal cavity barrier (approximately 2400-4700mm above combustion chamber).

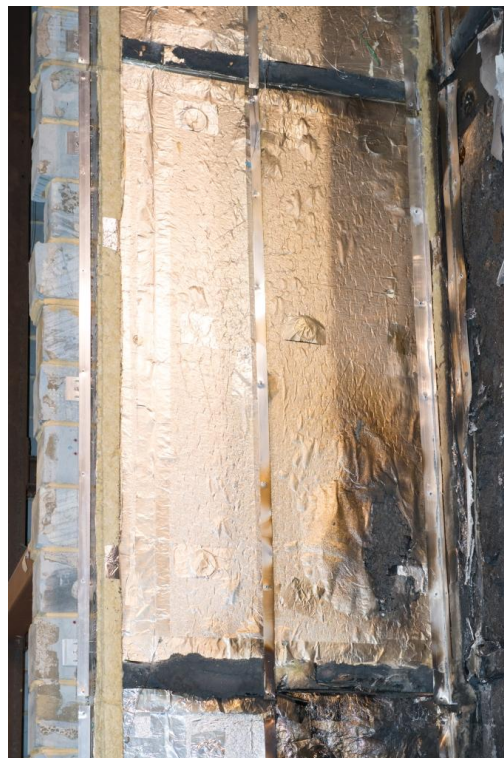
- 2A, the foil facing was consumed and the insulation charred in an area approximately 200mm-wide×400mm-high in a position directly adjacent to the main wall and approximately 250mm above the second horizontal cavity barrier. Blistering of the foil facing was most concentrated within a 300mm-radius of the exposed insulation. Minor discolouration to the foil facing was the extent of damage to the remainder of the insulation panel – see *Figure 32*.

Figure 32. Damage to cladding system beneath ACM panels on wing wall between the second and third horizontal cavity barrier (approximately 2400-4700mm above the height of the combustion chamber).

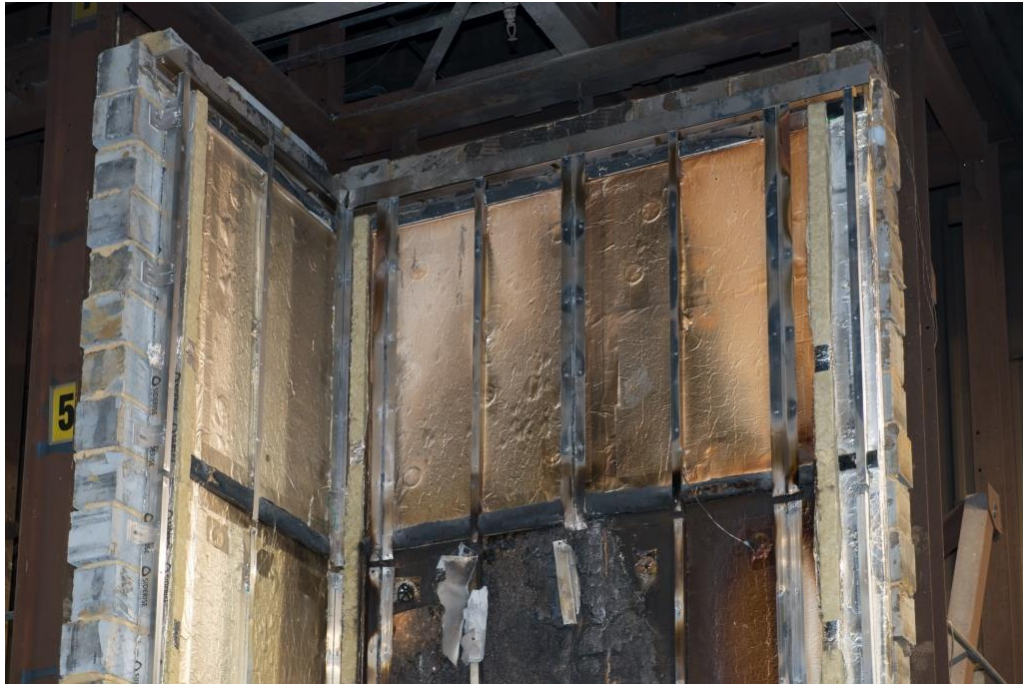
Figure 33. Damage to cladding system beneath ACM panels between the third and fourth horizontal cavity barrier (approximately 4700-6360mm above the combustion chamber).

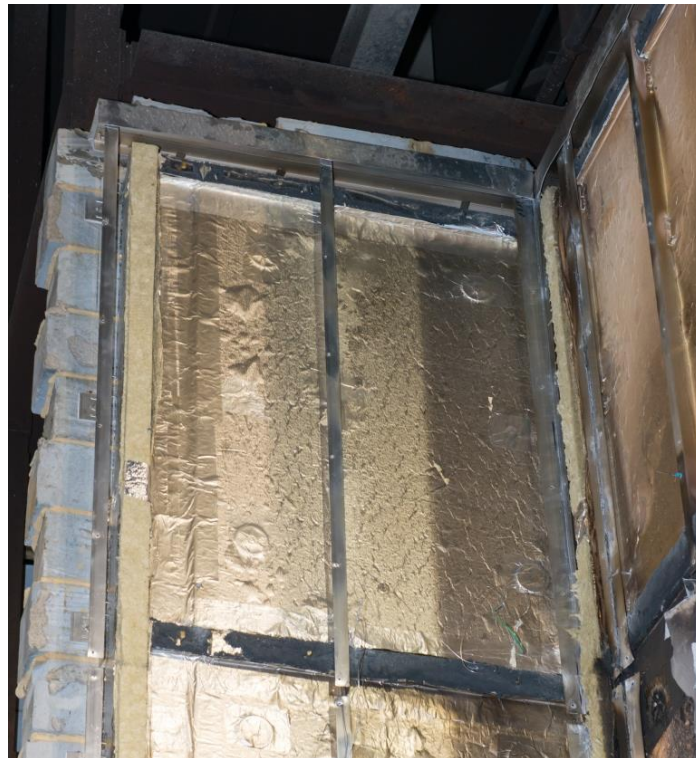
- 3A, minor discolouration to the foil facing was the extent of damage – see *Figure 34*.

Figure 34. Damage to cladding system beneath ACM panels on wing wall between the third and fourth horizontal cavity barrier (approximately 4700-6360mm above the height of the combustion chamber).
