BRE Global Client Report

BS 8414-1:2015 + A1:2017 test referred to as DCLG test 5.

Prepared for: DCLG
Date: 10th August 2017 (Issue 1.0)
12th September 2017 (Issue 1.2)
Report Number: B137611-1037 (DCLG test 5) Issue: 1.2

This report is one of a series, commissioned by the Department for Communities and Local Government (DCLG) intended to establish how different types of Aluminium Composite Material (ACM) panels in combination with different types of insulation behave in a fire.

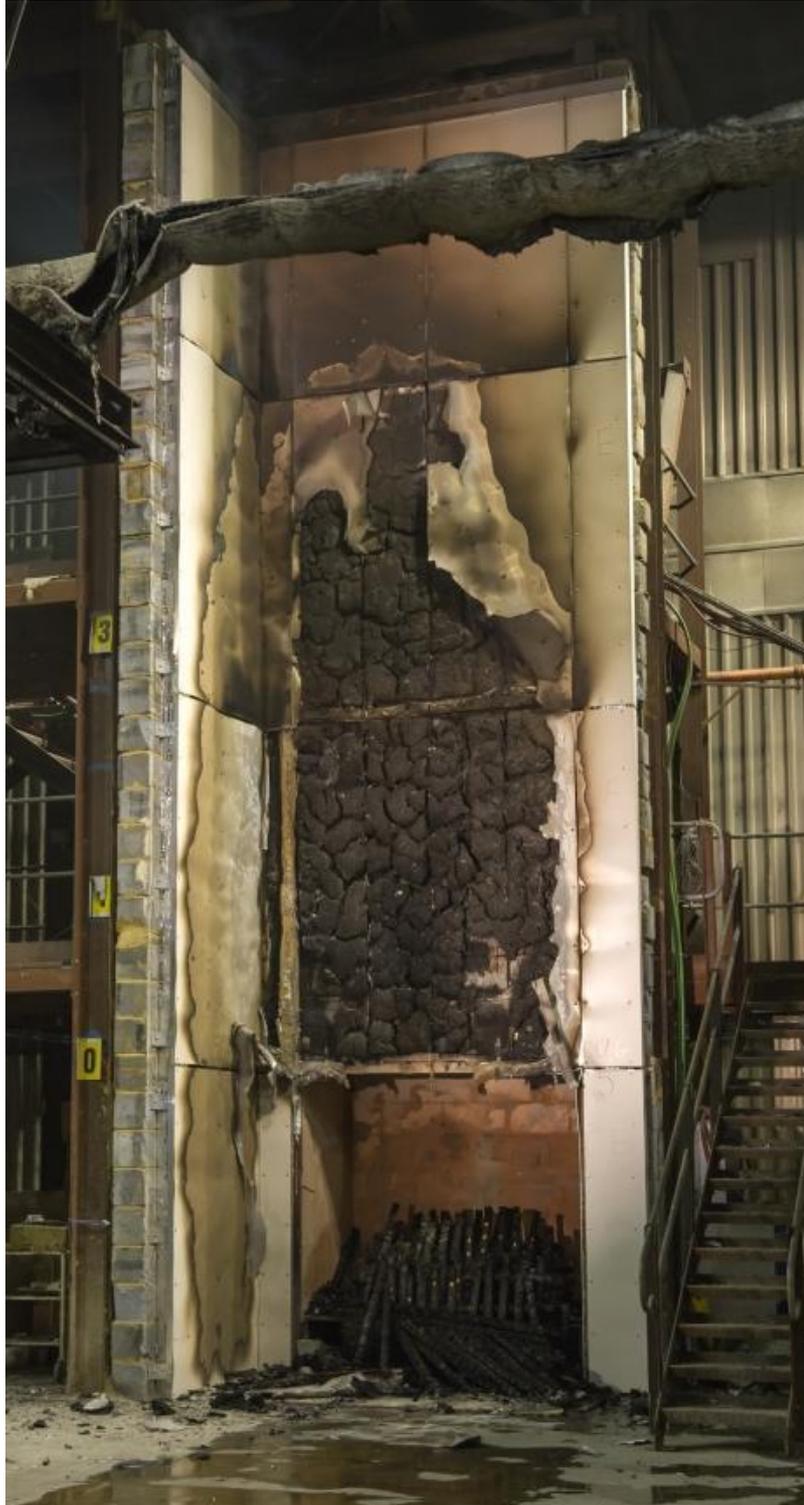
The cladding system was significantly damaged up to the height of the third horizontal cavity barrier – see *Figures 22-33*. The extent of the damage increased from black discolouration of the ACM panels at the edges of the flame damage zone to complete consumption of panels, rail substructure, substantial charring and detachment of the insulation across the full width of the combustion chamber opening up to a height of approximately 4600mm – see *Figures 22-33*. The wing wall was less severely damaged than the main wall with slight insulation charring adjacent to the main wall up to a height of approximately 4600mm above the combustion chamber, one area (<0.05m²) of partial panel consumption, and significant panel discolouration and distortion below the height of the third cavity barrier which reduced in severity towards the top of the cladding system – see *Figures 24-32*.

Significant discolouration and distortion was sustained by panels: 2B (85%), 2C (100% of remaining panel), 2D (40% - immediately adjacent to the area of panel consumption a damaged strip with an area approximately 0.9m² was present) – see *Figures 22, 23&27*.

Figure 22. Full height photograph of system post-test – general.

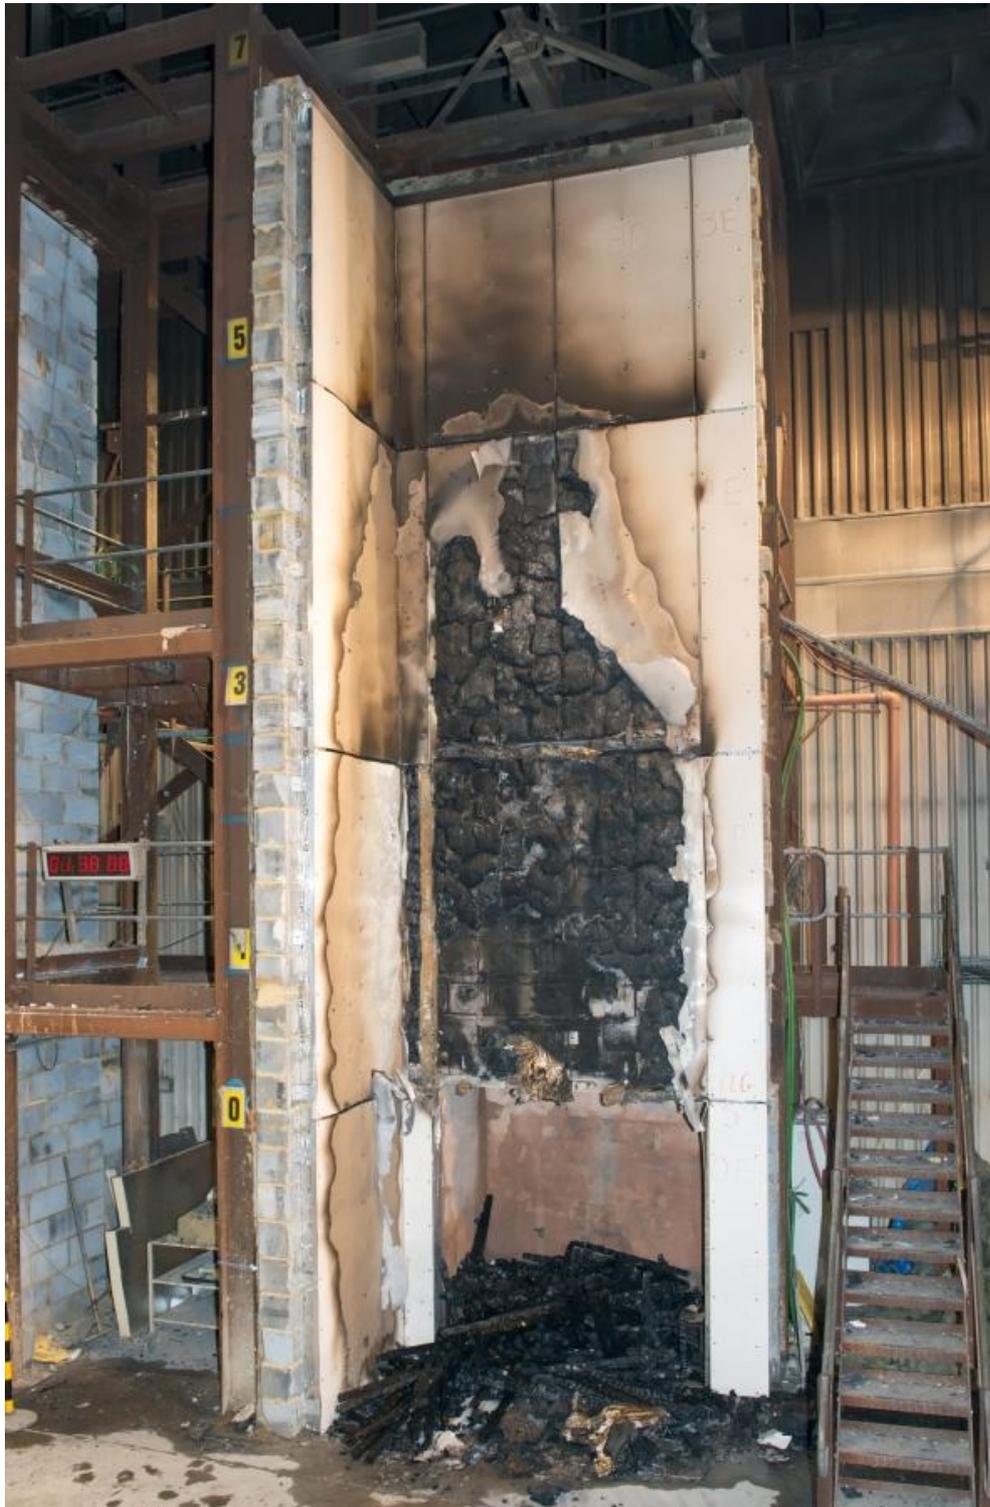
Figure 23. Full height photograph of system following post-test damping down procedures.

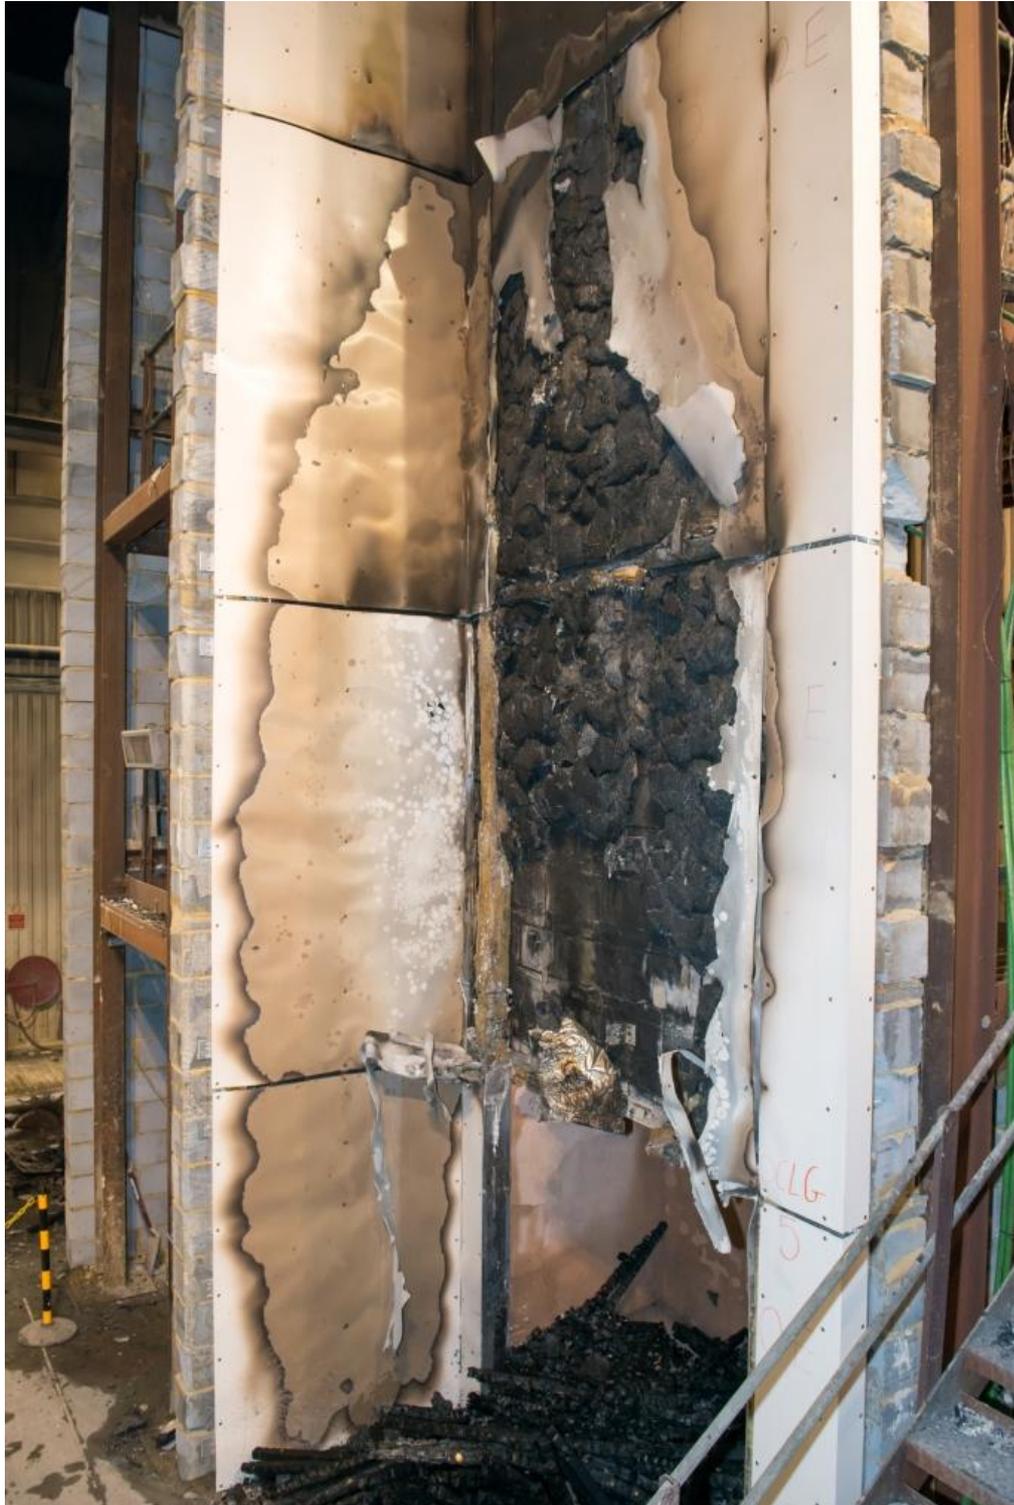
Significant discolouration and distortion was sustained by panels: 0A (75%), 1A (80%), 2A (50%) and 3A (5%) – see *Figures 24-29*. The damaged area tapered, in the direction of the main wall, from within 100mm of the outer edge of the wing wall (approximately 1300mm above the height of the combustion chamber) to the wing-main wall junction at the top of panel 2A.

Figure 24. Photograph of system post-test – wing wall.

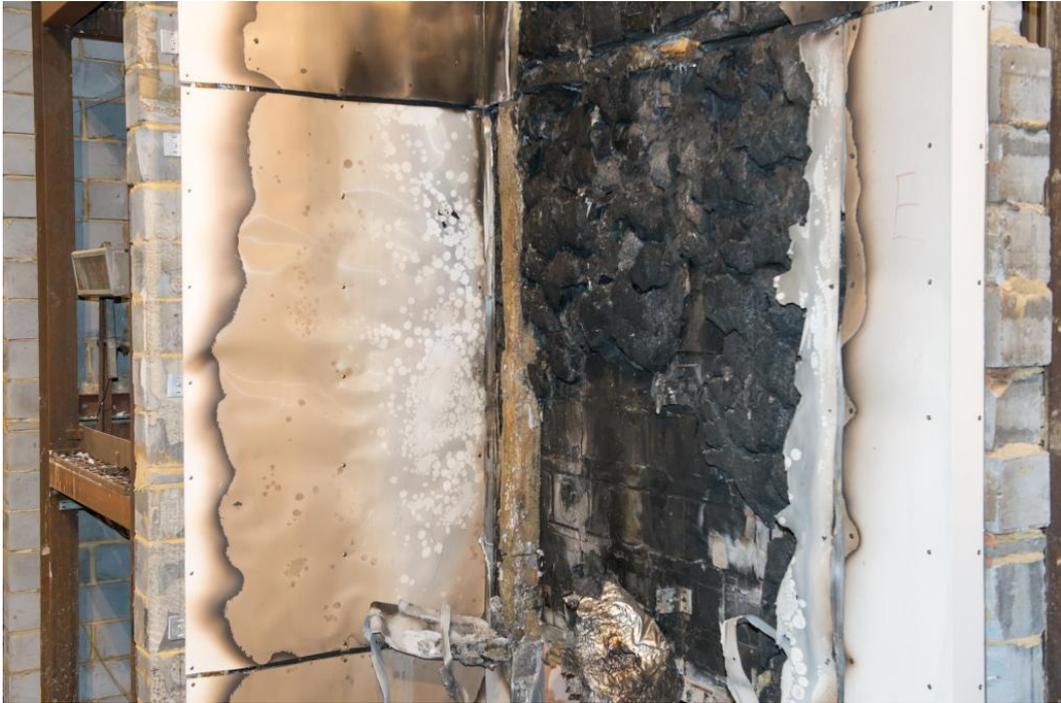
Figure 25. First row ACM panels (directly above combustion chamber).

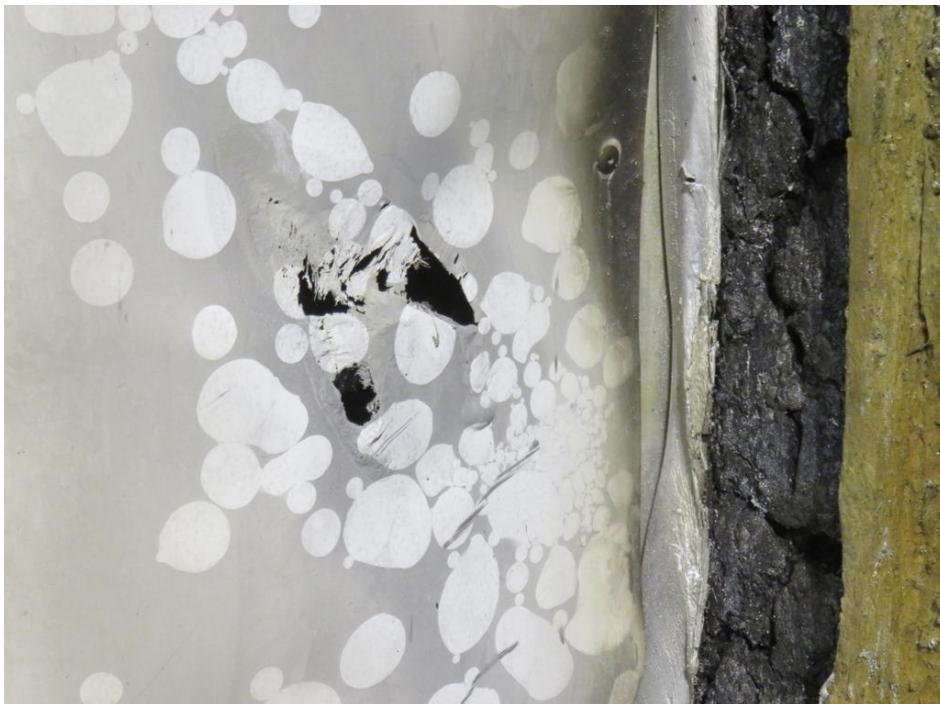
Figure 26. Close up view of partial panel consumption on the wing wall.

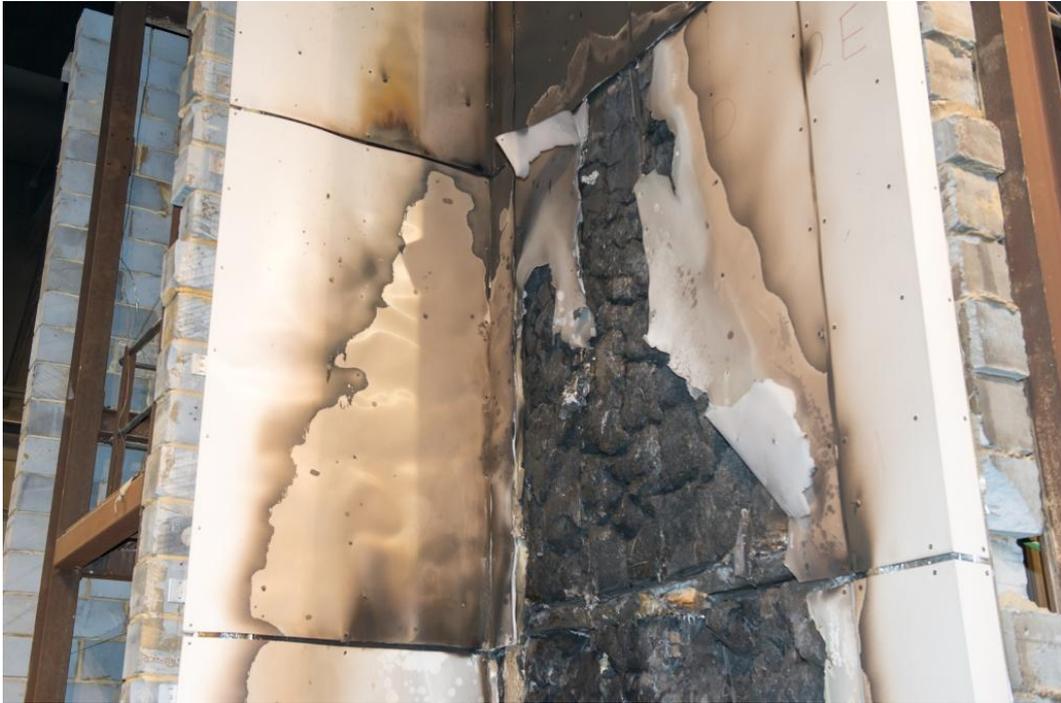
Figure 27. Second row ACM panels (approximately 2300mm-4600mm above combustion chamber).

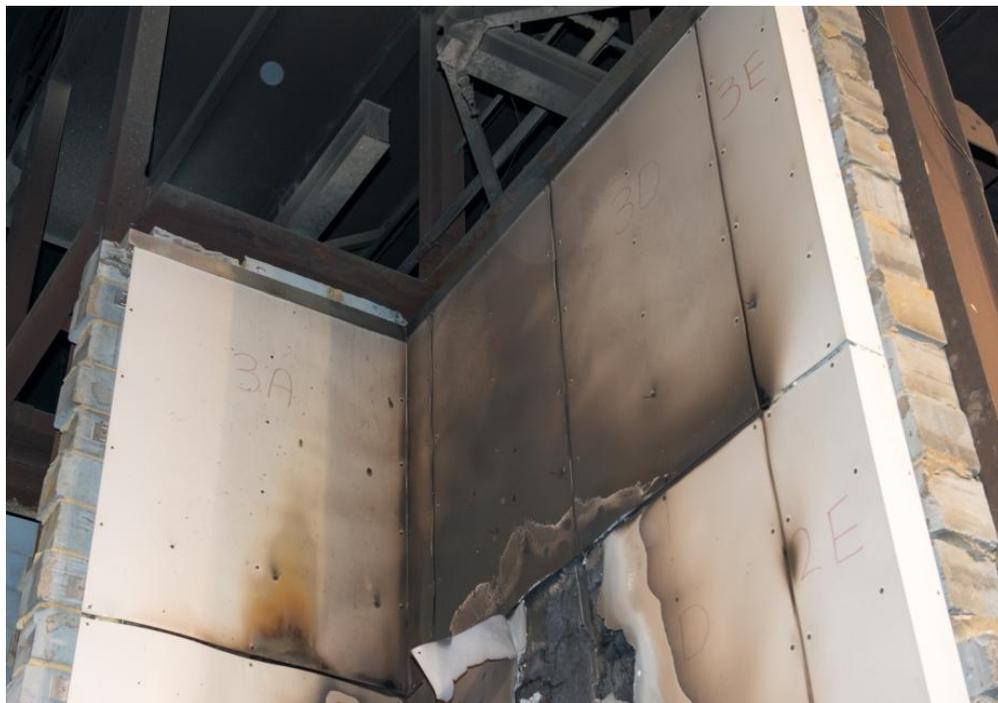
Figure 28. Third row ACM panels (approximately 4600mm-6500mm above combustion chamber).

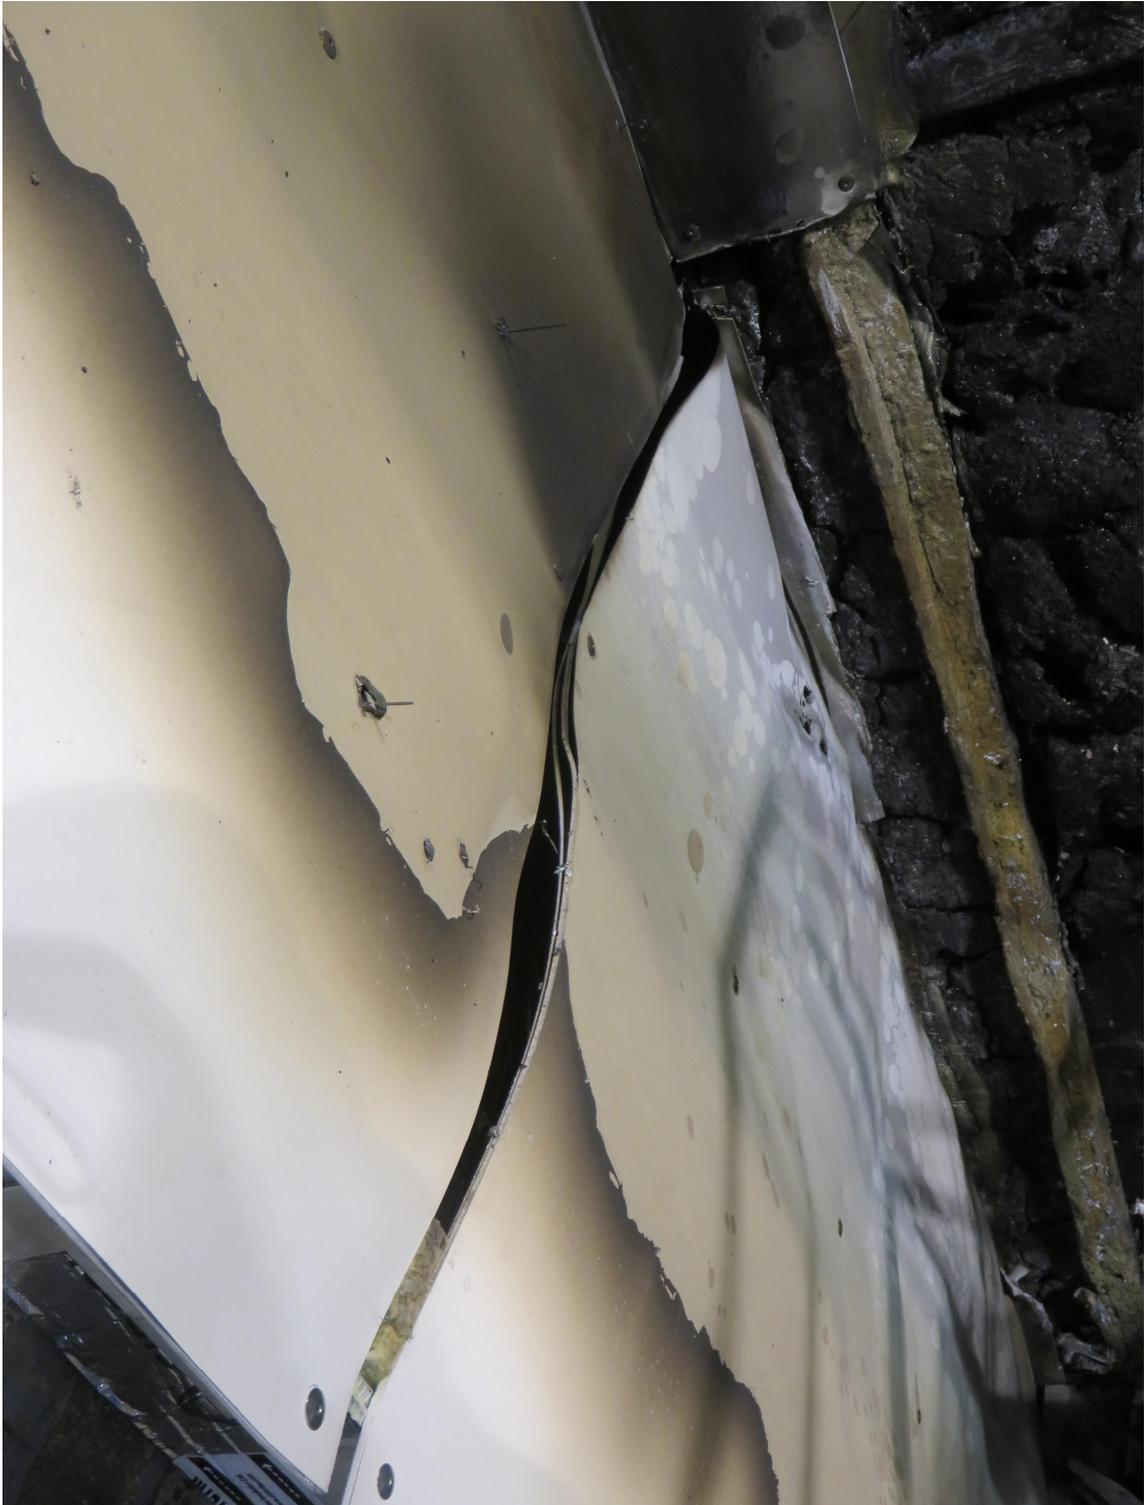
Figure 29. Distortion and delamination of ACM panel 1A – note some filler material remains intact.

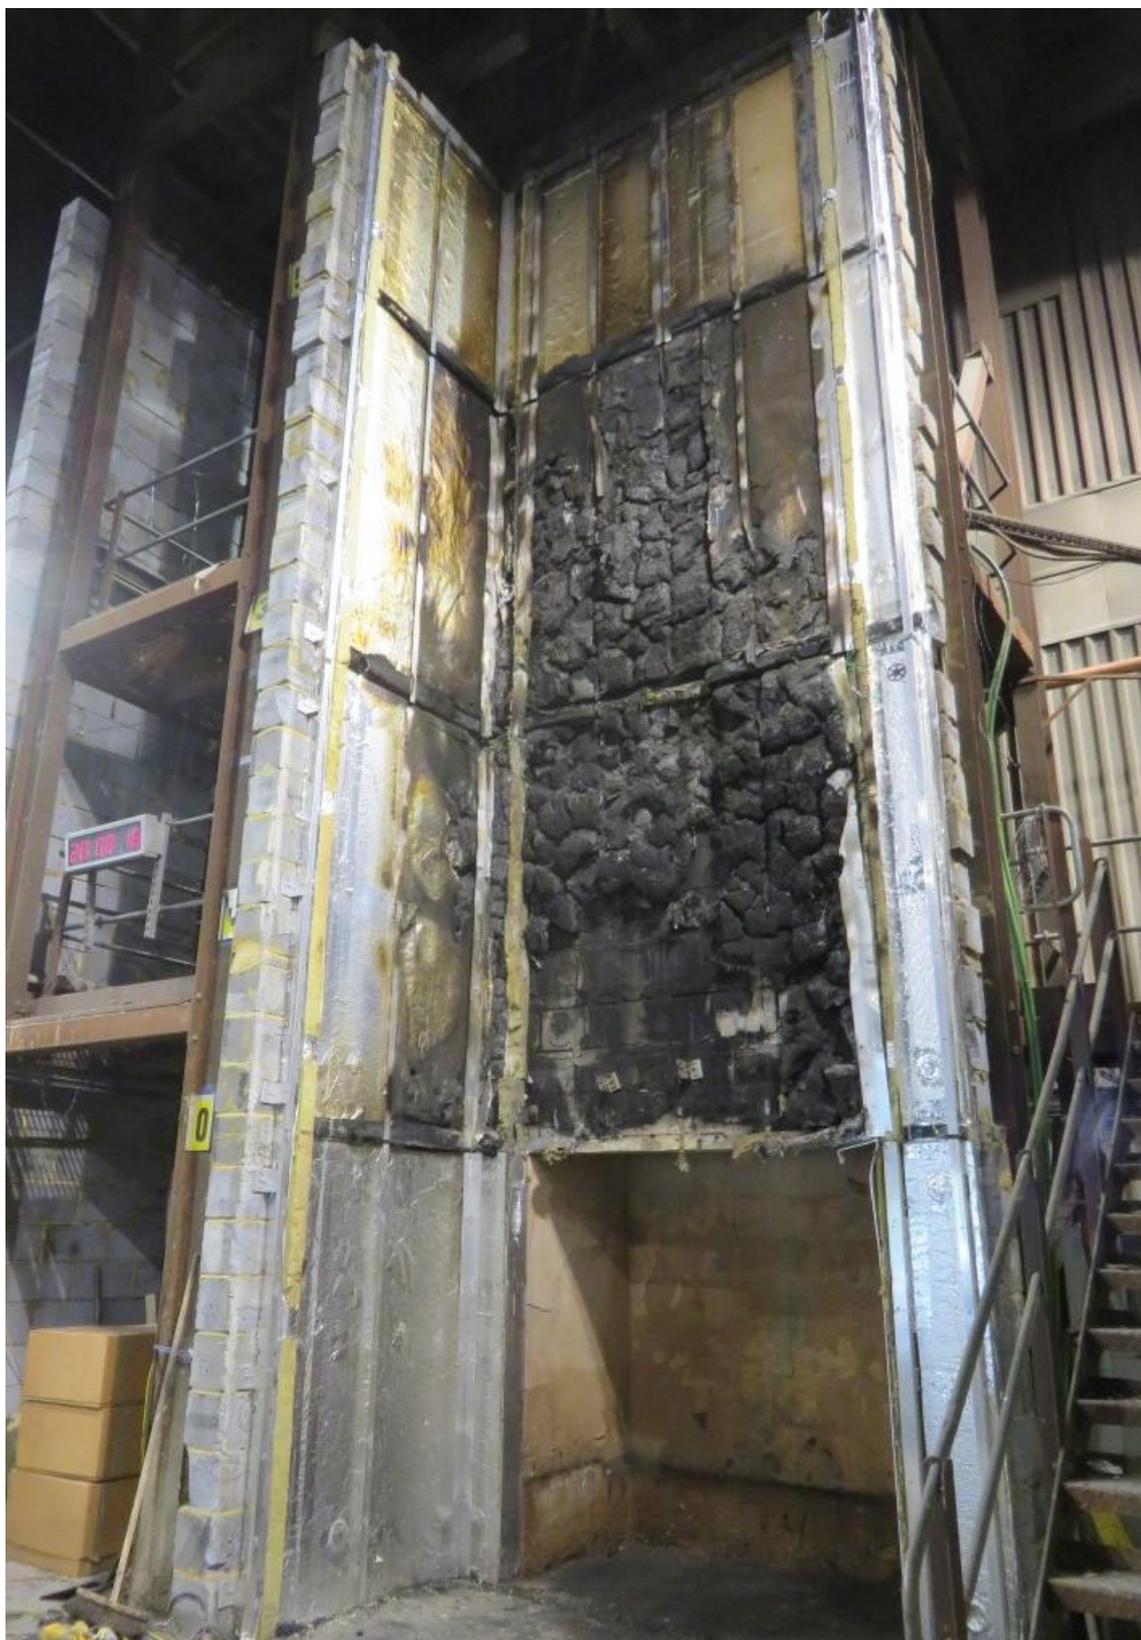
Damage to the rail substructure was most severe on the main wall with the five sections spaced evenly across the combustion chamber opening sustaining significant consumption below the height of the third cavity barrier – see *Figures 30-33*. At 500mm intervals from the edge of the combustion chamber adjacent to the wing wall the following damage occurred:

Damage to the rail substructure on the wing wall was far less severe – see *Figures 30-33*. Between the first and second cavity barrier, the 'L'-rail at the centre of panel 1A sustained five isolated areas of dark discolouration – see *Figure 31*. Between the second and the third cavity barrier, two isolated areas of dark discolouration were observed approximately at mid-height – see *Figure 32*. The rail substructure above this suffered minor discolouration and, at the outside edge of the vertical cavity barrier (full-height, main and wing wall) no damage was visible - see *Figures 30-33*.

- 0E-3E, damage to the insulation was not observed beyond the vertical cavity barrier – see *Figures 30-33*.

Figure 30. Full height photograph of system following removal of ACM panels.

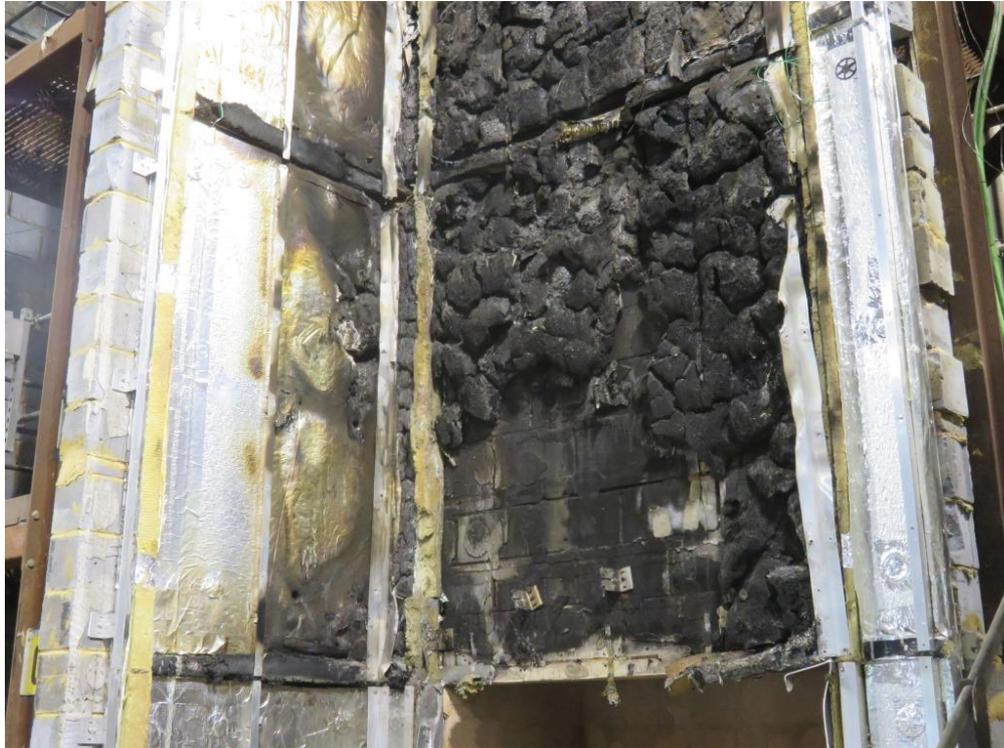
- 1B-2B, charring of the insulation ranged from 30mm-depth at 1B to a peak of 75mm-depth at the mid-height of 2B– see *Figures 31&32*.
- 3B-3D, light discolouration of the foil facing was the extent of the damage – see *Figure 33*.

Figure 31. Damage to cladding system beneath ACM panels directly above combustion chamber.

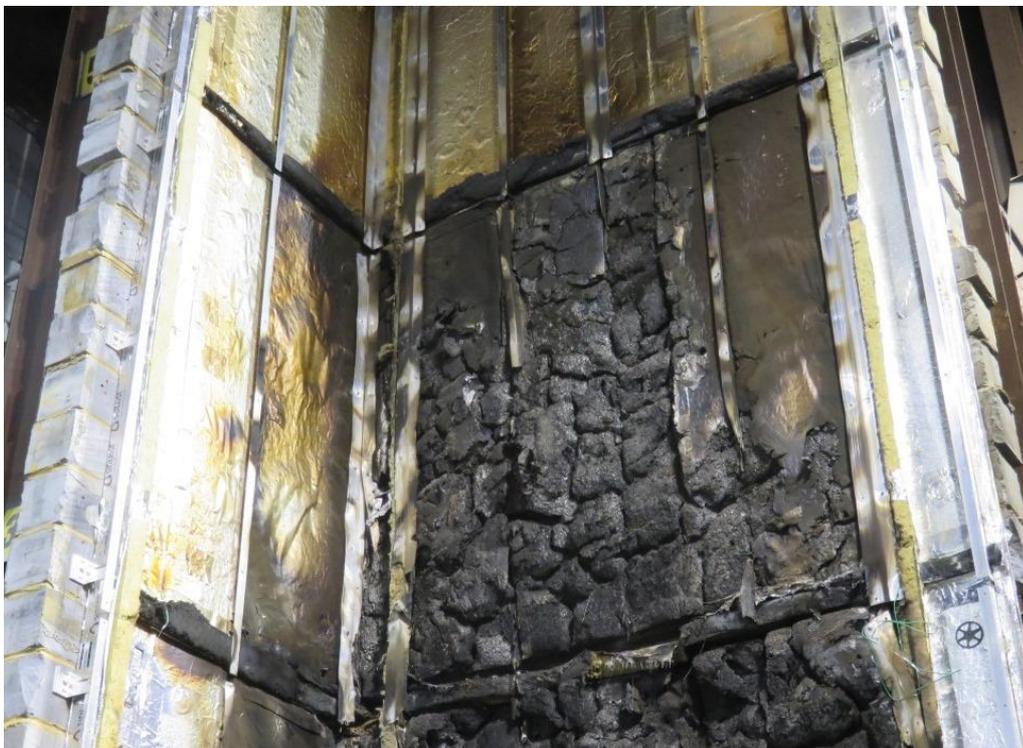
- 2A, the foil facing was blistered and discoloured between the central 'L'-section and the main wall. Minor discolouration and blistering was the extent of damage to the remainder of the insulation panel – see *Figure 32*.
- 3A, minor discolouration to the foil facing was the extent of damage – see *Figure 34*.

The second row horizontal cavity barrier shows evidence of activation but by test termination all expanded material directly in line with the combustion chamber opening had been consumed and the barrier had started to slump – see *Figures 32&34*. The section of cavity barrier at the outside edge, beneath panel 2E, displays the initial signs of activation. On the wing wall, full width activation of the cavity barrier is evident: from the outside edge to $\frac{3}{4}$ -width the intumescent material fills the void, towards the main wall the intumescent material has detached and deteriorated – see *Figure 32*.

Figure 32. Damage to cladding system beneath ACM panels between the second and third horizontal cavity barrier (approximately 2400-4700mm above combustion chamber).

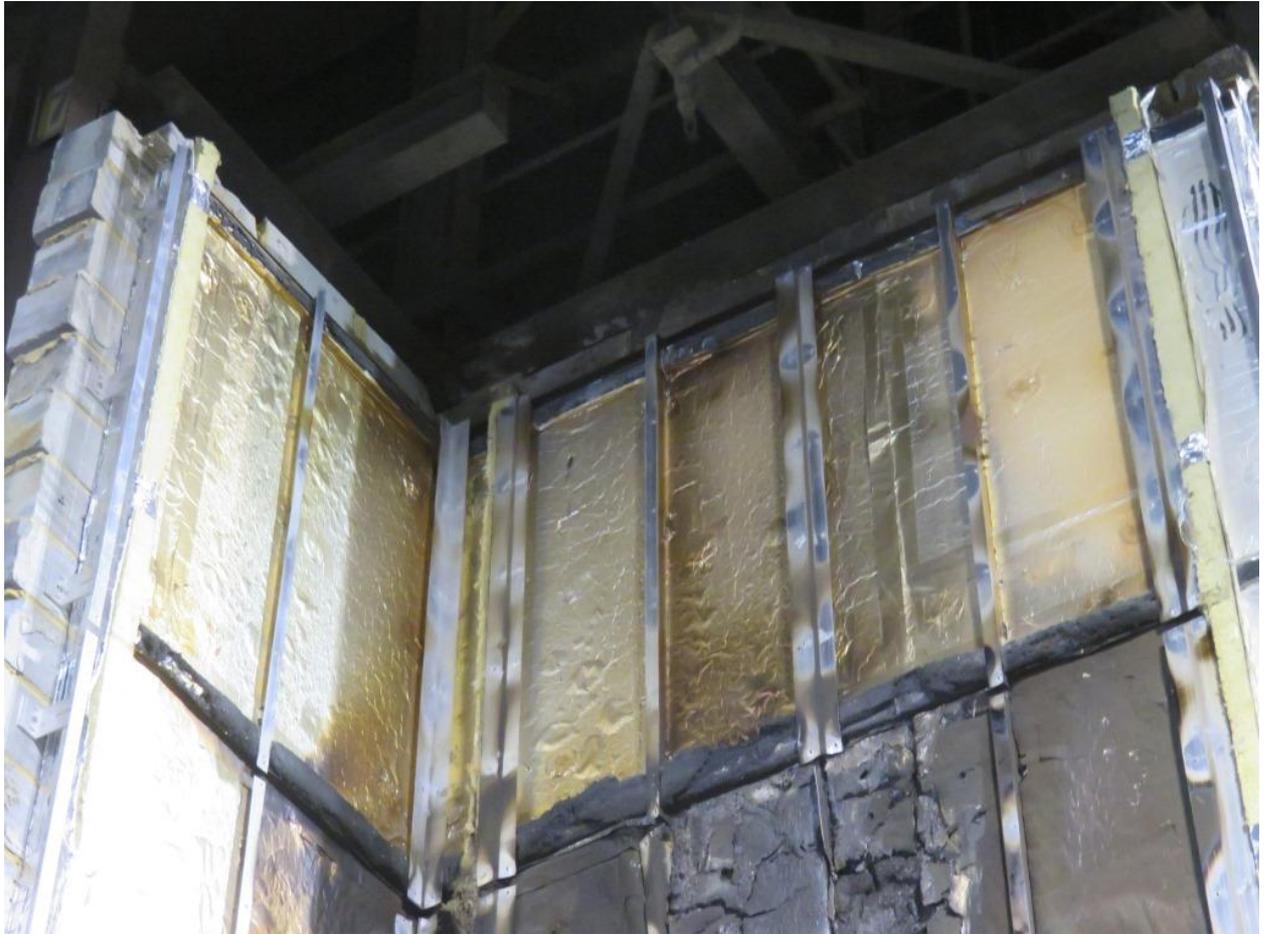
Figure 33. Damage to cladding system beneath ACM panels between the third and fourth horizontal cavity barrier (approximately 4700-6400mm above the combustion chamber).

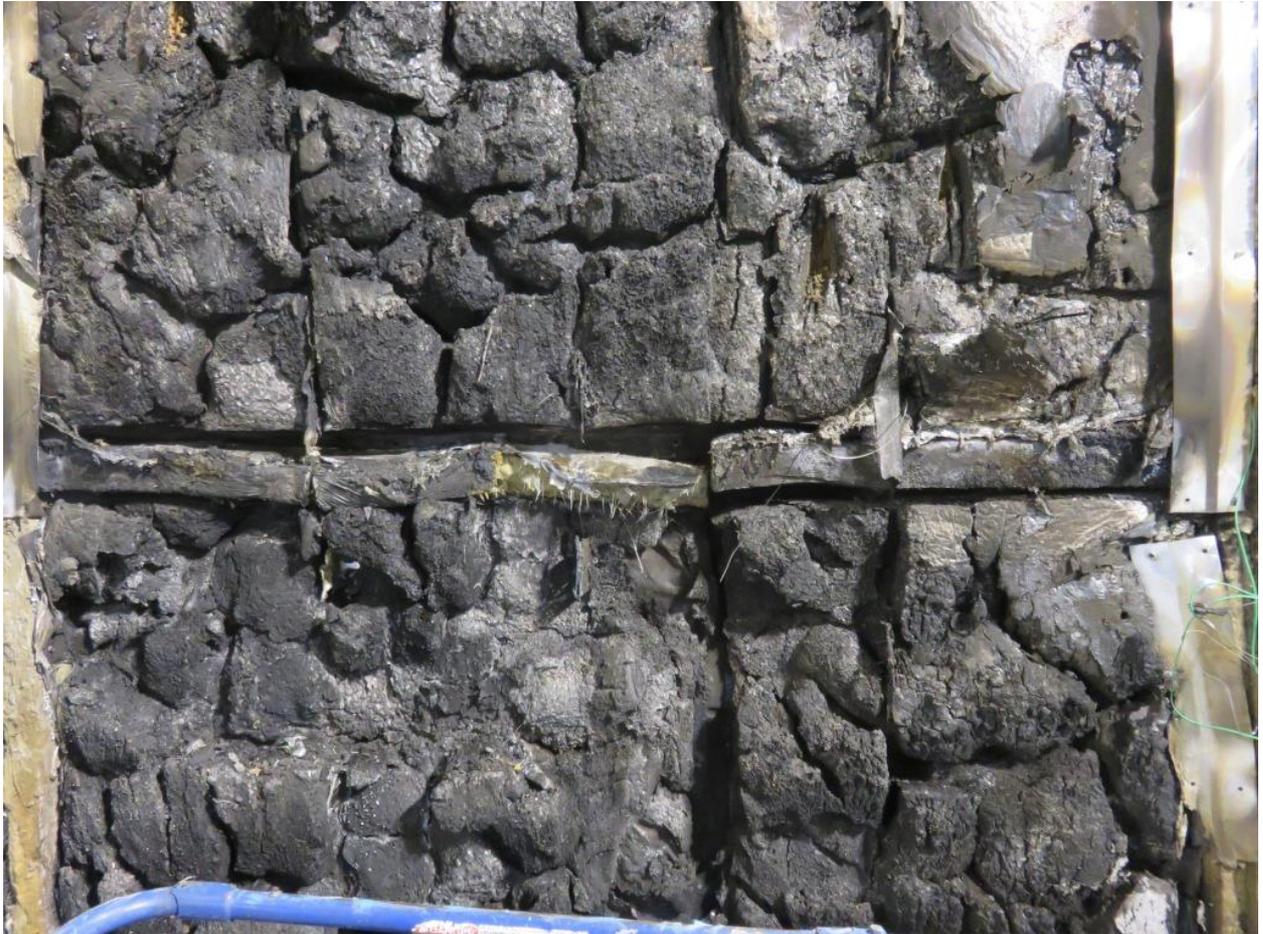
Figure 34. Close up of second cavity barrier in line with the combustion chamber opening.

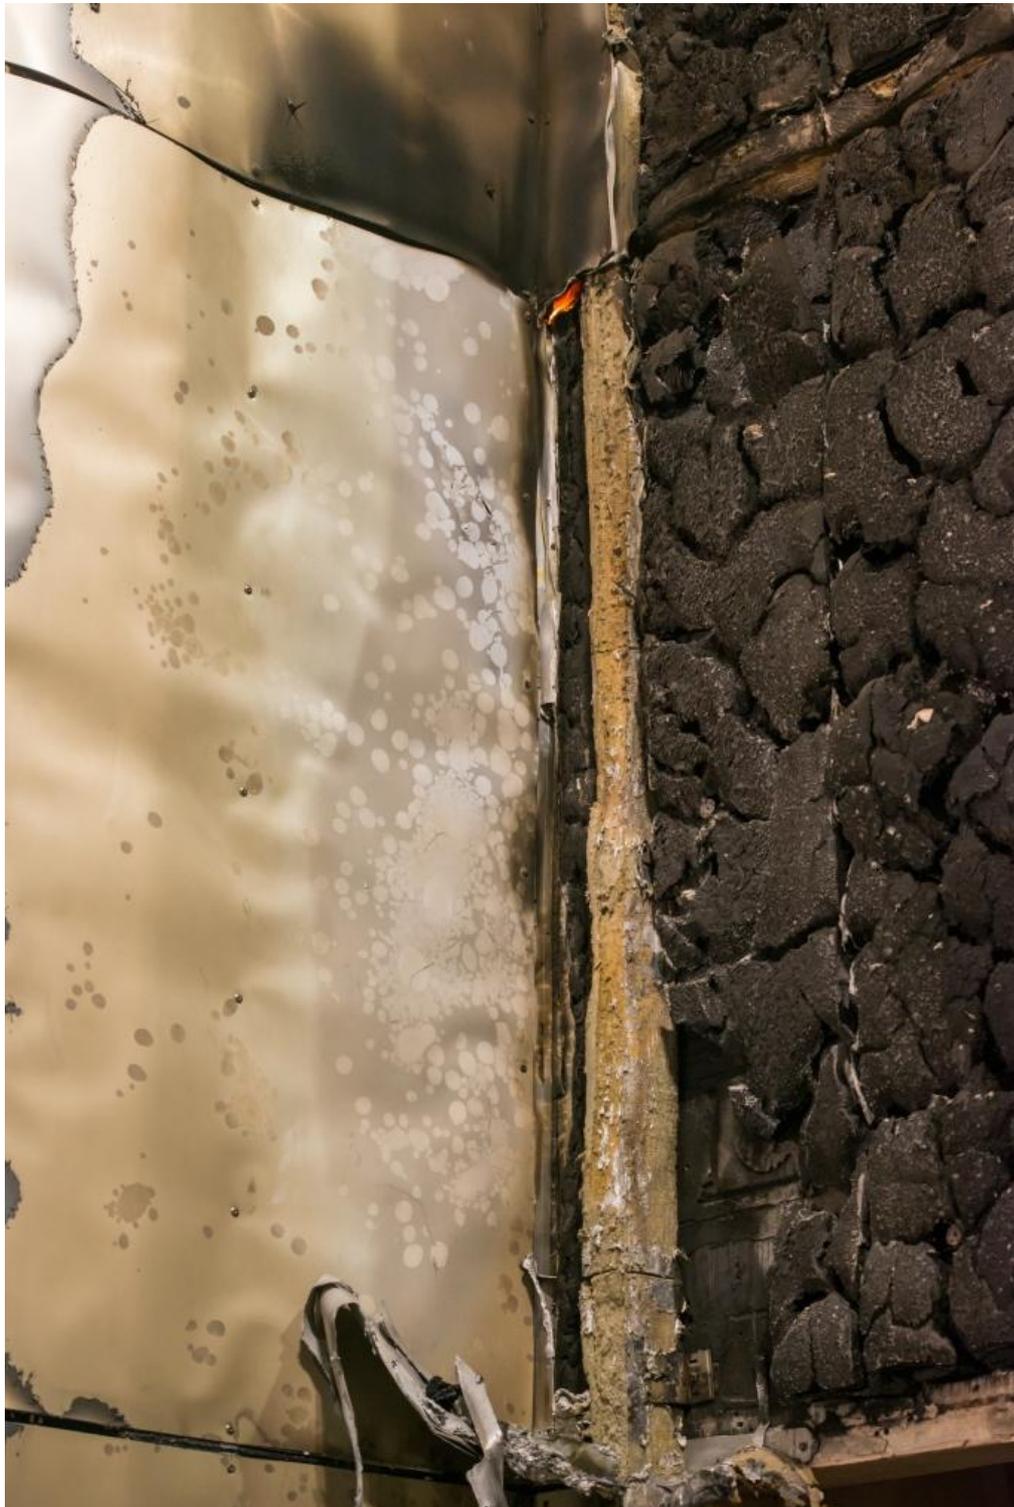
Figure 35. Close up of vertical cavity barrier adjacent to the wing wall directly above the combustion chamber (photograph taken during the 30-60 minute test period).
