MARINE ACCIDENT INVESTIGATION BRANCH

FLYER TO THE SHIPPING INDUSTRY Entering Dangerous Enclosed/Confined Spaces

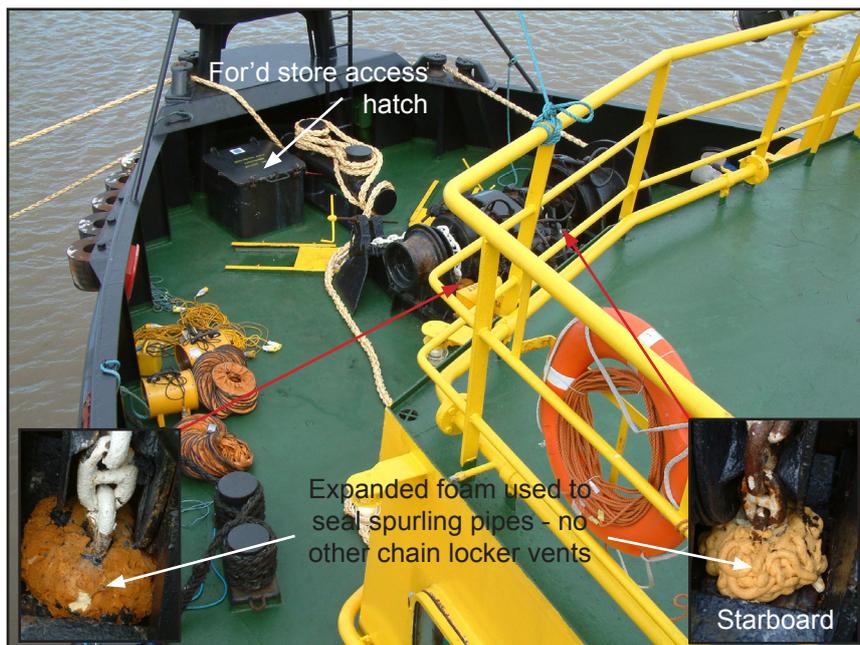
While attempting to secure a rattling anchor chain within the chain locker, one seaman collapsed. The supervisor raised the alarm and then entered the chain locker to rescue his shipmate; he too collapsed. Both men died as a result of the oxygen deficient atmosphere inside the chain locker; this was due to the natural on-going corrosion of the steel structure and anchor chain.

A simple inspection, taking only a few minutes, would have shown that this chain locker was effectively a tank, made air tight by expanding foam used to seal the spurling pipes. Even without the expanding foam this chain locker was a potentially dangerous enclosed/confined space, and a formal safe entry procedure should have been followed.
