## FISHING ACCIDENT FLYER

### VESSEL LOST FOLLOWING A FIRE

July 2006

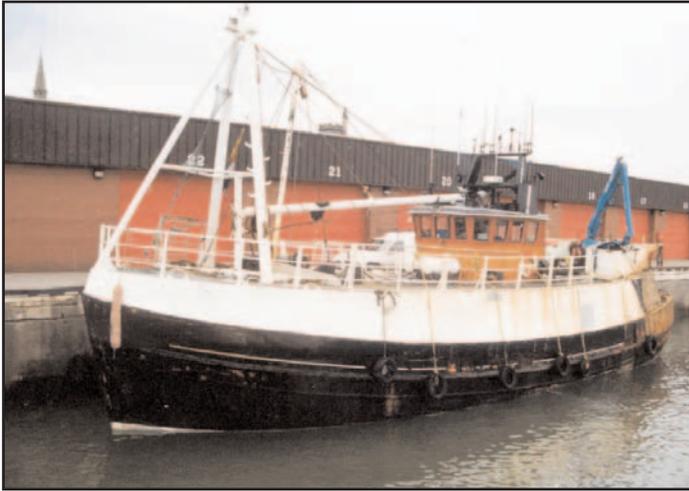
A 20m wooden fishing vessel suffered an engine room fire, thought to be caused by a fault in the electrical system. The emergency engine and fuel shut off systems did not operate correctly, and the engine had to be stopped by fouling the propeller with a rope. The fire was severe, and with dense smoke escaping from the engine room, the skipper sent a “Mayday” and evacuated his crew to the liferaft. They were all safely rescued by a nearby fishing vessel responding to the “Mayday” call.

1. Electrical systems and insulation material should be checked carefully to minimise the risk of fire.
2. Emergency engine and fuel system shut down arrangements should be tested regularly and repaired if they do not operate correctly.
3. Engine rooms should be checked to ensure that they can be fully closed down in a fire situation to prevent smoke spreading and to give CO<sub>2</sub> drench systems the maximum chance of success.
4. Do not put yourself back into danger by returning to the scene of a fire too soon. Re-opening a compartment causes air to enter, which can then allow a fire to re-ignite. Engine room fires may require many hours to cool before re-entry can be safely made. Compartment re-entry should be attempted by properly trained firefighters with the correct fire-fighting equipment and breathing apparatus.
