FISHING ACCIDENT FLYER

VESSEL LOST FOLLOWING A FIRE

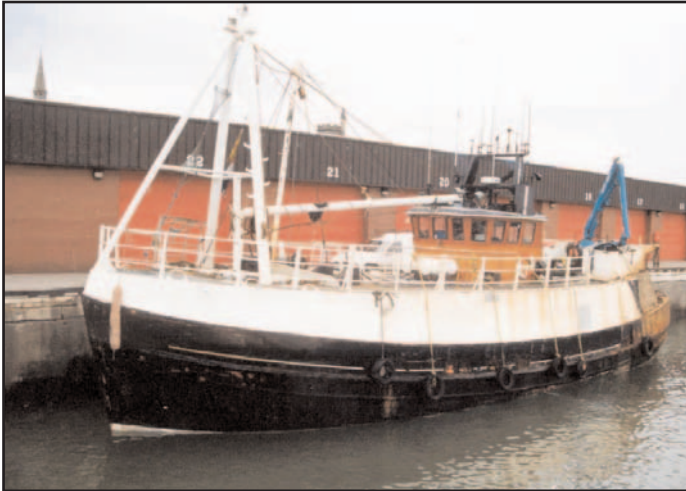
A 20m wooden fishing vessel suffered an engine room fire, thought to be caused by a fault in the electrical system. The emergency engine and fuel shut off systems did not operate correctly, and the engine had to be stopped by fouling the propeller with a rope. The fire was severe, and with dense smoke escaping from the engine room, the skipper sent a “Mayday” and evacuated his crew to the liferaft. They were all safely rescued by a nearby fishing vessel responding to the “Mayday” call.

1. Electrical systems and insulation material should be checked carefully to minimise the risk of fire.
2. Emergency engine and fuel system shut down arrangements should be tested regularly and repaired if they do not operate correctly.
3. Engine rooms should be checked to ensure that they can be fully closed down in a fire situation to prevent smoke spreading and to give CO₂ drench systems the maximum chance of success.
4. Do not put yourself back into danger by returning to the scene of a fire too soon. Re-opening a compartment causes air to enter, which can then allow a fire to re-ignite. Engine room fires may require many hours to cool before re-entry can be safely made. Compartment re-entry should be attempted by properly trained firefighters with the correct fire-fighting equipment and breathing apparatus.
